McINTOSH PERRY

COMBINED LATERAL SEWER CCTV INSPECTION

**637 CUMMINGS AVENUE
OTTAWA, ONTARIO**

Tuesday, May 17, 2022

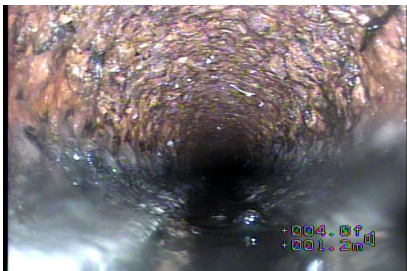
Figure#3: A view to the 0% water level, grease and surface wear large due to corrosion at 1.2 meters.

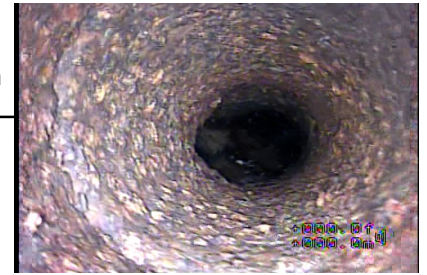
Figure#2: A view to the line deviation downwards at 0.0 meters. Notice the rough surface in the pipe wall.

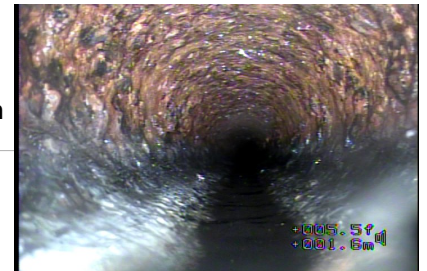
Figure#4: A view to the Surface Wear Large due to corrosion and grease at 1.6 meters from the top of the floor CO.

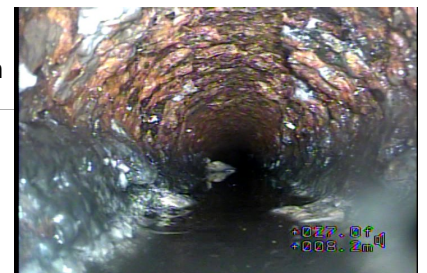
Figure#6: A view to the Pipe wall falling apart due to surface wear large at 8.2 meters from the top of the floor CO.

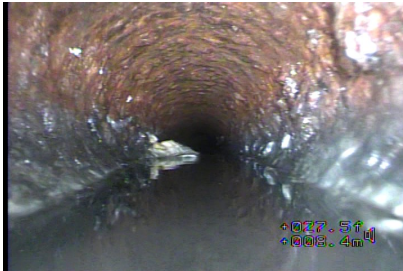
Figure#7: A view to the 10% water level and debris ragging at 8.4 meters from the top of HALLWAY FLOOR CO.

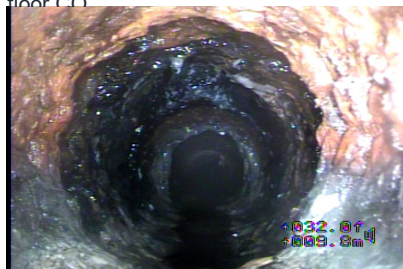
Figure#9: A view to the diameter change to 150mm and 12 o'clock connection at 9.8 meters from the top of floor CO.

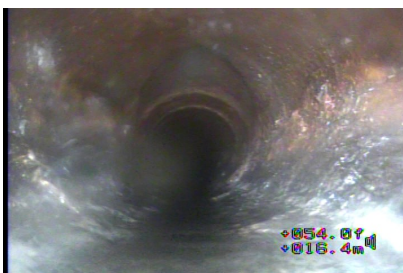
Figure#11: A view to the 150mm 12 o'clock connection at 16.4 meters from the top HALLWAY FLOOR CO.

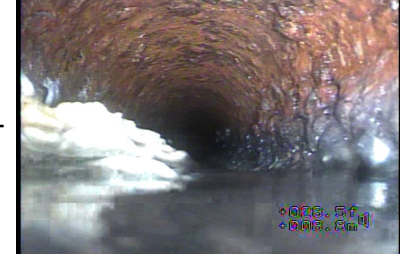
Figure#8: A view to the 10 % Debris ragging at 9.8 meters from the top of HALLWAY FLOOR CO.

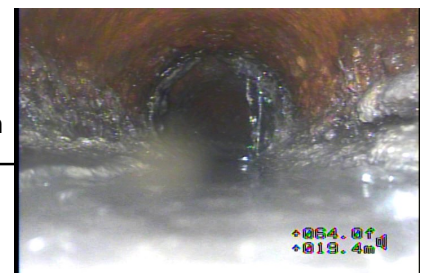
Figure#12: A view to the 100mm 12 o'clock connection at 19.4 meters from the top HALLWAY FLOOR CO.

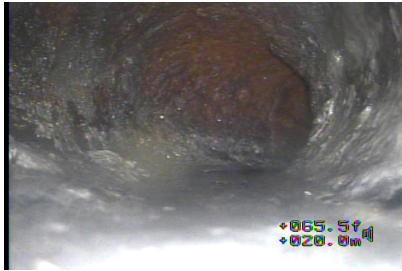
20.0 m

Figure#13: A view to the right line deviation at 20.0 meters from the top of HALLWAY FLOOR CO.

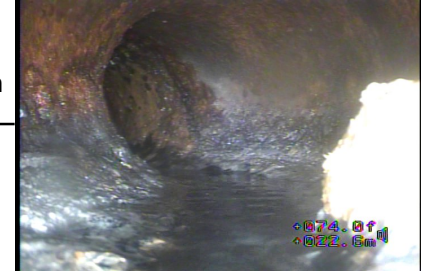
22.6 m

Figure#14: A view to the left line deviation at 22.6 meters from the top of HALLWAY FLOOR CO.

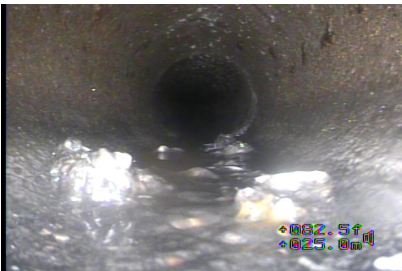
25.0 m

Figure#15: A view to the 150mm 12 o'clock connection at 25.0 meters from the top HALLWAY FLOOR CO.

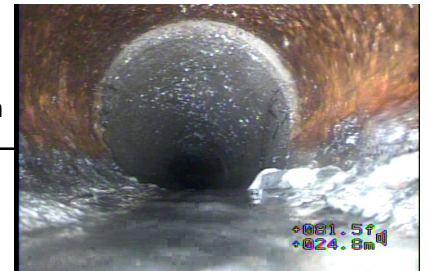
24.8 m

Figure#16: A view to the material change to Asbestos cement at 24.8 meters from the top of HALLWAY

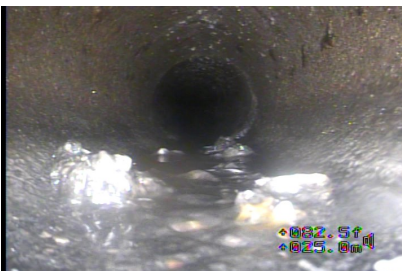
25.0 m

Figure#17: A view to the 10 % Debris ragging and sediment at 25.0 meters from the top of HALLWAY FLOOR CO.

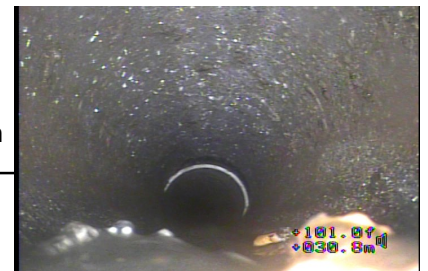
30.0 m

Figure#18: A view to the line deviation downwards at 30.0 meters from the top of HALLWAY FLOOR CO. Angular

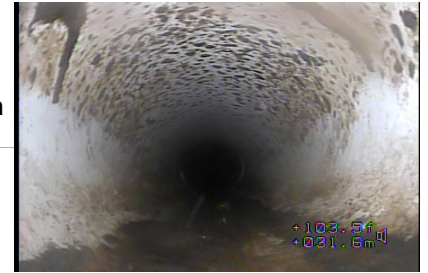
Figure#20: A view to the material change to PVC at 31.2 meters from the top of HALLWAY FLOOR CO.
