to:	10869279 Canada Inc. - Mr. Martin Chénier - chenierm@live.ca
re:	Environmental Remedial Action Plan Proposed Residential Development - 1649 Montreal Road & 741 Blair Road, Ottawa, Ontario
date:	January 24, 2022
file:	PE5061-RAP.01
from:	Nick Sullivan

Remedial Action Plan/Soil Quality Assessment

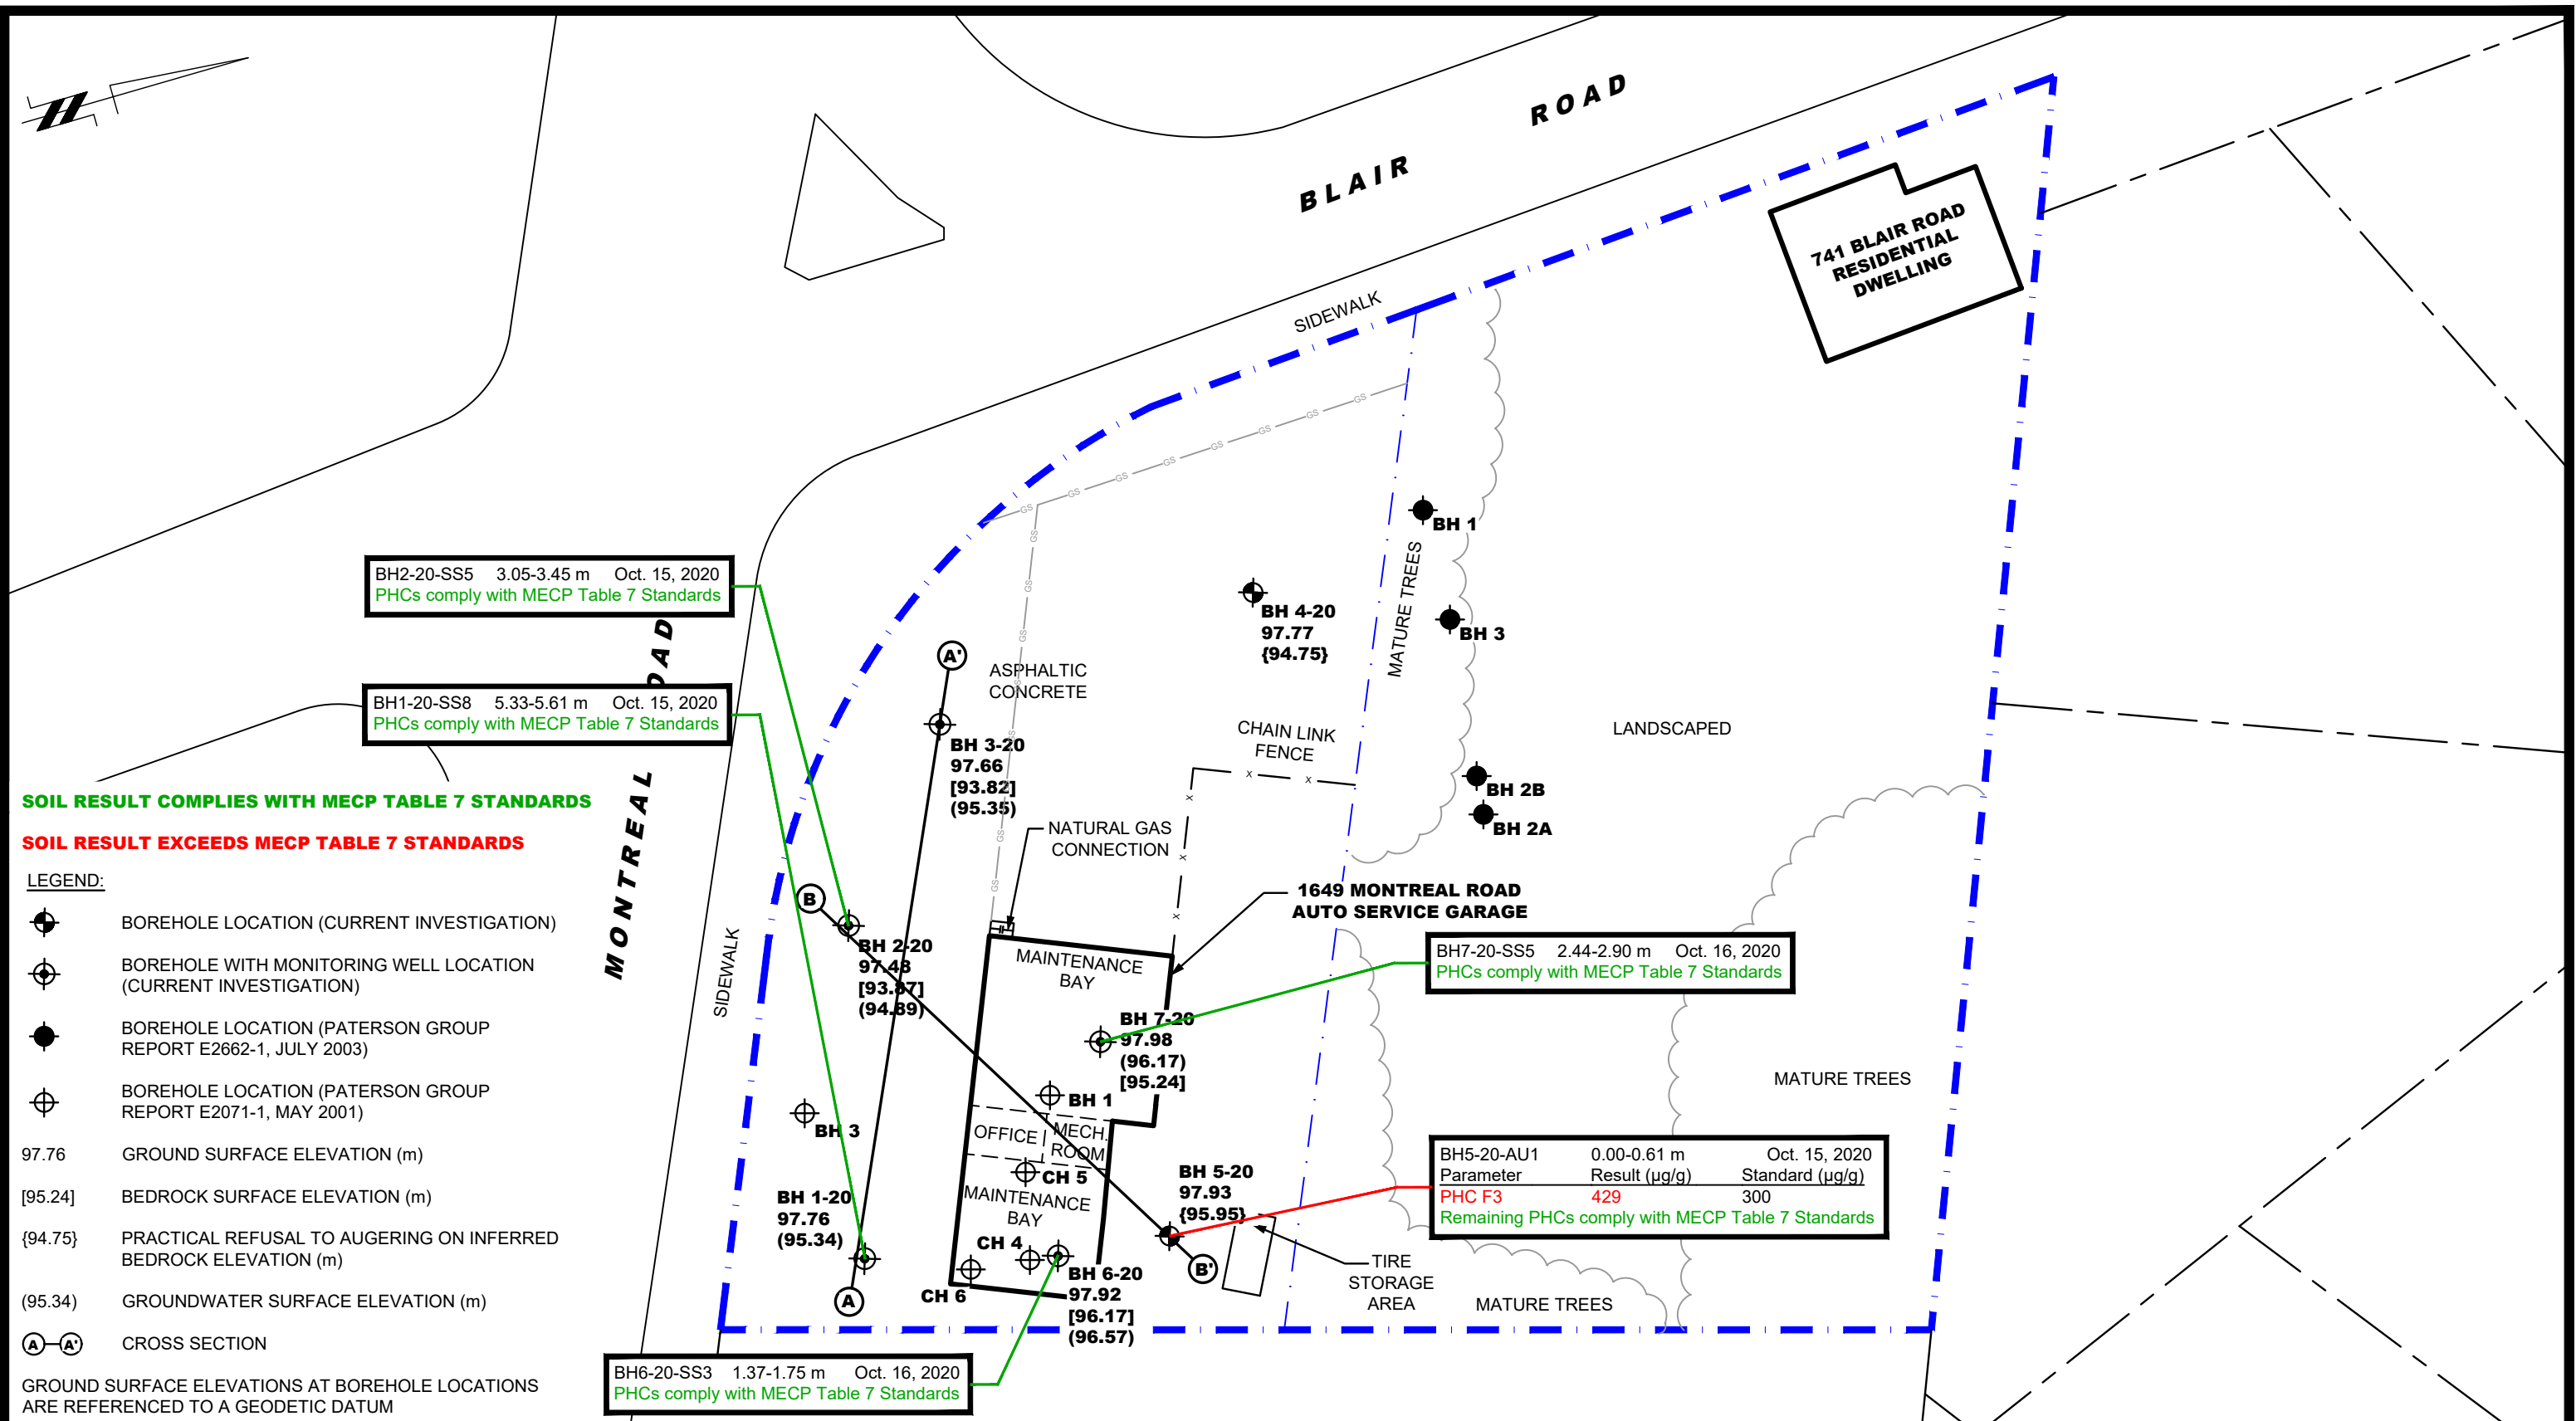
10869279 CANADA INC.
 PHASE II - ENVIRONMENTAL SITE ASSESSMENT
 1649 MONTREAL ROAD AND 741 BLAIR ROAD
 OTTAWA, ONTARIO
 Title: **ANALYTICAL TESTING PLAN - SOIL (PHCs)**

Nine (9) soil samples, recovered from the boreholes, were submitted for laboratory analysis of BTEX, PHCs (F1-F4), metals, and/or pH parameters. Based on the analytical test results, some petroleum hydrocarbon contamination was identified in the shallow layer of fill material (extending from ground surface to a depth of approximately 1.5 m) located at the rear of the auto service garage building.

BH5-20-AU1	0.00-0.61 m	Oct. 15, 2020
Parameter	Result (µg/g)	Standard (µg/g)
PHC F3	429	300
Remaining PHCs comply with MECP Table 7 Standards

The suggested action plan consists of a generic approach, where the excavation and removal of site soils will be undertaken. The suggested action plan is as follows:

- It is our understanding that the majority of the on-site soils will be removed during site re-development, and that the excavation will extend into the bedrock.

- Paterson personnel will be present on-site to monitor the excavation and removal of any impacted soils.
- Excavated soils will be screened using visual and olfactory observations as well as a portable soil vapour analyser. Field observations will be used in combination with the collection and analytical testing of interim confirmatory base samples for PHC parameters in the area of contamination.

- Any impacted soils identified will be placed in trucks and hauled to an approved waste disposal facility. A toxicity characteristic leaching procedure (TCLP) sample will be obtained and submitted for laboratory analysis prior to the transportation of any impacted soils to a licensed waste disposal site.
