September 28, 2022

220998

RE: LIMITED SUBSURFACE INVESTIGATION
PROPOSED PAVILION
6107 PERTH STREET, RICHMOND
CITY OF OTTAWA, ONTARIO

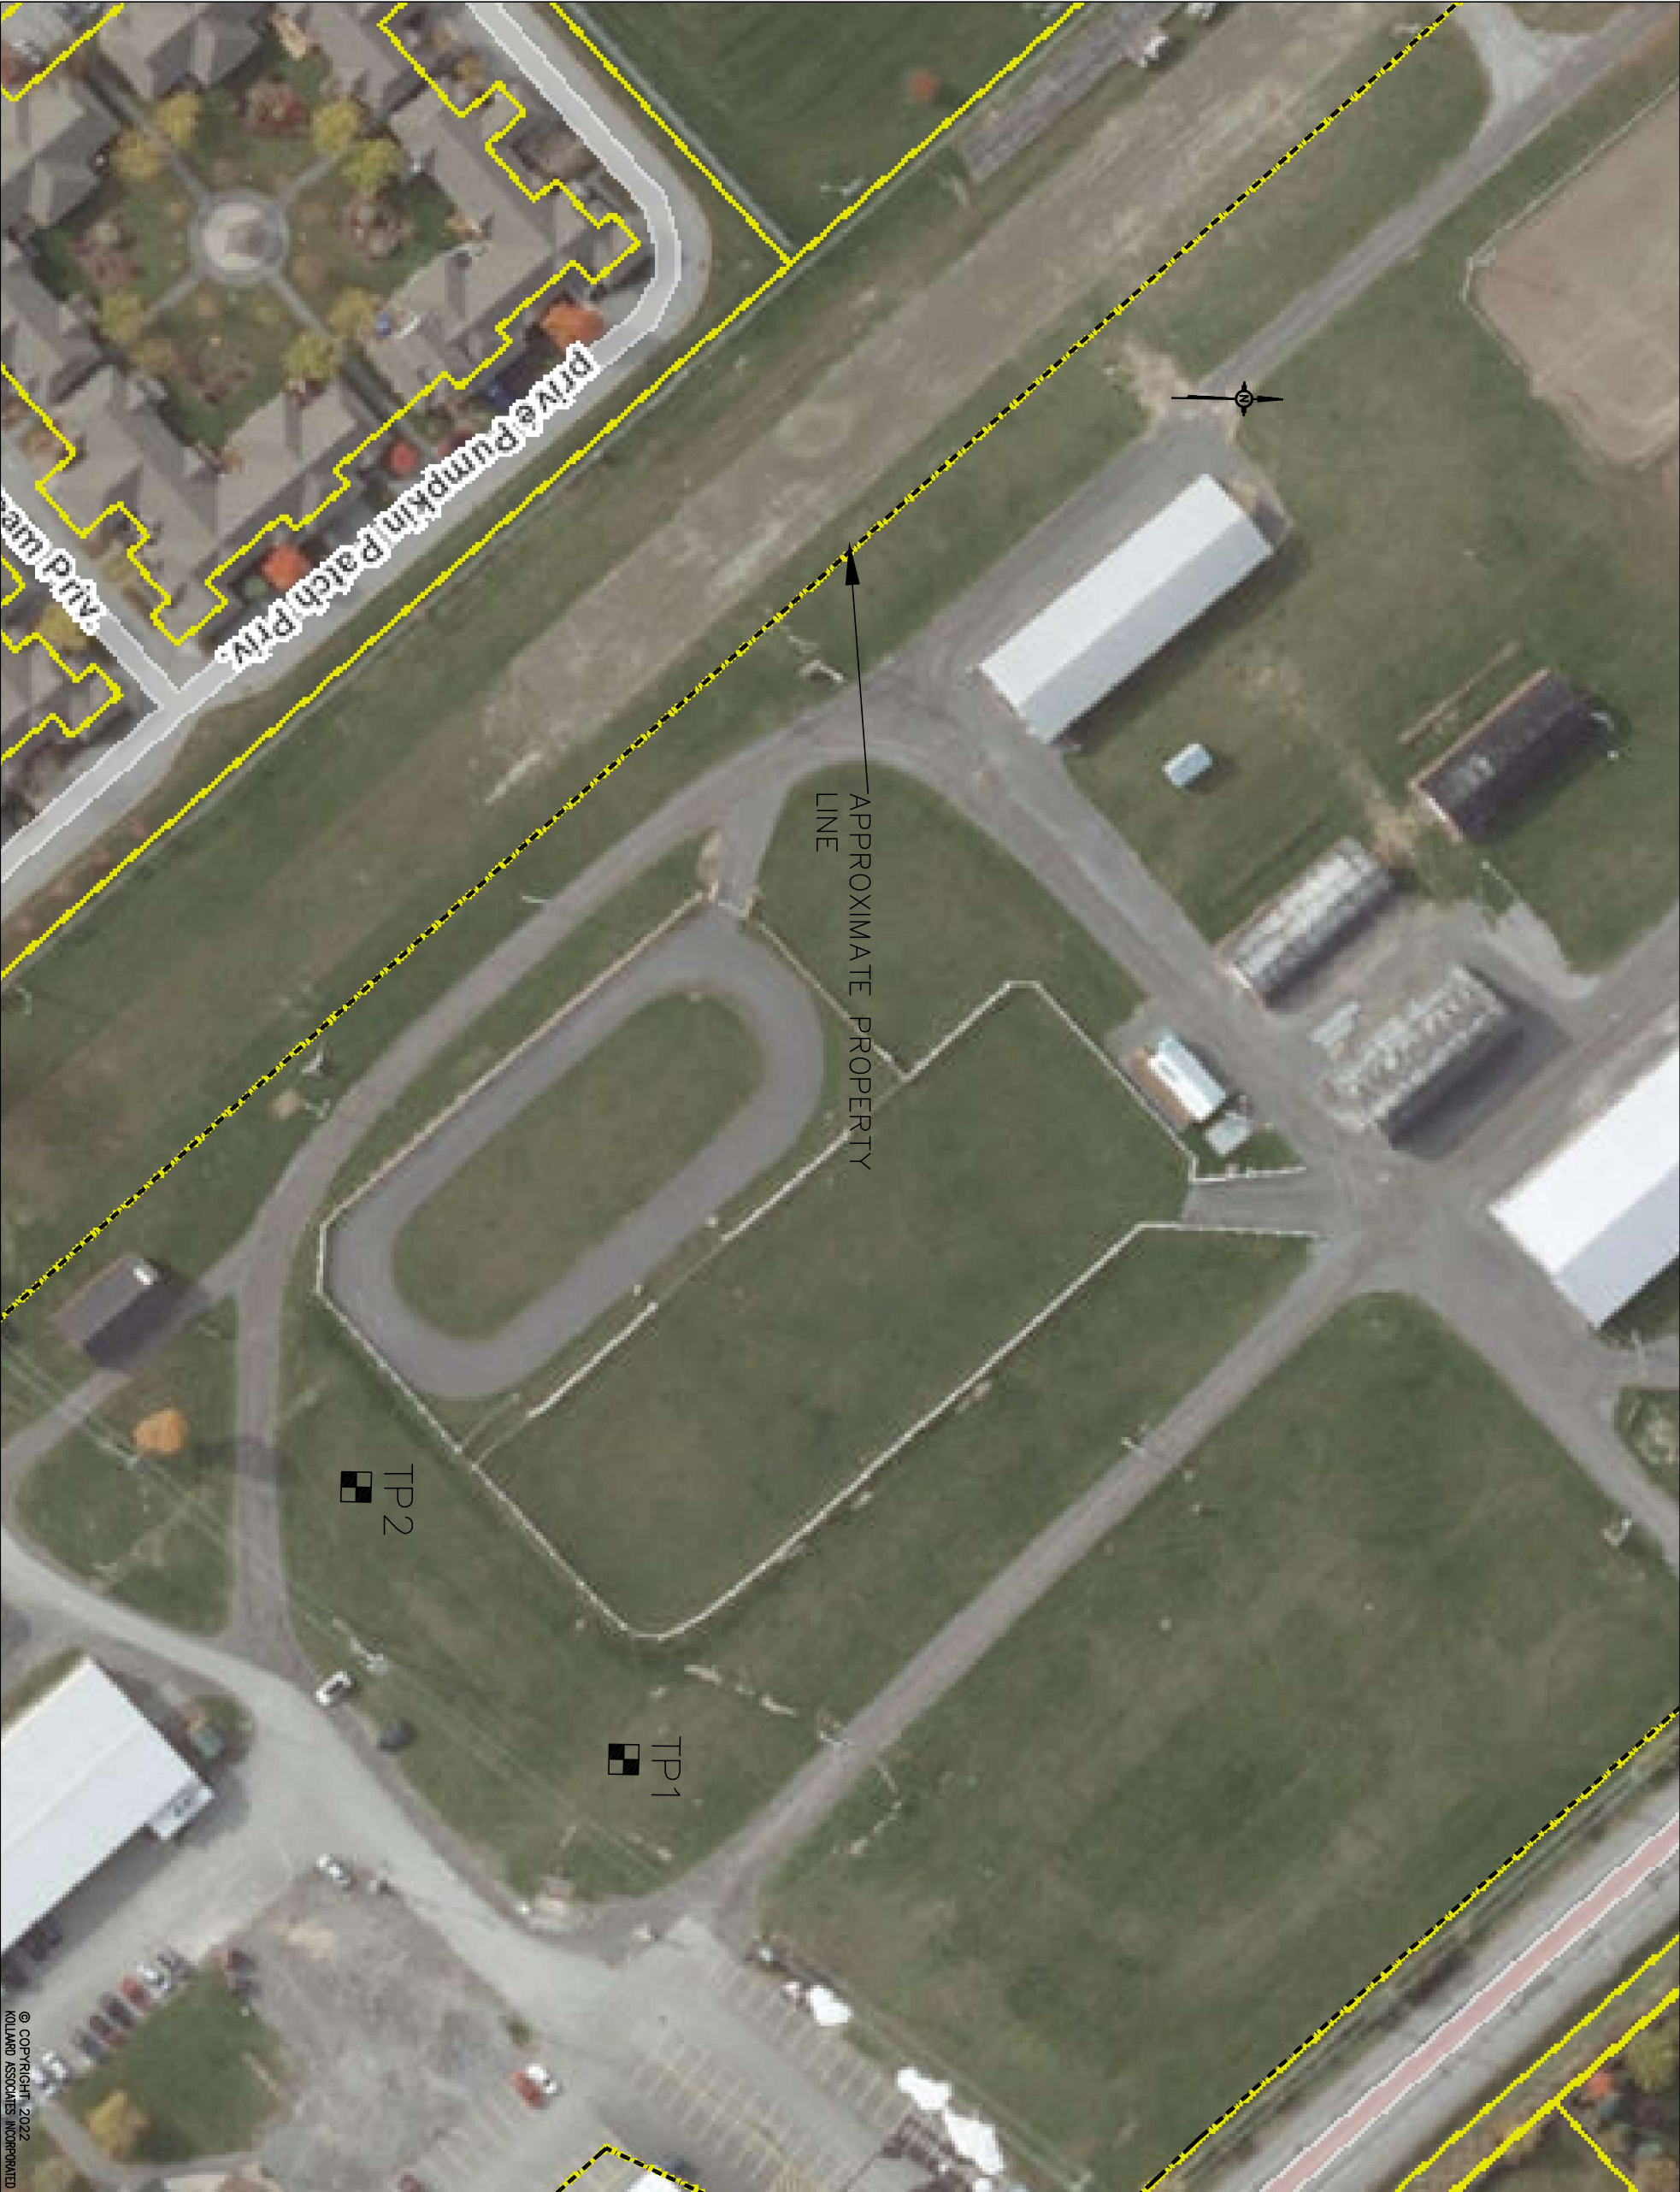
DRAWING NUMBER:
SITE PLAN, FIGURE 2

The field work for this investigation was carried out on September 27, 2022 at which time observations were made within two test pits (TP1 and TP2) put down in the area of the proposed pavilion.

The location of the test pits for this investigation are shown on the attached Site Plan, Figure 2. The test pits were advanced to depths of about 3.3 metres below the existing ground surface using a track mounted excavator supplied and operated by a local excavation contractor. In situ shear vane tests were completed in the softer cohesive materials at various intervals when encountered. The soil conditions observed in the test pits were classified based on the in situ shear vane results, the difficulty of digging and on visual and tactile examination of the materials on the walls and bottom of the test pits. The groundwater conditions were observed in the open test pits at the time of the field work.

In general, the soil conditions encountered at the test pits consisted of about 0.3 metres of topsoil overlying yellow brown to grey brown to grey silty clay. Test pits TP1 and TP2 were terminated within the silty clay at depths of about 3.3 metres below the existing ground surface.

Some groundwater seepage was encountered at test pits TP1 and TP2 at depths of about 2.1 and 2.7 metres, respectively, below the existing ground surface. It should be noted that the groundwater levels may be higher during wet periods of the year. A detailed account of the subsurface conditions encountered in each of the test pits is provided in the attached Table I, Record of Test Pits.
