**ARBORIST REPORT FOR
401 SMYTH ROAD,
CITY OF OTTAWA, ONTARIO**

**CHILDREN'S HOSPITAL OF EASTERN ONTARIO-OTTAWA
CHILDREN'S TREATMENT CENTRE (CHEO)
1DOOR4CARE INTEGRATED TREATMENT CENTRE**

Date: August 2022
File: C21114

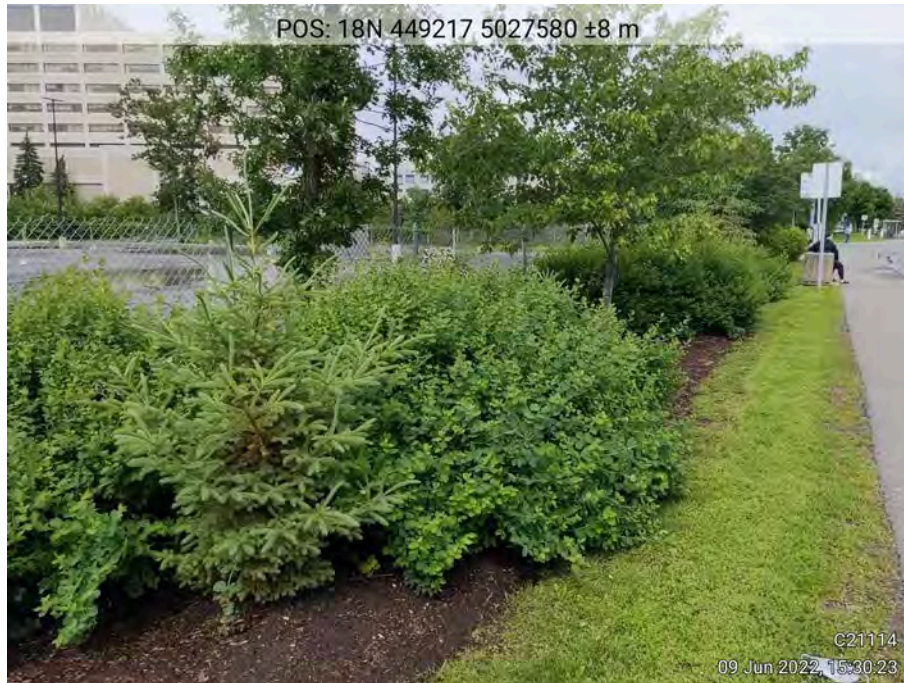
Photo 1: View east from sidewalk at landscaping along Ring Road.

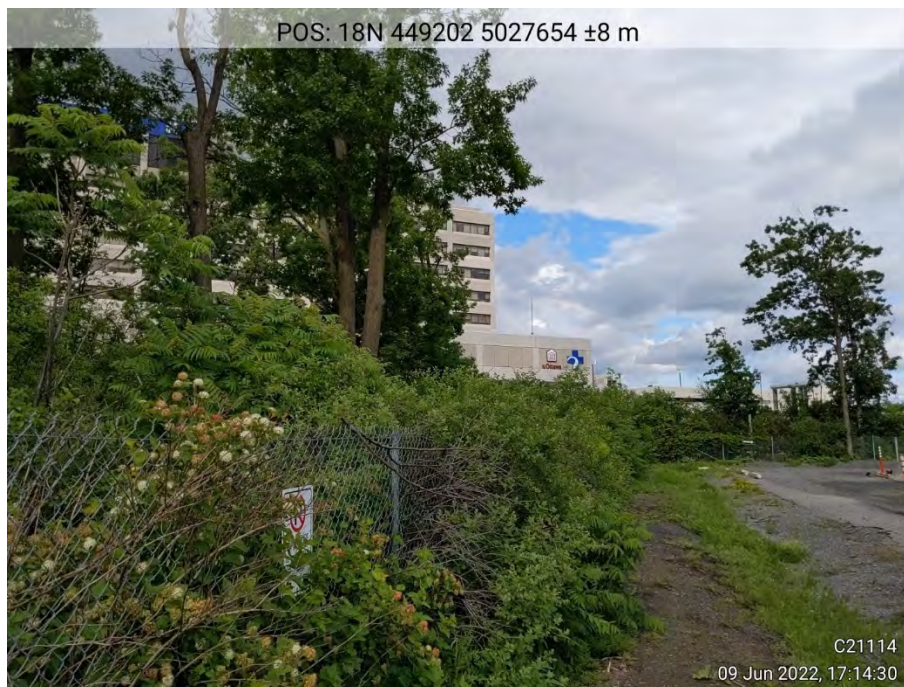
Photo 2: View of vegetation along north fence line of existing parking area and small oak woodlot feature north of existing parking lot

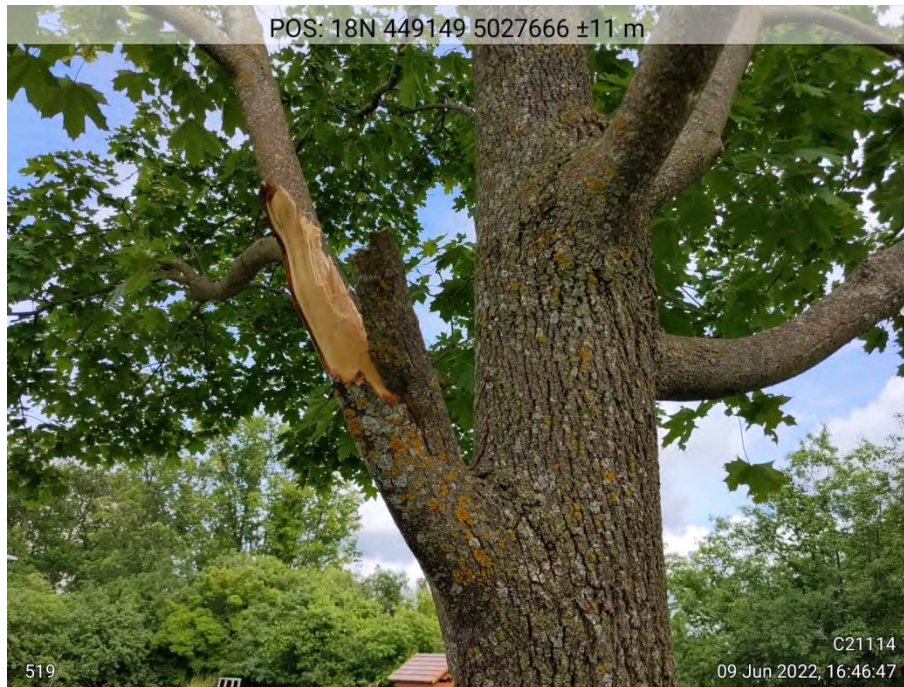
519	Norway Maple	<i>Acer platanoides</i>	Parking Structure	30	300	5	Good	Retain	Ripped lower limb	18T	5027666.601	449145.907
520	Norway Maple	<i>Acer platanoides</i>	Parking Structure	24	240	3	Fair	Retain	Union at 155cm, some dieback	18T	5027672.802	449139.649
521	Silver Maple	<i>Acer saccharinum</i>	Parking Structure	18	180	3	Good	Retain	Healed over frost crack	18T	5027667.516	449133.021
522	White Oak	<i>Quercus alba</i>	Parking Structure	54	540	7	Good	Retain	Some leaf wilt, good canopy.	18T	5027657.215	449145.774
523	Red Oak	<i>Quercus rubra</i>	Parking Structure	40	400	8	Good/Fair	Remove, grading	Buried root flare, 80% canopy, touching fence.	18T	5027646.617	449260.706
524	White Oak	<i>Quercus alba</i>	Parking Structure	28	280	4	Good	Remove, grading	90% canopy.	18T	5027590.175	449250.686
525	Red Oak	<i>Quercus rubra</i>	Parking Structure	42	420	6	Good	Retain	Good canopy condition, good taper.	18T	5027661.4	449204.913

Photo 3: Ripped limb damage on tree #519

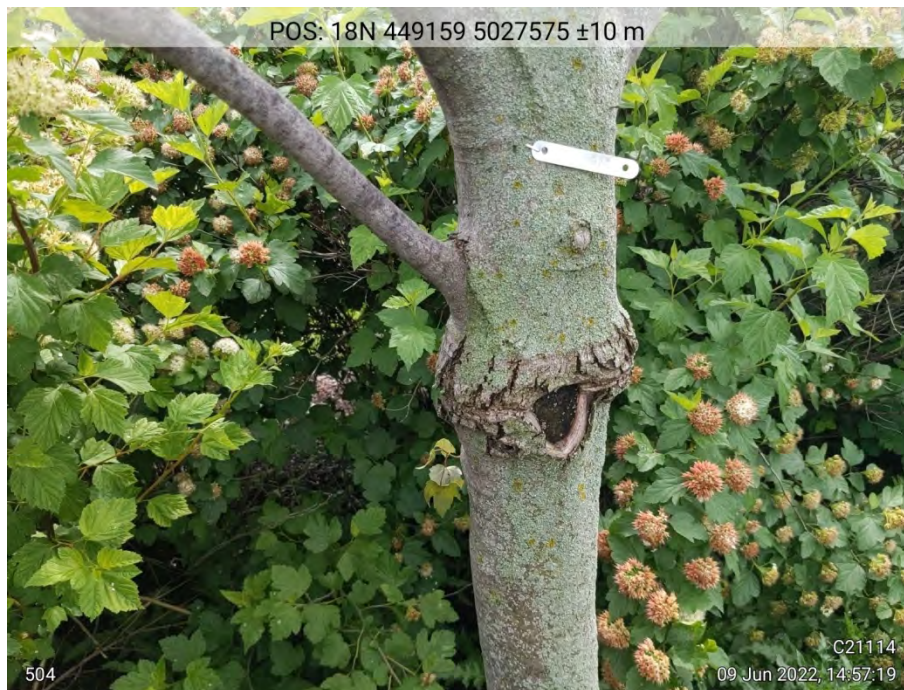
Photo 4: Trunk girdling on tree #504

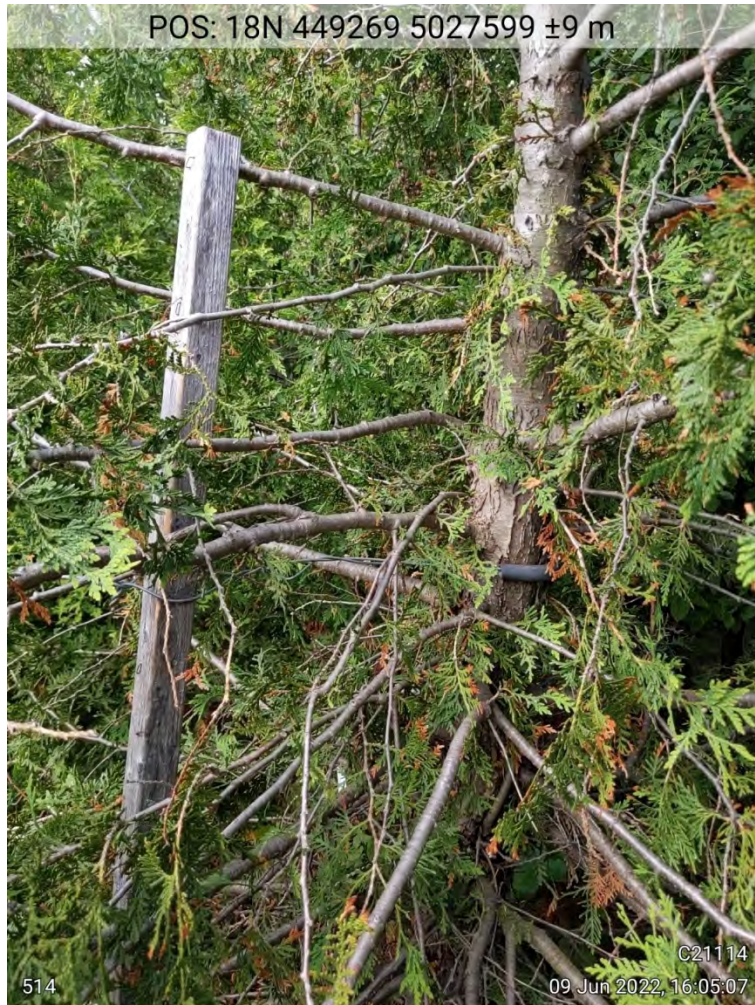
Photo 5: Cedar tree #514 with staking still attached

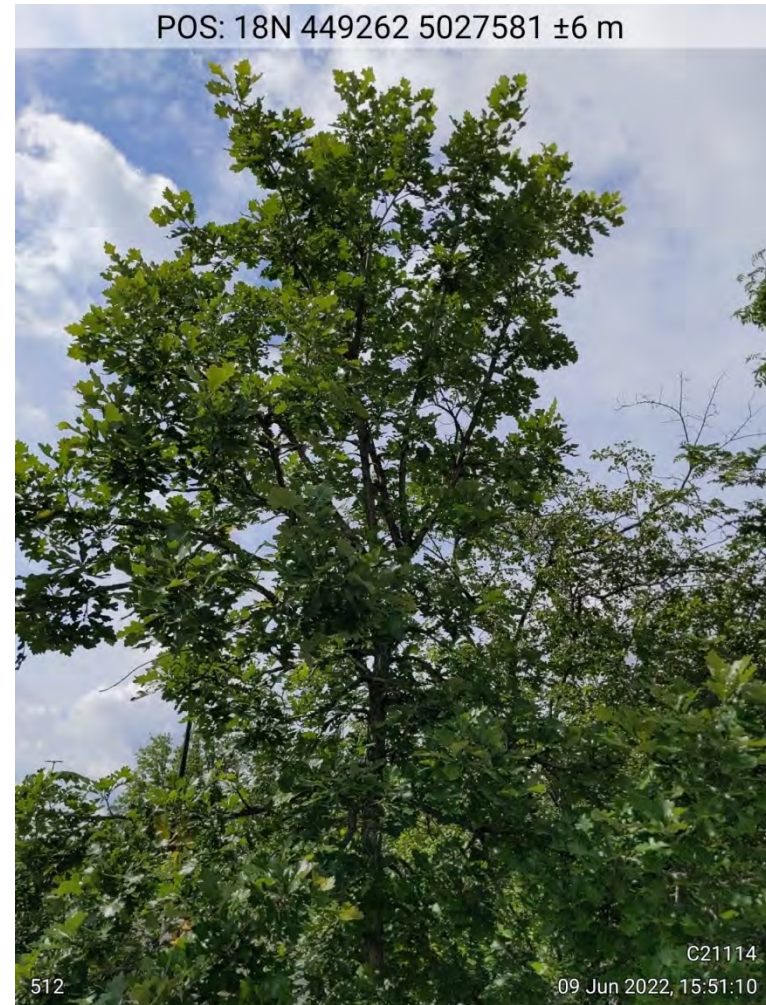
512	White Oak	<i>Quercus alba</i>	Parking Structure	10	100	2	Good	Remove, construction	Tight branching, good crown	18T	5027586.628	449262.836
513	Eastern white cedar	<i>Thuja occidentalis</i>	Parking Structure	10	100	2	Good	Remove, grading	Good canopy, still has staking attached.	18T	5027595.147	449267.504
514	Eastern white cedar	<i>Thuja occidentalis</i>	Parking Structure	10	100	2	Good	Remove, grading	Still has staking attached.	18T	5027601.127	449267.968
515	American Elm	<i>Ulnus americana</i>	Parking Structure	26	260	5	Good	Remove, grading	slight lean, 95% crown.	18T	5027613.413	449267.997
516	American Elm	<i>Ulnus americana</i>	Parking Structure	16,12,10,10	160	5	Good	Remove, grading	Multi stem, Good canopy	18T	5027614.15	449270.01
517	White Oak	<i>Quercus alba</i>	Parking Structure	38	380	6	Good	Remove, grading	1' from fence line, good taper.	18T	5027646.276	449262.683
518	White Oak	<i>Quercus alba</i>	Parking Structure	18	180	4	Good	Retain	Surrounded by buckthorn, good canopy, good taper	18T	5027652.101	449264.057

Photo 6: White Oak #512 in landscaped area adjacent Ring Road.

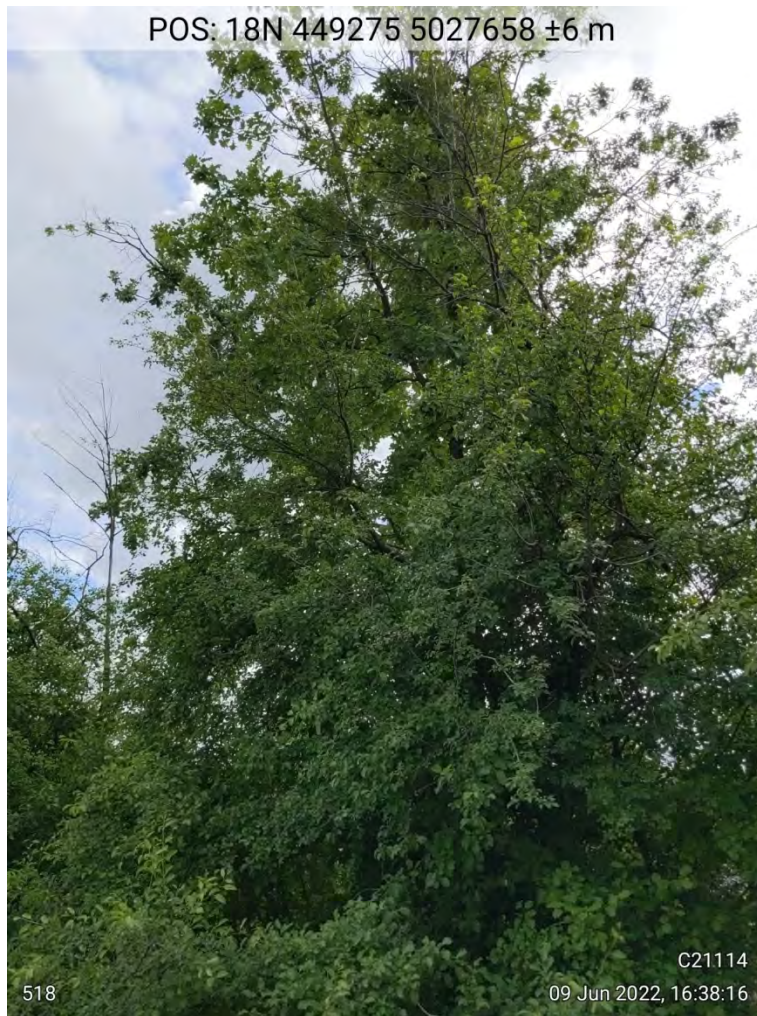
Photo 7 : White Oak #518 at northeast corner of parking lot, surrounded by buckthorn

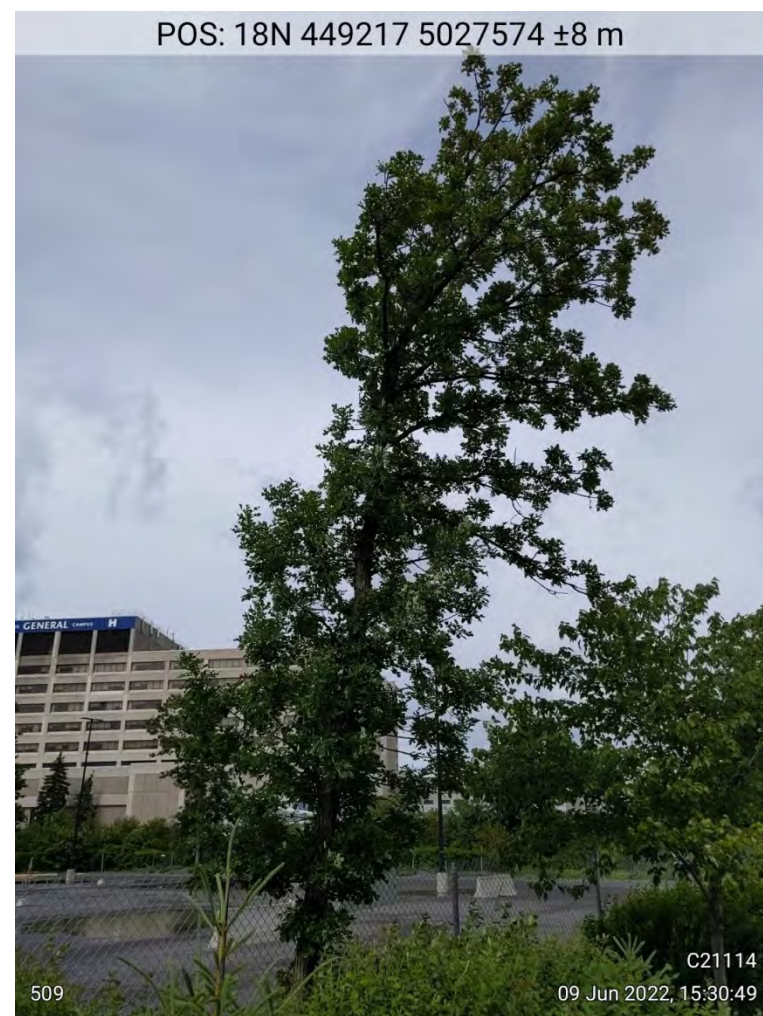
Photo 8: Tree #509 adjacent Ring Road.

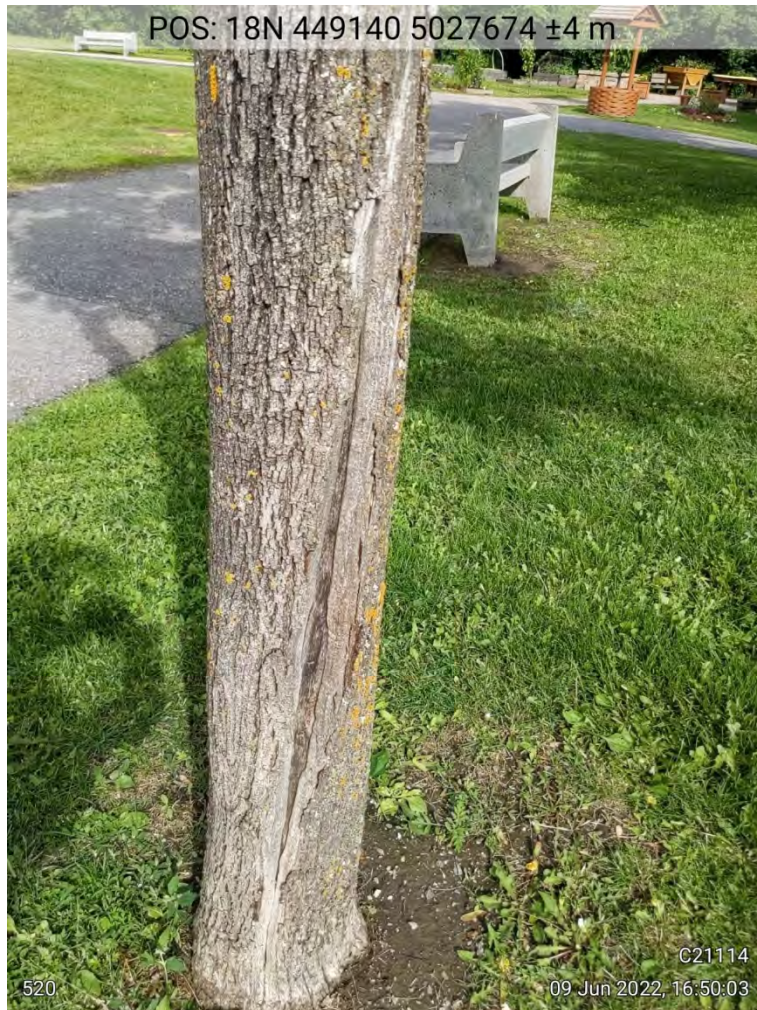
Photo 9: Frost crack on tree #520.

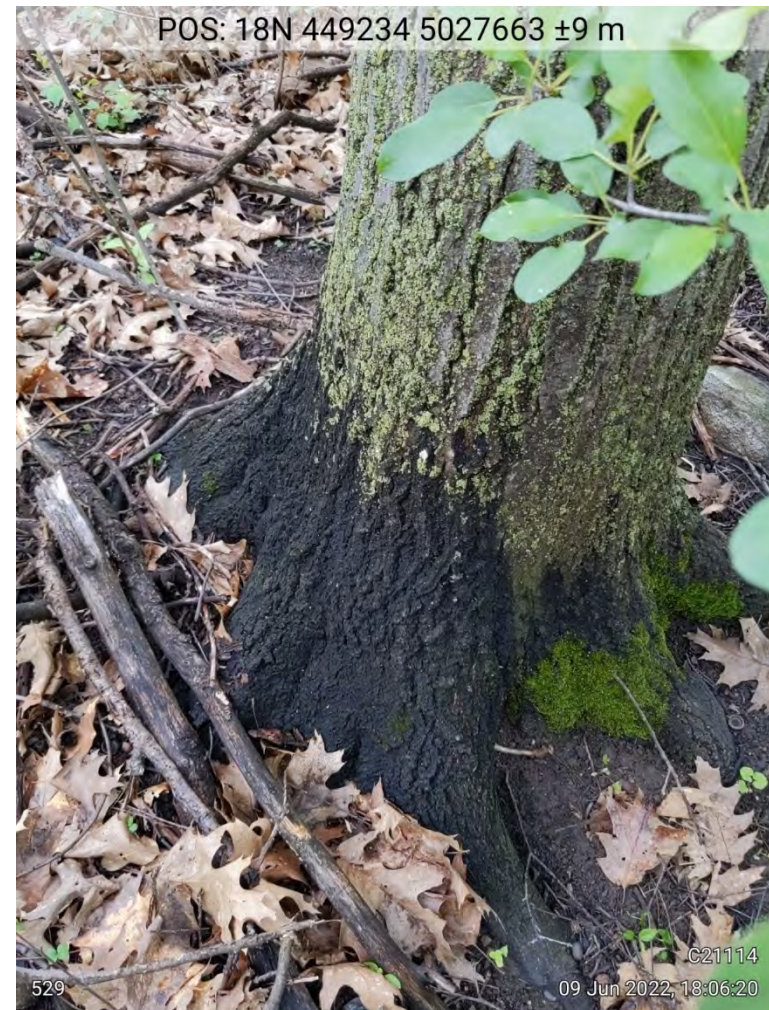
Photo 10: Possible slime flux or other disease on Tree #529 root collar. Tree located in woodland north of existing parking area.

- ◆ Further risk assessment of trees located north of the proposed parking structure (Trees #525-530) is recommended to better determine overall tree health and assess if selective tree removal should be completed.

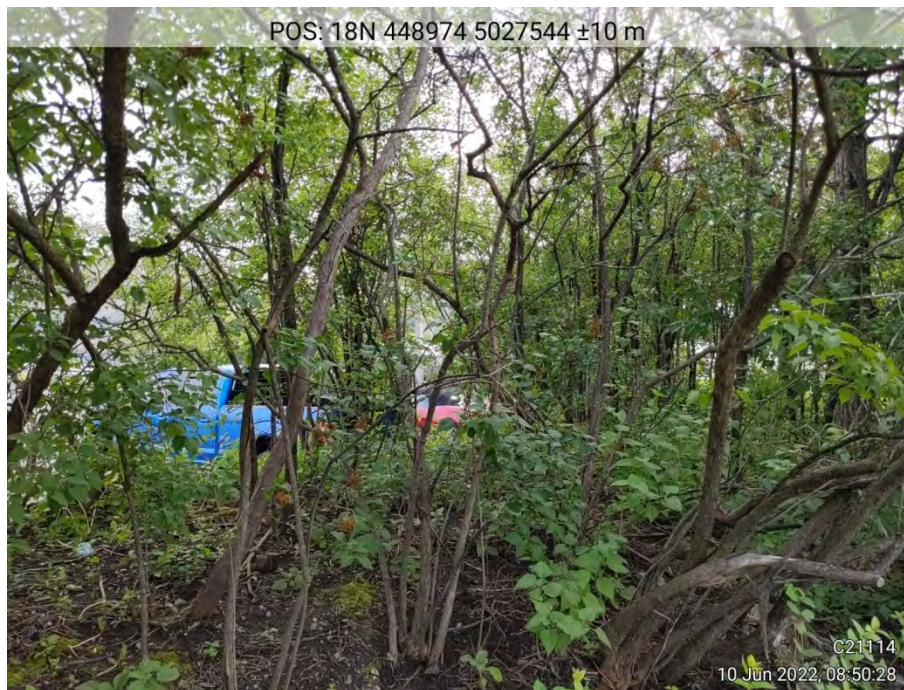
Of the trees to be retained, eight (8) are invasive common buckthorn. A significant amount of smaller common buckthorn was also observed within the hedgerows adjacent to Ring Road. Removal of these invasive specimens is strongly recommended.

Photo 2: Example of vegetation conditions within hedgerow along Ring Road.

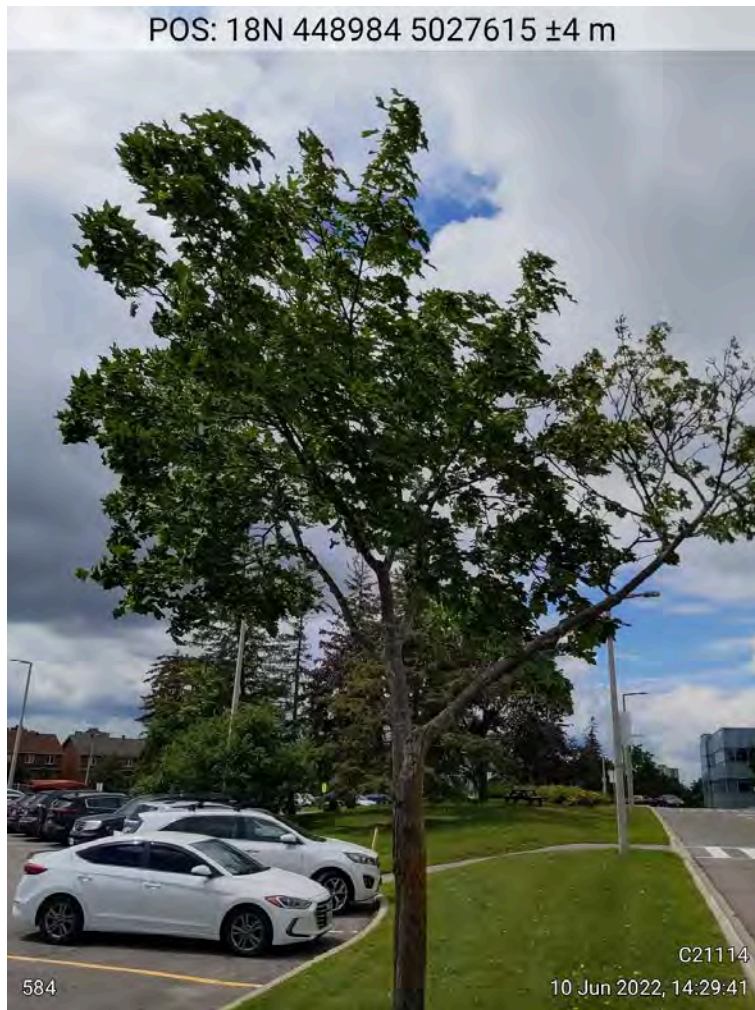
Photo 7: Norway Maple #584 adjacent parking, reduced canopy.

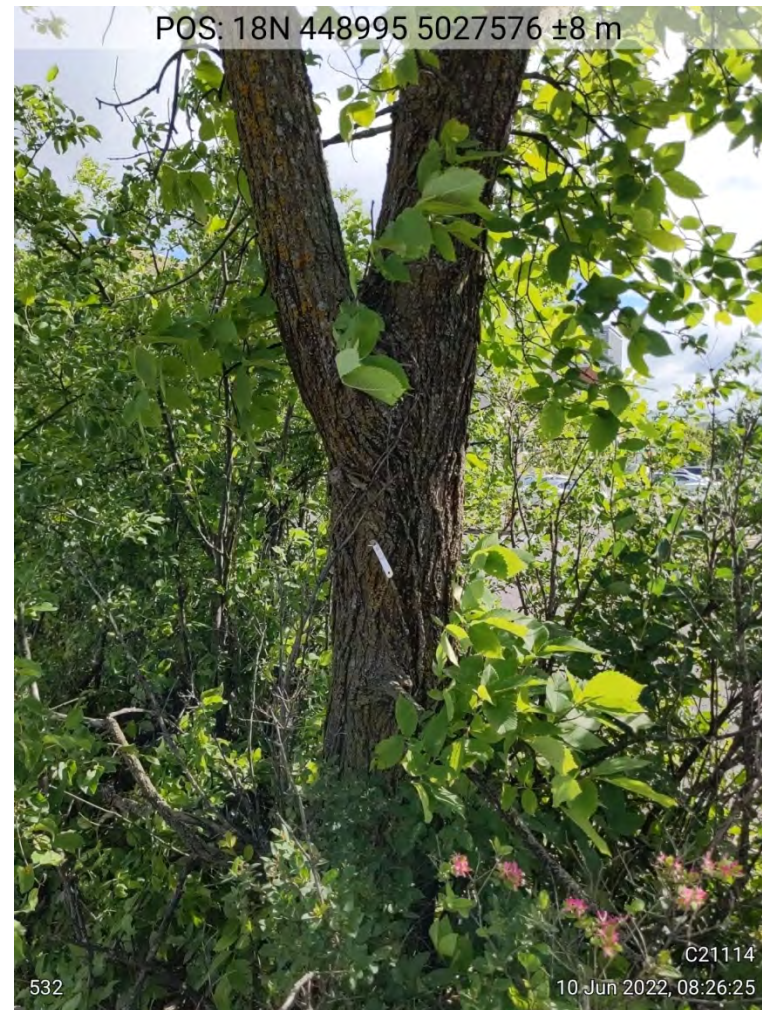
532	American Elm	<i>Ulnus americana</i>	Treatment Facility	30	300	4	Good/Fair	Remove, construction	Union at 2m, 80% canopy, some dieback	18T	5027568.935	448999.757
533	Cherry Plum	<i>Prunus cerasifera</i>	Treatment Facility	14,14,12,12	140	5	Good	Remove, construction	Coppice, at corner of driveway	18T	5027553.417	448996.889
534	American Elm	<i>Ulnus americana</i>	Treatment Facility	24	240	4	Fair/Poor	Remove, construction	60% canopy dieback	18T	5027552.341	448994.681
535	Red Pine	<i>Pinus resinosa</i>	Treatment Facility	40	400	4	Poor	Remove, construction	Lots of dieback, epicormic growth	18T	5027553.266	448988.935
536	Red Pine	<i>Pinus resinosa</i>	Treatment Facility	34	340	3	Good	Remove, construction	Good canopy, good taper	18T	5027549.829	448986.092
537	American Elm	<i>Ulnus americana</i>	Treatment Facility	36	360	6	Good	Remove, construction	Compacted soils, union at 2m	18T	5027547.428	448932.098

Photo 8: Tree #532, American Elm, codominant with weak union at 2 metres

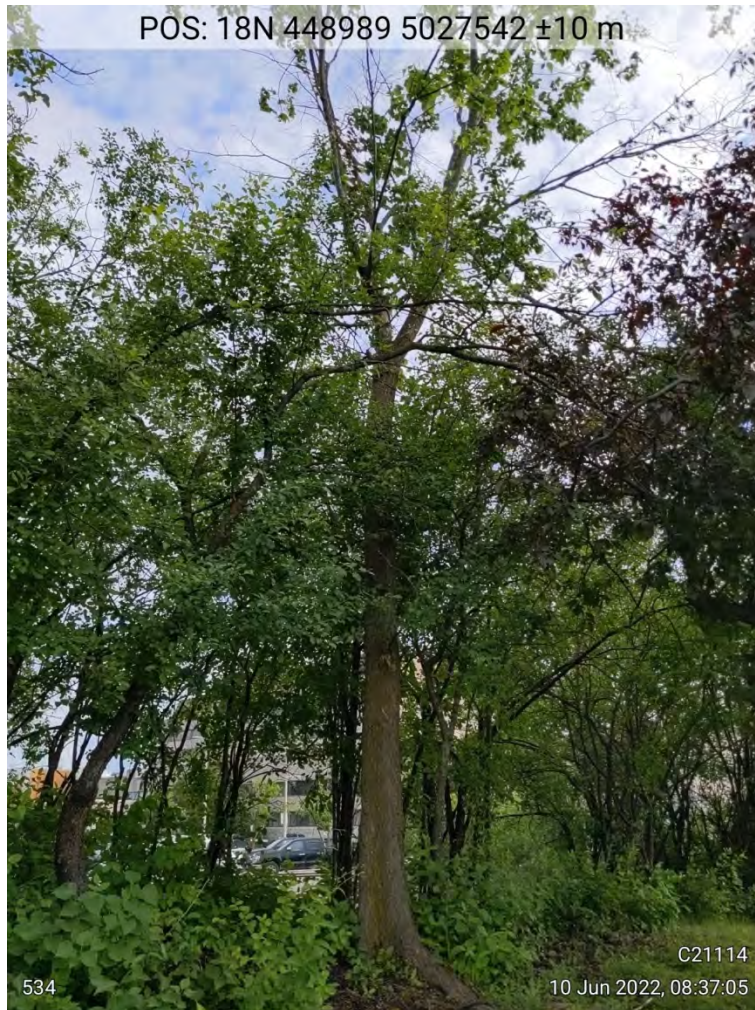
Photo 9: Tree #534 in poor/fair condition with significant canopy dieback.

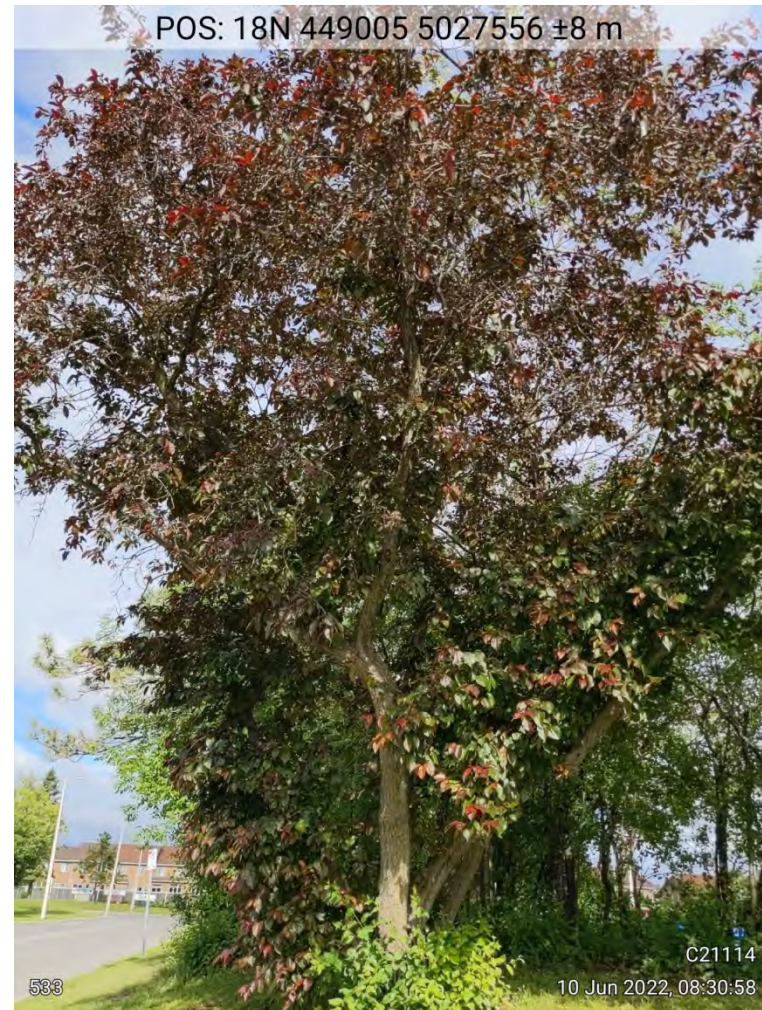
Photo 10: Tree #533 at the southeast corner of the Subject Lands

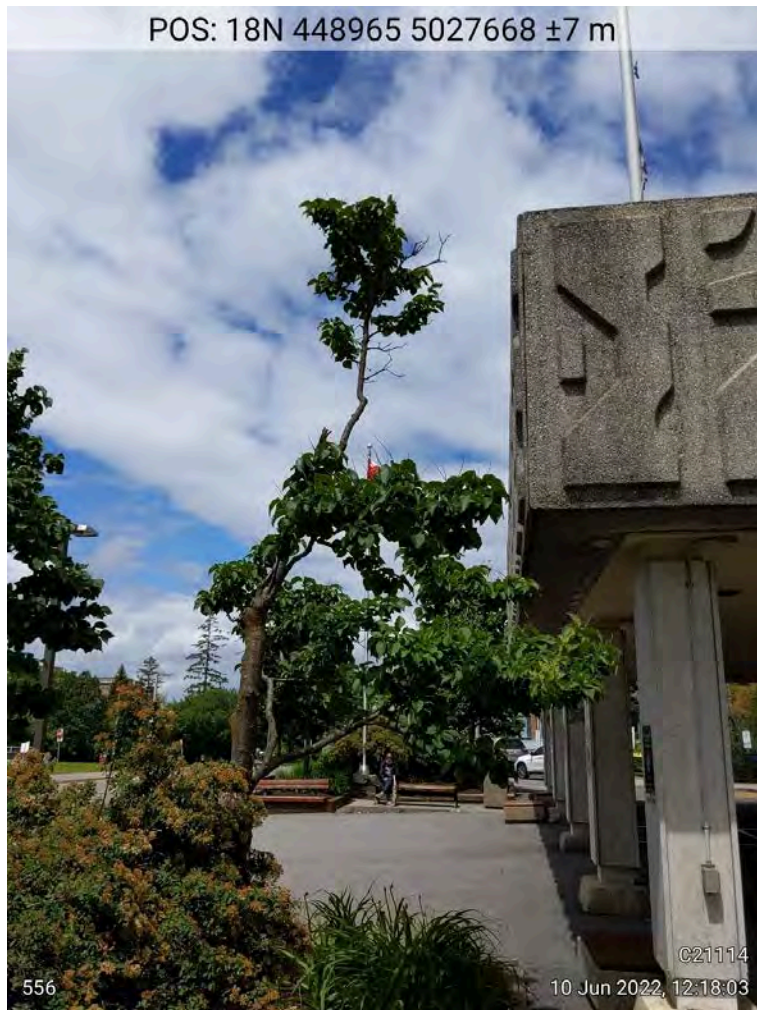
Photo 11: Tree #556 adjacent CHEO main entrance, fair condition with reduced canopy.

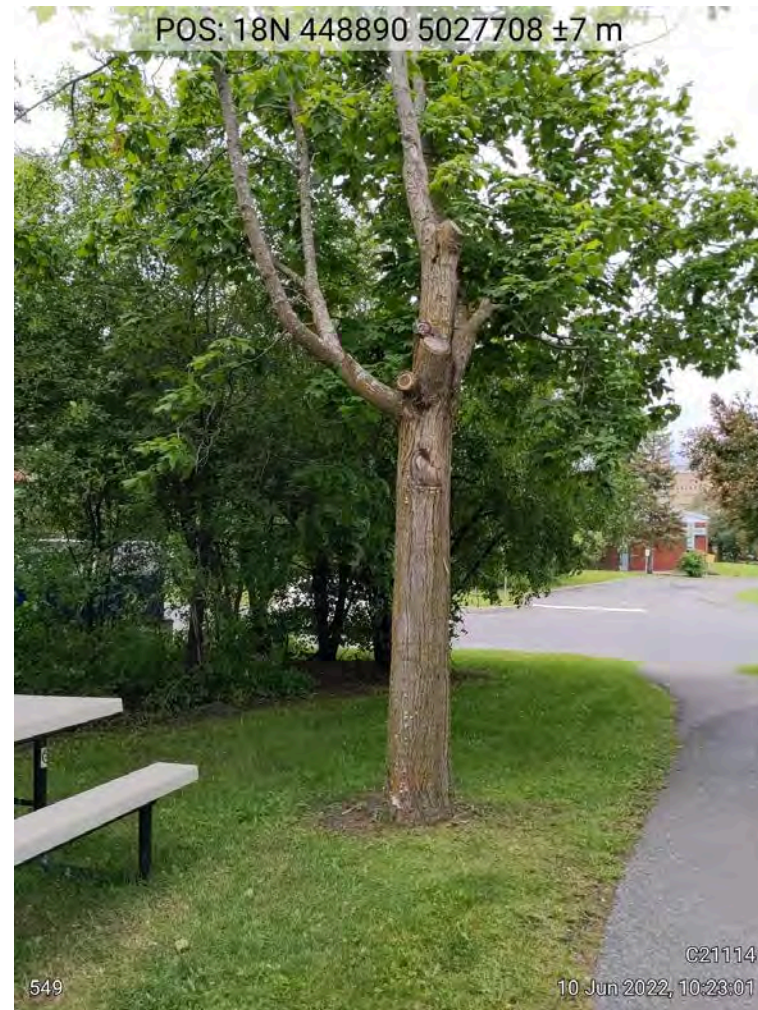
Photo 12: Tree #549 adjacent foot path, branches previously removed.

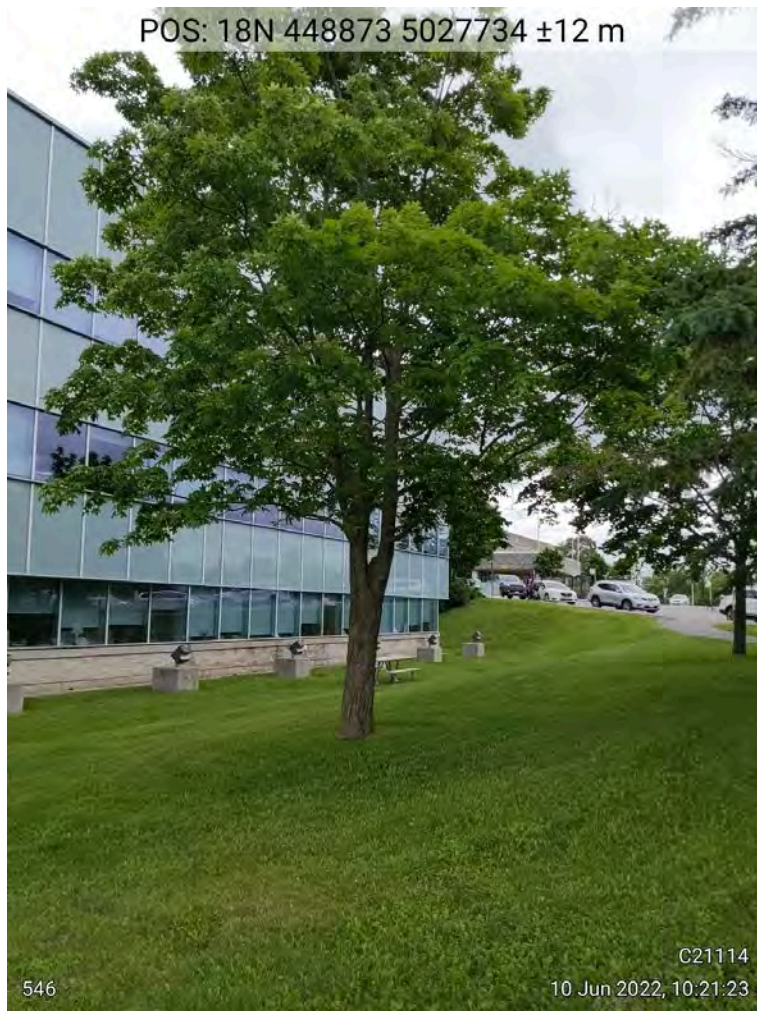
Photo 13: Tree #546, weak union at 1.5 metres.

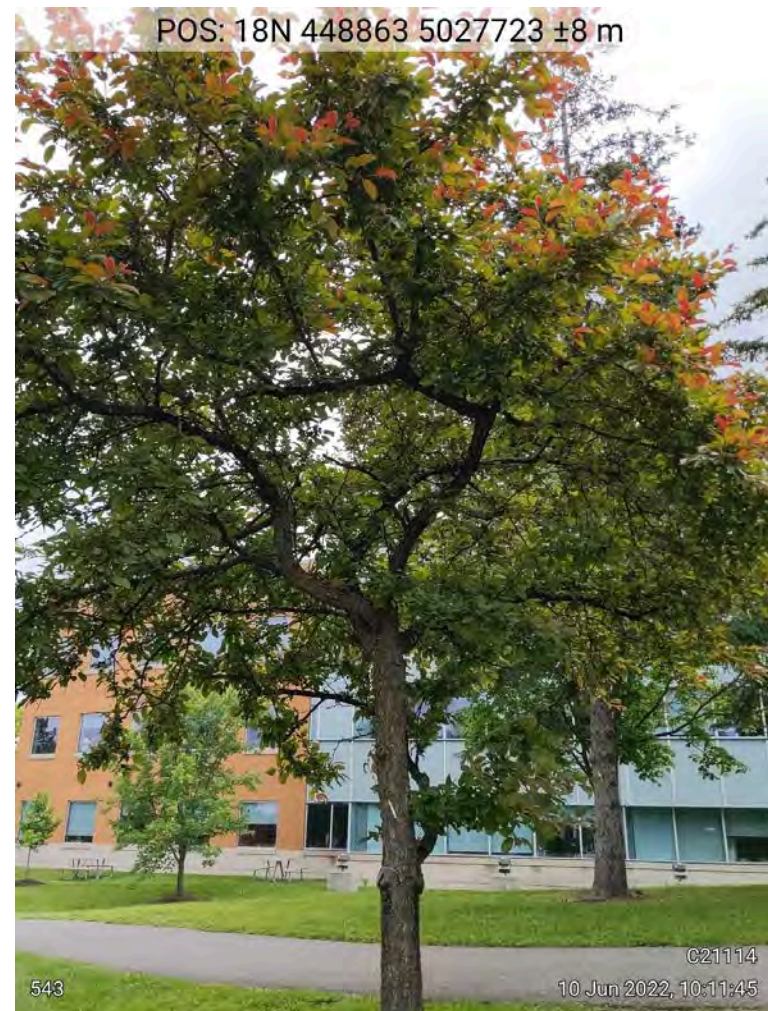
Photo 14: Tree #543 adjacent foot path.

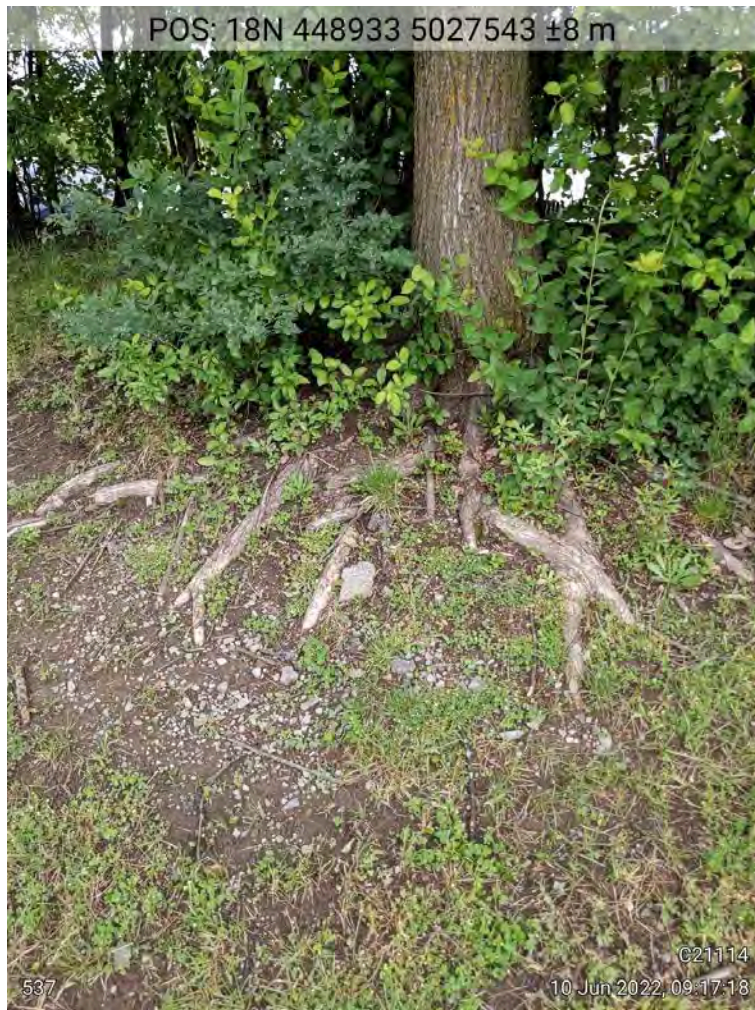
Photo 15: Tree #537 adjacent Ring Road, roots exposed at surface, compacted soil present on site

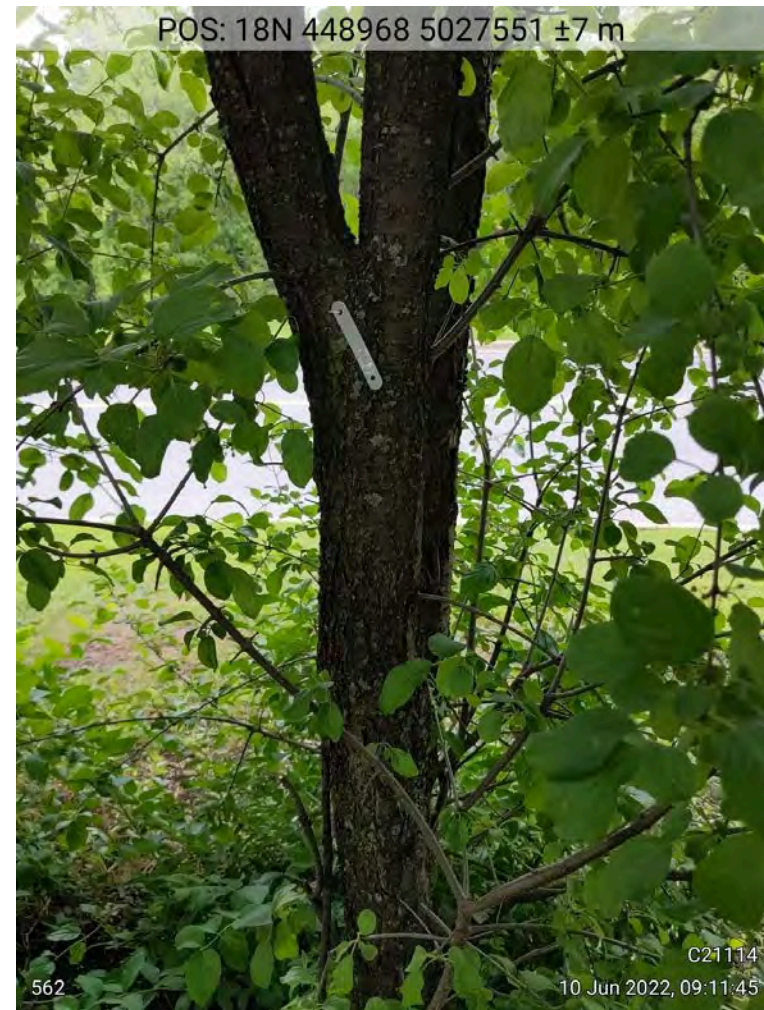
Photo 16: Tree #562, example of larger DBH Common Buckthorn present in hedgerows around parking area.
