## **Geotechnical Investigation and Slope Stability Assessment**

Final (4th Revision)

Proposed Humanics Sanctuary and Sculpture Park  
3400 Old Montreal Road  
Part of Lot 7, Concession 1, Old Survey  
Ottawa (Formerly Township of Cumberland), Ontario

OTT-00229886-A0

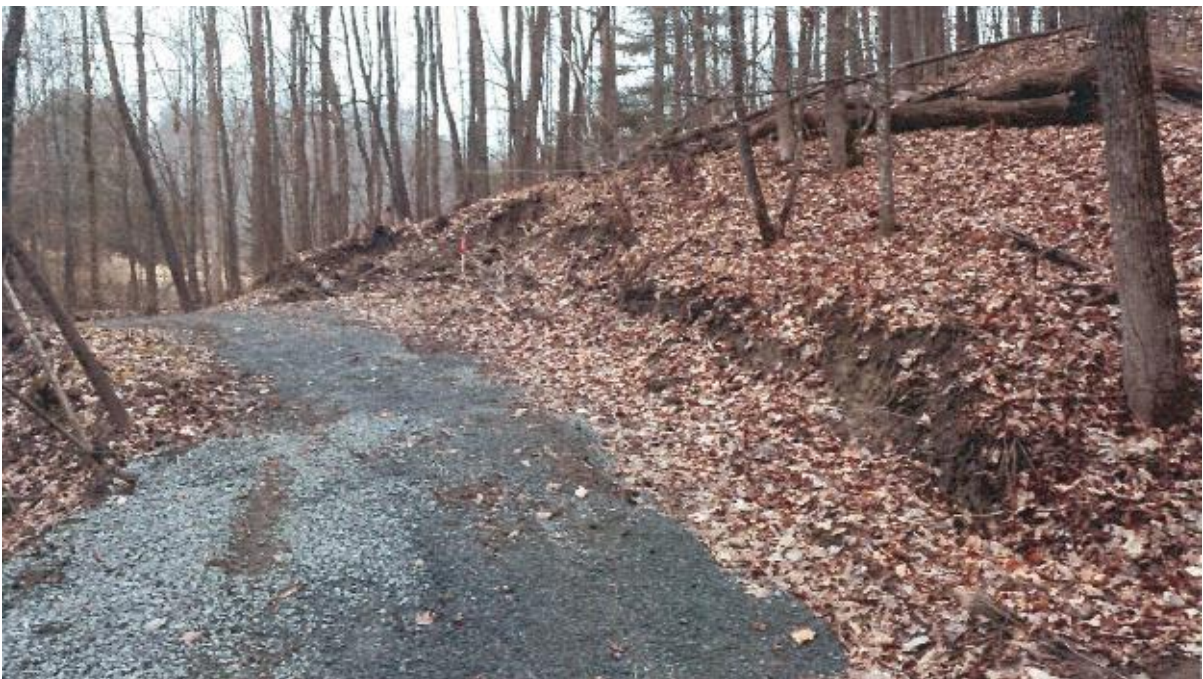
**Photo No. 2 – Erosion of cut uphill of pathway. Cut approximately 9 m long x 0.4 m high.**

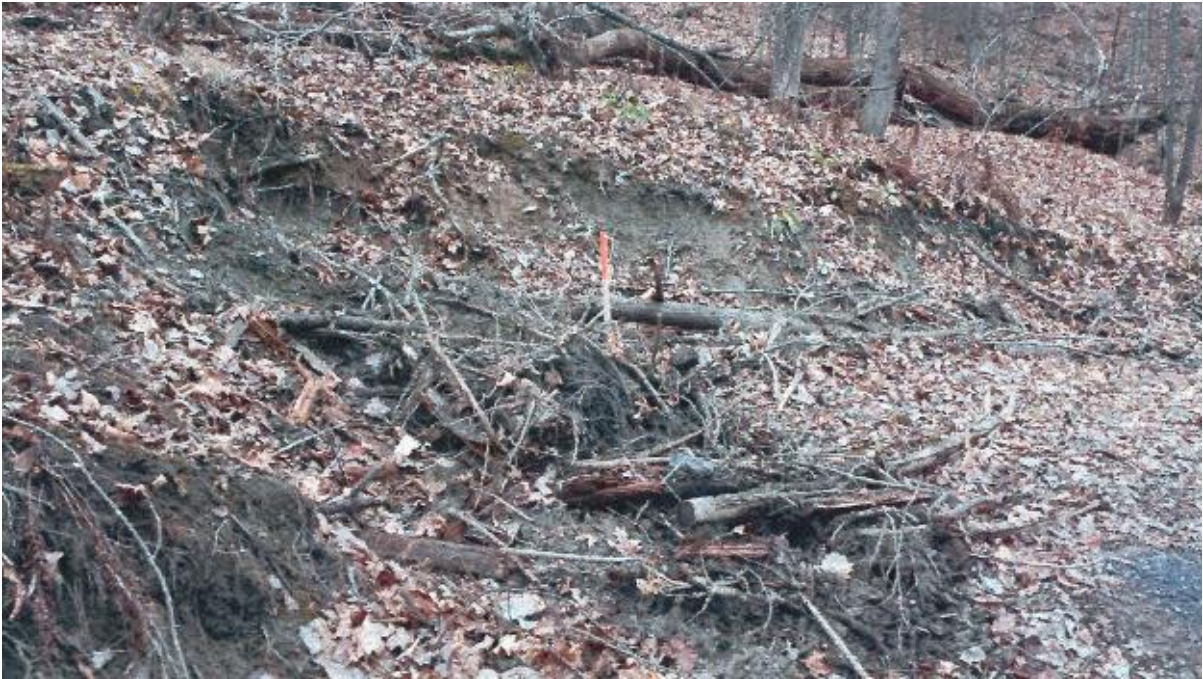
**Photo No. 3 – Erosion above pathway approximately 5 m long x 0.4 to 1.0 m high**

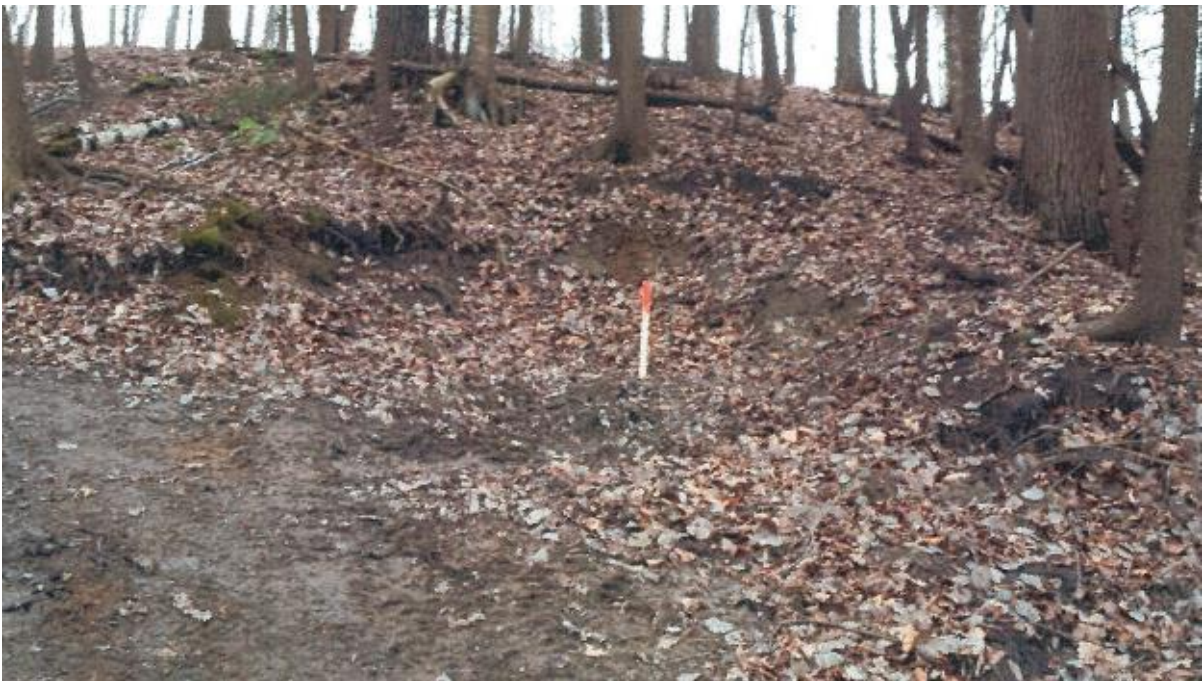
**Photo No. 4 – Erosion above pathway. Approximately 3 m deep and 0.6 m to 1.3 m high.**

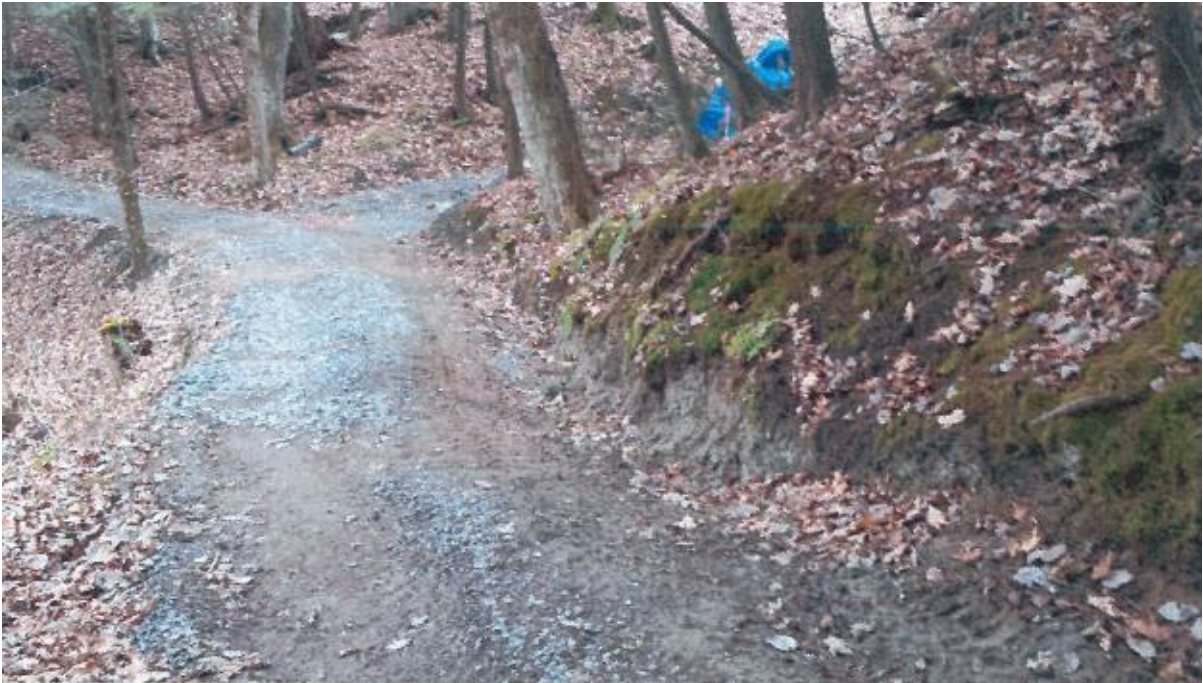
**Photo No. 5 – Erosion of cut uphill of pathway. Cut approximately 12 m long x 0.9 m high.**

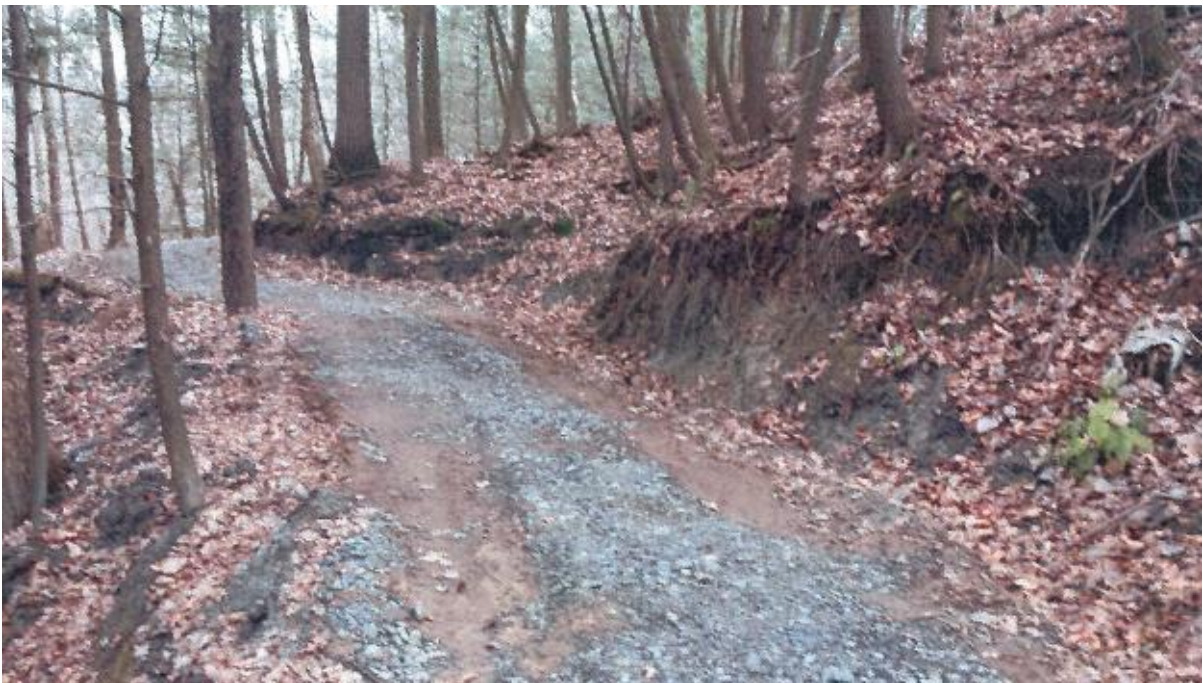
**Photo No. 6 – Erosion of cut uphill of pathway.  
Cut approximately 16 m long x 0.5 m to 1 m high.**

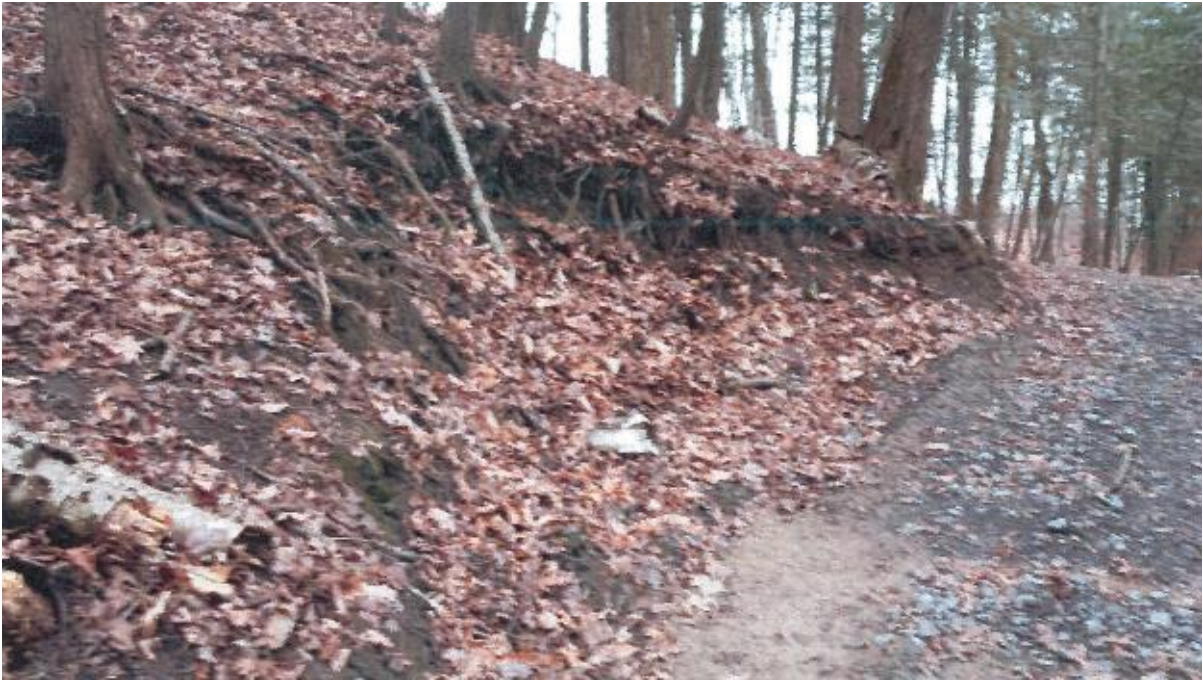
**Photo No. 13 – Erosion of slope uphill of pathway.  
Area approximately 5 m long and 1 m to 1.5 m high.**

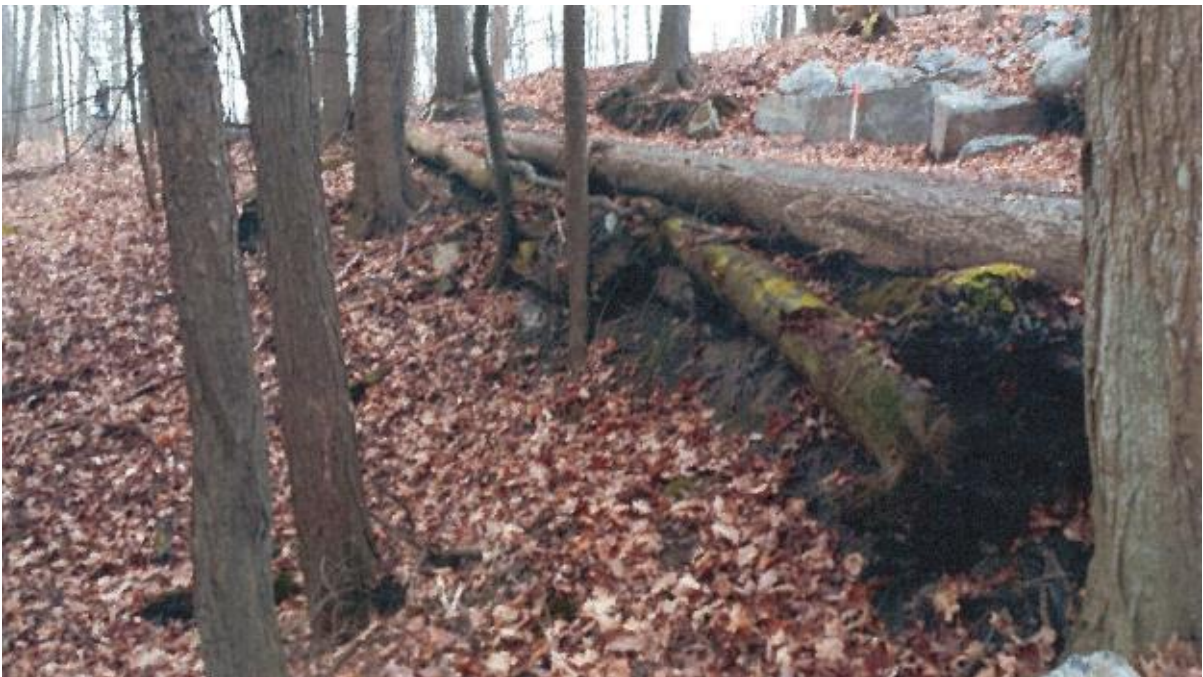
**Photo No. 14 – Erosion of slope downhill of pathway.  
Note placement of logs to prevent erosion.**

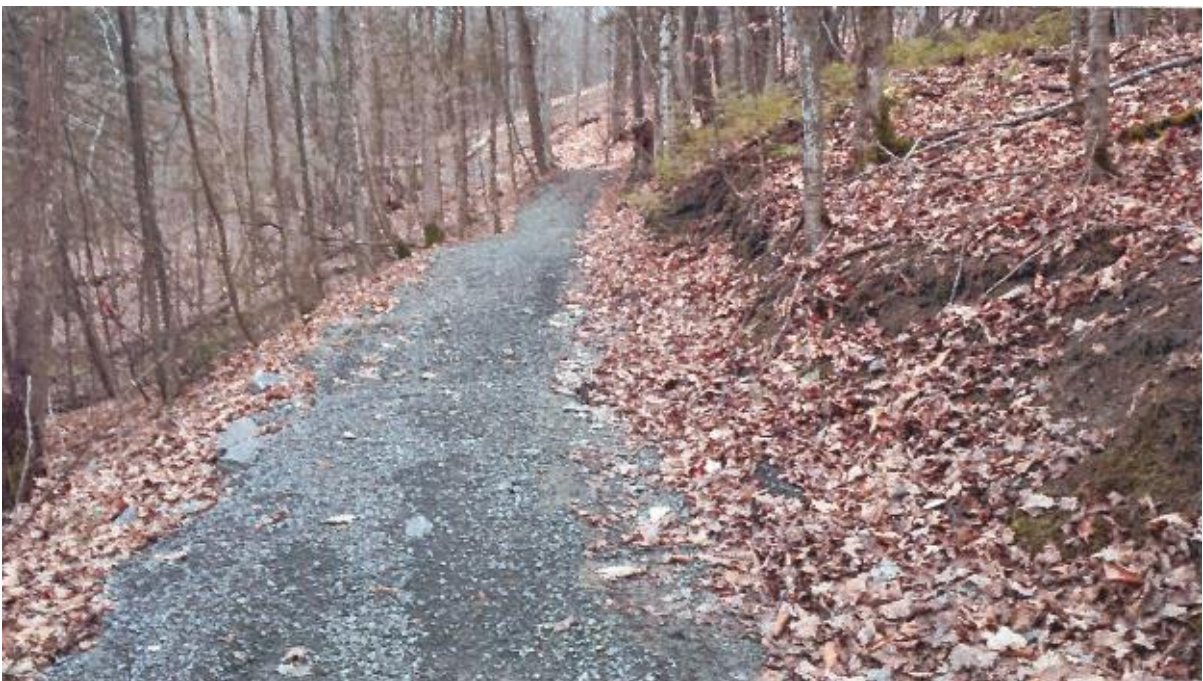
**Photo No. 21 – Erosion of cut above pathway.  
Cut approximately 45 m long x 0.3 m to 0.8 m high.**

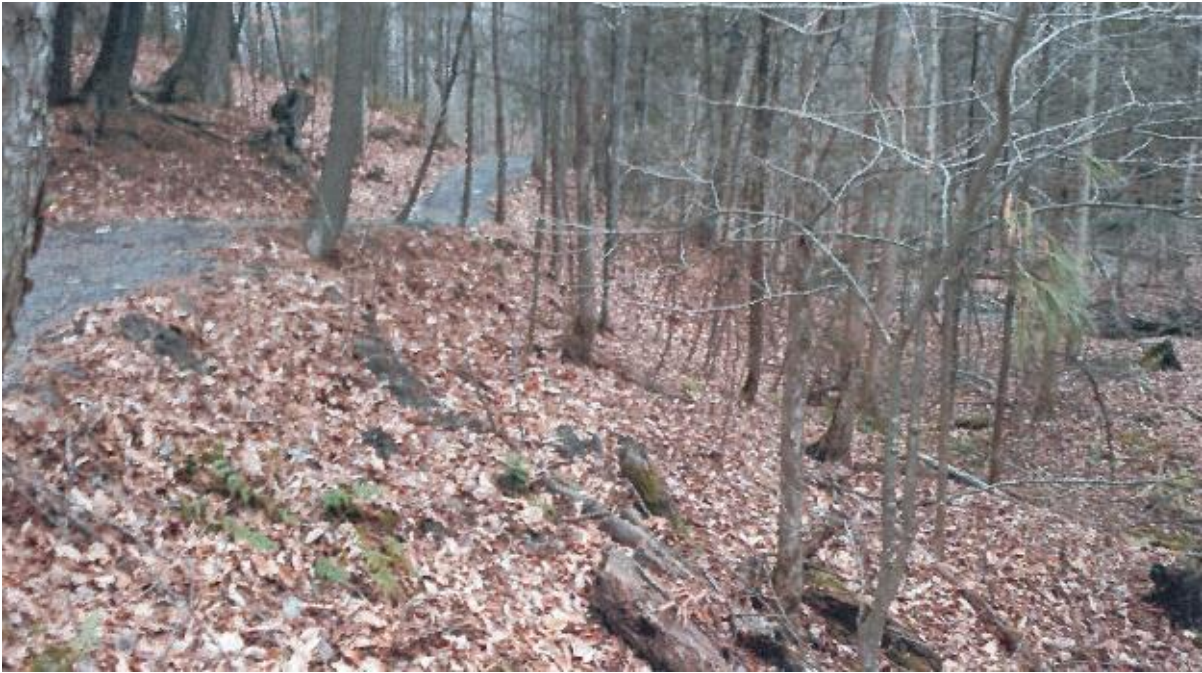
**Photo No. 22 – Erosion below pathway. Cut approximately 30 m long x 0.5 to 2 m high.**

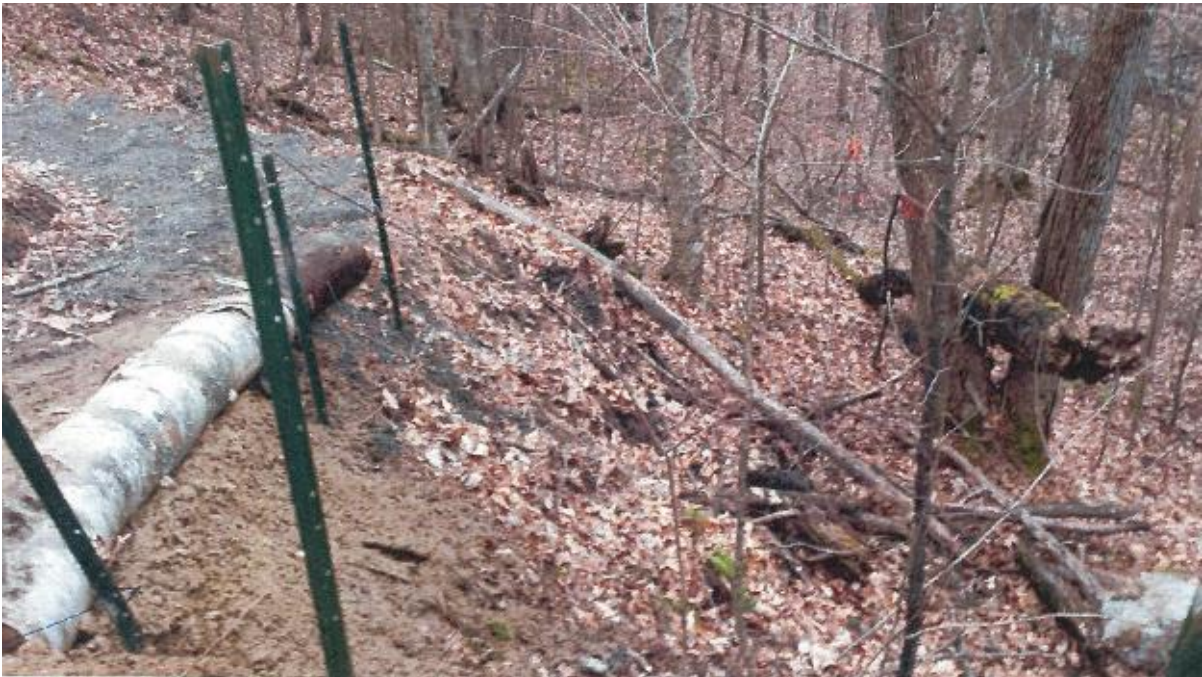
**Photo No. 23 – Erosion of slope downhill of pathway.  
Area approximately 12 m long x 1.5 m to 2 m high.**

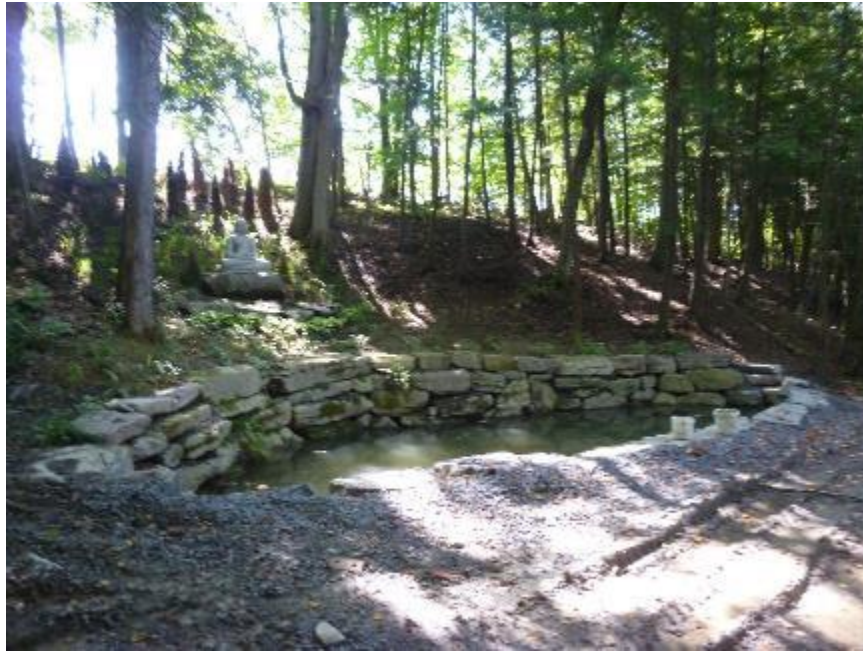
**Photo No. 26 –Retaining wall at pond location.**

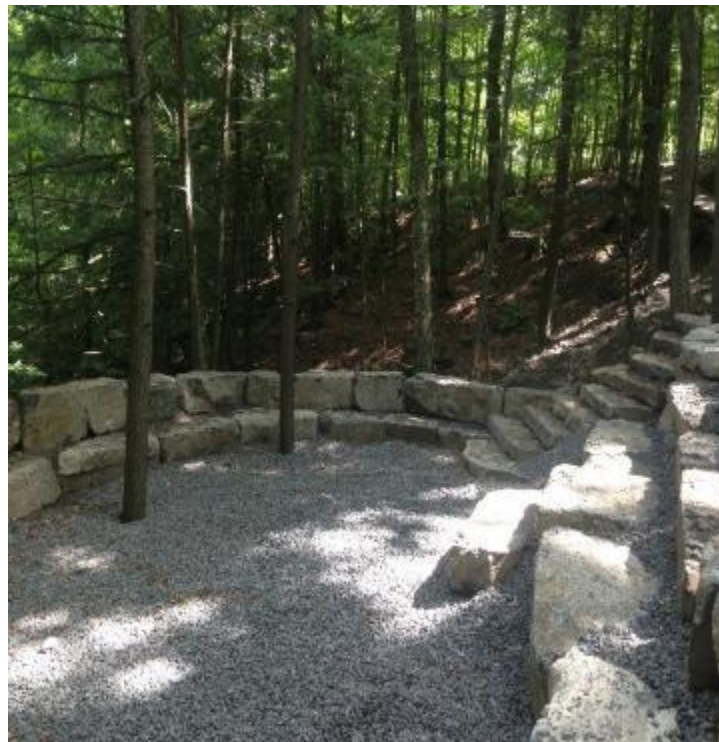
**Photo No. 27 –Retaining walls across from the pond and the pathway.**

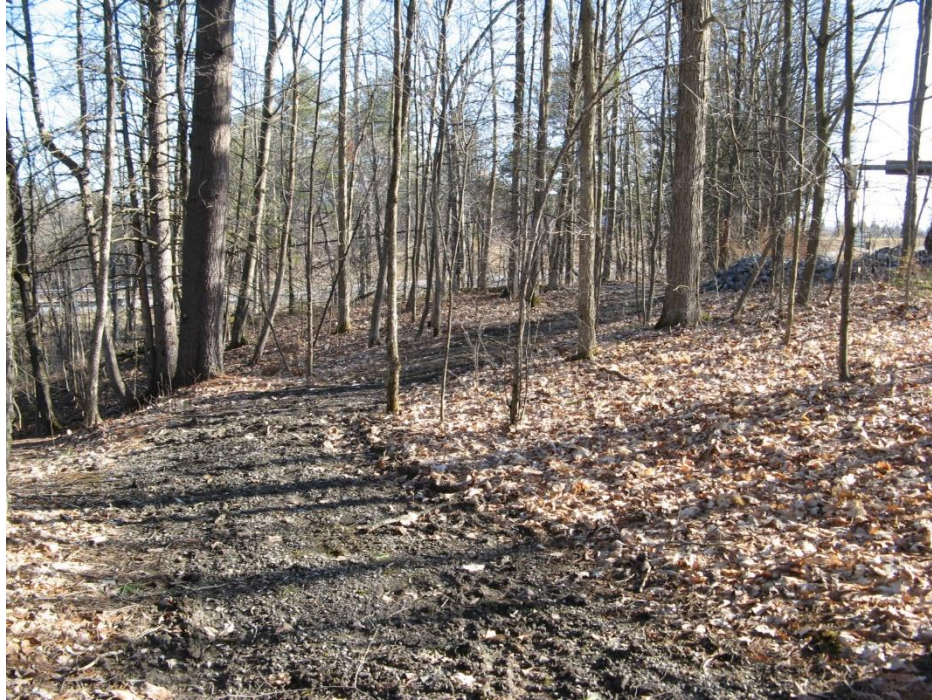
*Photo 3 – Typical condition of setback between the proposed gazebo locations and the crest of slope (to left) with a permeable pathway. View looking north towards Old Montreal Road*
