Geotechnical Investigation and Slope Stability Assessment

Final (5th Revision)

Proposed Humanics Sanctuary and Sculpture Park
3400 Old Montreal Road
Part of Lot 7, Concession 1, Old Survey
Ottawa (Formerly Township of Cumberland), Ontario

OTT-00229886-A0

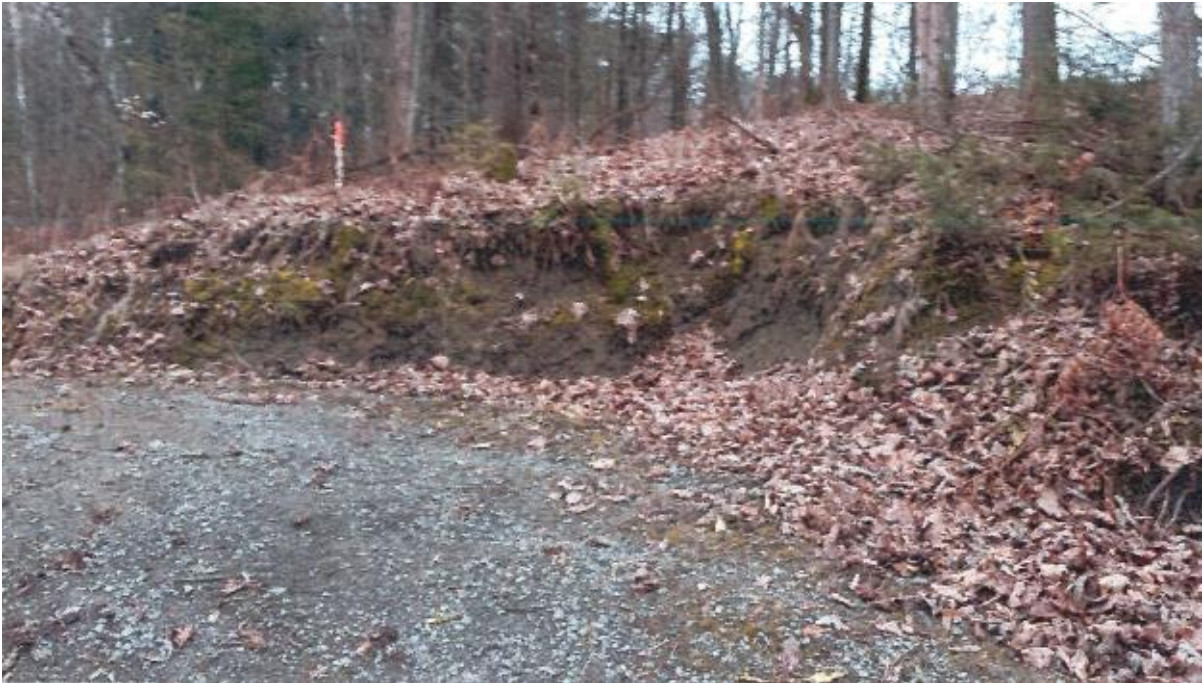
It is considered that cave-in and undermining of the toe of the upper slope is likely due to steepening of the slope and removal of vegetation from the face of the slope. The cave-in and undermining of the upper slope is expected to continue if not remediated and may result in eventual failure of the slope. Potential remedies may consist of armour stone retaining walls, gabion baskets, coir logs, etc.

Photo No. 18 – Erosion of cut uphill of pathway. Cut approximately 3 m long x 1.2 m high.

It is recommended that the above slopes should be stabilized by construction of armour stone retaining walls, gabion baskets, coir logs, etc.

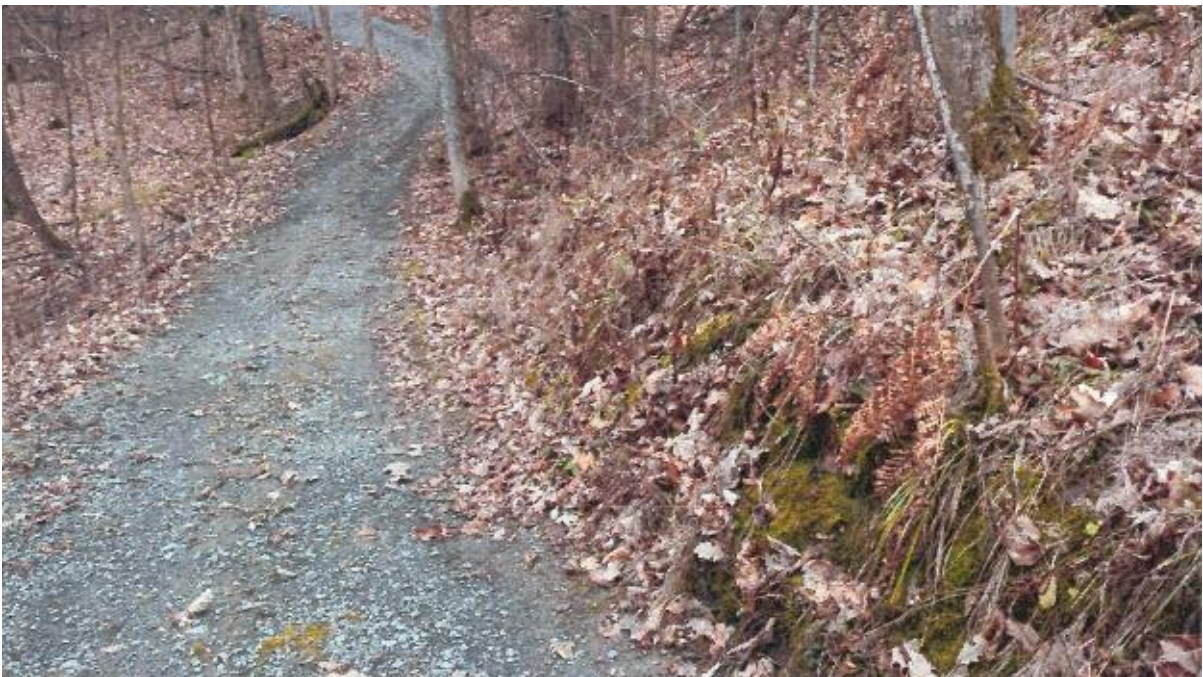
Photo No. 19 – Erosion of cut above pathway. Cut approximately 7 m long x 0.8 m high.

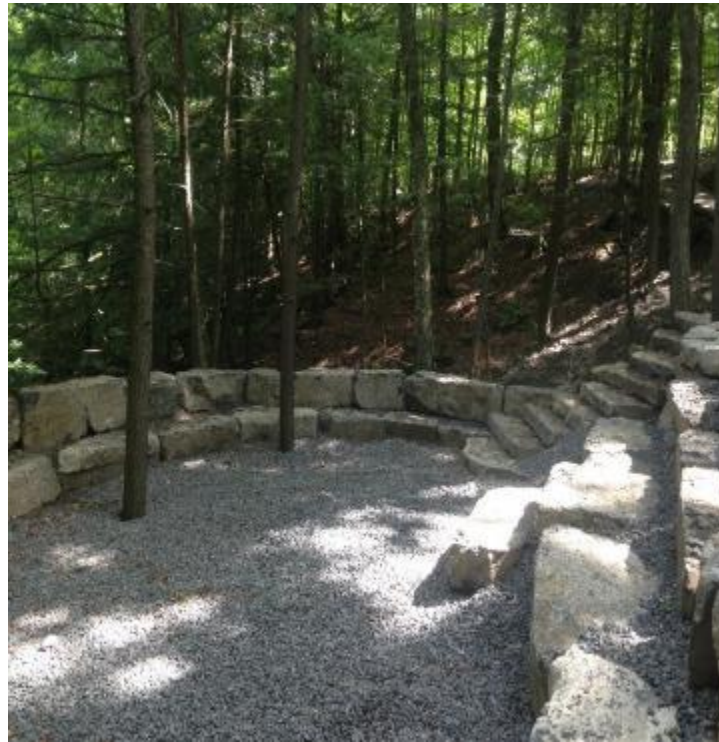
The owner has already constructed retaining walls at several locations. These include the pond area (Photo 26), across from the pond and the pathway (Photo 27), the Buddhist section (Photos 28) and the Christian Meditation area located in the northeast portion of the site where the slope has been terraced with armour stone retaining walls (Photo 29). Similarly, a retaining wall has been constructed at the entrance to the sanctuary (Photo 30). The construction of these retaining walls would increase the stability of the slopes and prevent slope failures in the areas.

Photo No. 27 –Retaining walls across from the pond and the pathway.

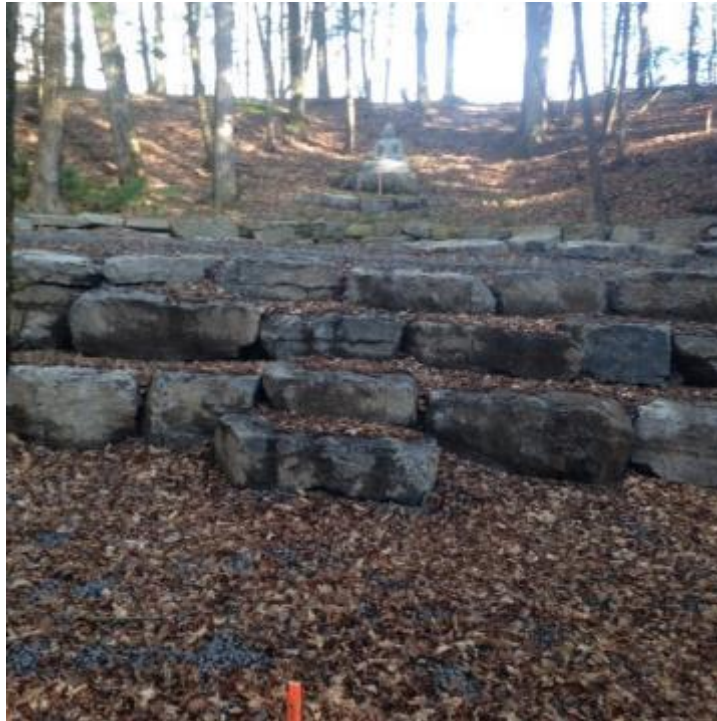
Photo No. 28 – Terraced retaining wall at the Buddhist Meditation section.

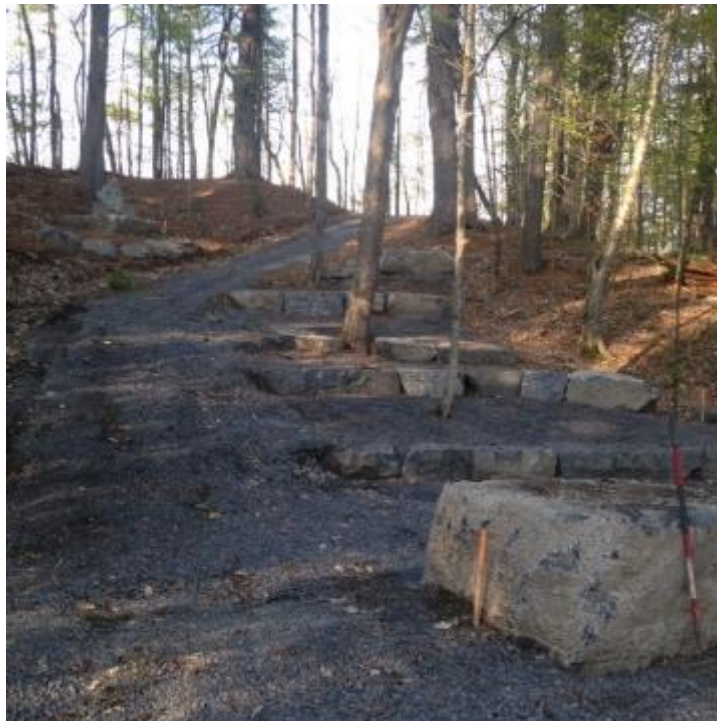
Photo No. 29 – Terraced retaining wall at the Christian Meditation area.

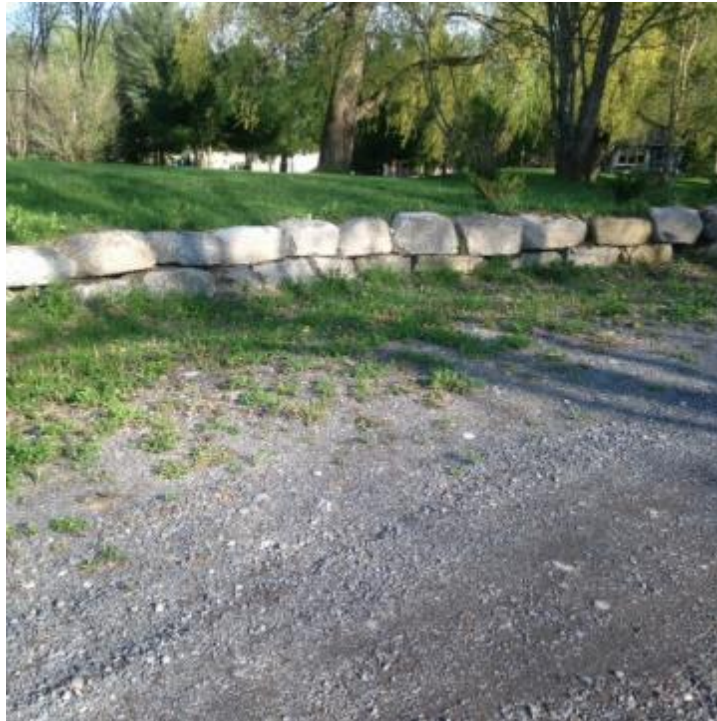
Photo No. 30 – Retaining wall at the entrance to the sanctuary.
