## **Geotechnical Investigation and Slope Stability Assessment**

Proposed Humanics Sanctuary and Sculpture Park  
3400 Old Montreal Road  
Part of Lot 7, Concession 1, Old Survey  
Ottawa (Formerly Township of Cumberland), Ontario

OTT-00229886-A0

November 25, 2022

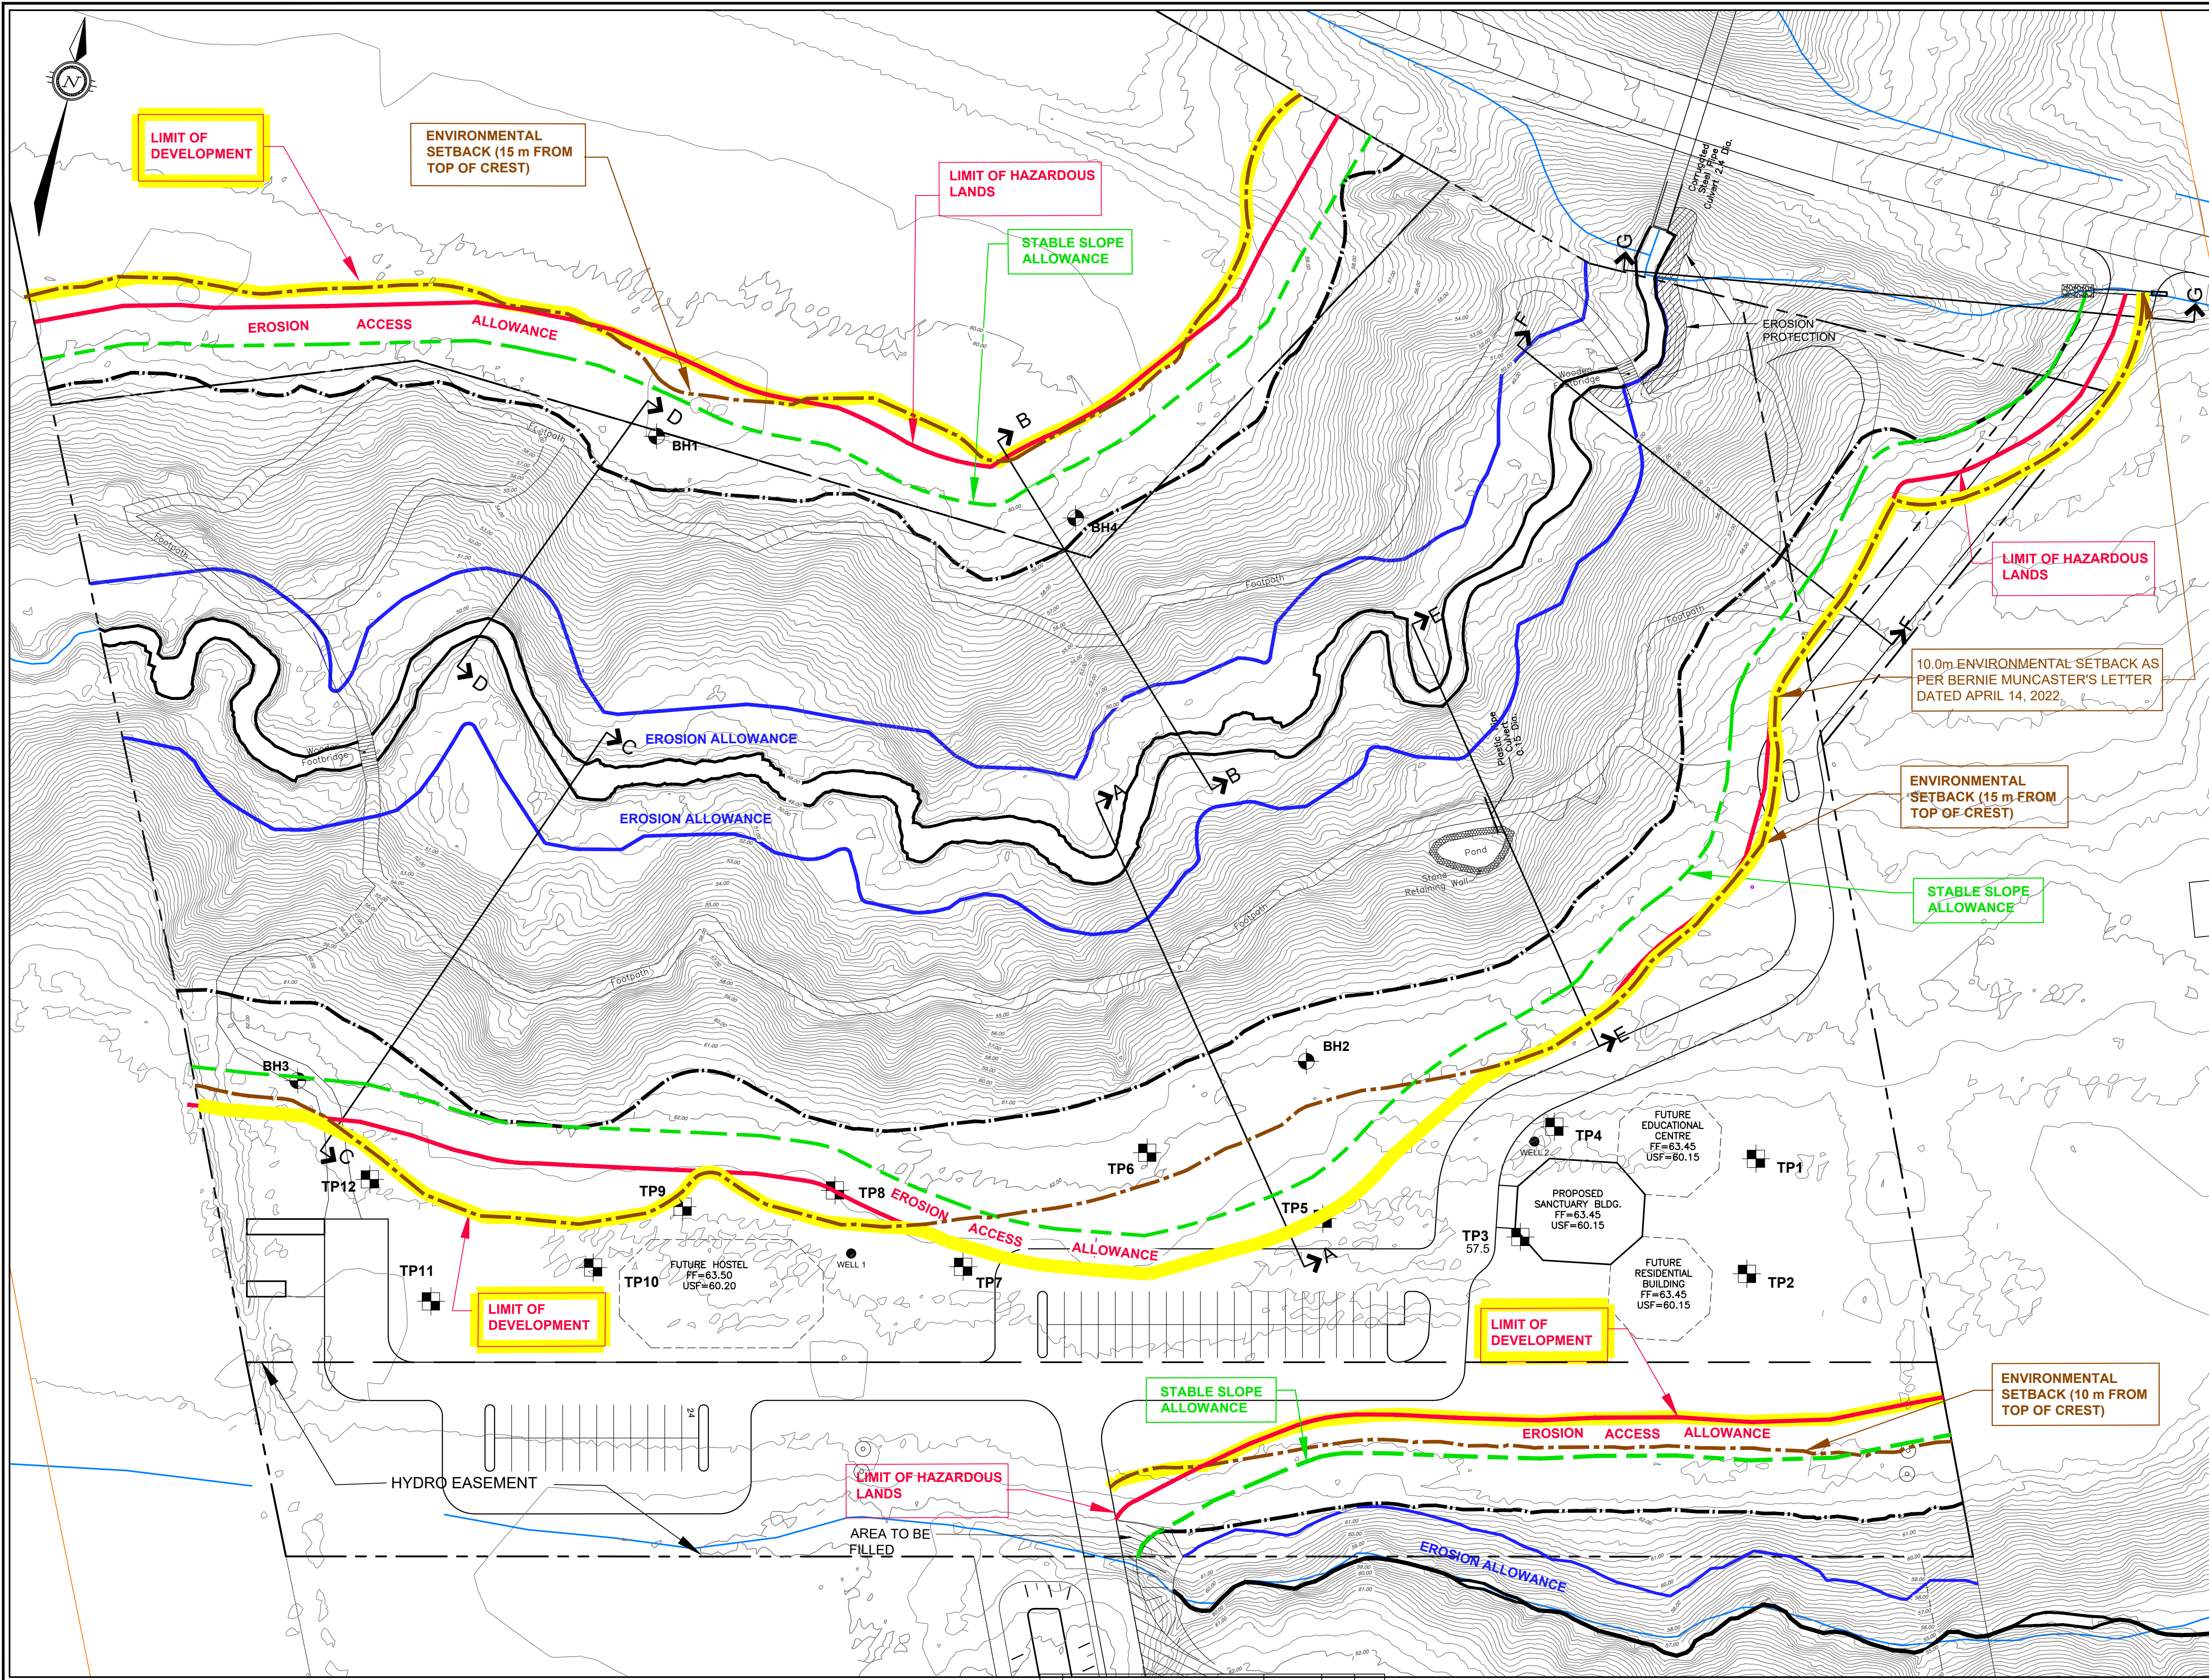
Slope stability analysis was undertaken to compute the slope inclination, which will have a minimum factor of safety of 1.5. This information was used to compute geotechnical set back. To this was added the erosion allowance and erosion access allowance to arrive at limit of hazardous lands. These limits have been plotted on the Site Plan, Figure 2.

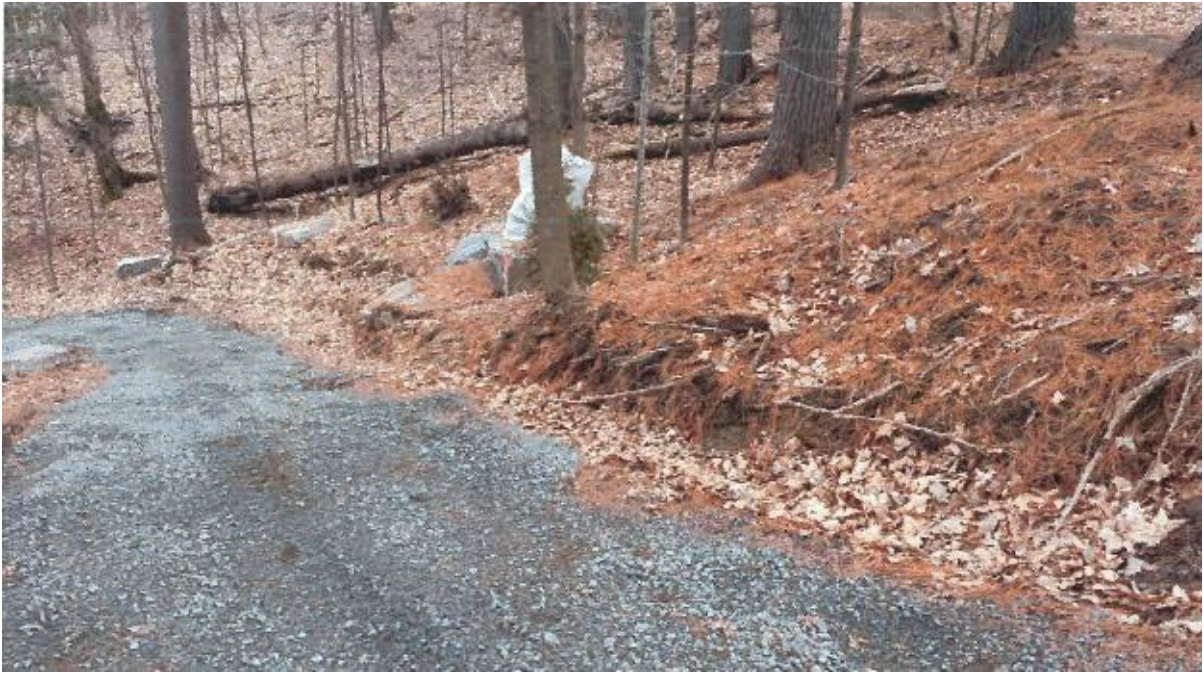
**Photo No. 1 – Erosion of cut uphill of the pathway.  
Cut approximately 18 m long x 0.3 m high**

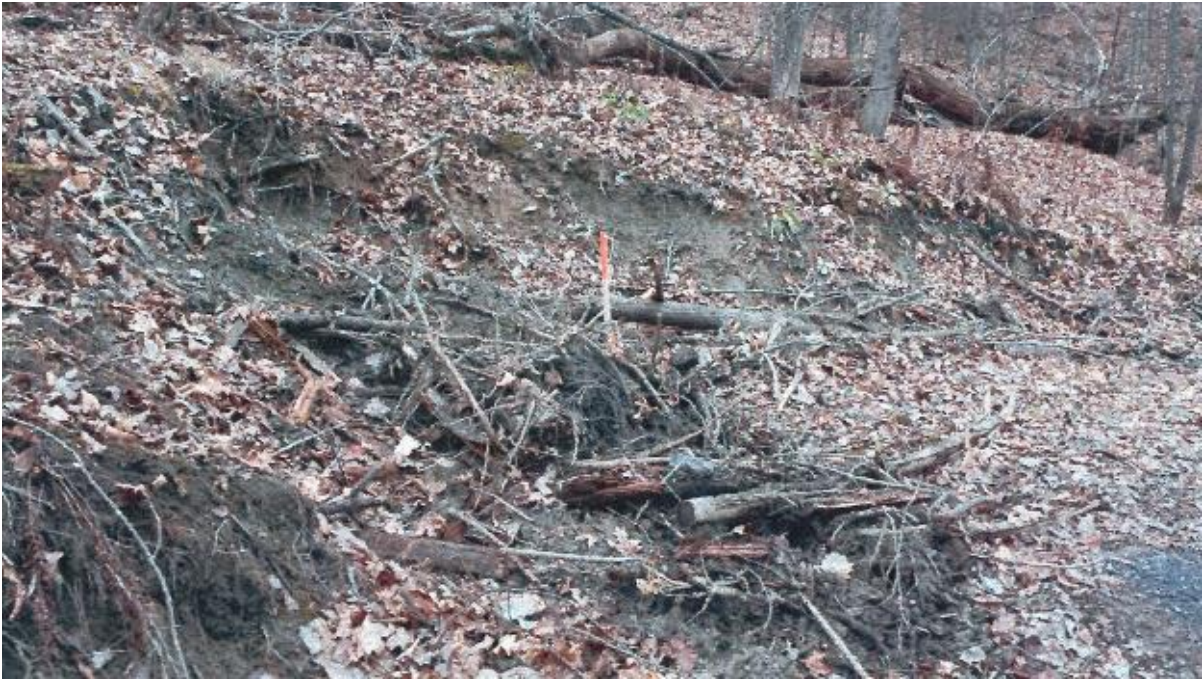
**Photo No. 3 – Erosion above pathway approximately 5 m long x 0.4 to 1.0 m high**

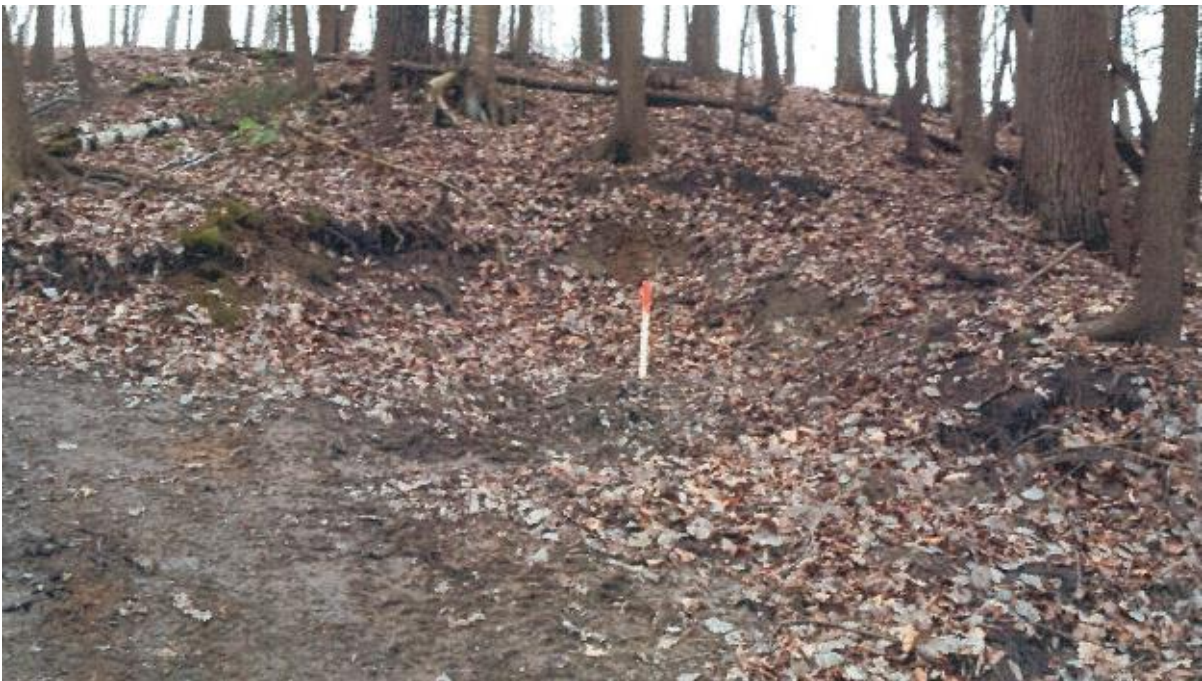
**Photo No. 4 – Erosion above pathway. Approximately 3 m deep and 0.6 m to 1.3 m high.**

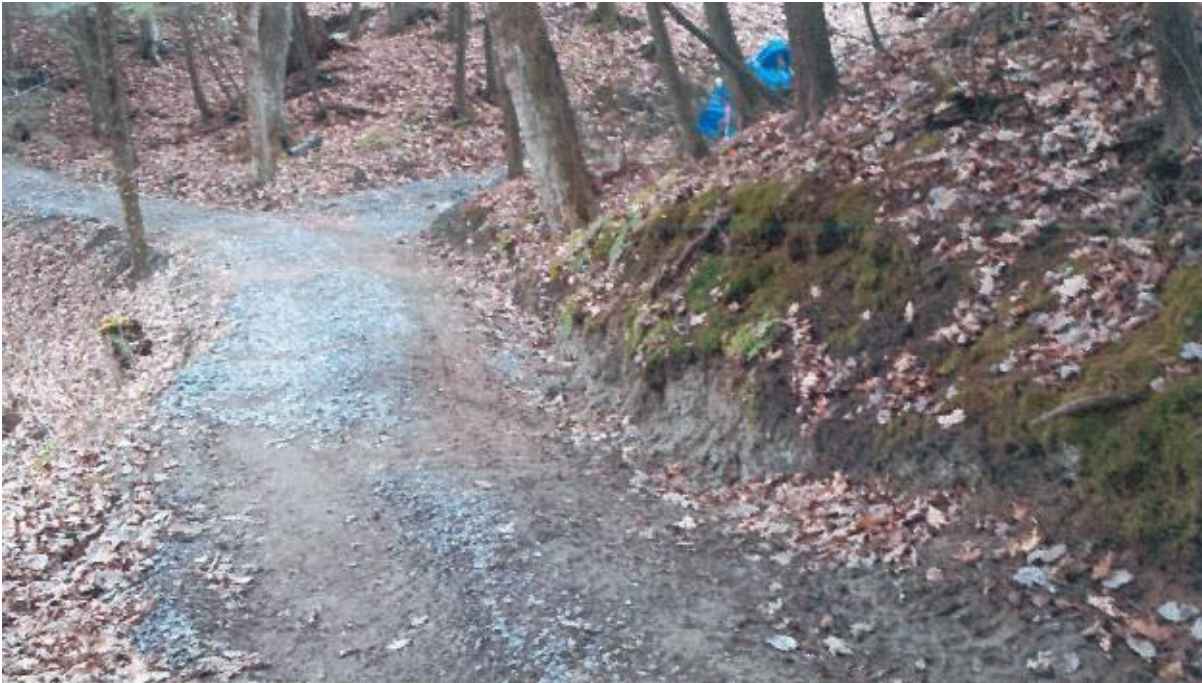
**Photo No. 5 – Erosion of cut uphill of pathway. Cut approximately 12 m long x 0.9 m high.**

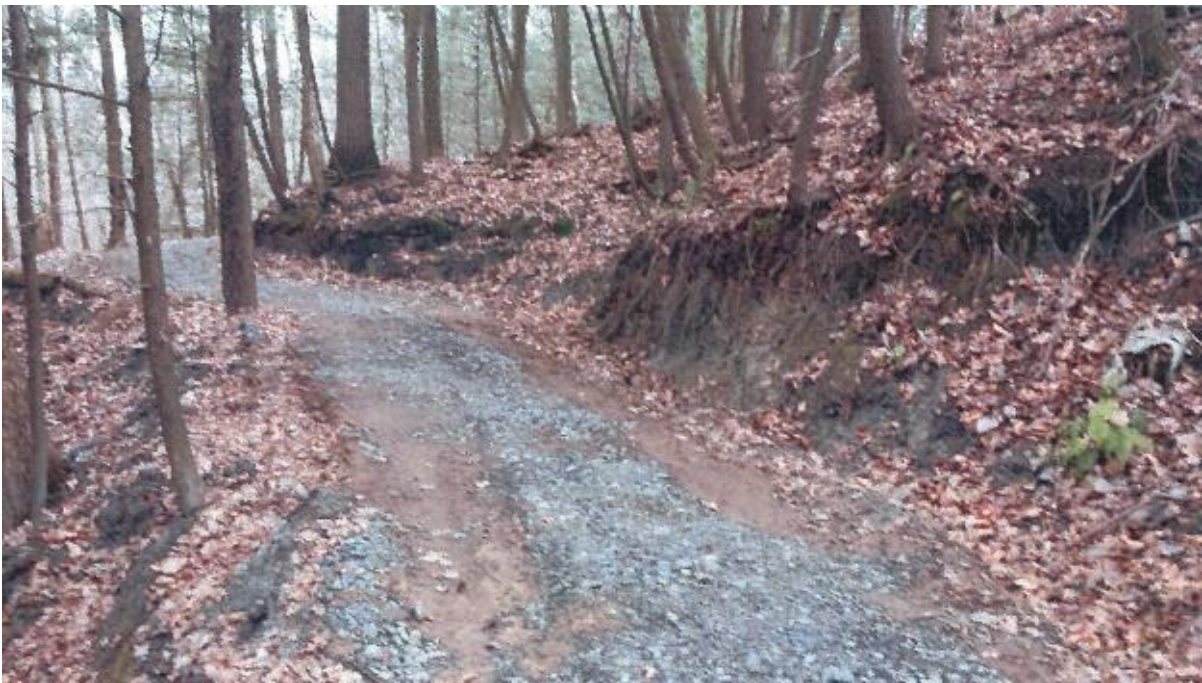
**Photo No. 6 – Erosion of cut uphill of pathway.  
Cut approximately 16 m long x 0.5 m to 1 m high.**

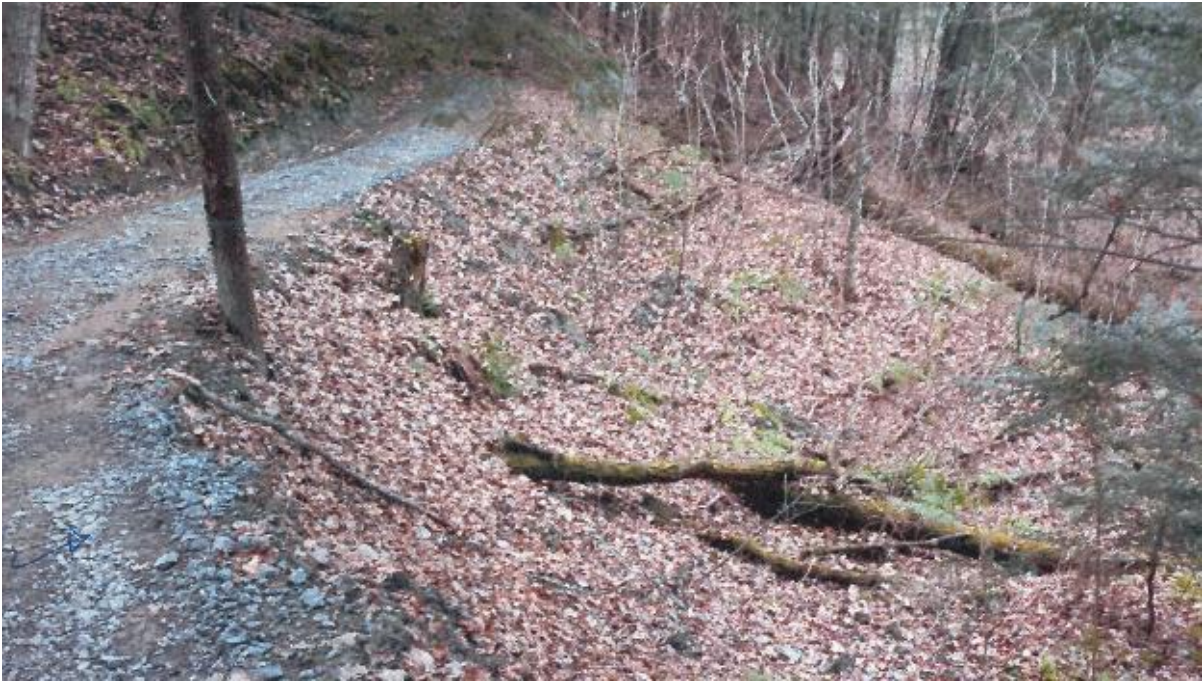
**Photo No. 7 – Erosion of slope downhill of pathway.  
Area approximately 30 m long x 1 m to 3 m high.**

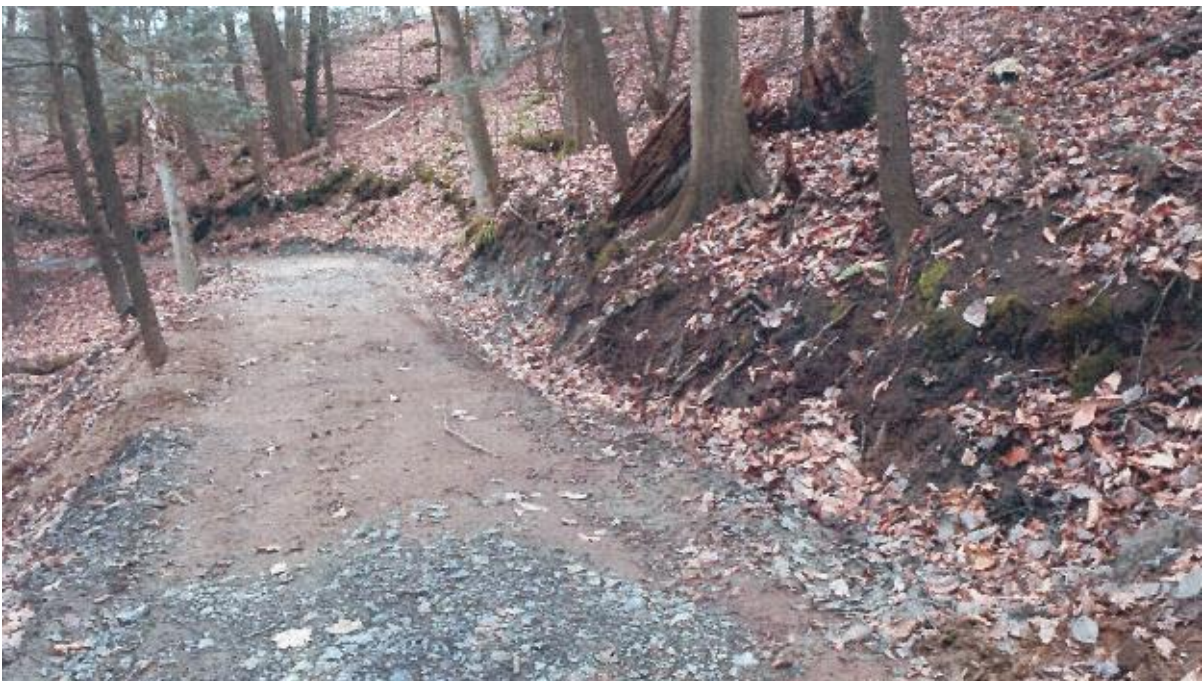
**Photo No. 8 – Erosion of cut uphill of pathway.  
Cut approximately 42 m long x 0.5 m to 1.3 m high.**

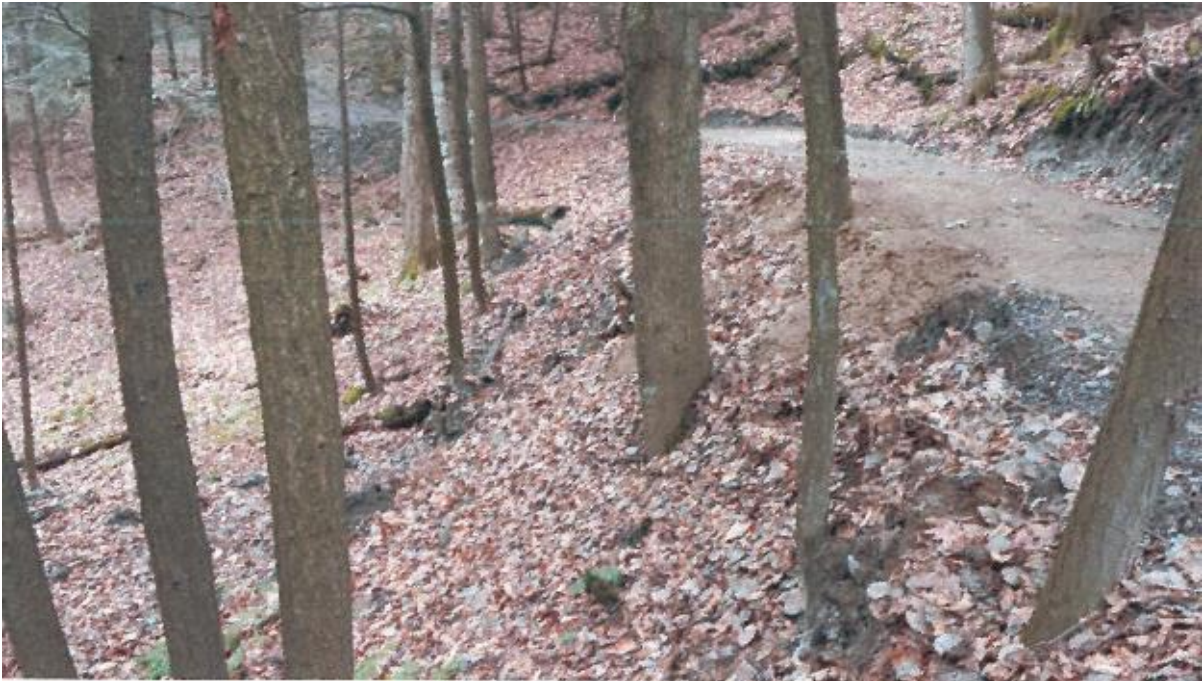
**Photo No. 9 – Erosion of slope downhill of pathway.  
Area approximately 30 m long by 2 m to 3 m high.**

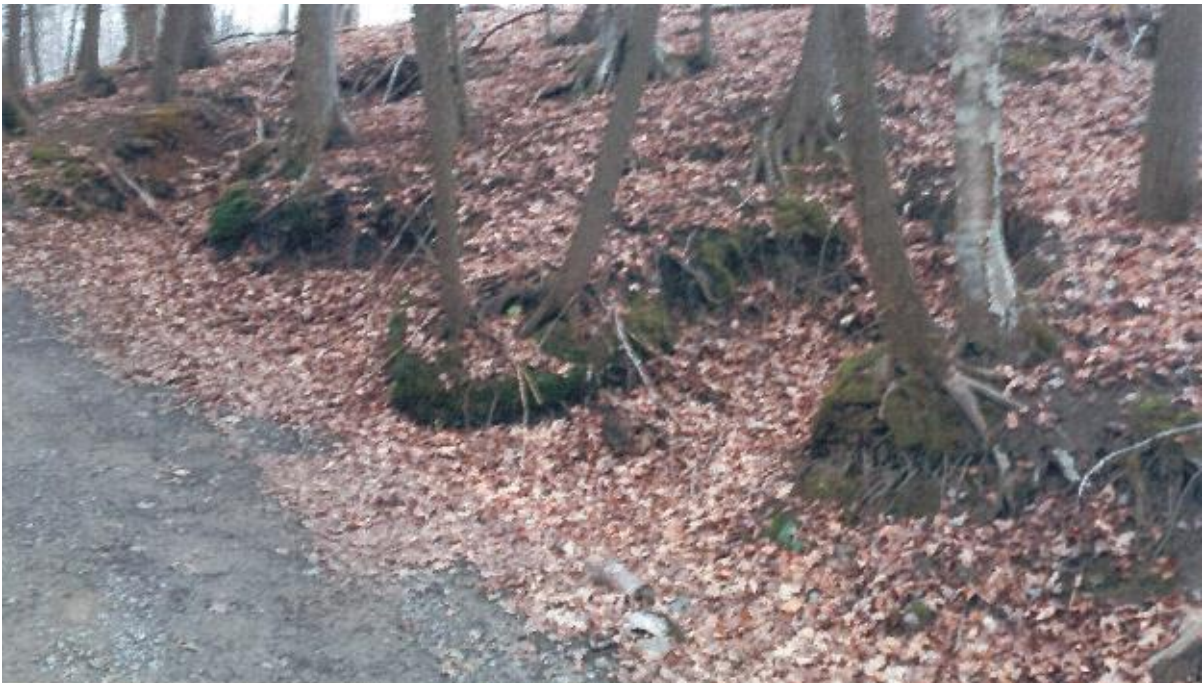
**Photo No. 10 – Erosion of cut uphill of pathway.  
Cut approximately 20 m long x 0.4 m to 1.2 m high.**

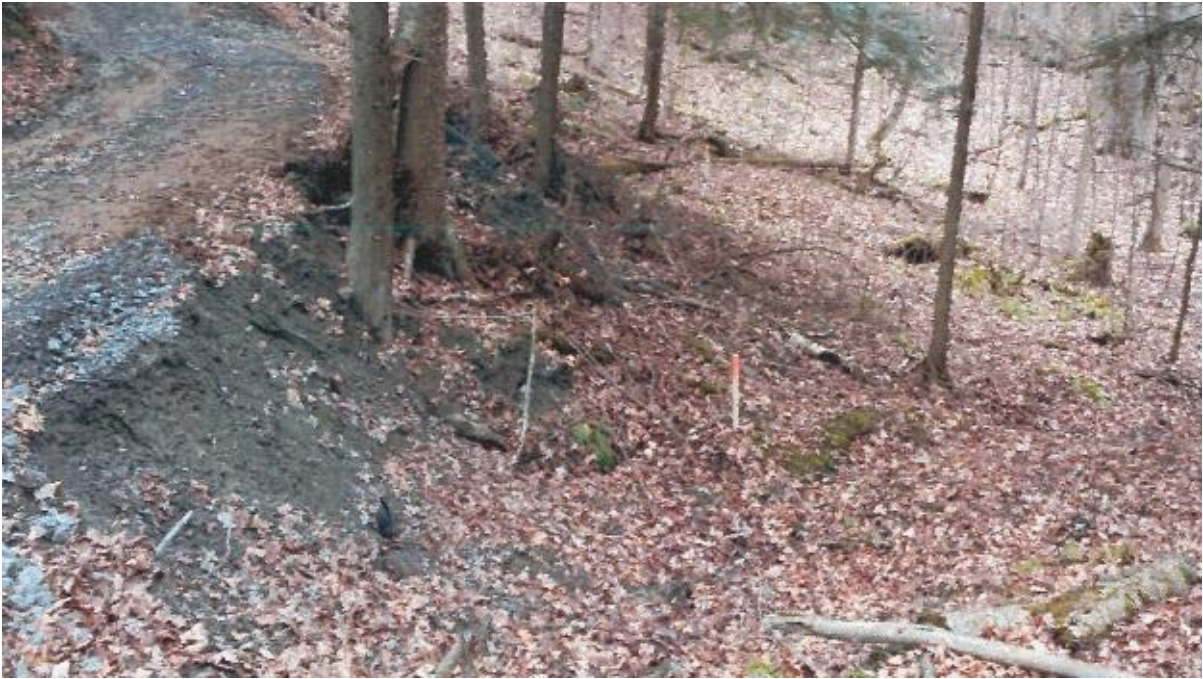
**Photo No. 11 – Erosion of slope downhill of pathway.  
Approximately 18 m long x 1 m to 2 m high.**

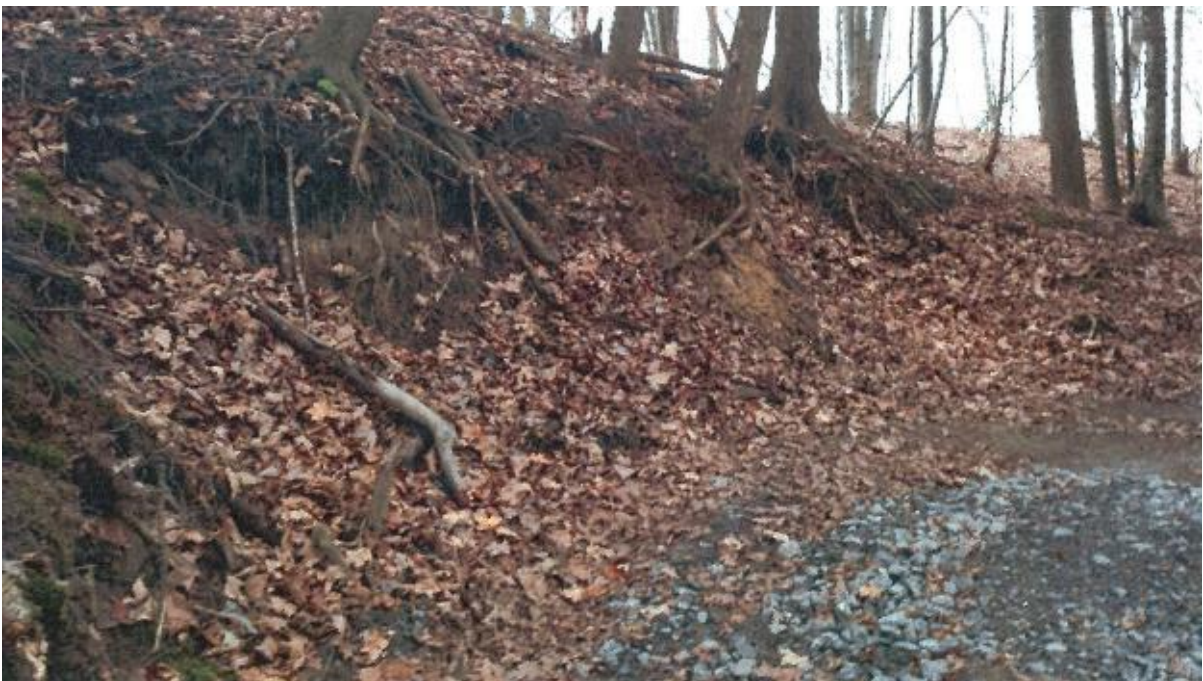
**Photo No. 12 – Erosion of slope uphill of pathway.**

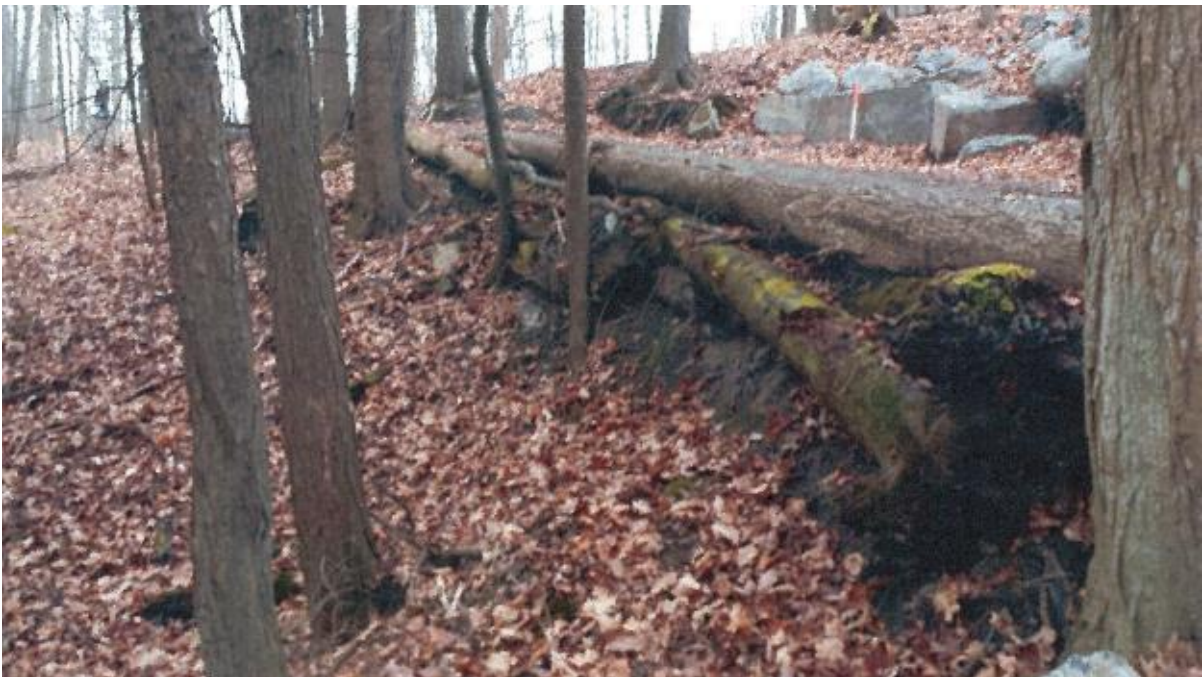
**Photo No. 14 – Erosion of slope downhill of pathway.  
Note placement of logs to prevent erosion.**

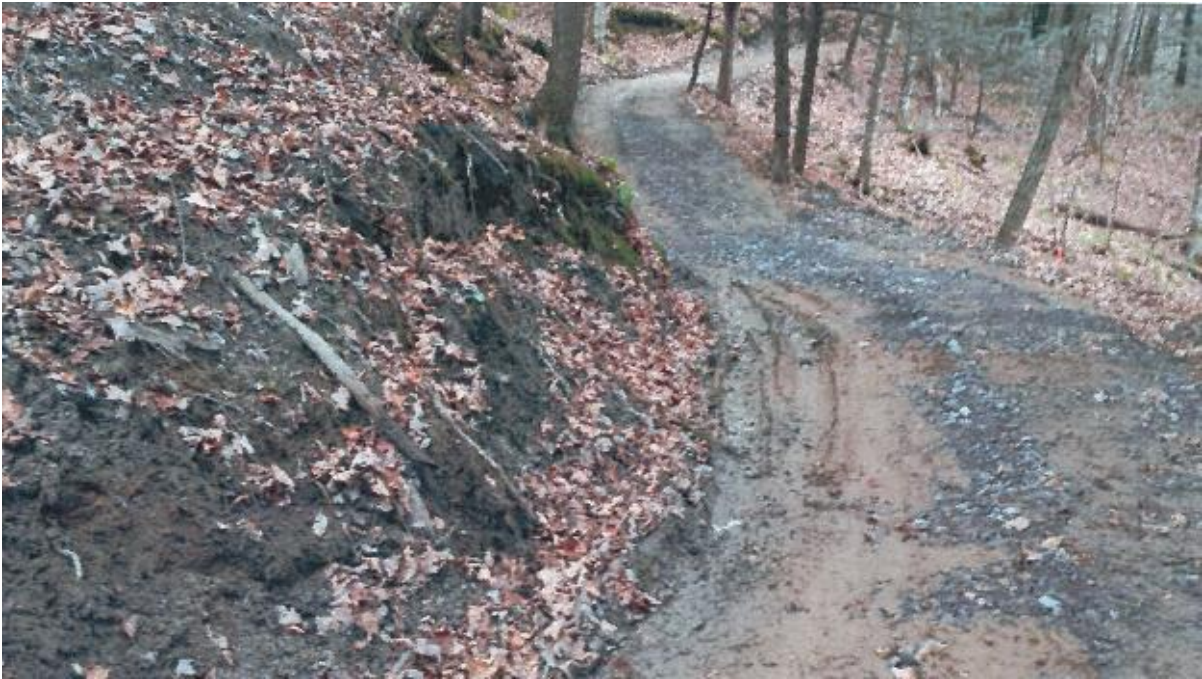
**Photo No. 15 – Erosion of cut uphill of pathway.  
Area approximately 7 m long and 0.8 m to 1.6 m high.**

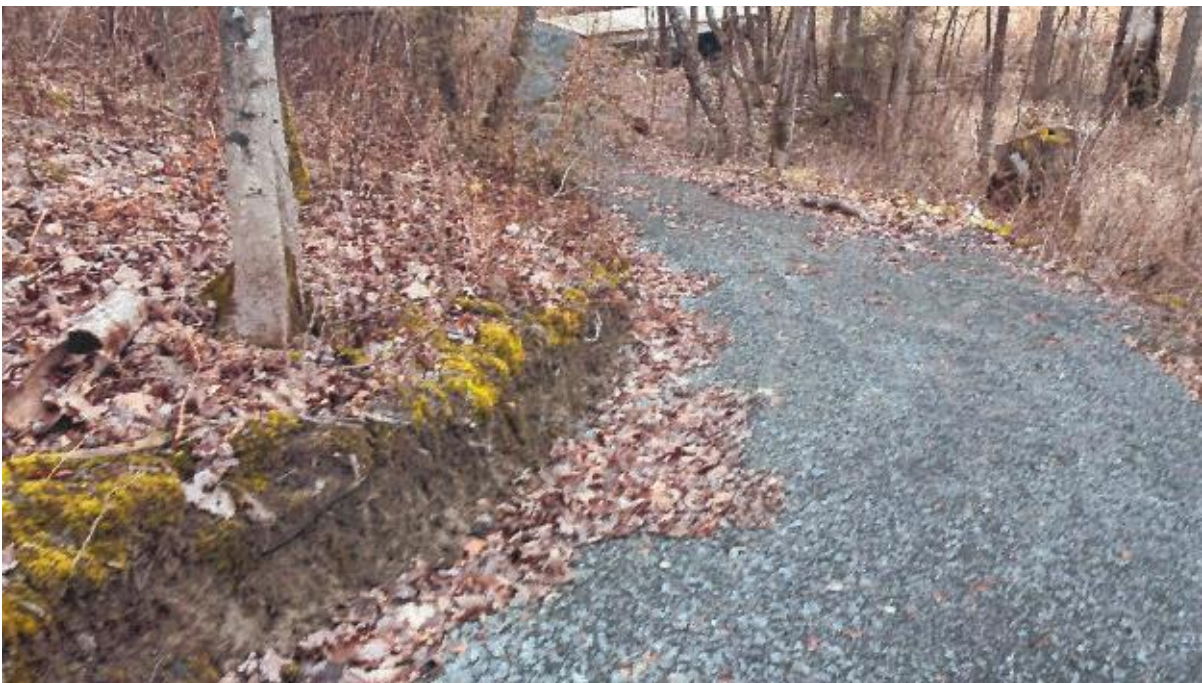
**Photo No. 17 – Erosion of cut downhill of pathway.  
Cut approximately 30 m long x 0.3 m high.**

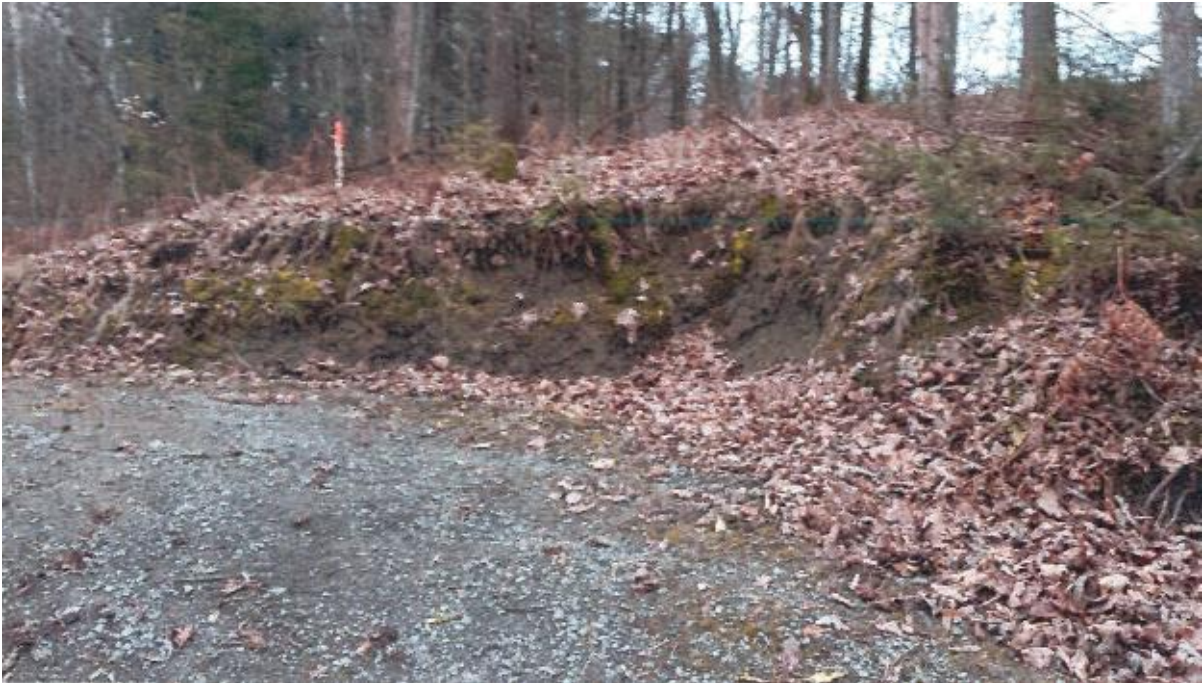
**Photo No. 18 – Erosion of cut uphill of pathway. Cut approximately 3 m long x 1.2 m high.**

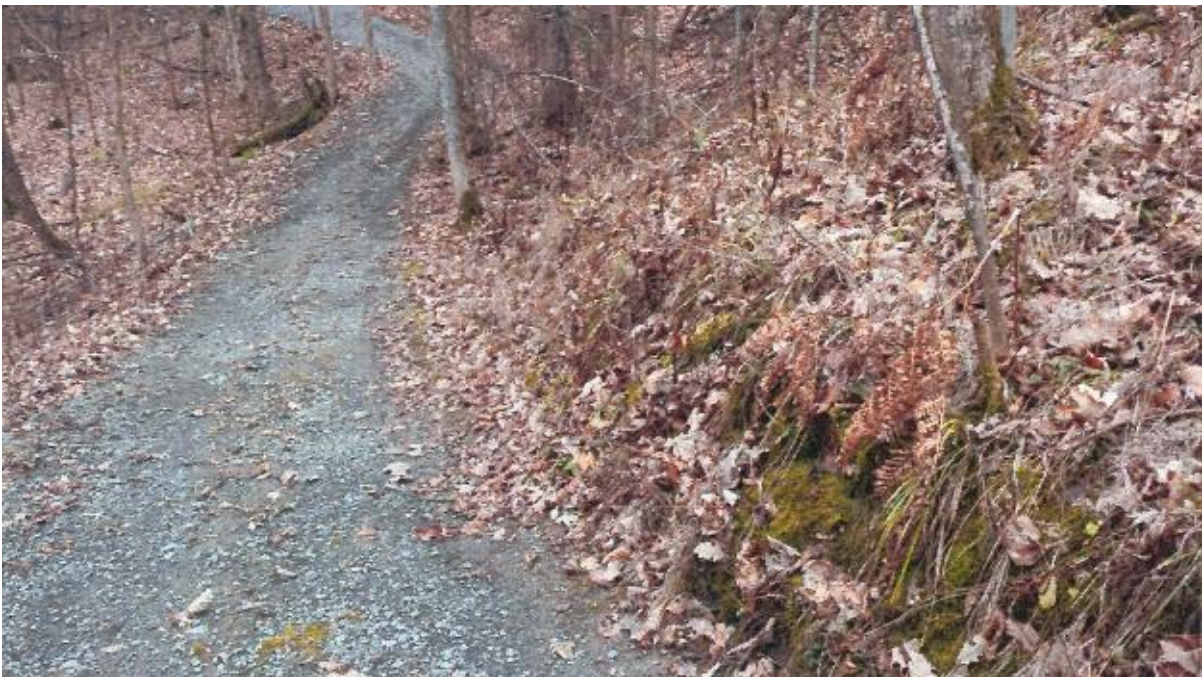
**Photo No. 19 – Erosion of cut above pathway. Cut approximately 7 m long x 0.8 m high.**

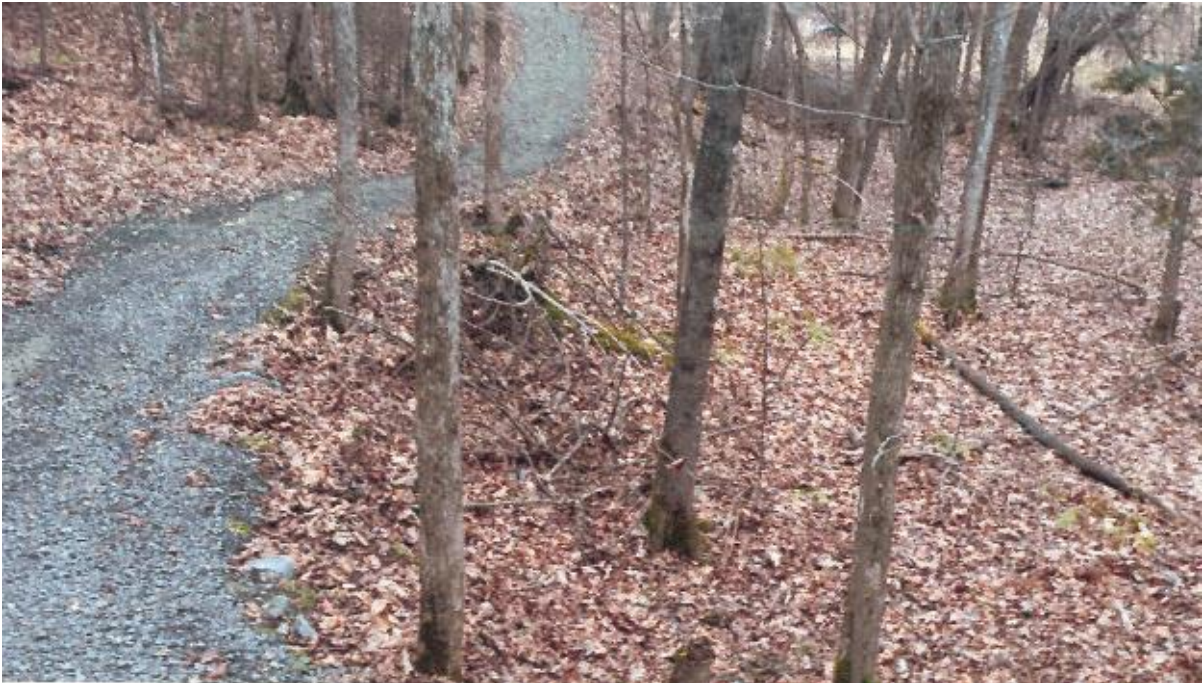
**Photo No. 20 – Deep cut downhill of pathway.  
Cut approximately 12 m long x 0.5 m to 1 m high.**

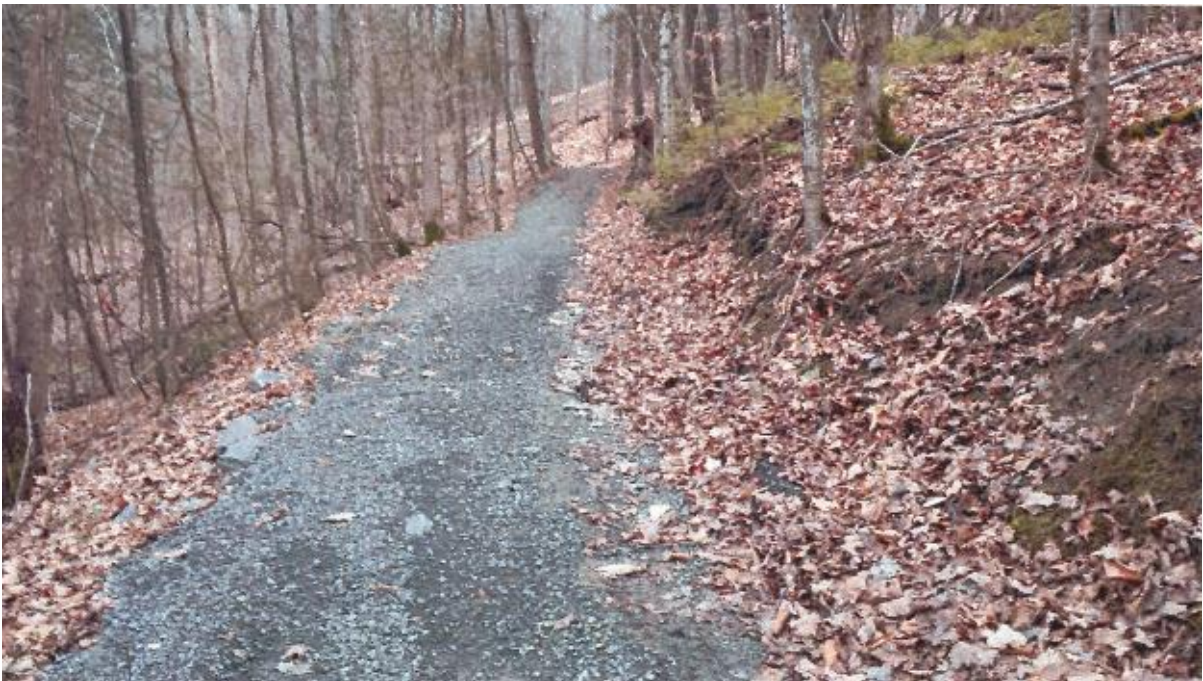
**Photo No. 21 – Erosion of cut above pathway.  
Cut approximately 45 m long x 0.3 m to 0.8 m high.**

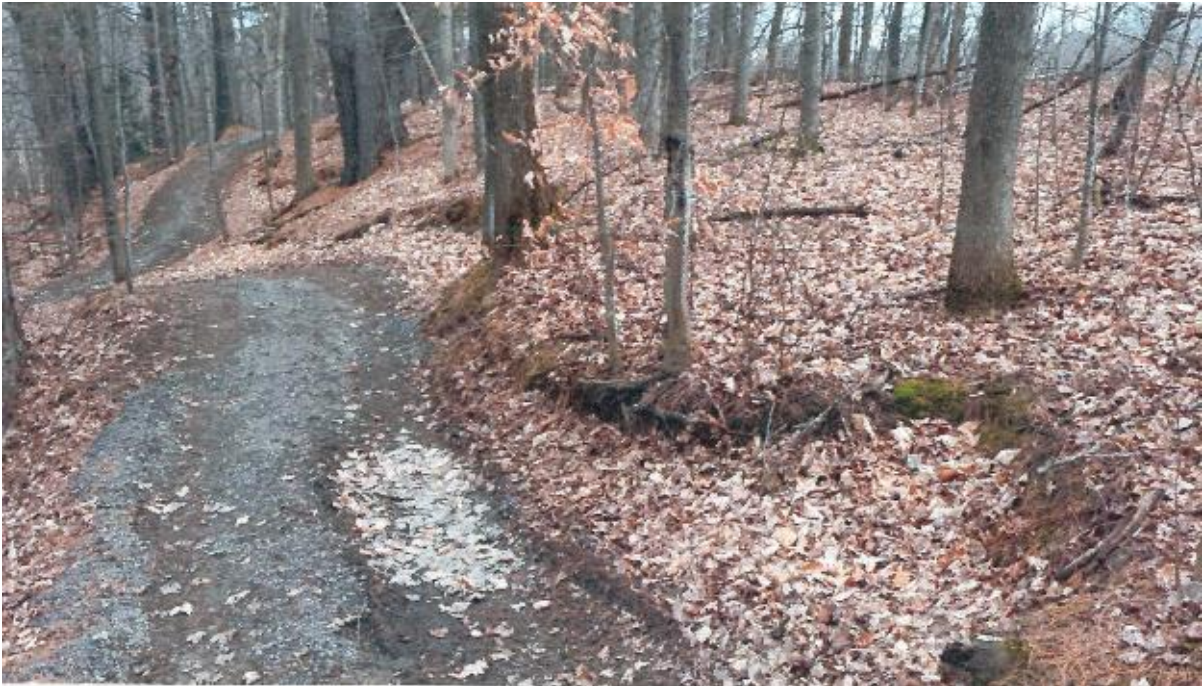
**Photo No. 24 – Erosion of cut above pathway. Cut approximately 20 m long x 0.4 m high.**

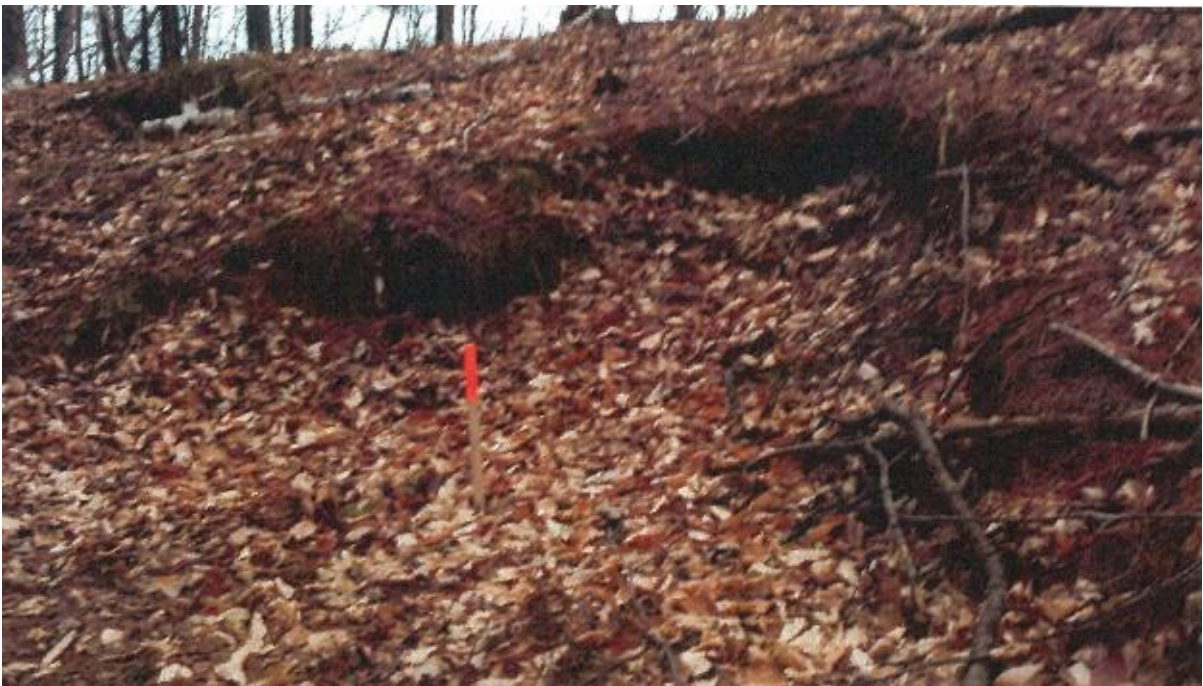
**Photo No. 25 – Erosion of cut above pathway. Cut approximately 4 m long x 0.6 m high.**
