Re: **Remedial Action Plan**
Proposed Residential Development
2006, 2020, & 2026 Scott Street and 314 & 318 Athlone Avenue
Ottawa, Ontario

Date: September 1, 2022

File: PE5303-RAP.01

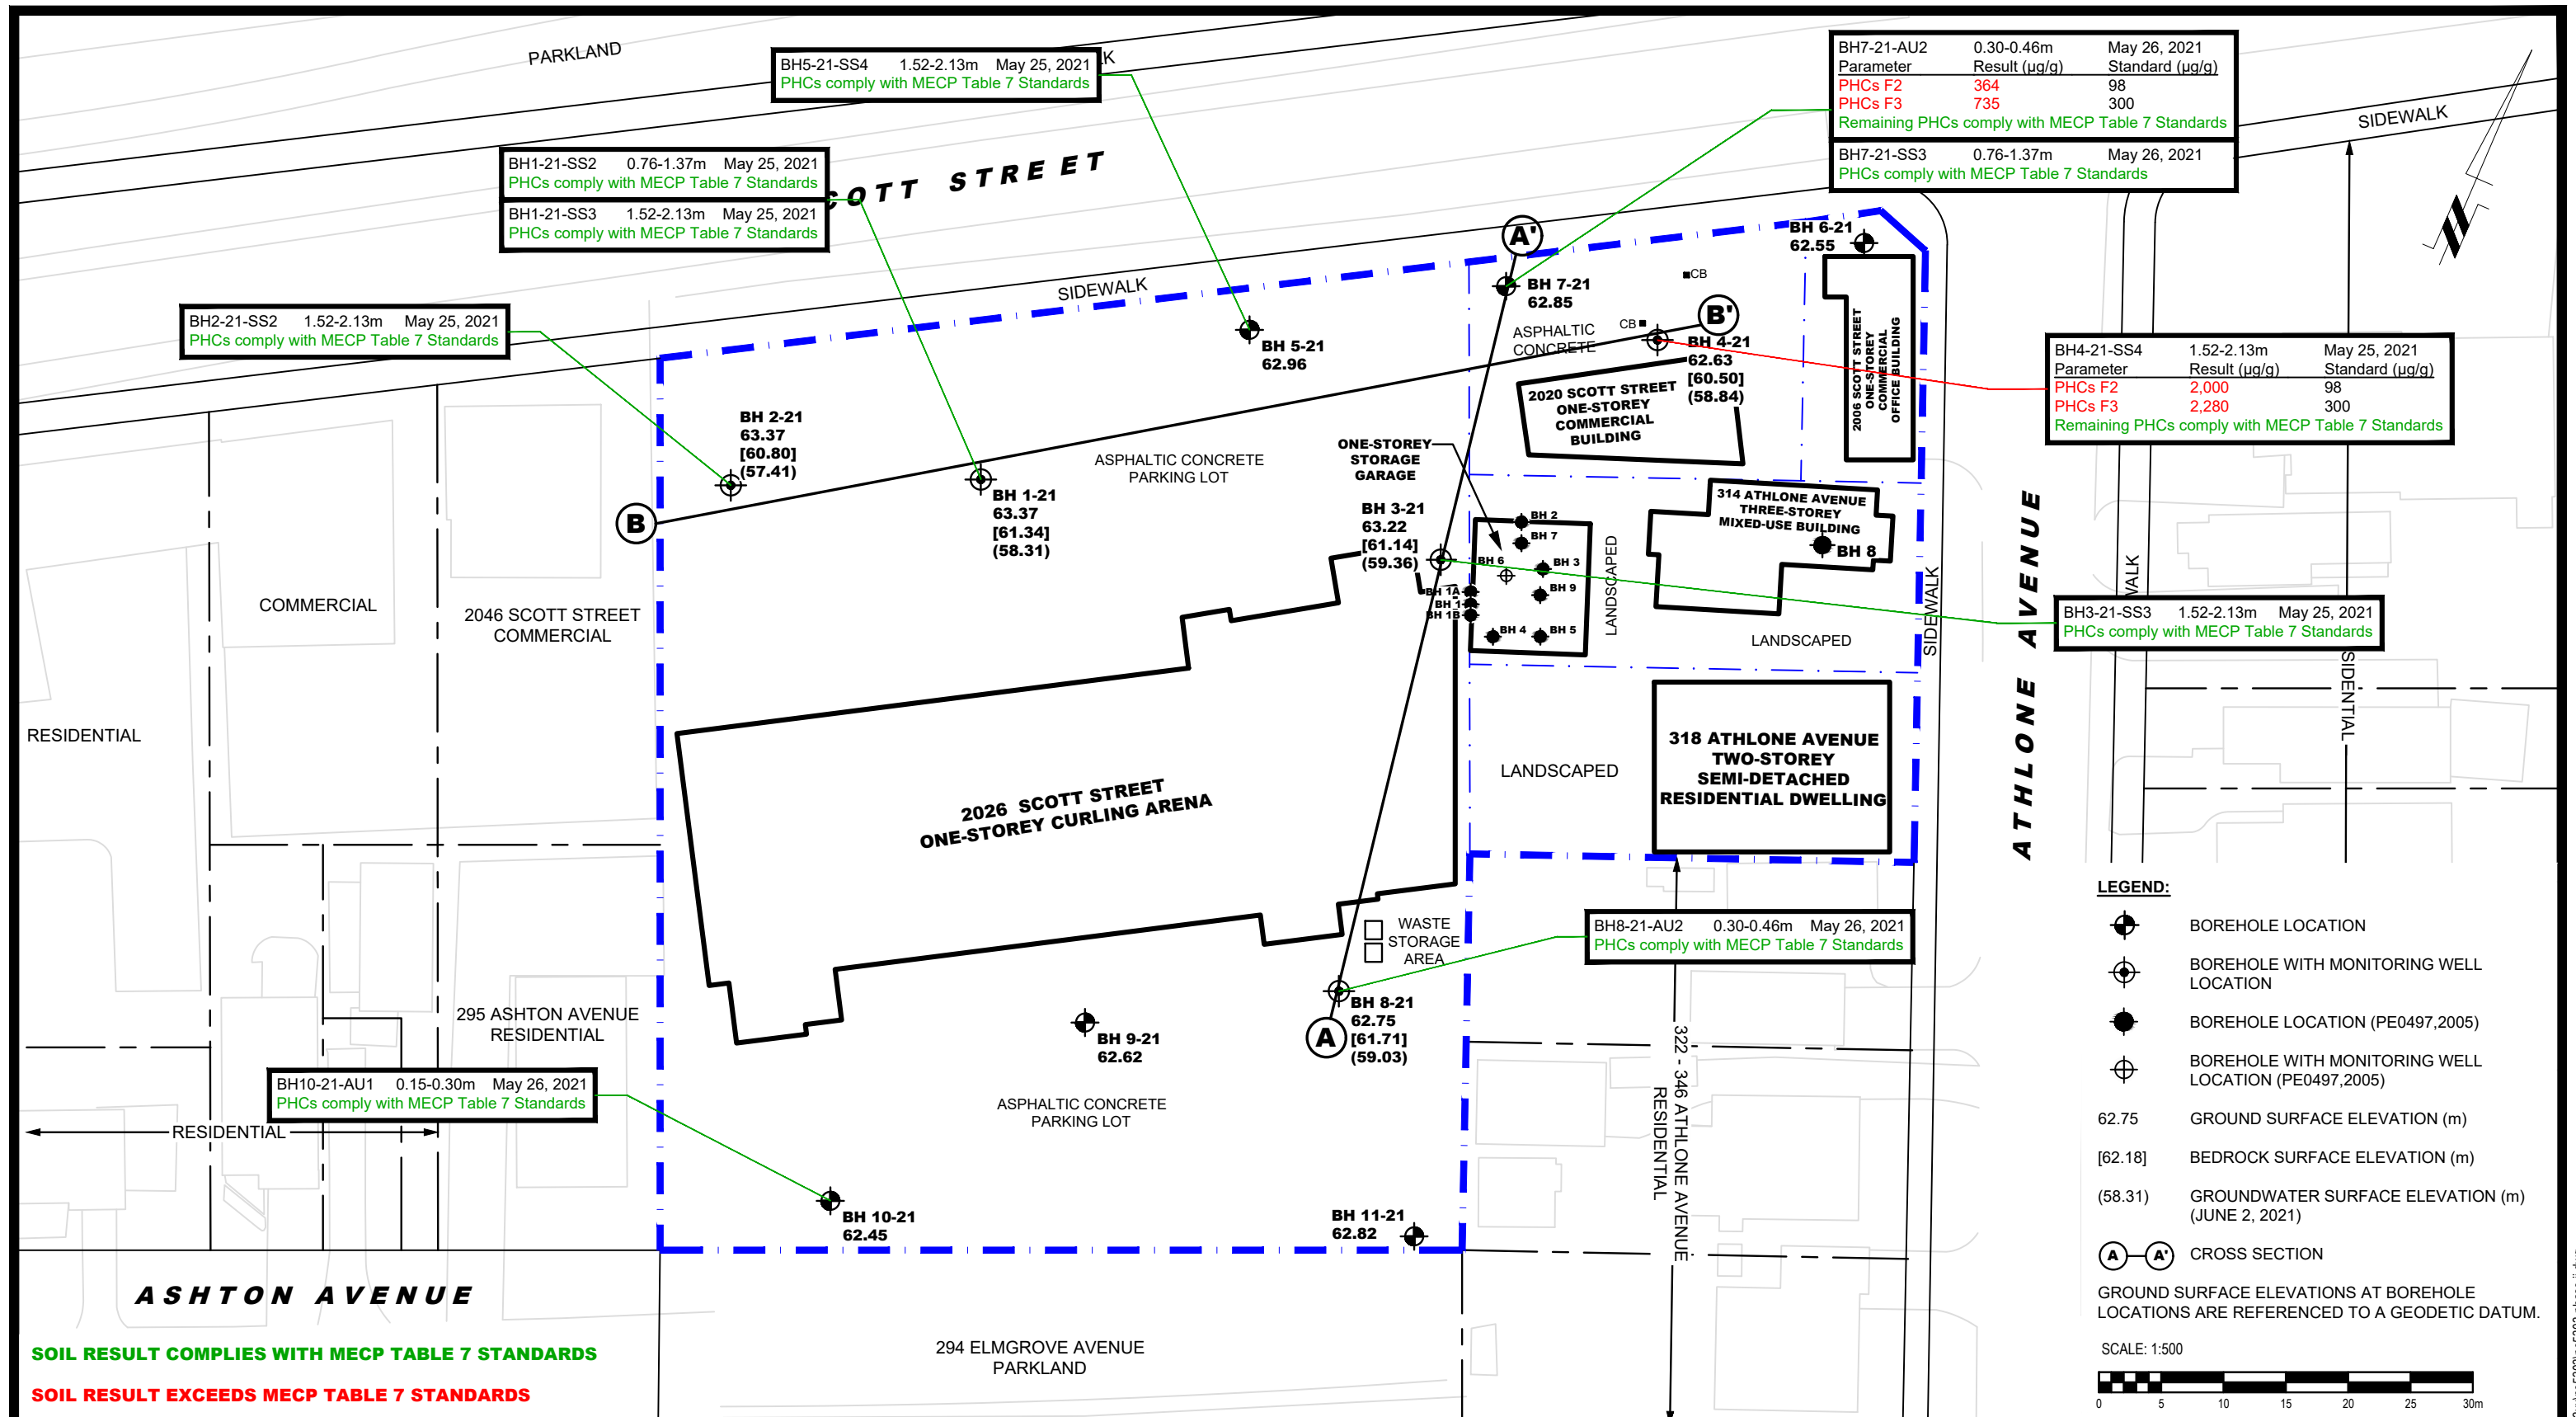
Title: **ANALYTICAL TESTING PLAN - SOIL (PHCs)**

Based on the analytical results, some PHC impacted soil/fill was identified in soil samples BH4-21-SS4 and BH7-21-SS3 in excess of the selected MECP Table 7 Coarse-Grained Residential Soil Standards.

The identified area of soil contamination is located in the northeastern portion of the subject site (2020 Scott Street) and is suspected to have resulted from the discharge of fuel and/or oil products from a former on-site auto service garage in this location. Due to its shallow nature, as well as the clean groundwater results, this contamination is anticipated to be limited to the soil/fill in this location.

- A remediation program using a full-depth generic approach will be implemented. This will involve the excavation and removal of all impacted soil from the subject site. Prior to its off-site disposal, a leachate analysis of a representative sample of contaminated soil must be completed in accordance with O. Reg. 347/55.

- During the excavation of contaminated soils, a screening procedure will be implemented using visual and olfactory observations as well as a portable soil vapour analyser. Field observations will be used in combination with the collection and analysis of confirmatory samples to determine the remedial excavation limits.

- Any impacted soil identified in excess of the selected MECP Table 7 Residential Coarse-Grained Soil Standards for Non-Potable Groundwater Conditions will be placed into trucks and hauled to an approved waste disposal facility.
