Re: Remedial Action Plan and Cost Estimate

Proposed Residential Development

84 and 100 Gloucester Street – Ottawa, Ontario

File: PE5571-RAP.01

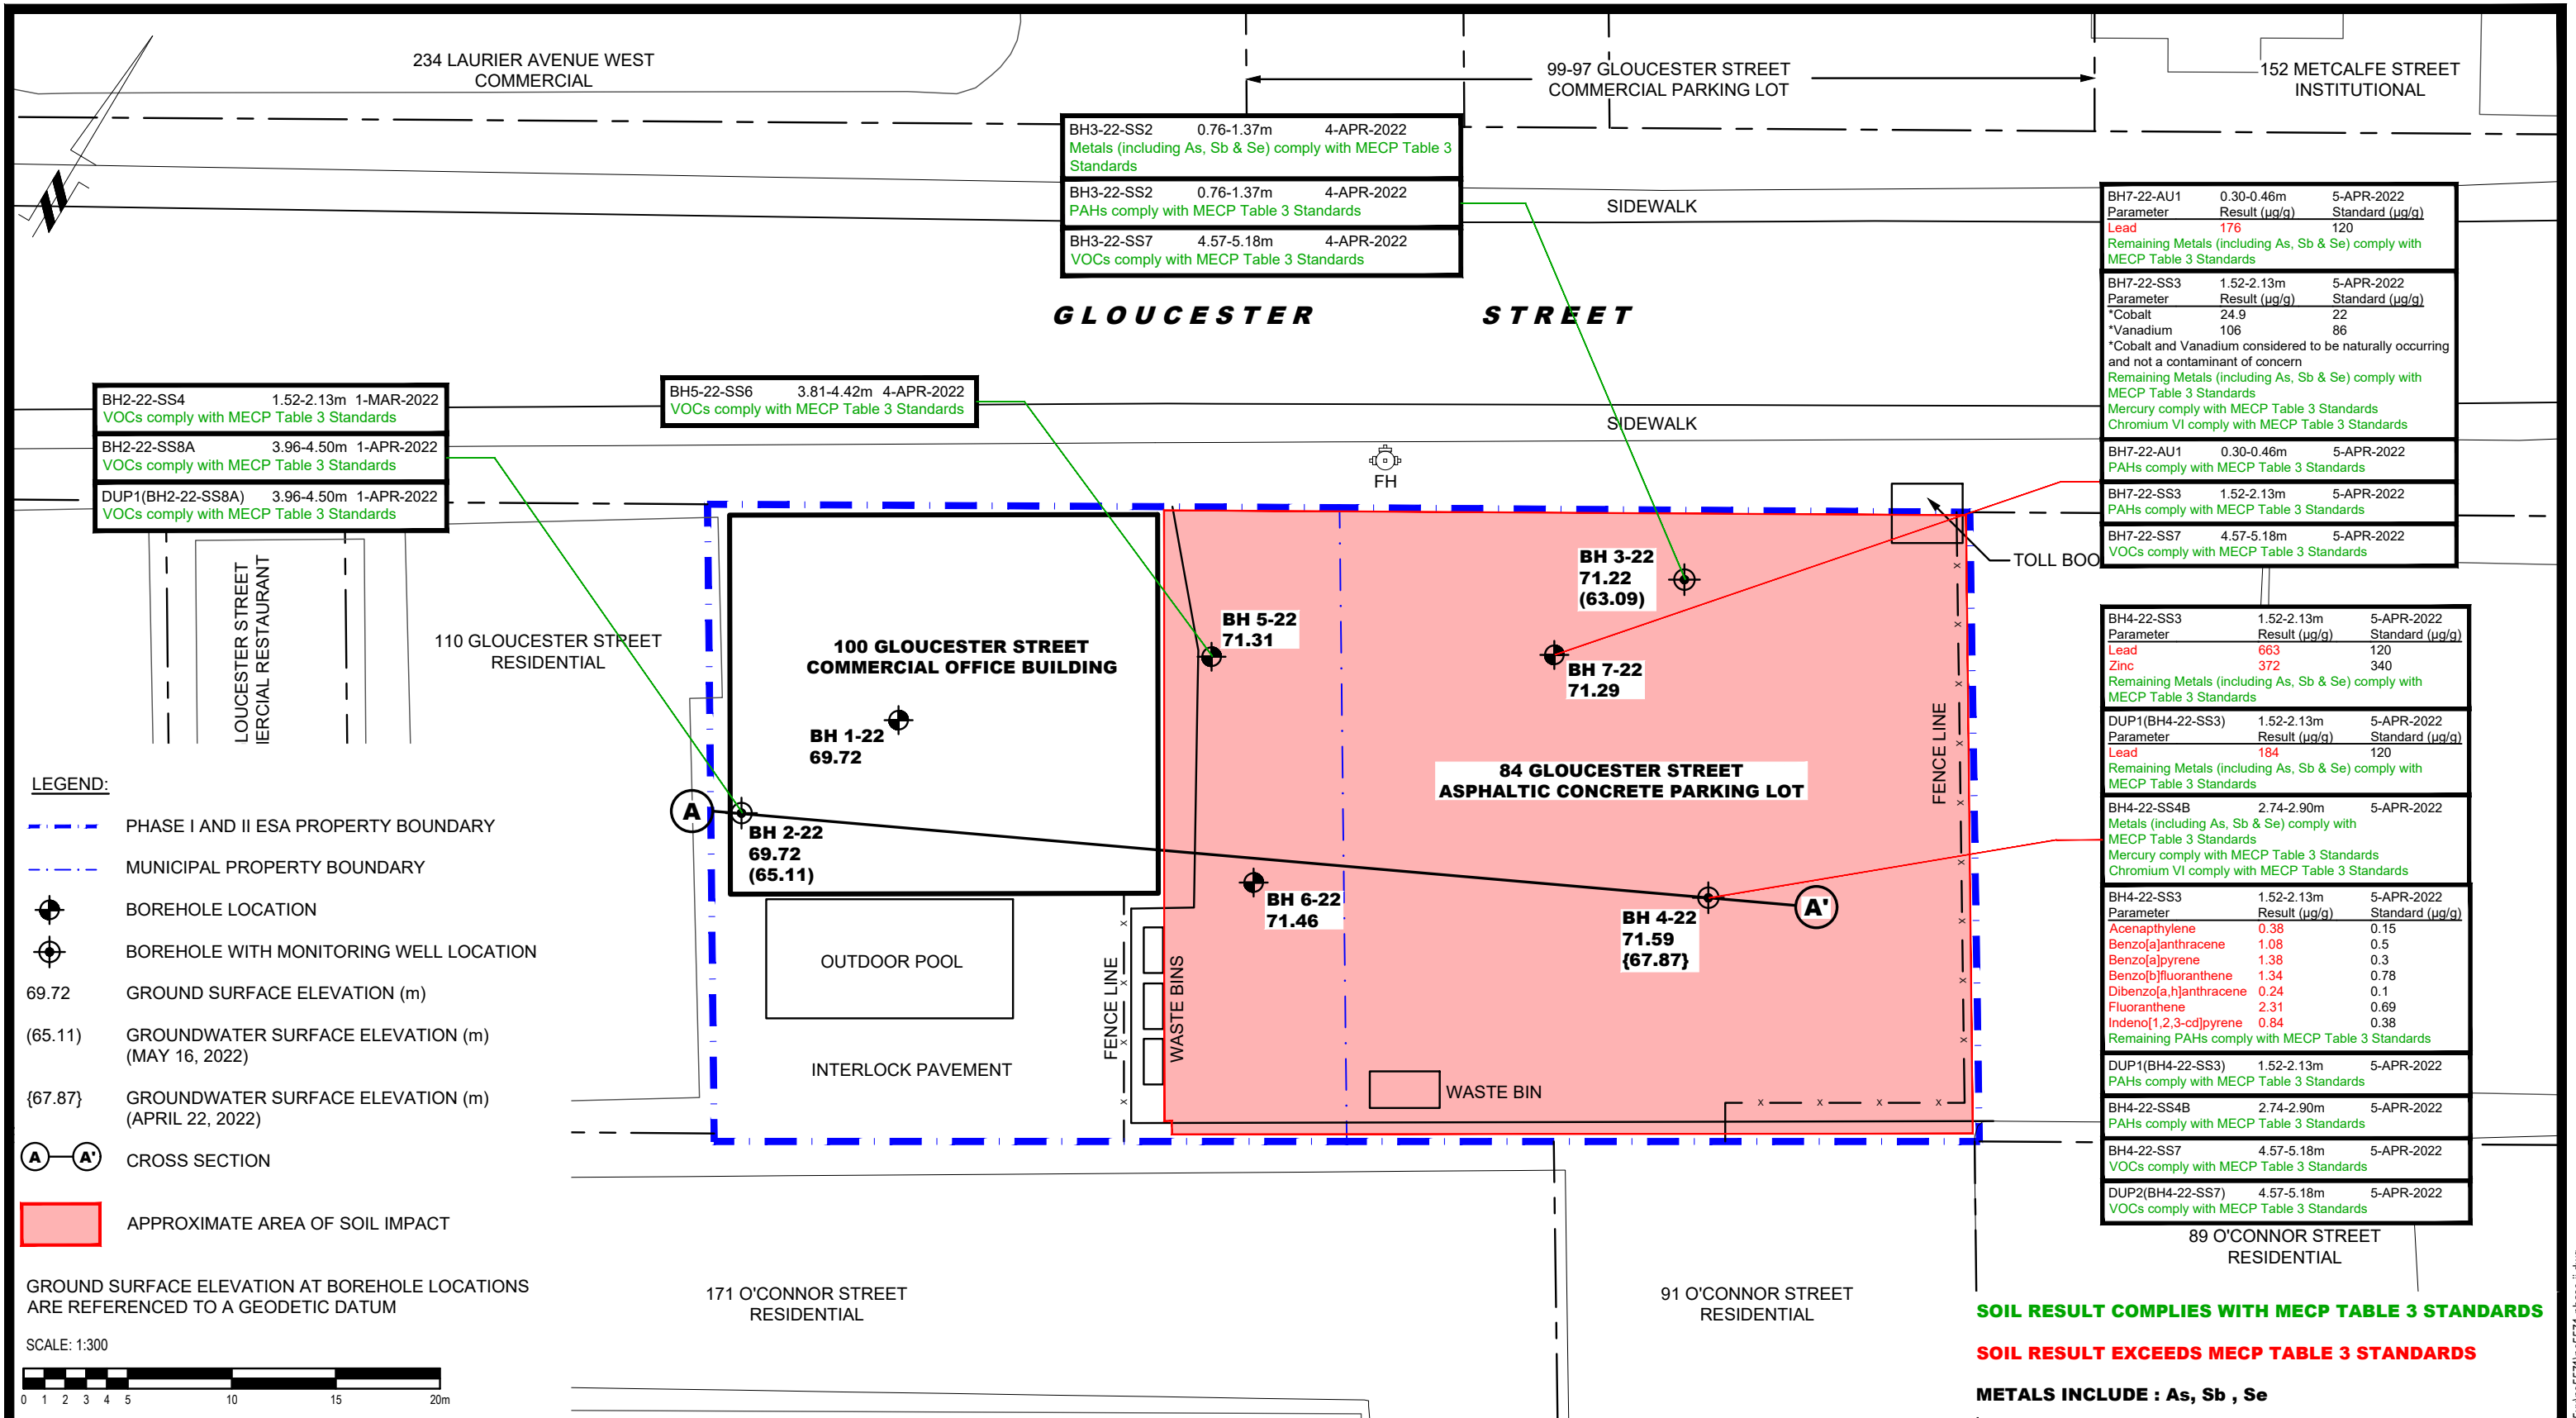
- Drawing PE5571-6 – Analytical Testing Plan – Soil (Approximate Area of Impacted Soil)

Based on the analytical results, some metal and/or PAH parameter concentrations were identified in soil samples BH4-2-SS3 and BH7-22-AU1 in excess of the selected MECP Table 3 Residential Soil Standards. Given the non-homogenous nature of the fill material, pockets of impacted fill are expected to be encountered across the subject site.

- The areas marked out on the enclosed Drawing PE5571-4 – Analytical Testing Plan – Soil, have or are expected to have soil impacted with metals to depths of approximately 2.0 m below ground surface.

- A remediation program using a full-depth generic approach will be implemented. This will involve the excavation and removal of all impacted soil from the subject site. Prior to its off-site disposal, a leachate analysis of a representative sample of contaminated soil must be completed in accordance with O. Reg. 347/55.

- Any impacted soil identified in excess of the selected MECP Table 3 Residential Coarse-Grained Soil Standards for Non-Potable Groundwater Conditions will be placed into trucks and hauled to an approved waste disposal facility.
