**RE: TREE CONSERVATION REPORT FOR PART 2 OF 56 CAPILANO DRIVE, OTTAWA**

DRAWING: Tree Conservation Plan

PROJECT: 56 CAPILANO DRIVE  
CITY OF OTTAWA

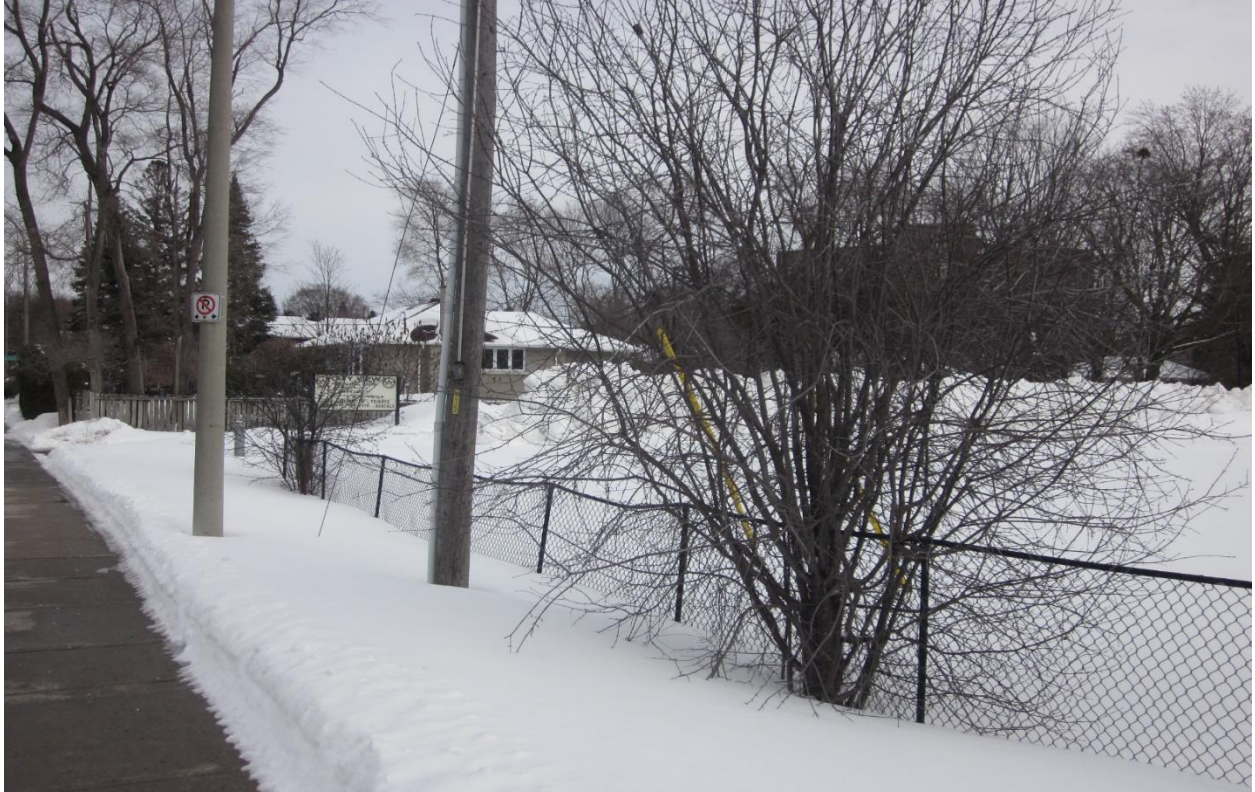
Tree No.	Tree species	Presumed ownership <sup>1</sup>	DBH <sup>2</sup> (cm)	Tree Condition; Age Class; Condition Notes; Species Origin & <b>Preservation Status</b> (to be removed or preserved and protected)
1	Glossy buckthorn ( <i>Frangula alnus</i> )	Shared with city property	2 avg.	Fair; immature; introduced invasive species; originated from seed; <b>to be removed</b> (conflicts with fence demolition and construction access)
2	Glossy buckthorn ( <i>Frangula alnus</i> )	Shared with city property	5 avg.	Fair; mature; introduced invasive species; originated from seed; <b>to be removed</b> (conflicts with fence demolition and construction access)
3	White cedar ( <i>Thuja occidentalis</i> ) & White elm ( <i>Ulmus americana</i> )	City	< 13 avg.	Good; maturing; cedars planted as part of a hedge, elms originated from seed; both native species; <b>to be preserved and protected</b>
4	Manitoba maple ( <i>Acer negundo</i> )	Shared with adjacent private property	14	Fair; immature; single stemmed; naturalized species; originated from seed; <b>to be removed</b> (conflicts with fence demolition and landscape construction)

Picture 1. Trees #1-2 (left to right), buckthorn shared with City land at 56 Capilano Drive

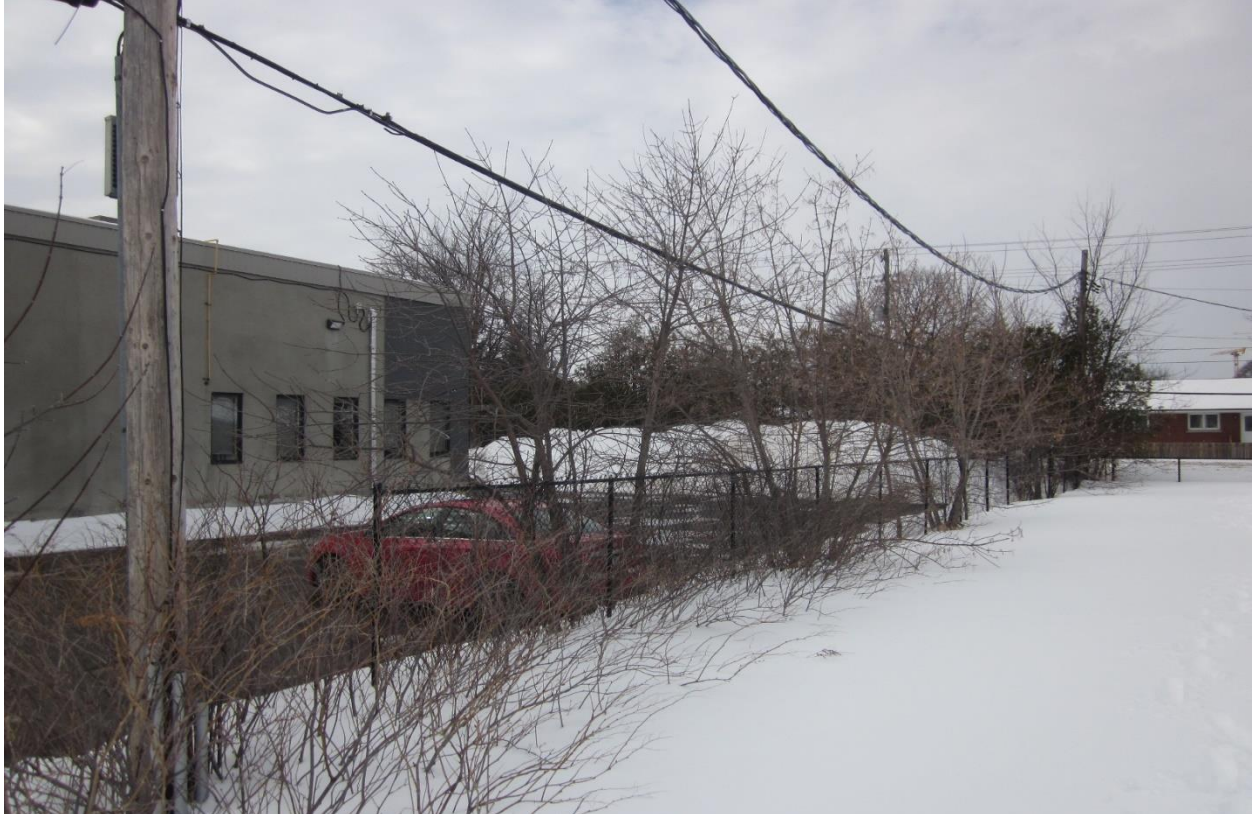
5	Manitoba maple ( <i>Acer negundo</i> )	Shared with adjacent private property	< 10 avg.	Fair; immature; five-stemmed from grade – likely coppicing from stump; naturalized species; originated from seed; <b>to be removed</b> (conflicts with fence demolition and landscape construction)
6	Manitoba maple ( <i>Acer negundo</i> )	Shared with adjacent private property	< 10 avg.	Fair; immature; nine-stemmed from grade – likely coppicing from stump; naturalized species; originated from seed; <b>to be removed</b> (conflicts with fence demolition and landscape construction)
7	Ash ( <i>Fraxinus</i> spp.)	Shared with adjacent private property	< 10 avg.	Fair; immature; five-stemmed from grade – likely coppicing from stump; native species; originated from seed; <b>to be removed</b> (conflicts with fence demolition and landscape construction)

Picture 2. Trees #4-7 (background to foreground), shared with private property adjacent to 56 Capilano Drive

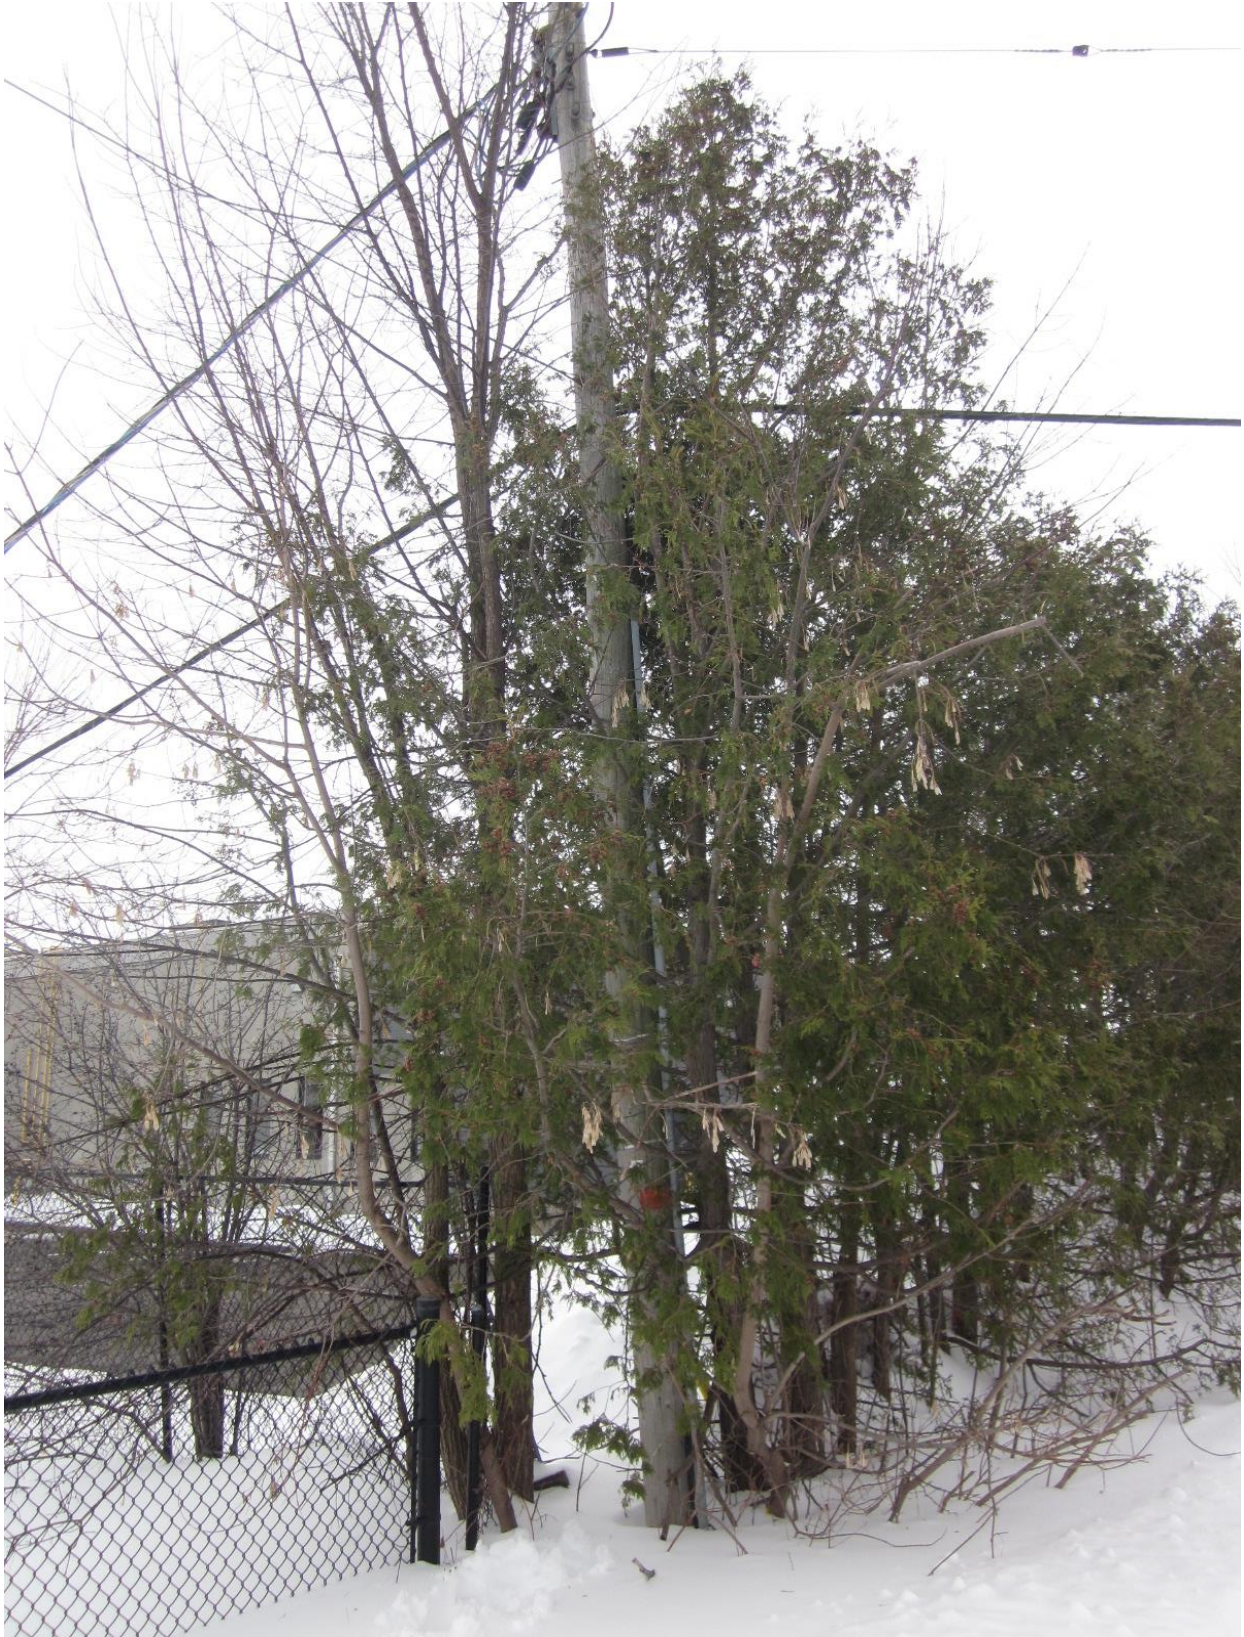
As excavation will likely be within the CRZs of trees #3 and 9, the following measures will be taken:

Picture 3. Trees #3, white elms and white cedars on City property adjacent to 56 Capilano Drive

1. Hydro excavation along the line of excavation in closest proximity to the trees to carefully expose roots. Exposed roots will then be cleanly cut and sealed before being reburied. Excavation can then resume using traditional mechanical means. Sealing the cleanly cut root ends with a beeswax product will help prevent the loss of moisture and facilitate healing.

2. If the excavation is to be left open for any time a covering of at least three layers of moistened burlap is to be draped over the exposed face of excavation closest to the tree. This will help reduce the loss of soil moisture (as soil dries the roots contained within die).

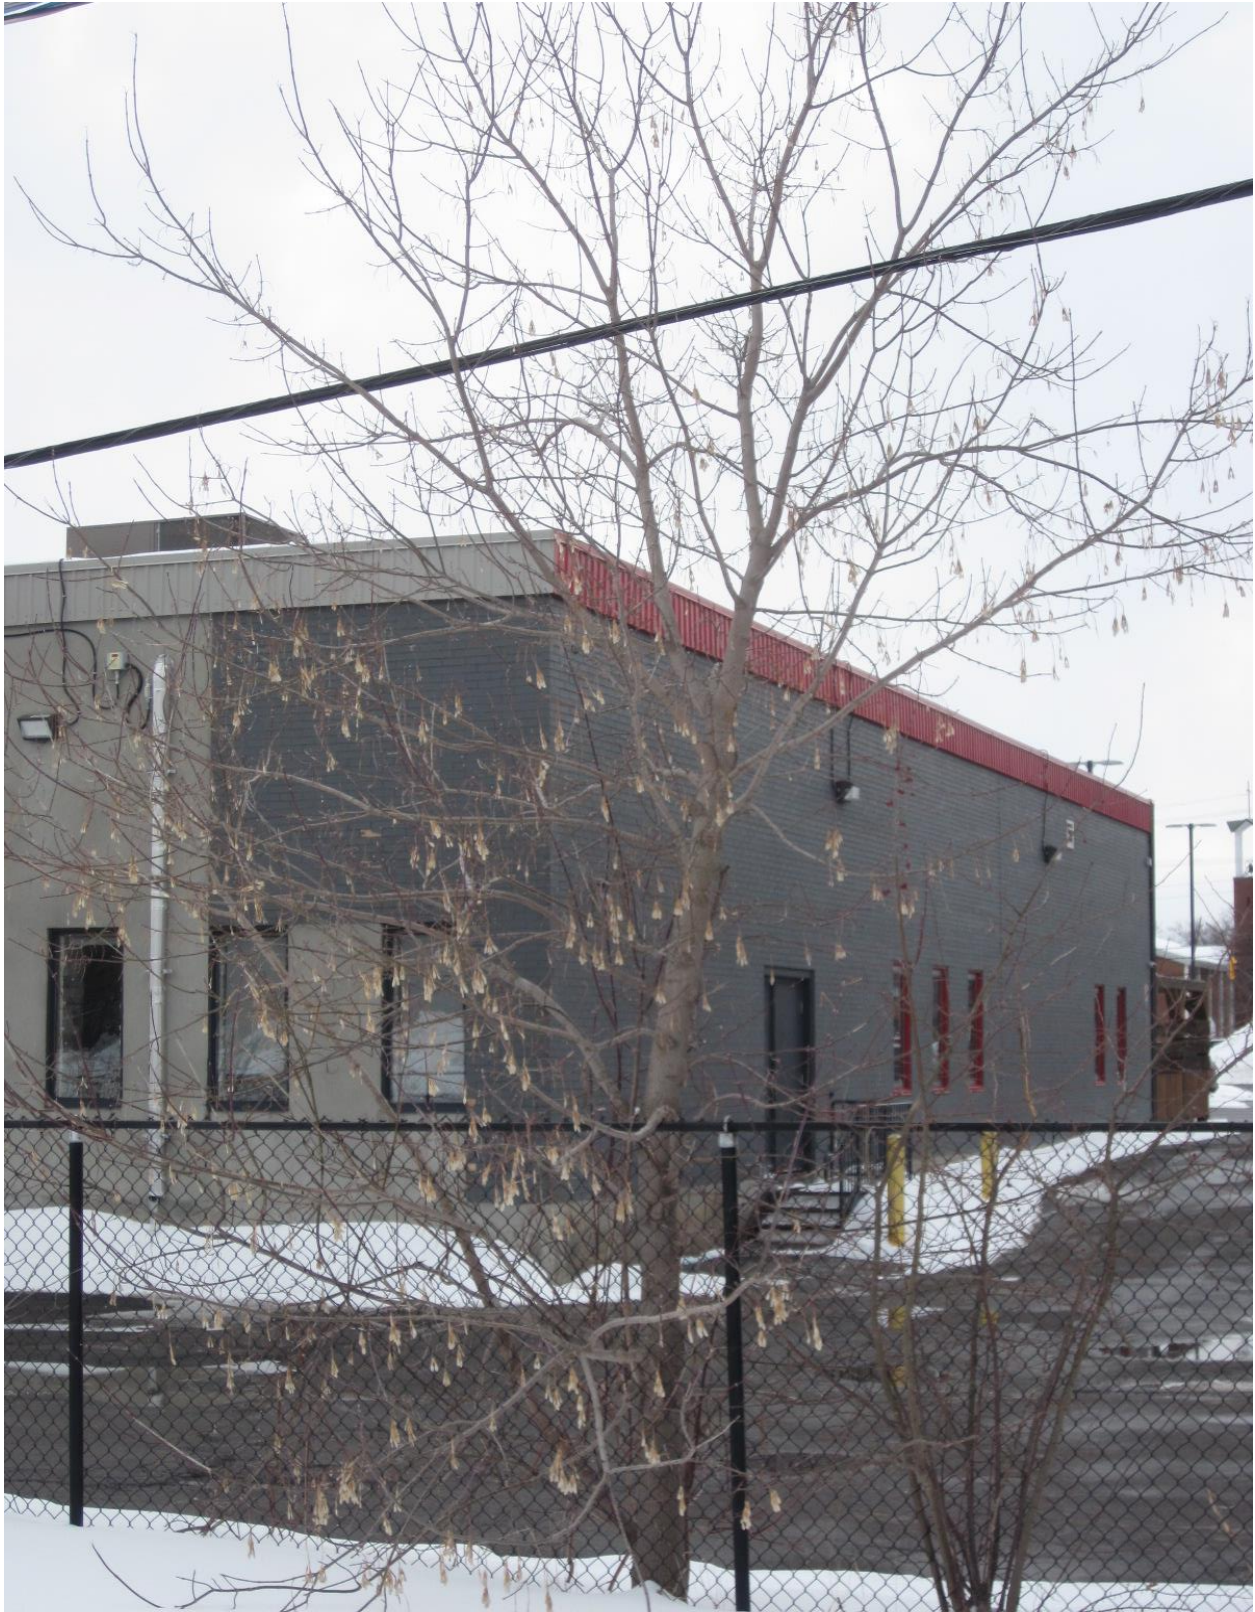
Picture 4. Tree #4, Manitoba maple shared with private property adjacent to 56 Capilano Drive

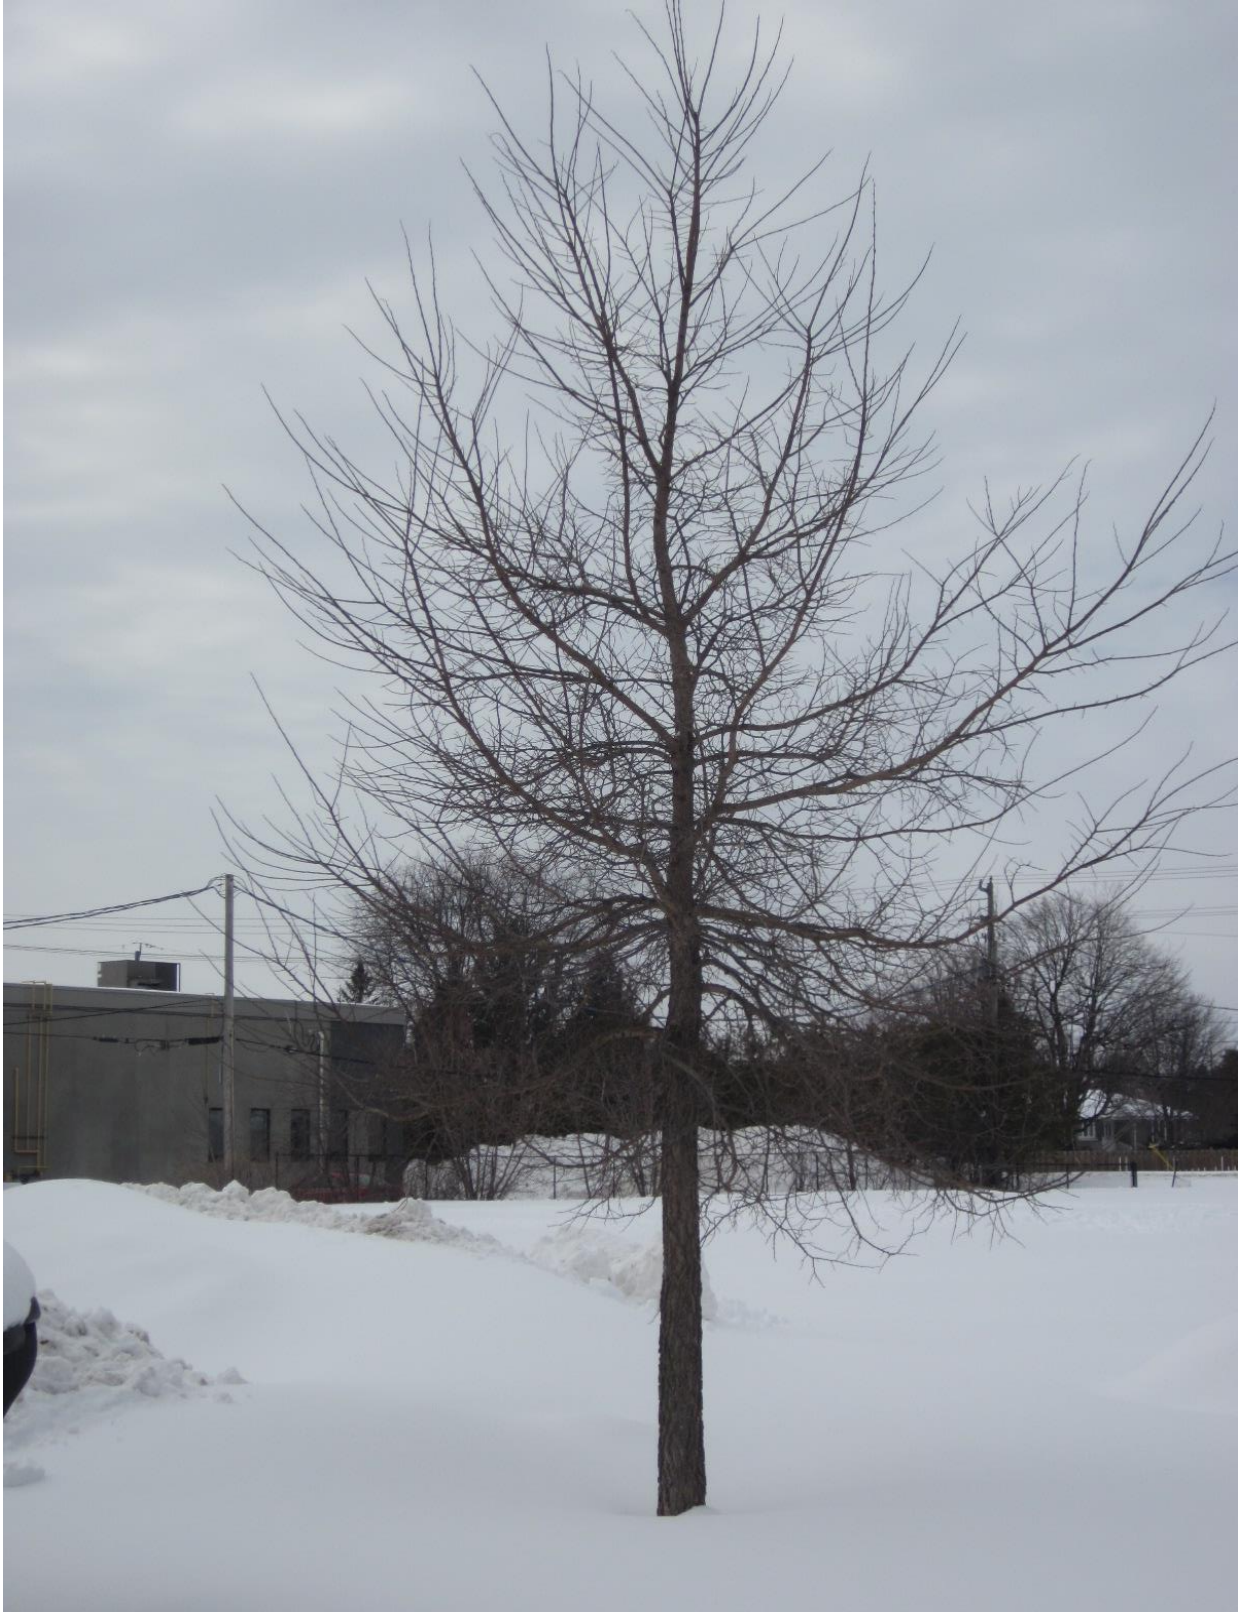
Picture 5. Tree #9, hackberry on private property adjacent to 56 Capilano Drive

Protection measures intended to mitigate damage during construction will be applied for the trees to be retained on City property and the private hackberry tree. The following measures are the minimum required by the City of Ottawa to ensure tree survival during and following construction:
