**Slope Stability Assessment  
Ottawa-Carleton Detention Centre  
Parking Lot Expansion - 2244 Innes Road  
Ottawa, Ontario**

July 29, 2022  
Project: 100009.037 R0

**Re: Slope Stability Assessment  
Ottawa-Carleton Detention Centre  
Parking Lot Expansion - 2244 Innes Road  
Ottawa, Ontario**

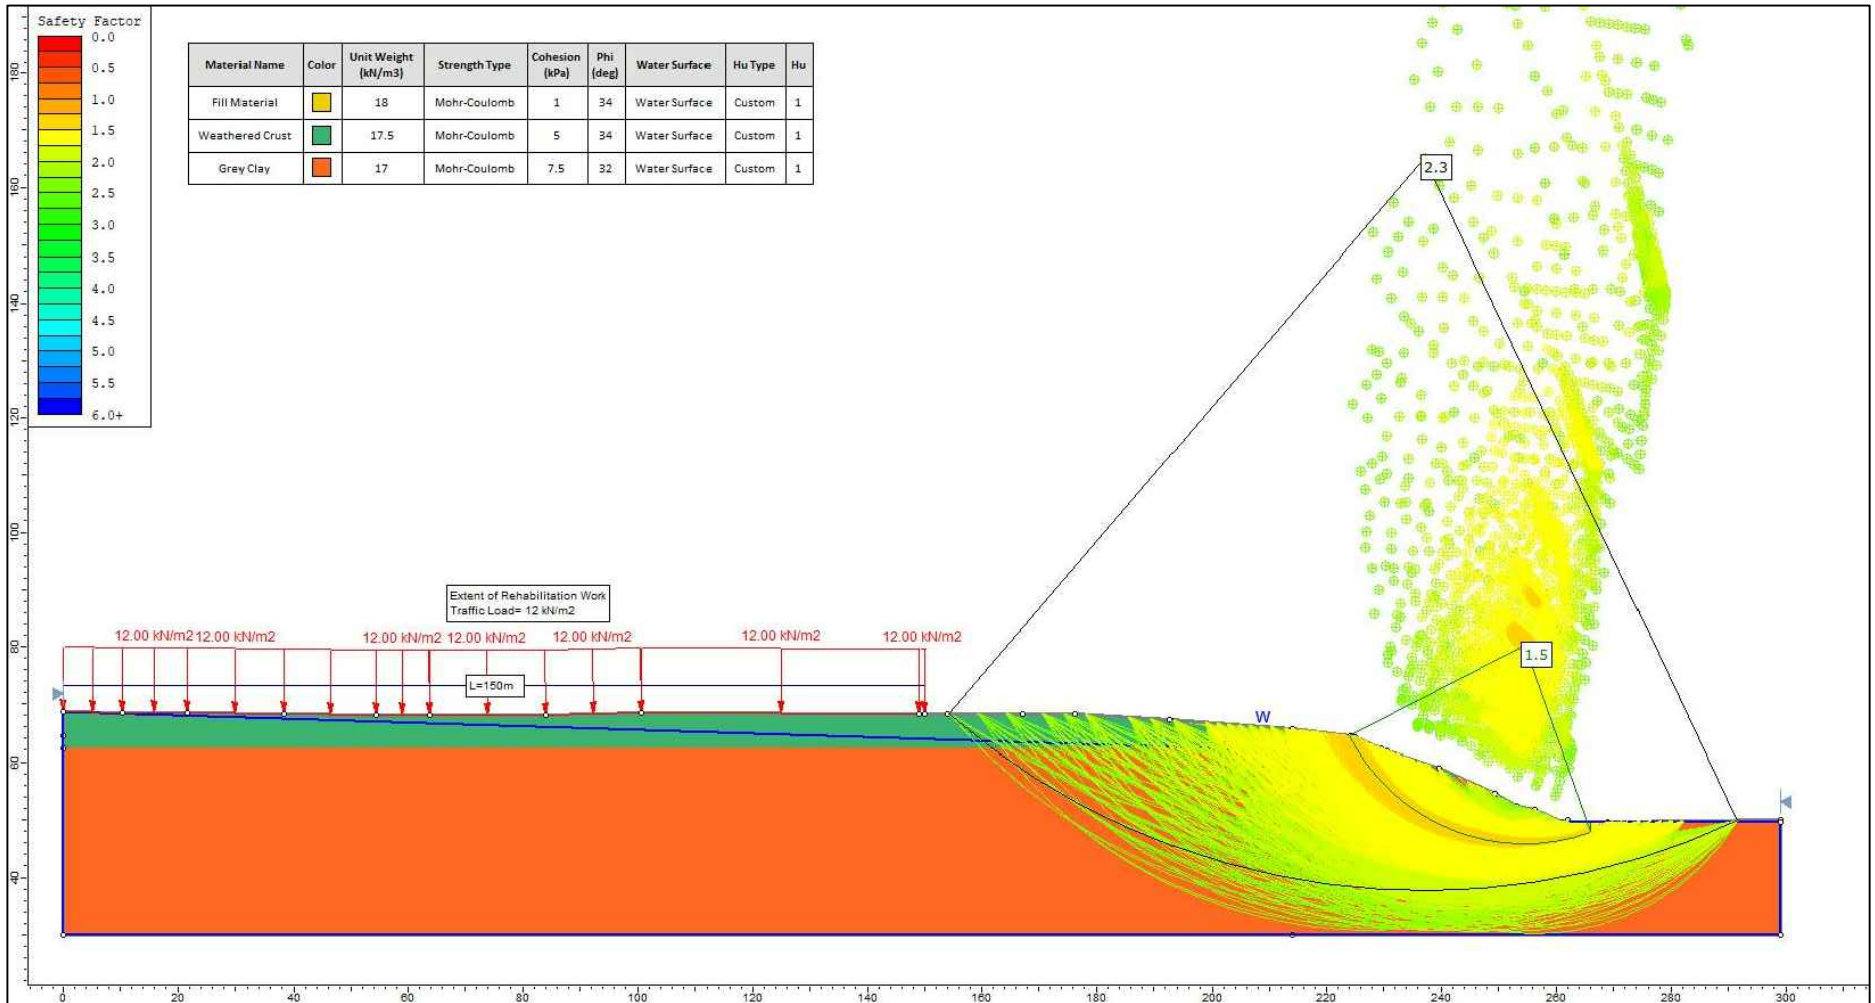
The slope stability analysis indicates that the existing slope at Section A-A', in its current configuration, has a factor of safety against overall rotational failure of approximately 1.5 for static loading conditions. At the limit of the proposed rehabilitation work, the factor of safety against overall rotational failure is about 2.3 (refer to Figure E1 in Appendix E).

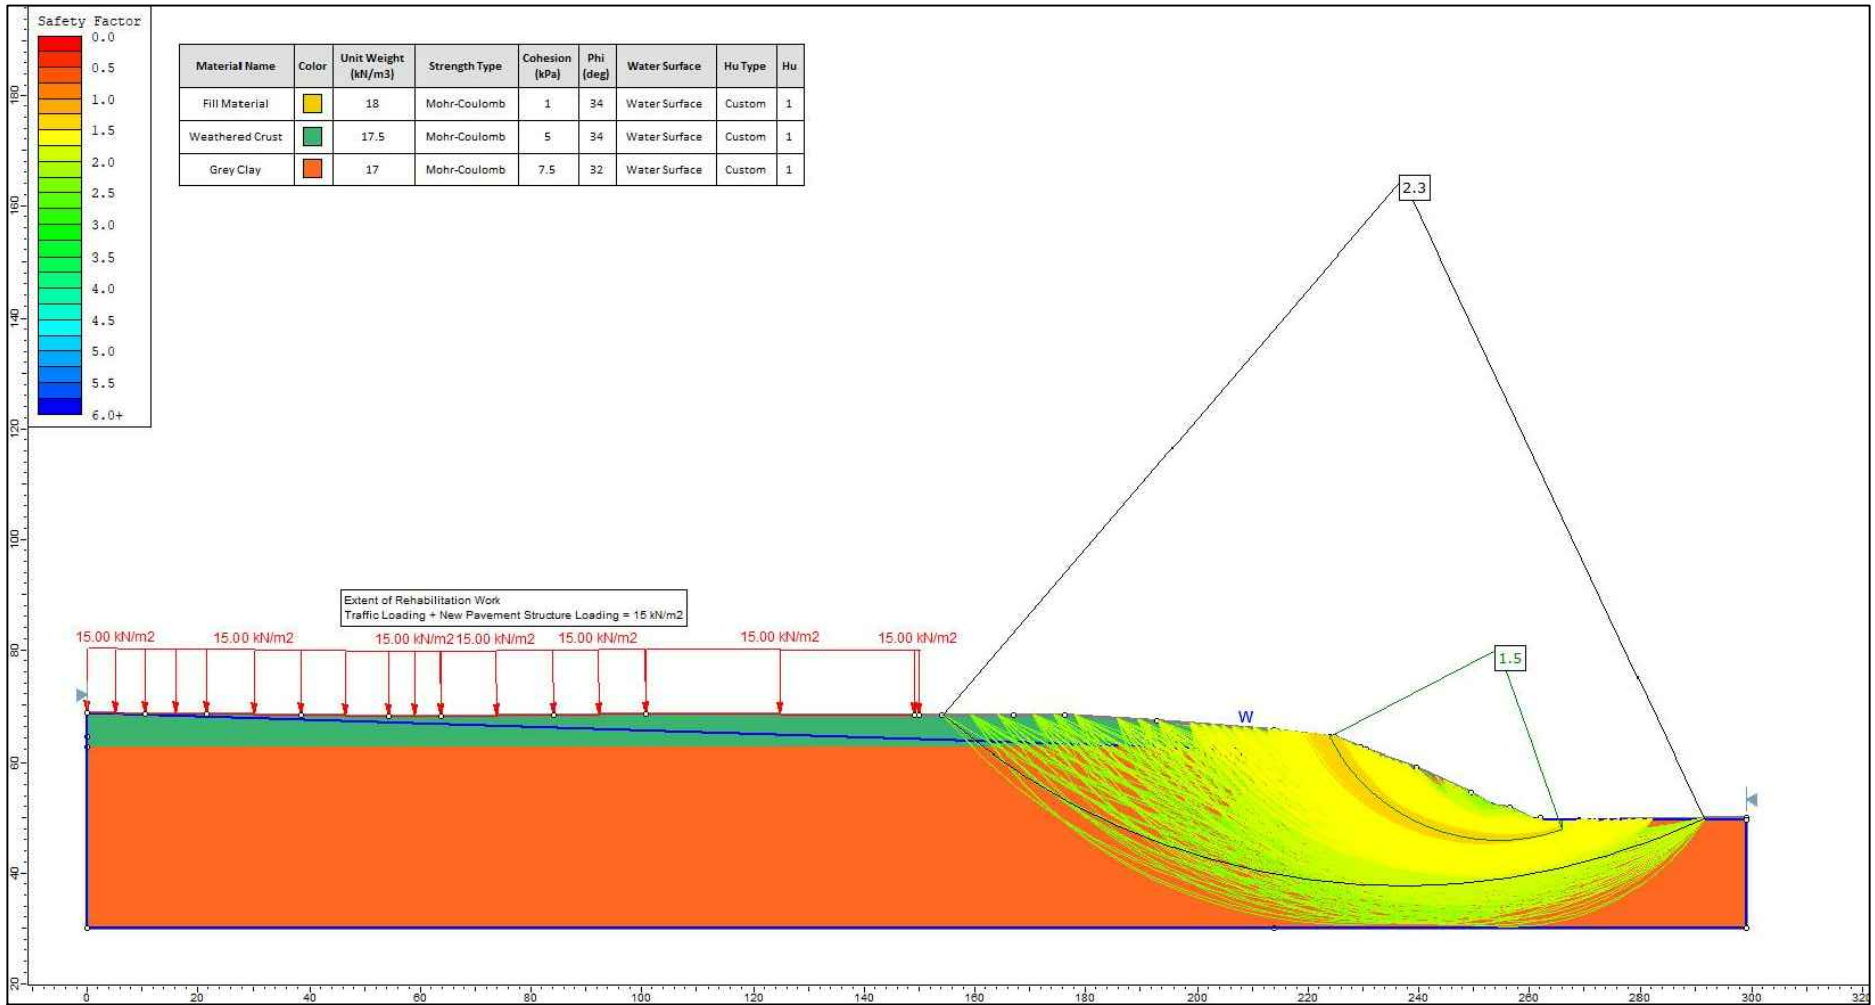
Based on the results of the slope stability analyses, the findings indicate that the rehabilitation of the parking area for both Sections A-A' and B-B' will not alter the factor of safety of the slope (refer to Figures E2 and E6 in Appendix E) from the pre-construction conditions.

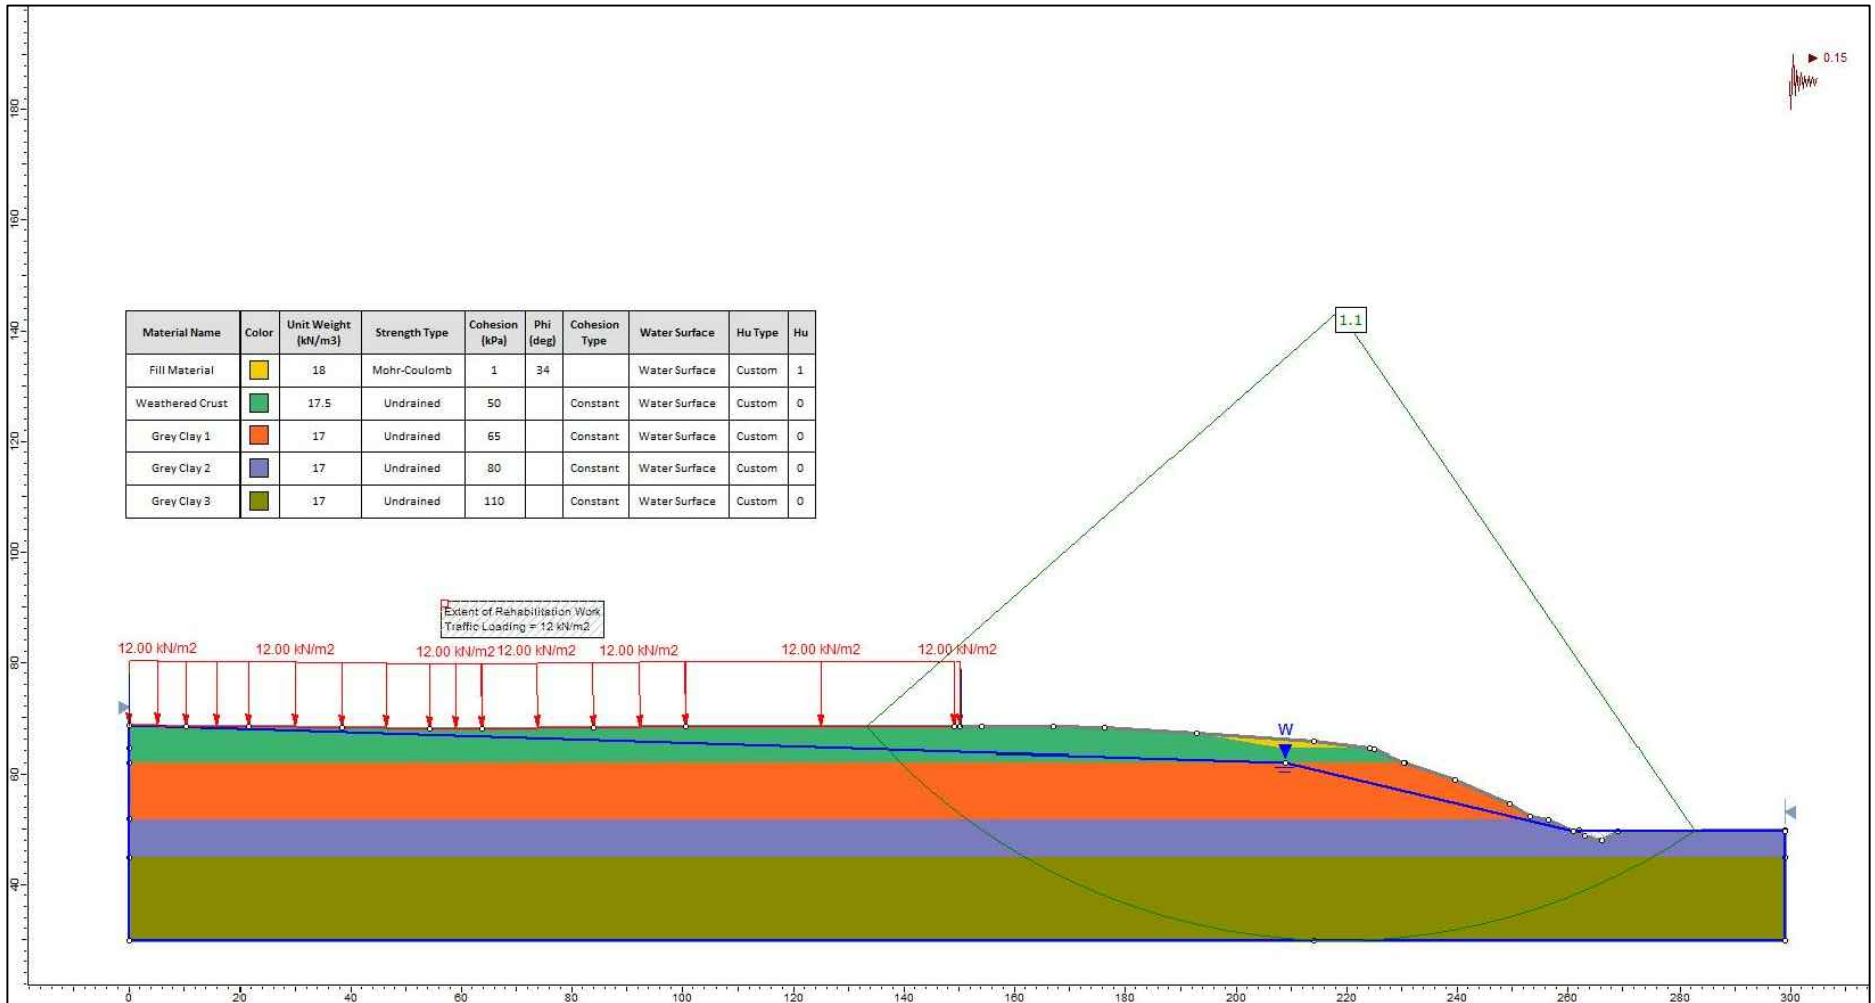
Pseudo-static slope stability analyses were also carried out in an attempt to model the potential seismic loading conditions. A seismic coefficient ( $k_h$ ) of 0.15 was used in the analysis (i.e., half of the Peak Ground Acceleration for the Ottawa area according to the Ontario Building Code 2015). The slope stability analyses indicate the slope, in its current configuration, has a factor of safety against instability of approximately 1.1 for pseudo-static (seismic) conditions, which is considered acceptable (refer to Figures E3 and E7 in Appendix E).

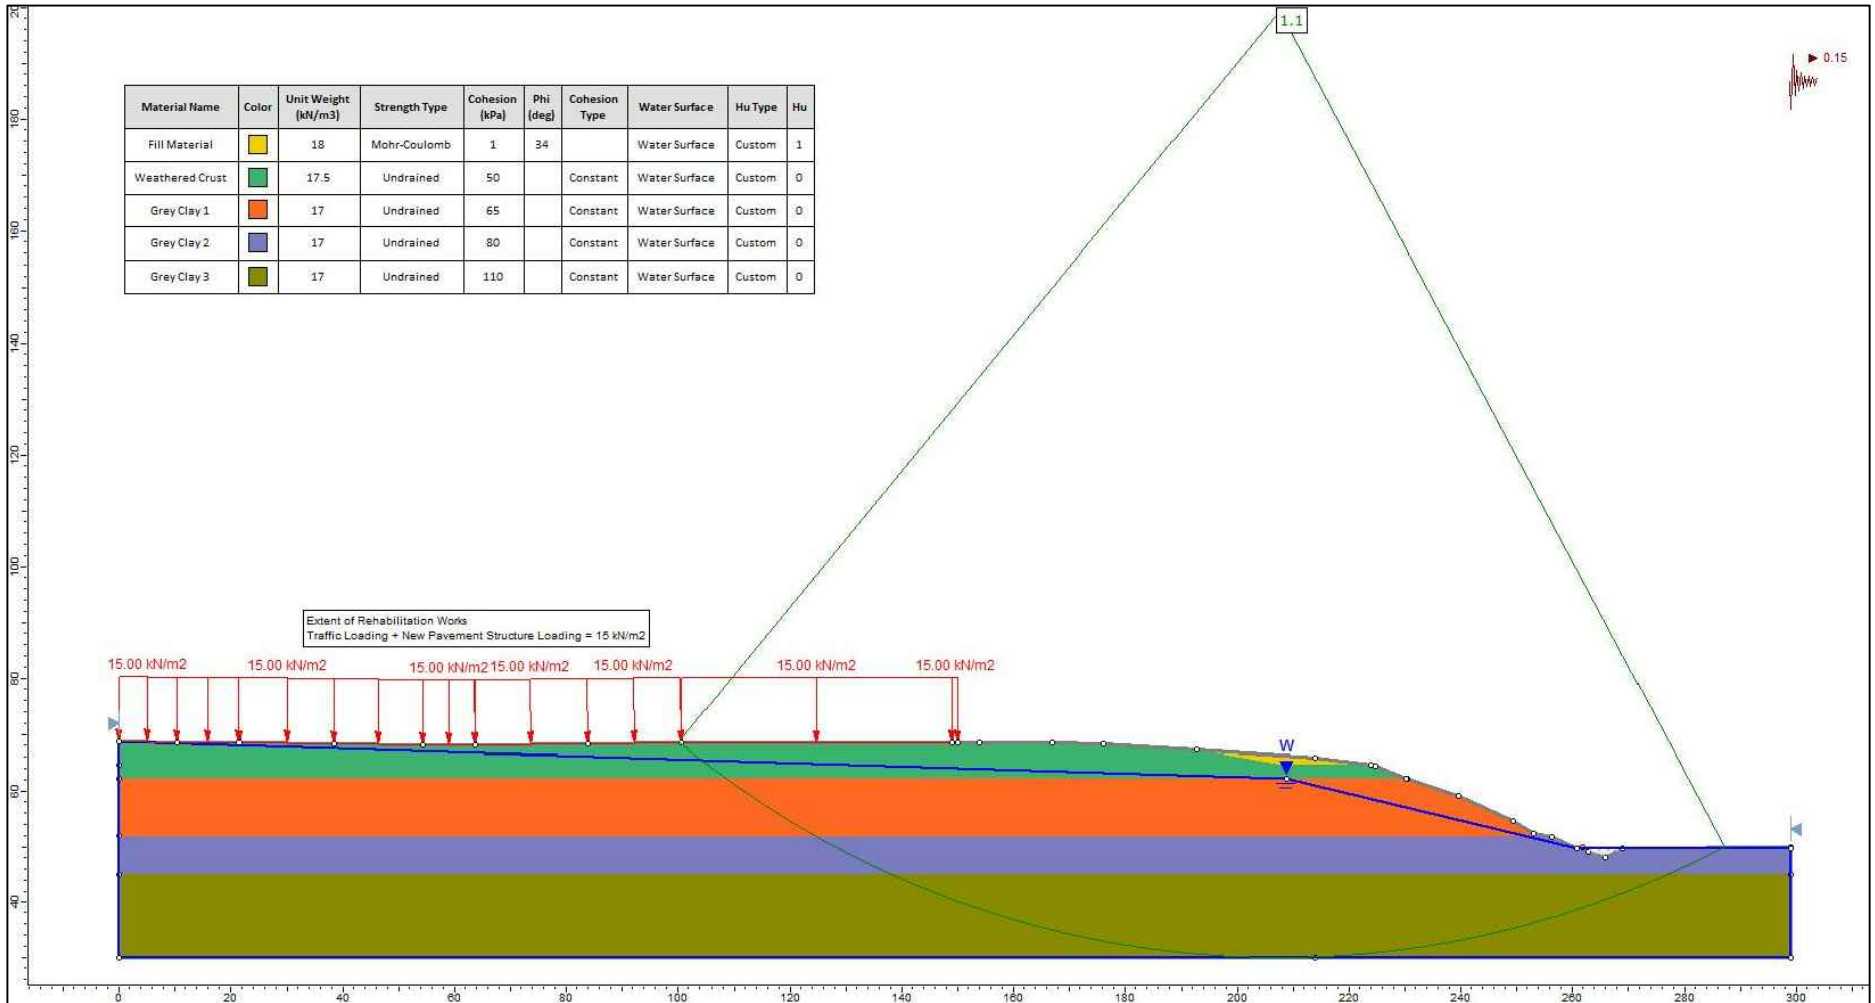
The slope was again analysed for pseudo static (seismic) conditions. Based on the results of the pseudo static analyses, the findings indicate that the rehabilitation of the parking area for both

Sections A-A' and B-B' will not alter the factor of safety of the slope (refer to Figures E4 and E8 in Appendix E) from the pre-construction conditions.

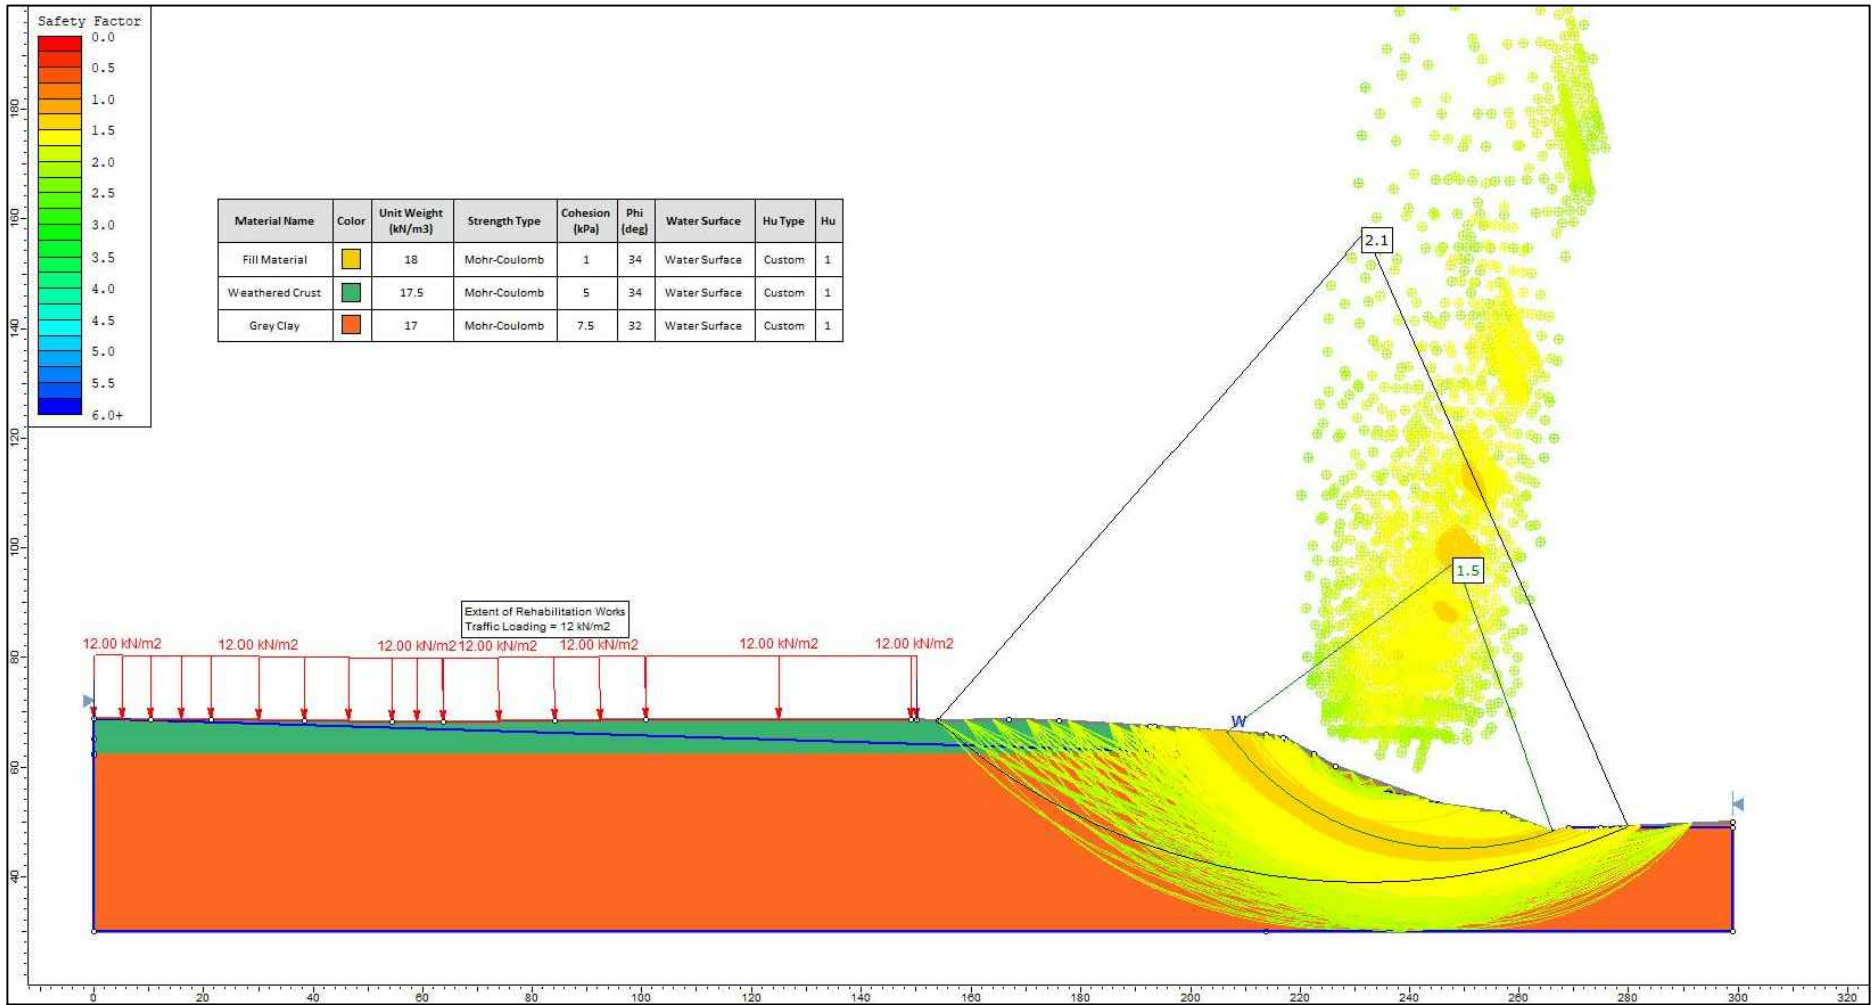
The slope stability analysis indicates that the existing slope at Section B-B', in its current configuration, has a factor of safety against overall rotational failure of approximately 1.5 for static loading conditions. At the limit of the proposed rehabilitation work, the factor of safety against overall rotational failure is about 2.1 (refer to Figure E5 in Appendix E).
