**PATERSON
GROUP**

July 19, 2022
File: PE4937-LET.04

Subject: **Phase II - Environmental Site Assessment Update
Navan at Renaud Road
Ottawa, Ontario**

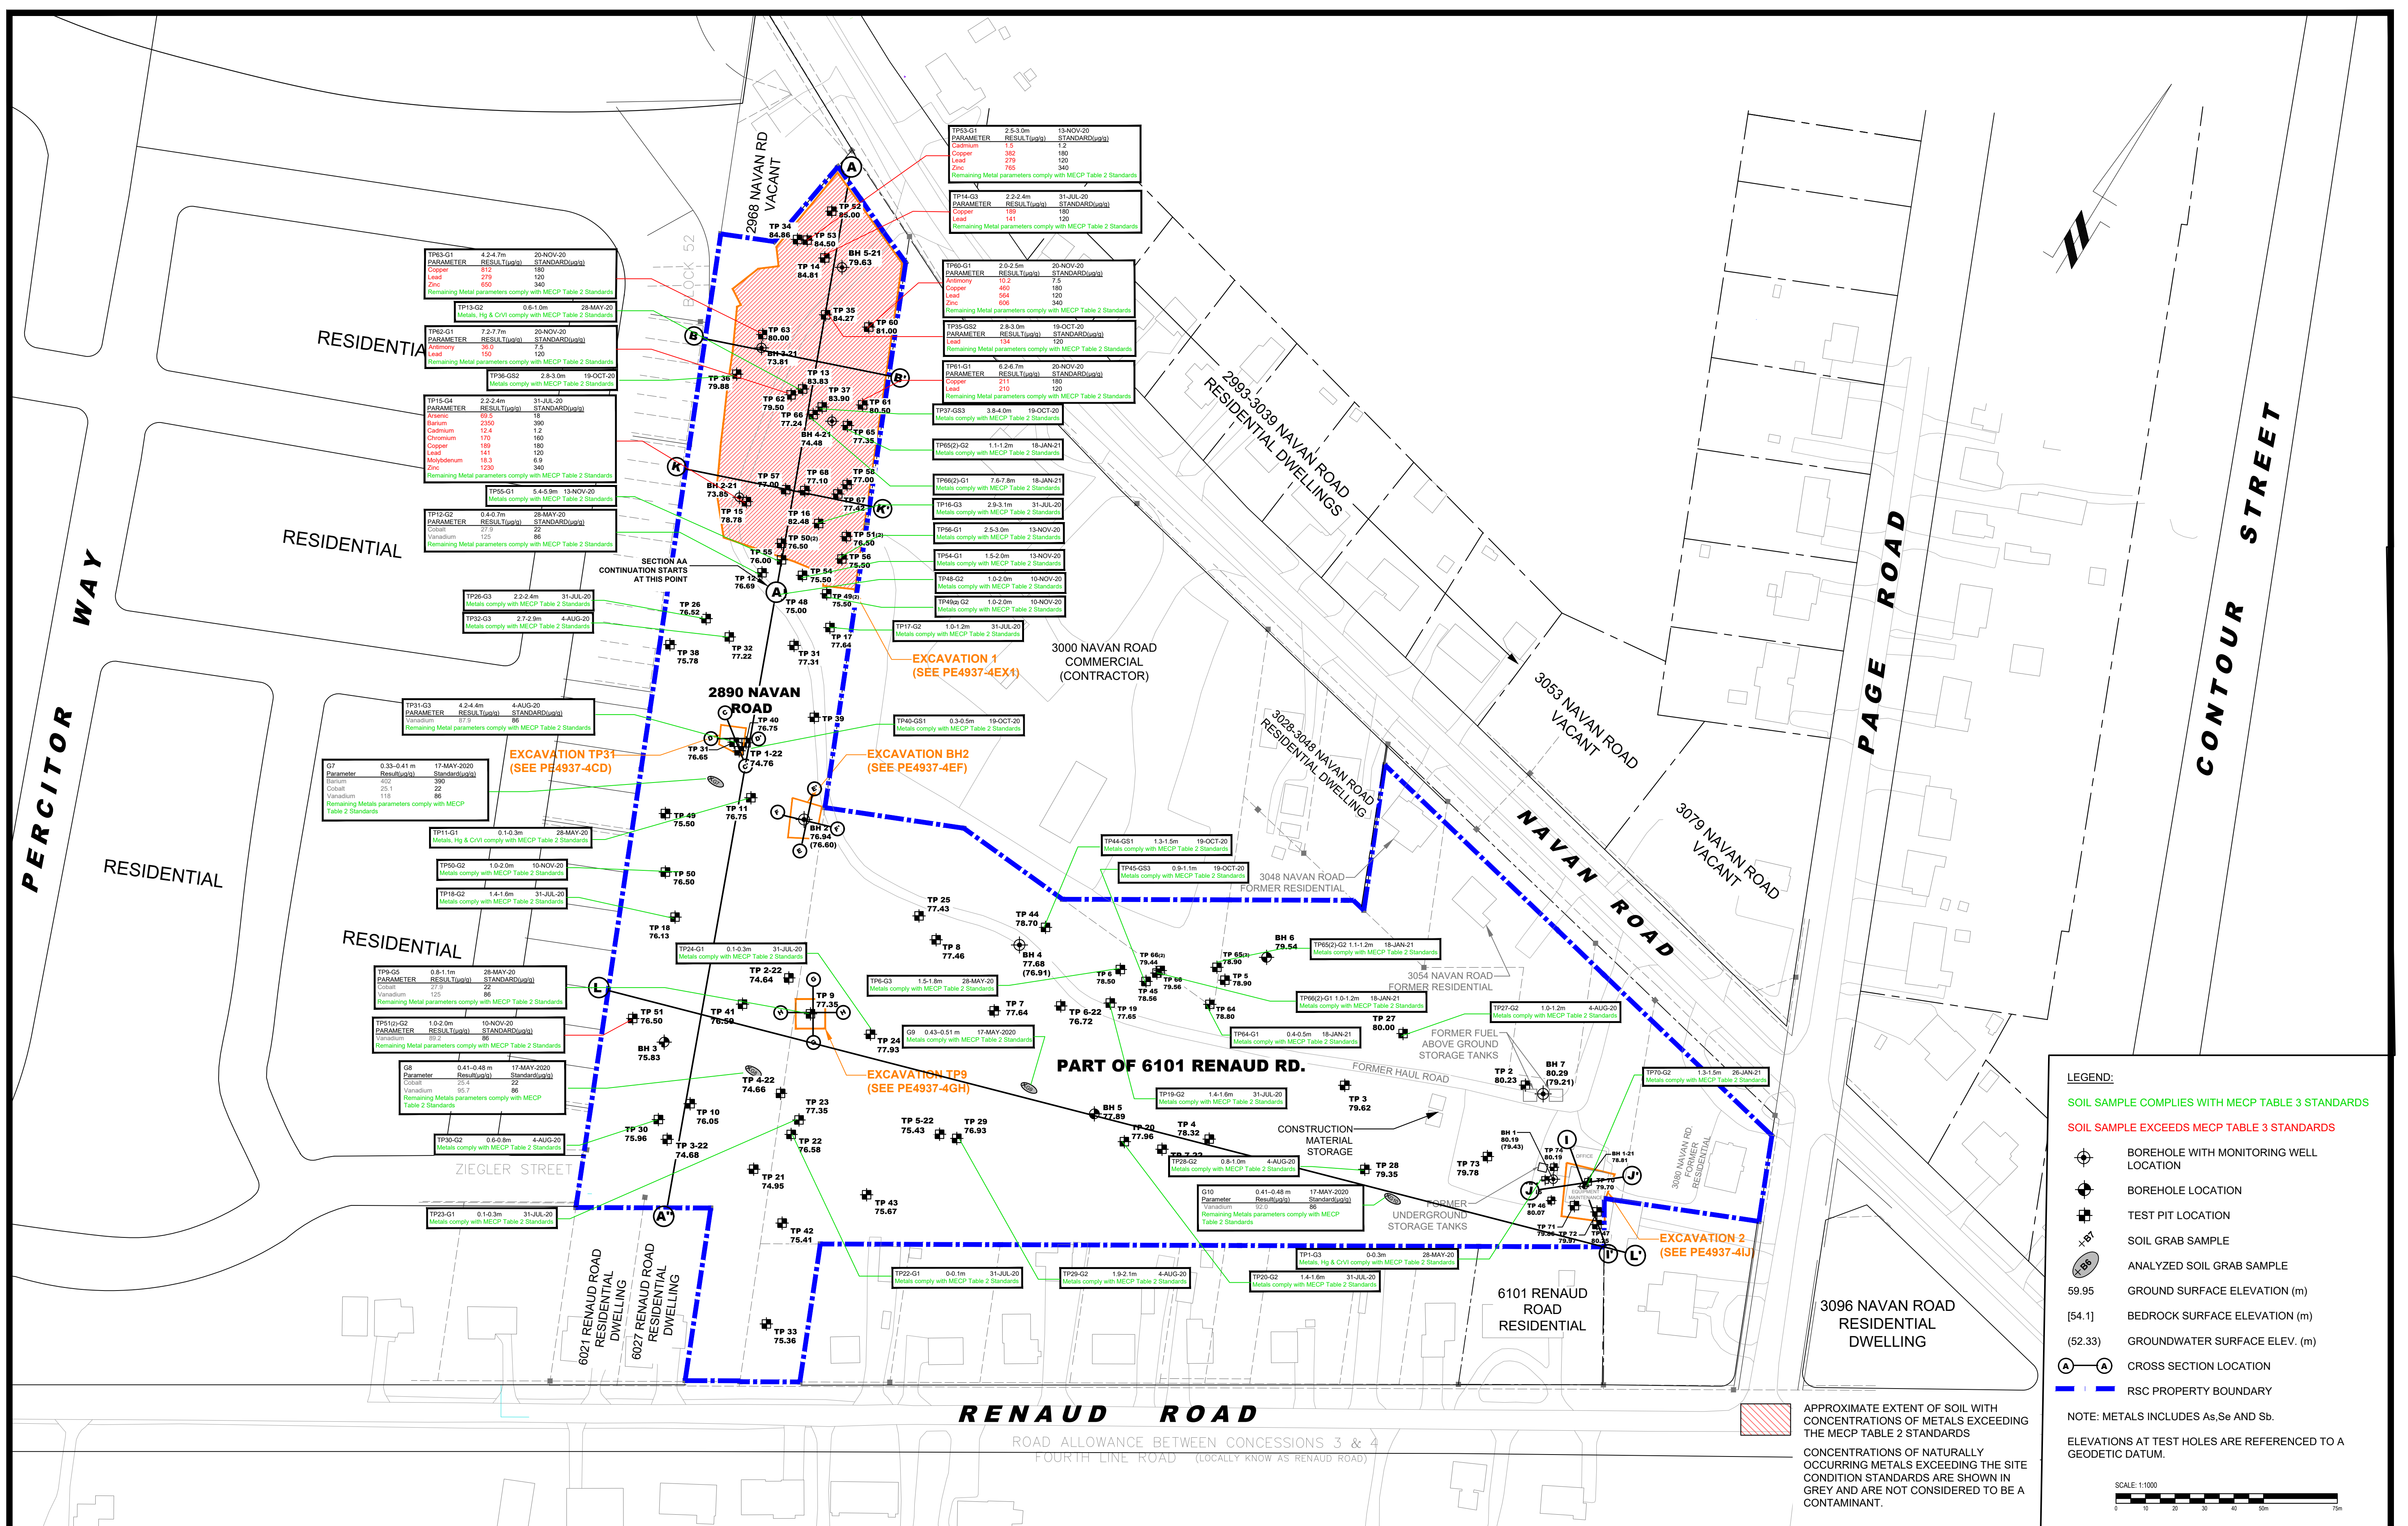
Scale: 1:1000	Report No.: PE4937
Drawn by: RG	Drawing No.:
Checked by: JC	PE4937-4
Approved by: MB	Revision No.: 0
Date: 03/2021

As shown on Drawing PE4937-4, samples from across the RSC property exceeded the Site Condition Standards (SCS) for Barium, Cobalt, and Vanadium, however the remaining metals parameters listed above only exceeded the site condition standards in the northwest corner of the RSC property.

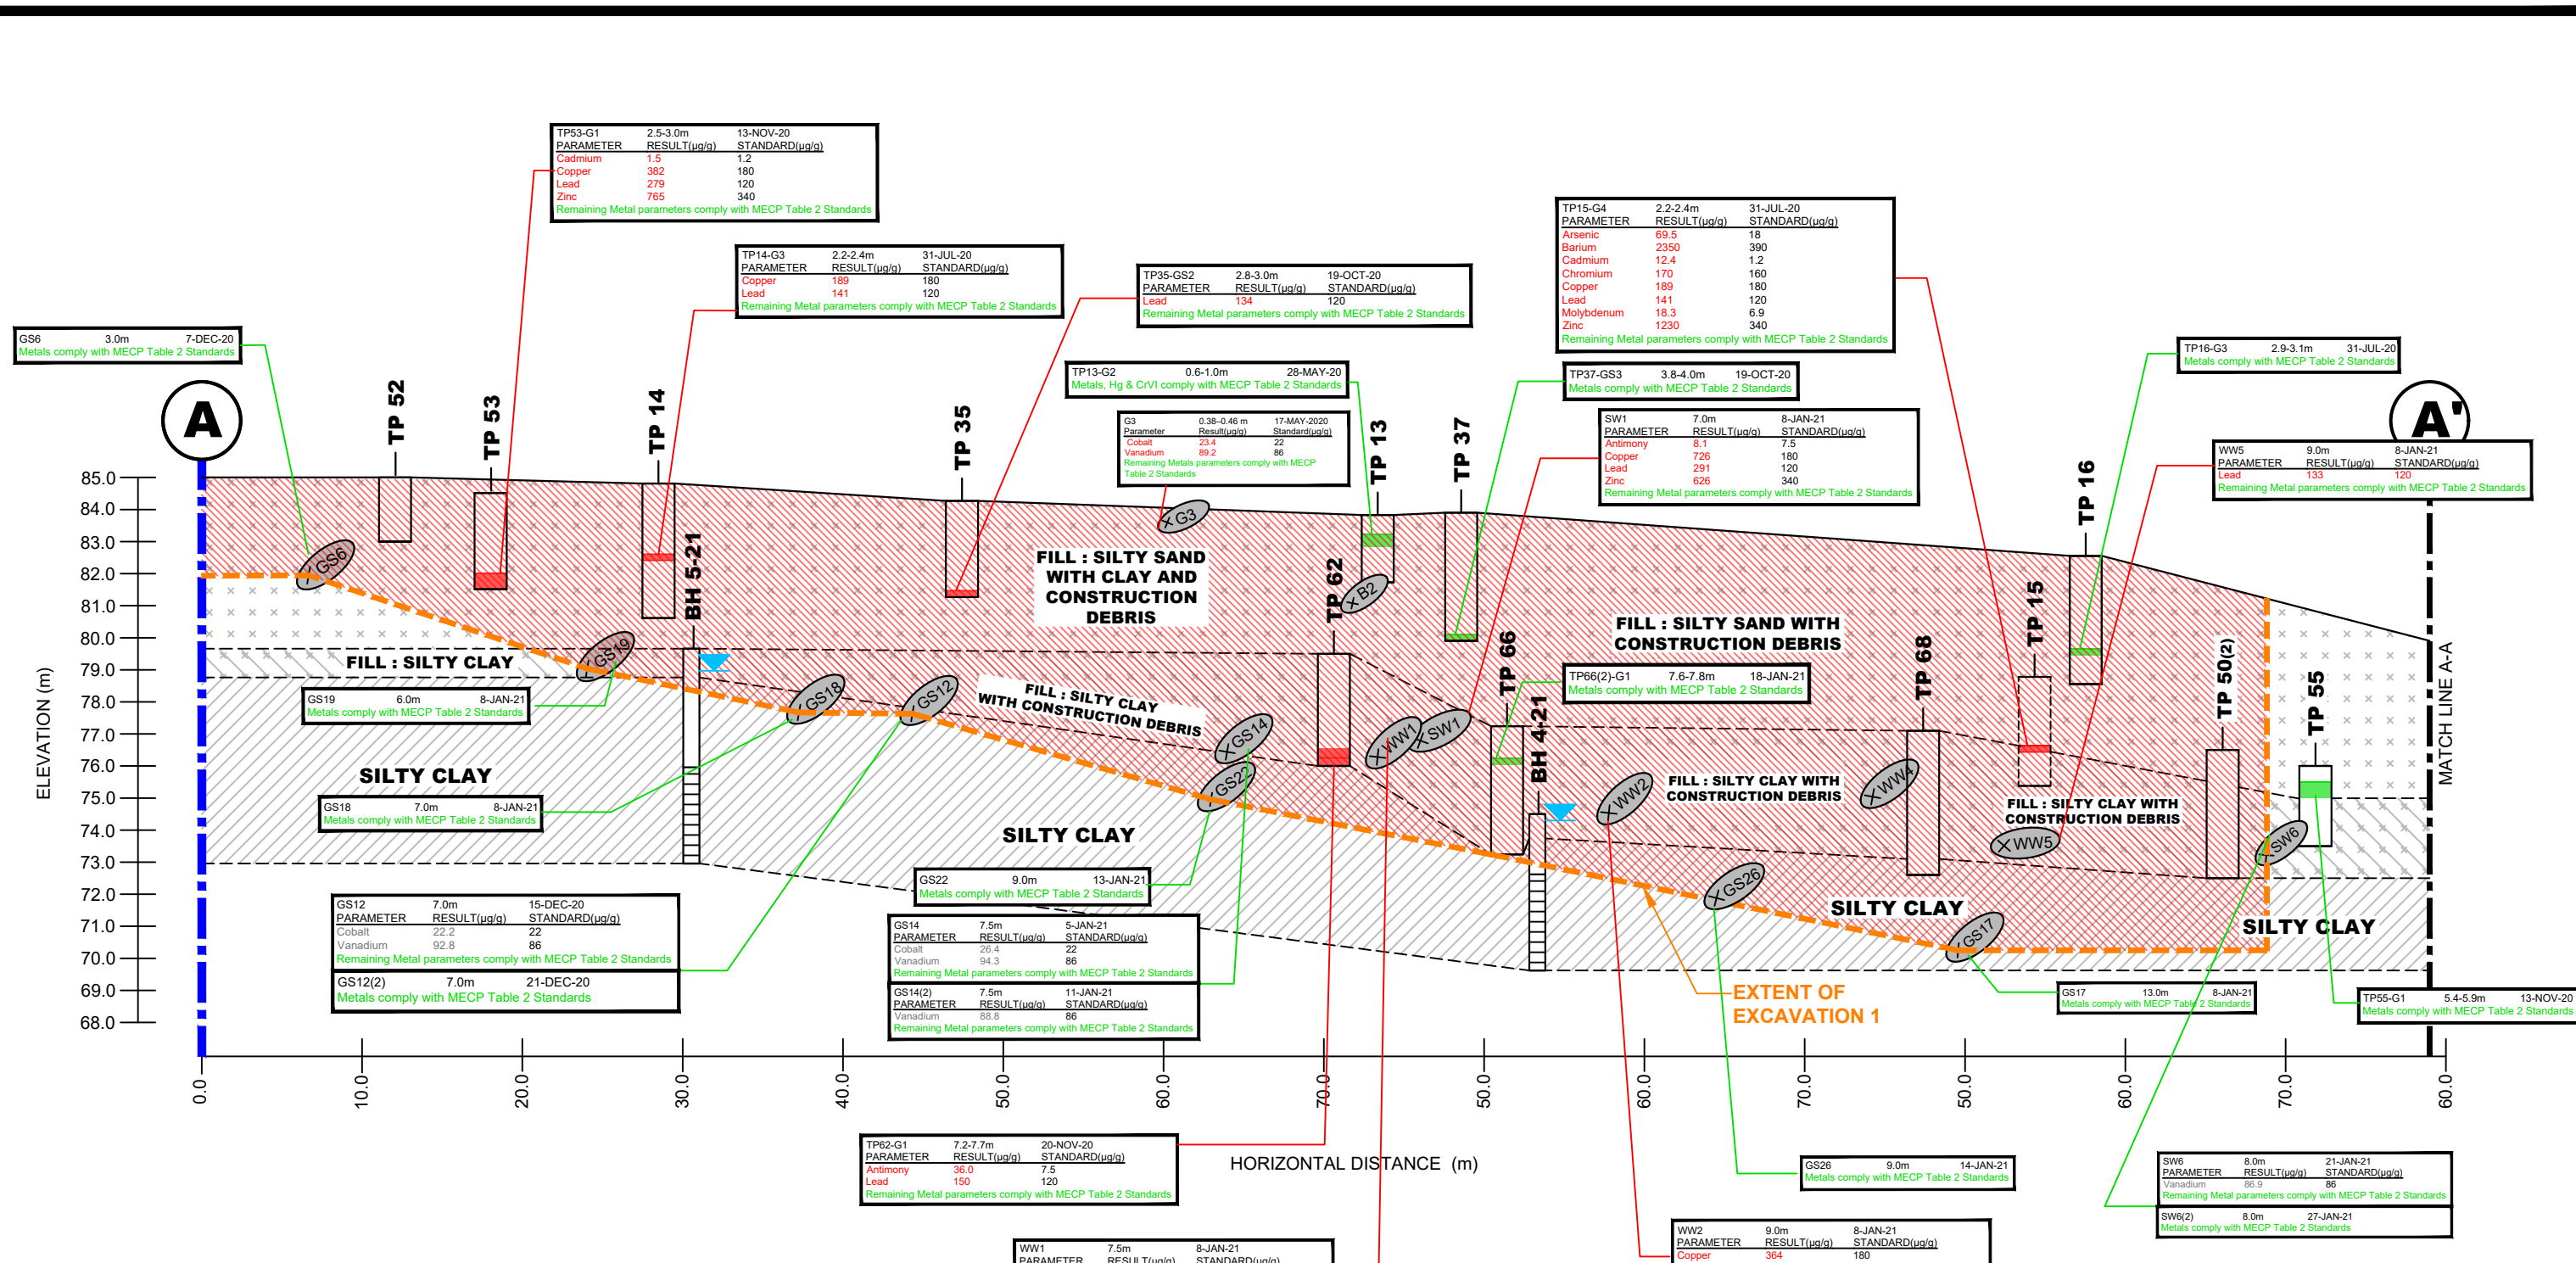
CAIVAN COMMUNITIES
PHASE II - ENVIRONMENTAL SITE ASSESSMENT
RENAUD ROAD AT NAVAN ROAD
 OTTAWA, ONTARIO
 Title: **CROSS SECTION A-A' - SOIL (METALS)**

APPROXIMATE EXTENT OF SOIL WITH CONCENTRATIONS OF METALS EXCEEDING THE MECP TABLE 2 STANDARDS
 CONCENTRATIONS OF NATURALLY OCCURRING METALS EXCEEDING THE SITE CONDITION STANDARDS ARE SHOWN IN GREY AND ARE NOT CONSIDERED TO BE A CONTAMINANT.

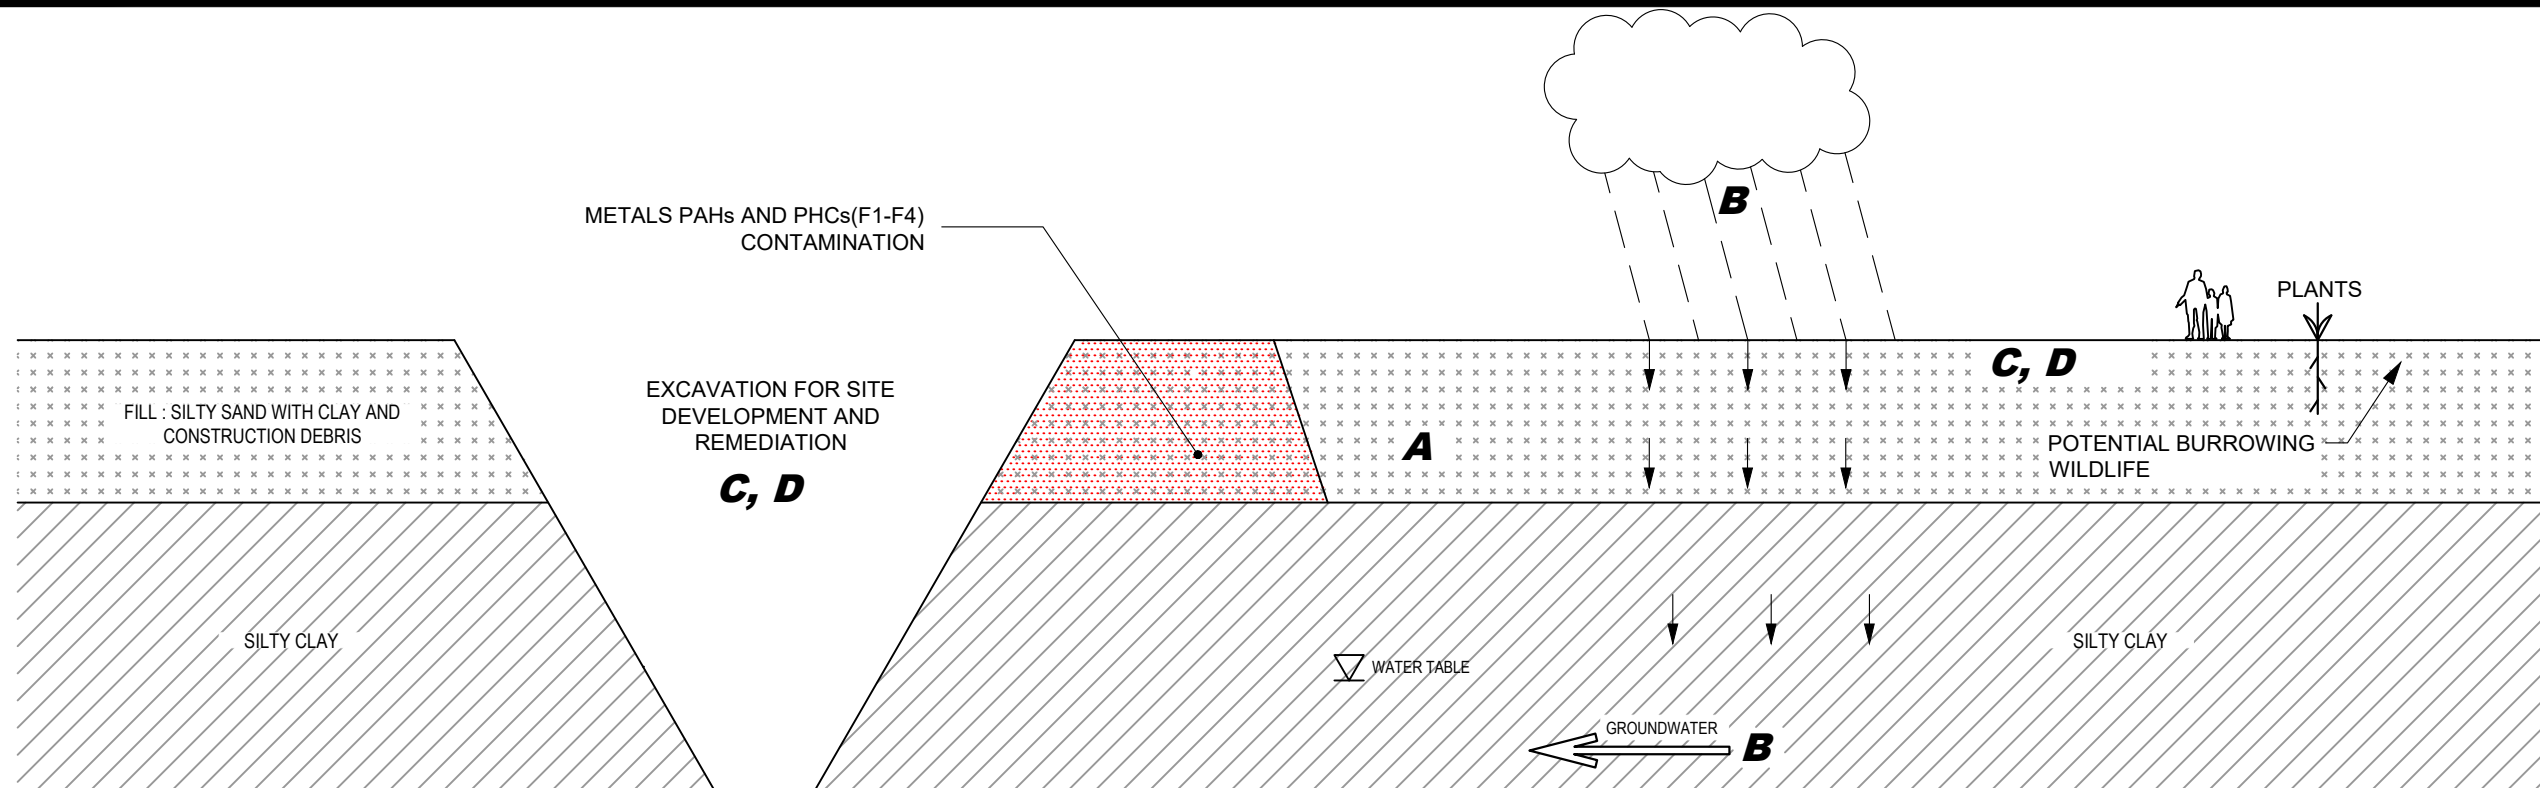
A Contaminant Transport Pathways

Physical transport – one potential contaminant transport pathway is the physical transport from one location to another of impacted soil, either intentionally or unintentionally, by earth moving equipment, vehicle traffic, or pedestrian traffic. The potential for physical transport of contaminants to have occurred on the RSC Property is considered to be low.
 Precipitation/Infiltration/Leaching – As precipitation falls on the ground surface and subsequently infiltrates through the soil to the groundwater table, there is the potential for contaminants in the soil phase to enter the groundwater, depending on the solubility of the contaminants. Impacts to the groundwater were not identified as such, precipitation, infiltration or leaching are not considered to have played a significant role in contaminant transport.
