**PATERSON  
GROUP**

July 19, 2022  
File: PE4937-LET.04

Subject: **Phase I - Environmental Site Assessment Update  
Navan at Renaud Road  
Ottawa, Ontario**

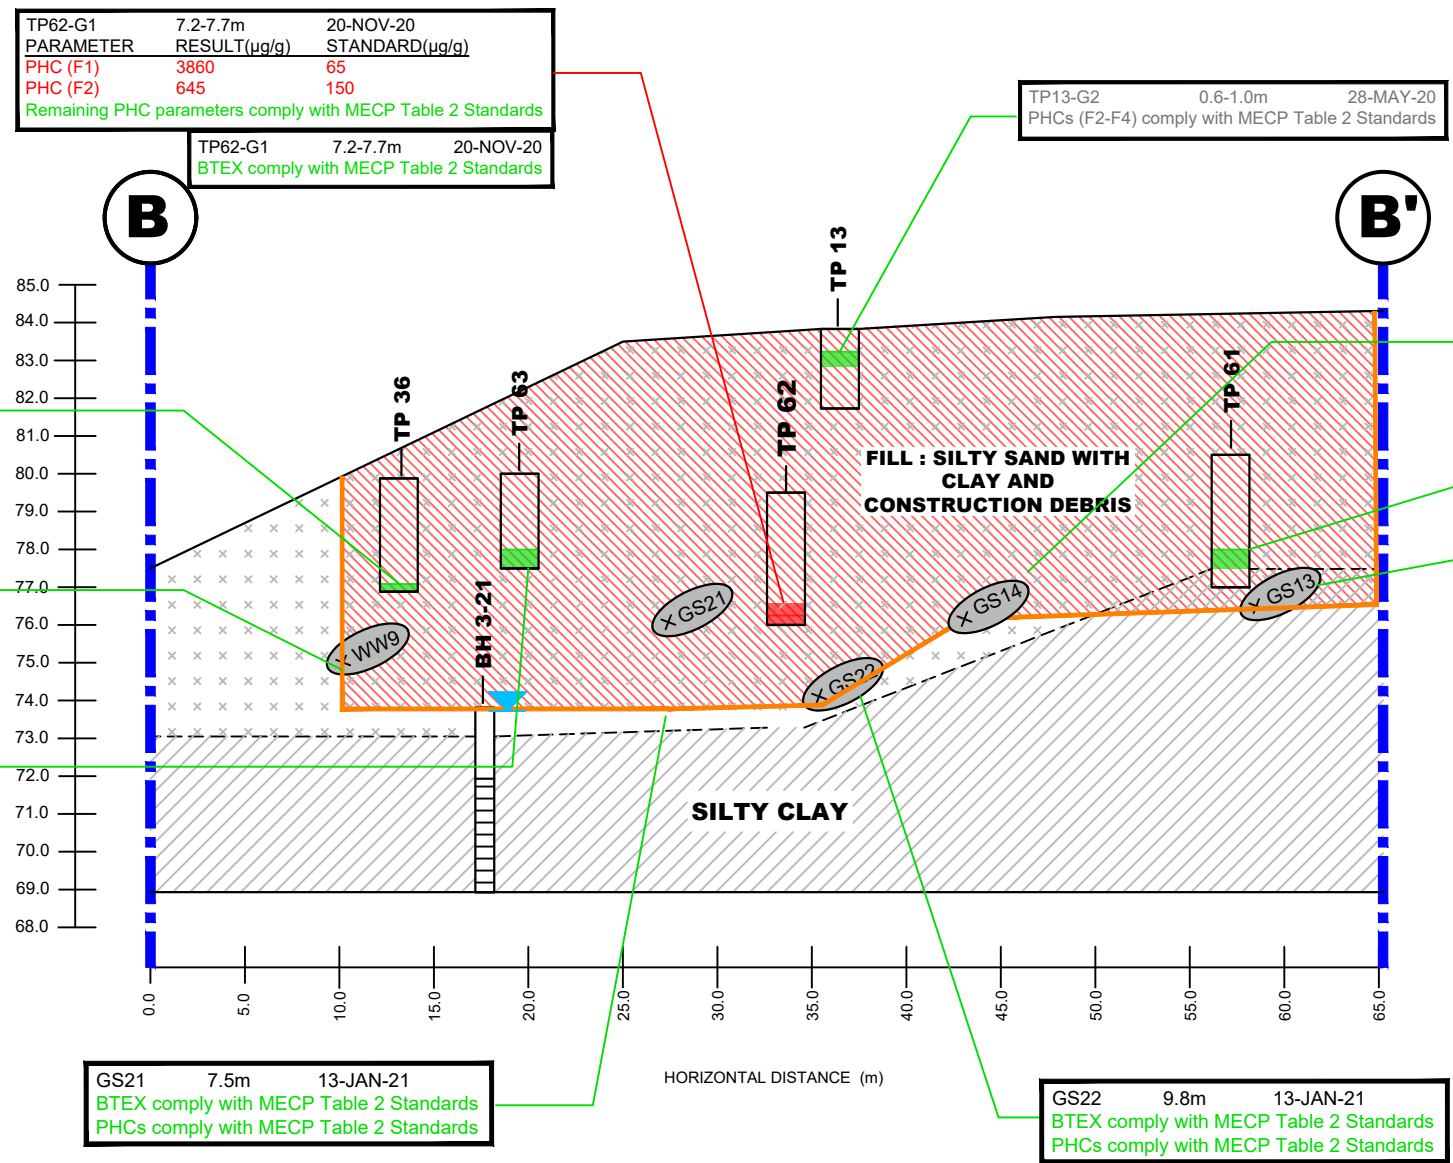
TP62-G1	7.2-7.7m	20-NOV-20
PARAMETER	RESULT(µg/g)	STANDARD(µg/g)
PHC (F1)	3860	65
PHC (F2)	645	150
Remaining PHC parameters comply with MECP Table 2 Standards		
TP62-G1	7.2-7.7m	20-NOV-20
BTEX comply with MECP Table 2 Standards
