THOMSON WATSON CONSULTING ARBORISTS Inc

October 20, 2023 (revised March 14, 2025)

Re: Tree Conservation Report for Canadian Tire Centre at 2501 Greenbank Road, Nepean

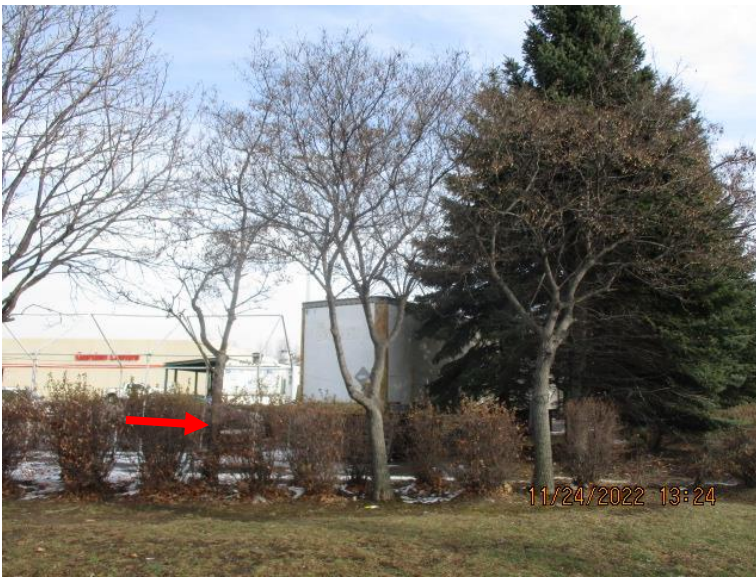
Tree 42 – Amur Maple

Trees 42, 50, 54, 62, 63, 66, 67 and 68 (8 trees). Tree 50 is dead and should not require a permit to allow its removal.

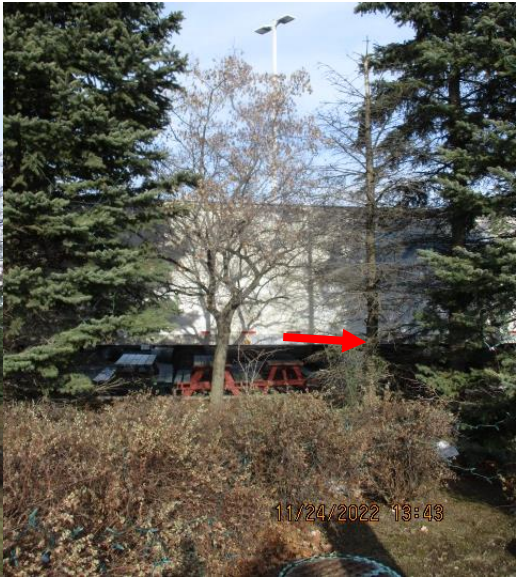
Tree 50 – dead Spruce

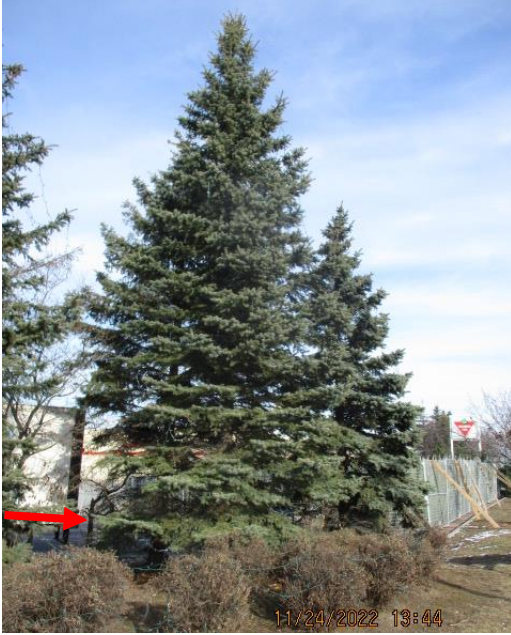
Tree 54 – Amur Maple

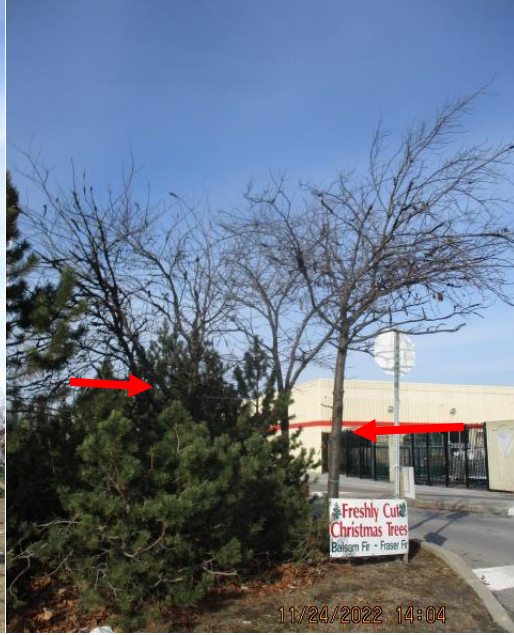
There are four Schubert Cherries (*Prunus virginiana* 'Schubert') growing on site. The trees are infected with Black Knot fungus (*Dibotryon morbosum* or *Apiosporina morbosa*) which affects branches and stems. The symptoms of the disease create a poor appearance and results in dead branches and stems. I have recommended the removal of all four trees.

Trees 62(left) and 63 (right) – Schubert Cherry

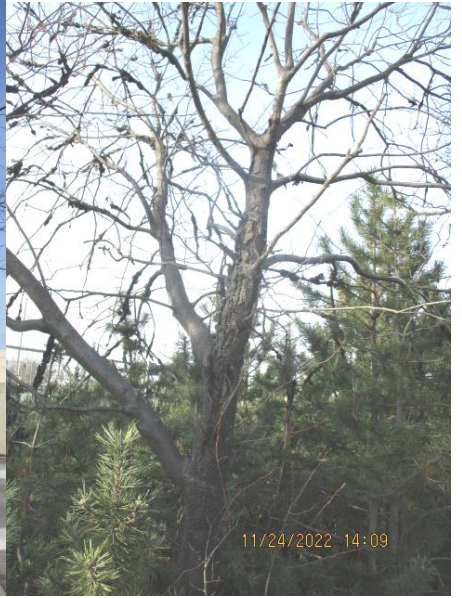
Tree 62 – Canker on trunk

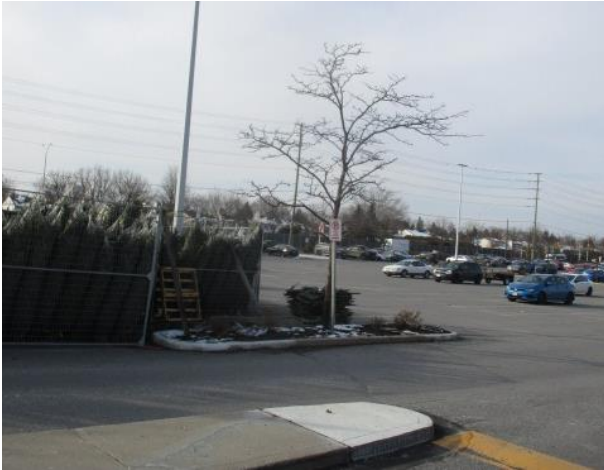
Tree 65 – Honeylocust

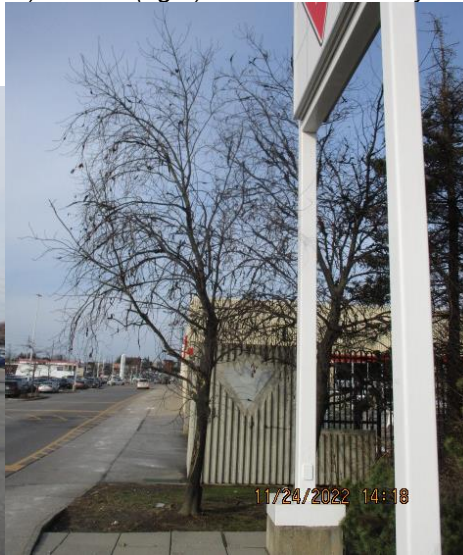
Trees 66 (left) to 68 (right)

Along this side of the proposed building, it is proposed to remove Trees 66, 67 and 68 due to their health condition, Trees 70, 72, 74, 76, 77 and 78 for their location adjacent to the swale and Trees 82 to 90 due to excavation, construction access and proposed grade changes required to allow construction access. Trees 82 to 86 are growing on a sloped area. The grade will have to be dropped to the building side of the trees. Trees 87 to 90 will have excavation close to the base of the trees, removing 25 to 50% of their root systems. The canopies of these trees also extend up to and into the vertical footprint of the addition.

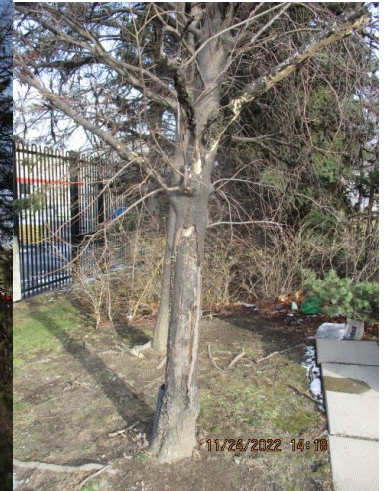
Dieback in trunk – Tree 66

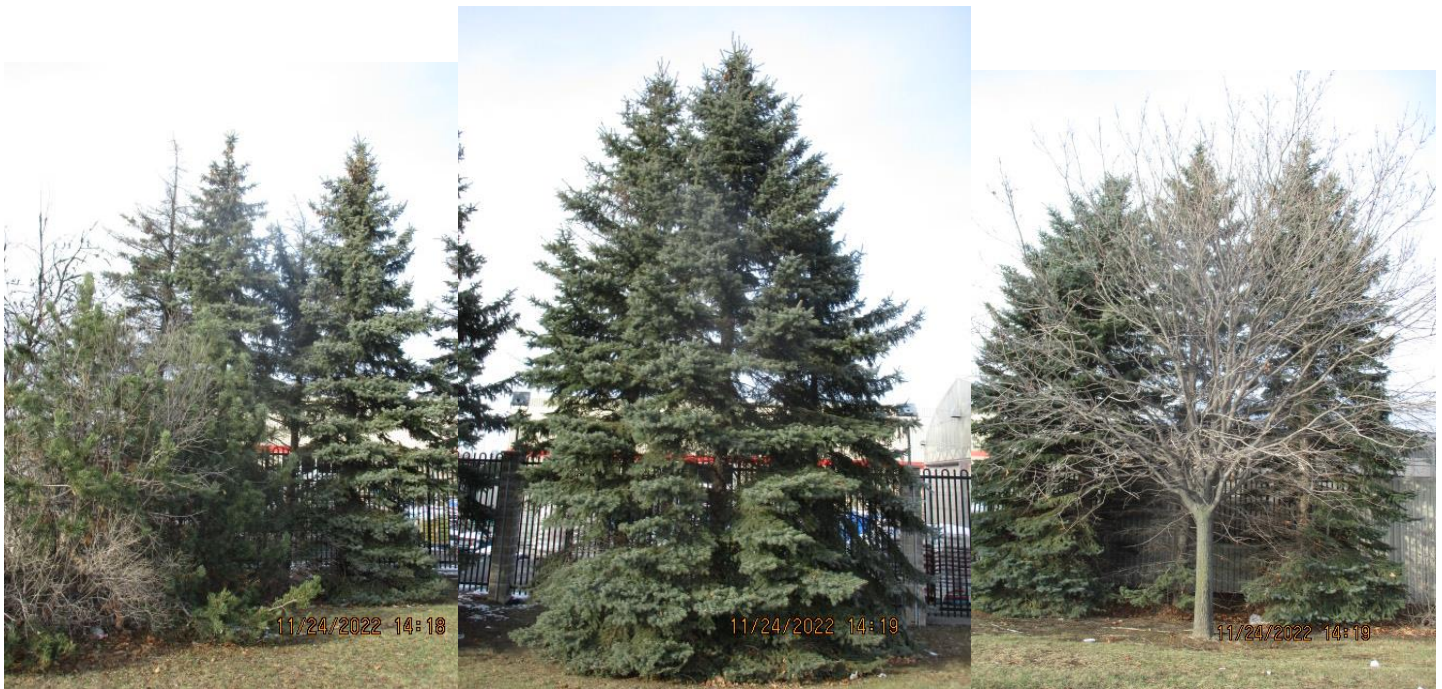
Trees 68 to 71 – Colorado Spruce

Trees 72 to 74 – Colorado Spruce

Trees 75 to 78 (Spruce) and 79 (Maple)

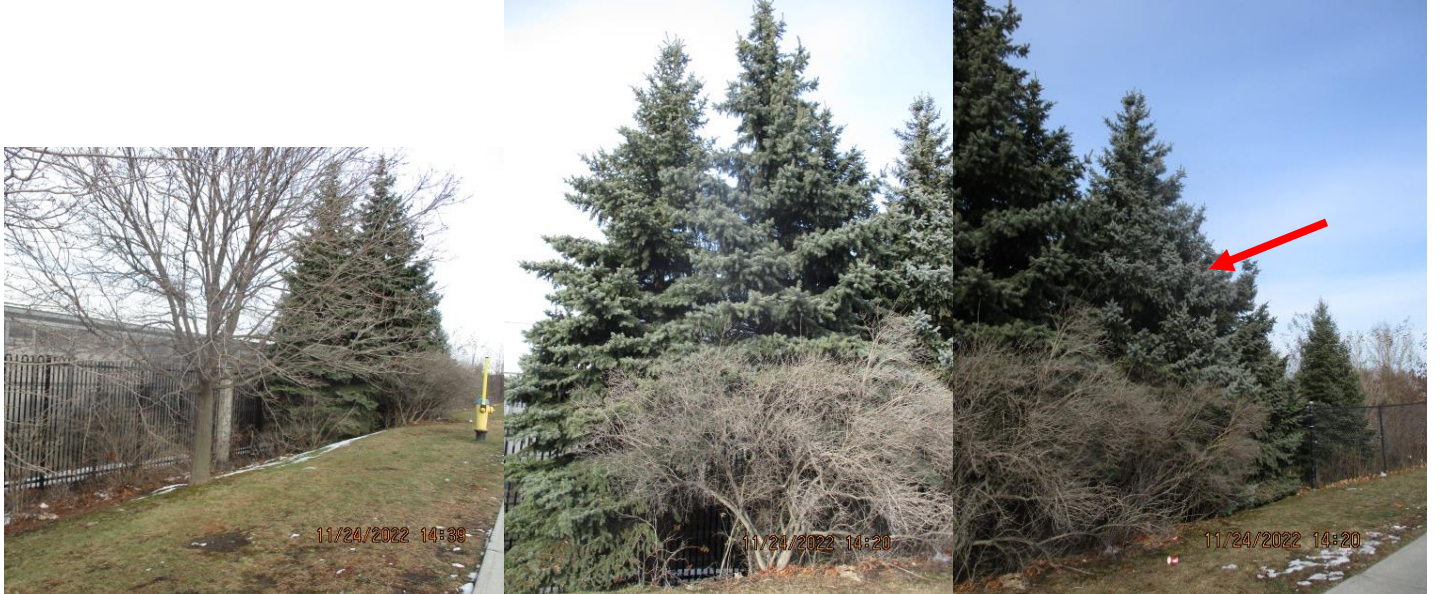
Tree 80 with grade increase in NE corner

Trees 82 to 85 – Colorado Spruce

Tree 86 – Colorado Spruce

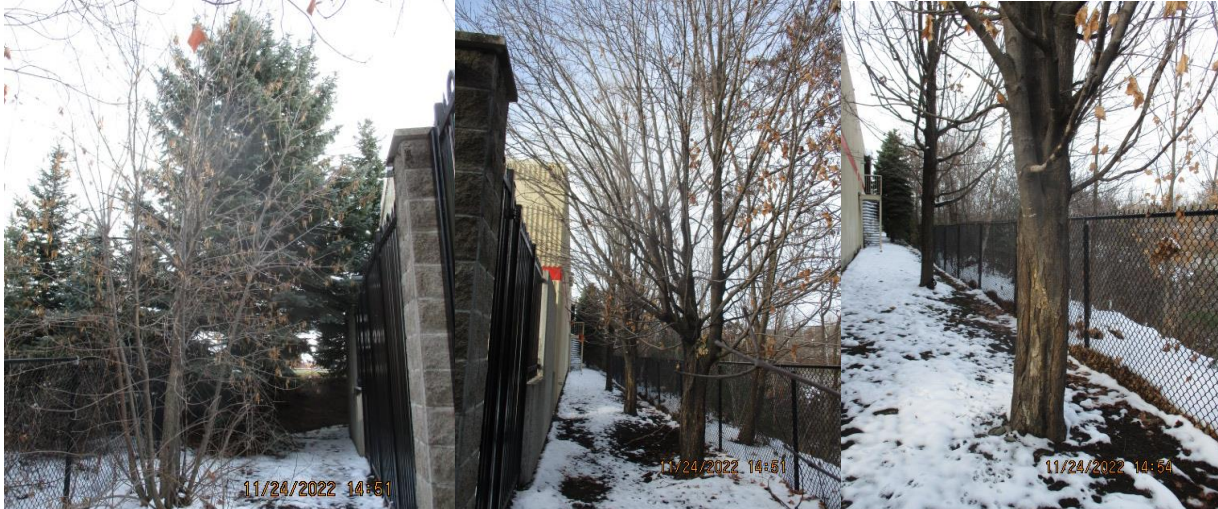
Tree 88 is a Green Ash which has been affected by Emerald Ash Borer, leaving stems with a maximum diameter of 7 cm. A permit should not be required for this tree.

Tree 88 – Green Ash with 87 to south

Trees 89, 90 and 91 – Sugar Maple

Tree 90 – trunk wound
