# THOMSON WATSON CONSULTING ARBORISTS Inc

## **Re: Tree Conservation Report for Canadian Tire Centre at 2501 Greenbank Road, Nepean**

**TREE PHOTOGRAPHS – 2501 Greenbank Road, Nepean**

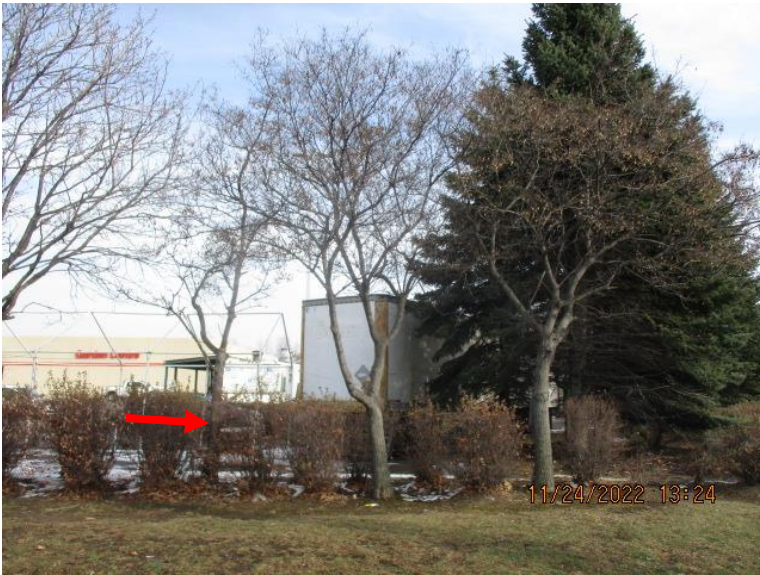
*Tree 42 – Amur Maple*

*Trees 42, 50, 54, 62, 63, 66, 67 and 68 (8 trees).* Tree 50 is dead and should not require a permit to allow its removal.

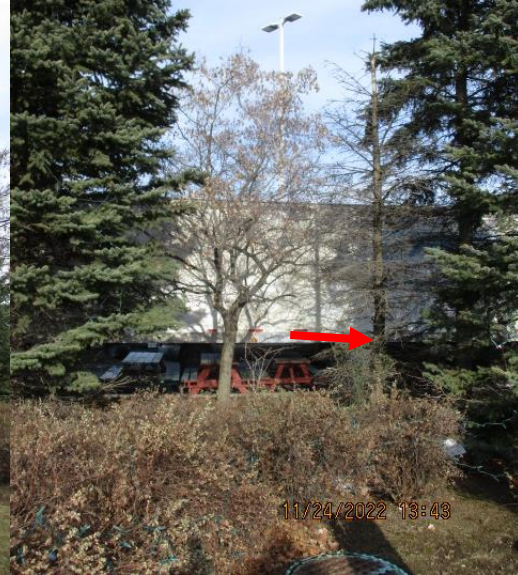
*Tree 50 – dead Spruce*

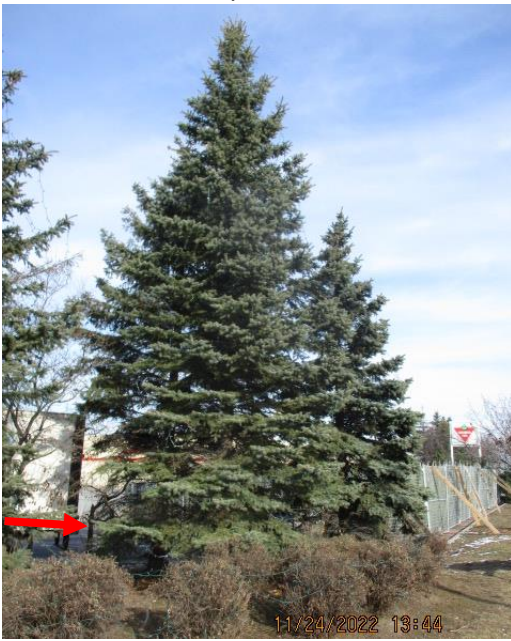
*Tree 54 – Amur Maple*

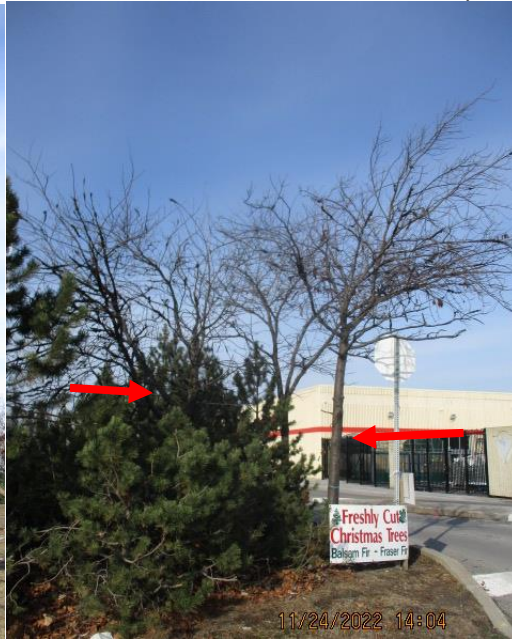
There are four Schubert Cherries (*Prunus virginiana* 'Schubert') growing on site. The trees are infected with Black Knot fungus (*Dibotryon morbosum* or *Apiosporina morbosa*) which affects branches and stems. The symptoms of the disease create a poor appearance and results in dead branches and stems. I have recommended the removal of all four trees.

*Trees 62(left) and 63 (right) – Schubert Cherry*

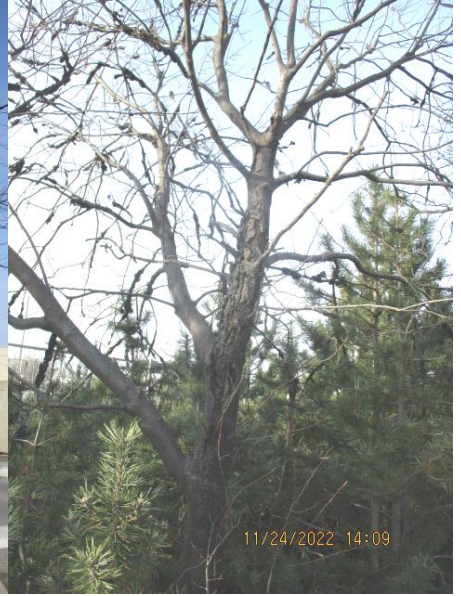
*Tree 62 – Canker on trunk*

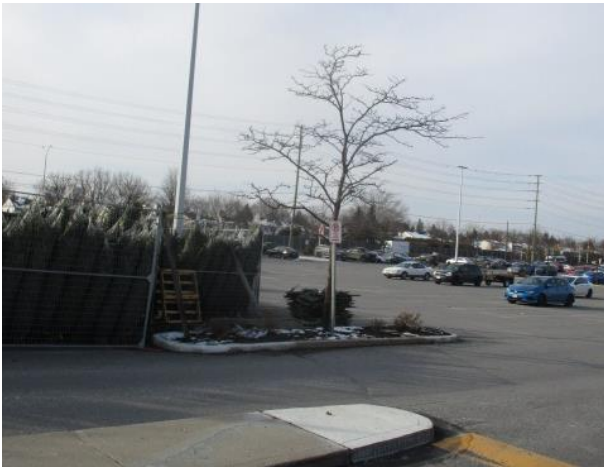
*Tree 65 – Honeylocust*

The garden centre will be moved south to the southeast corner of the parking lot. A metal chain-link fence will be erected around the garden centre supported by concrete pillars placed within the asphalt parking lot surface. Two light posts will be installed to protect north and east of the garden centre. The pillar installations and light posts will be installed within the Critical Rooting Zone of Trees 40, 43, 44, 45, 47, 57, 58, 59, 61 and 64; all of these trees will be injured by the proposed excavation. . It is proposed to place a Tree Protection Fence along the top edge of the parking lot curb, from Tree 39 to Tree 64. The installation of the garden centre posts, fence and light post should be completed from the parking lot surface. Any required excavation should be done by hand to the required depth and the width of the excavation must be kept to the width of the base of the support. All exposed roots must be cut sharply at the edge of the excavation. It is proposed to remove the landscape island at the north end of the proposed garden centre; Tree 65 will need to be removed.

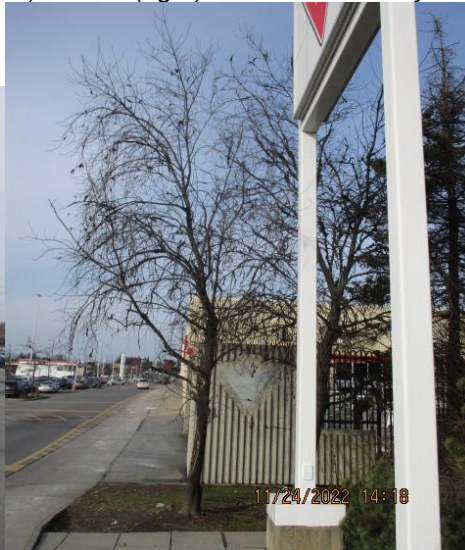
*Trees 66 (left) to 68 (right)*

Along this side of the proposed building, it is proposed to remove Trees 66, 67 and 68 due to their health condition, Trees 70, 72, 74, 76, 77 and 78 for their location adjacent to the swale and Trees 82 to 90 due to excavation, construction access and proposed grade changes required to allow construction access. Trees 82 to 86 are growing on a sloped area. The grade will have to be dropped to the building side of the trees. Trees 87 to 90 will have excavation close to the base of the trees, removing 25 to 50% of their root systems. The canopies of these trees also extend up to and into the vertical footprint of the addition.

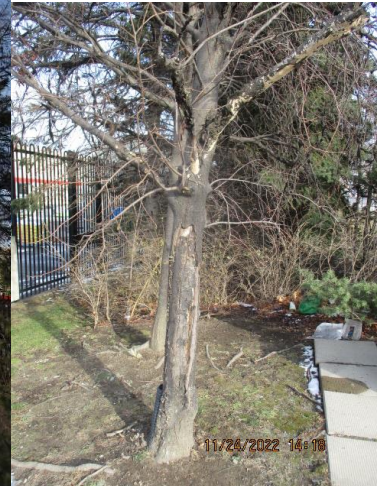
*Dieback in trunk – Tree 66*

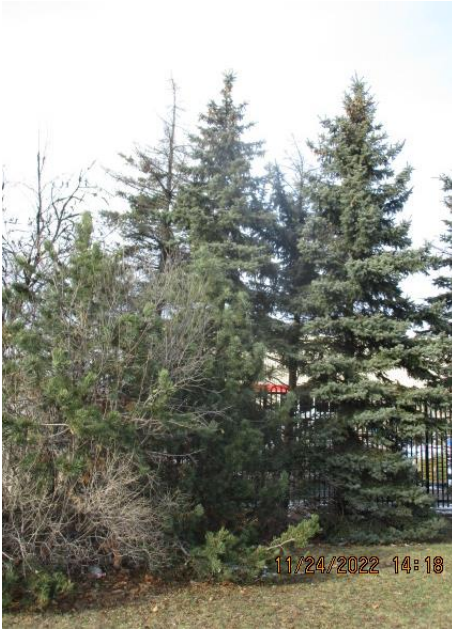
Trees 68 to 71 – Colorado Spruce

A Tree Protection Fence should be erected 3.0 metres from Trees 69, 71 and 73 and 4.0 metres from Trees 75, 79, and 81 to protect these trees during the construction of the building. When it is proposed to excavate the swale, the Fence will be moved to the road edge of the swale. It is assumed that the swale will be dug by machine. The machine used should be as small as possible to minimize soil compaction by the tracked vehicle. Soil excavated from the swale must be placed outside of the Tree Protection Fences and cannot be placed between trees. The excavation for the 3 to 1 swale slope adjacent to Tree 81 must be done by hand to allow significant roots (50 mm +) to be preserved above grade, if this is possible.

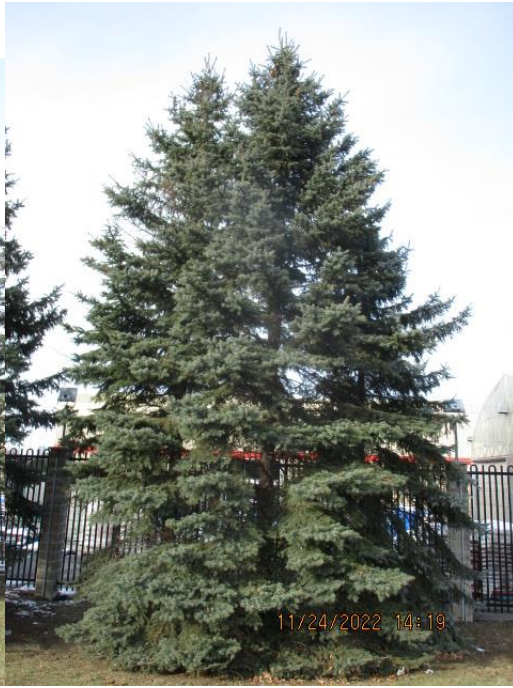
Trees 72 to 74 – Colorado Spruce

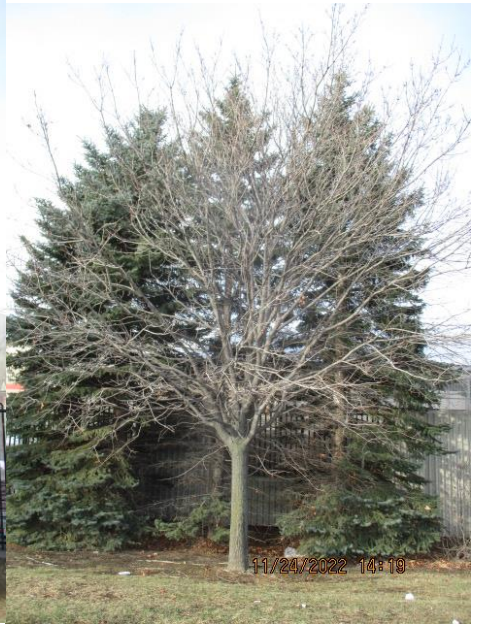
Trees 75 to 78 (Spruce) and 79 (Maple)

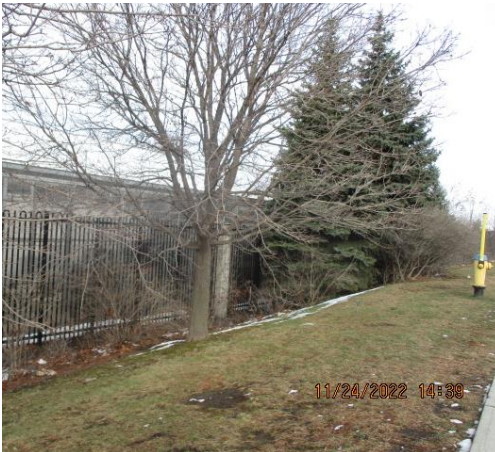
Tree 80 with grade increase in NE corner

*Swale installation injuries - Trees 69, 71, 73, 79, 80 and 81 (6 trees)*

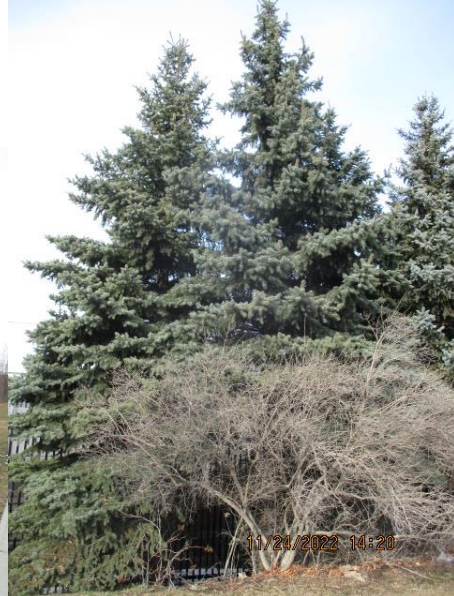
Trees 82 to 85 – Colorado Spruce

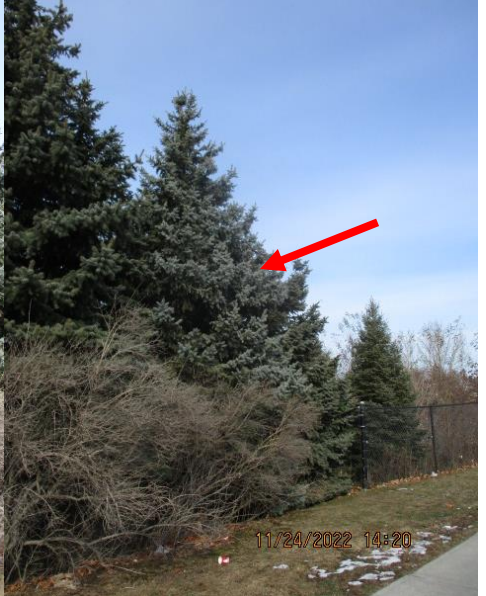
Tree 86 – Colorado Spruce

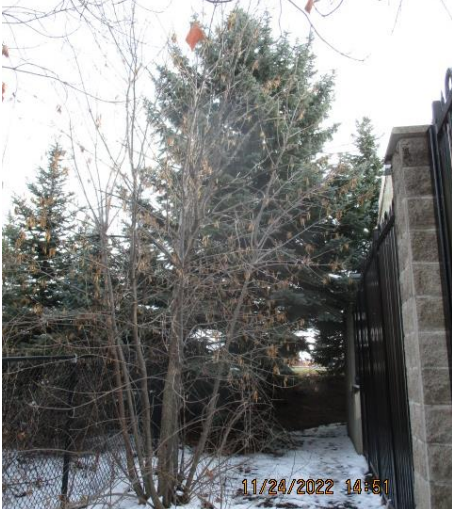
Tree 88 is a Green Ash which has been affected by Emerald Ash Borer, leaving stems with a maximum diameter of 7 cm. A permit should not be required for this tree.

Tree 88 – Green Ash with 87 to south

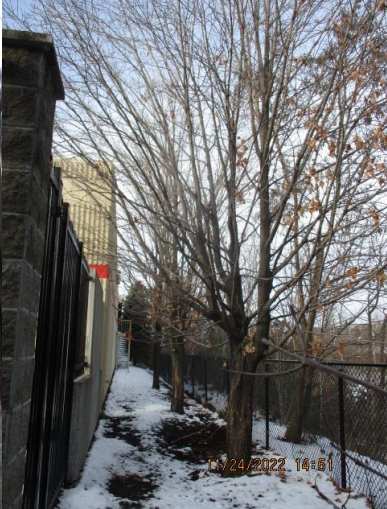
Trees 89, 90 and 91 – Sugar Maple

A Tree Protection Fence will need to be installed a minimum 2.5 metres east of Tree 91, from existing building to property line fence, to keep construction activities from the north side of the existing building.

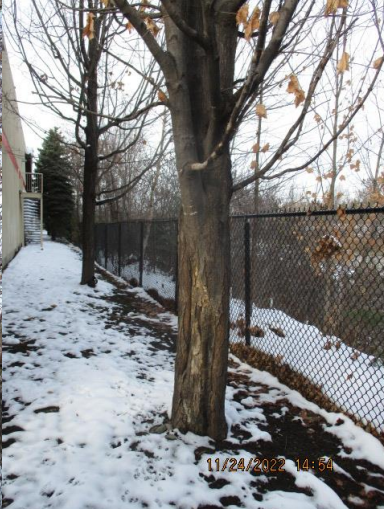
Tree 90 – trunk wound
