February 13, 2023
File: PE4934-LET.02R

Subject: **Phase II-Environmental Site Assessment Update
30, 38, 42 and 48 Chamberlain Avenue
Ottawa, Ontario**

QUANTUM PROJECT MANAGEMENT SERVICES INC.
PHASE II - ENVIRONMENTAL SITE ASSESSMENT UPDATE
 30, 38, 42 & 48 CHAMBERLAIN AVENUE
 OTTAWA, ONTARIO
TEST HOLE LOCATION PLAN

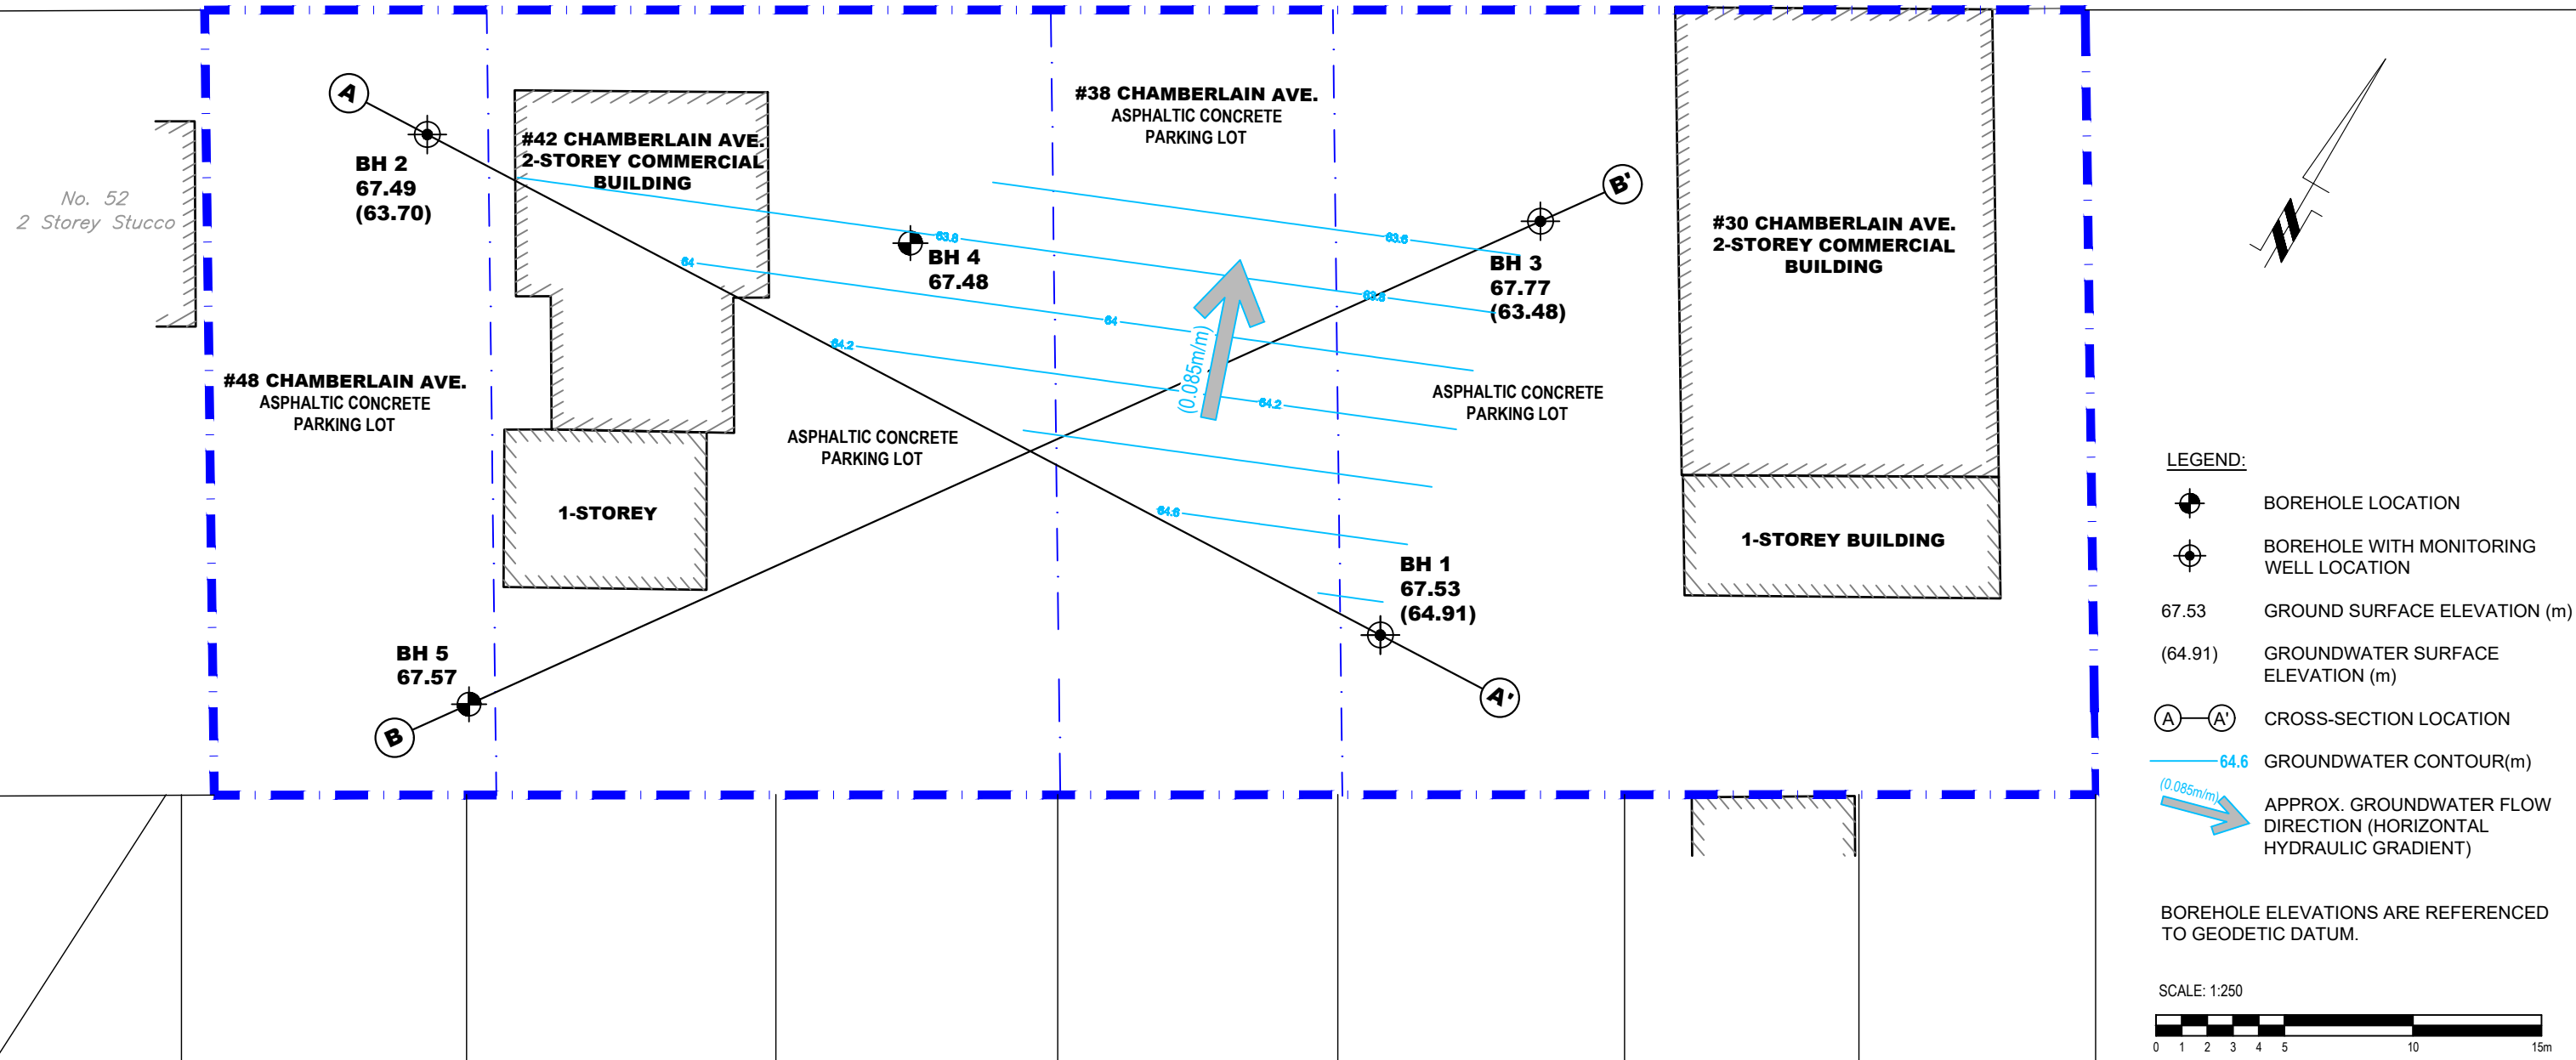
Date: 01/2023
 Report No.: PE4934-LET.02
 Dwg. No.: **PE4934-3R**
 Revision No.:

Groundwater flow was measured in a northerly direction with a hydraulic gradient of 0.085 m/m. Groundwater contours are shown on Drawing PE4934-3R–Test Hole Location Plan.

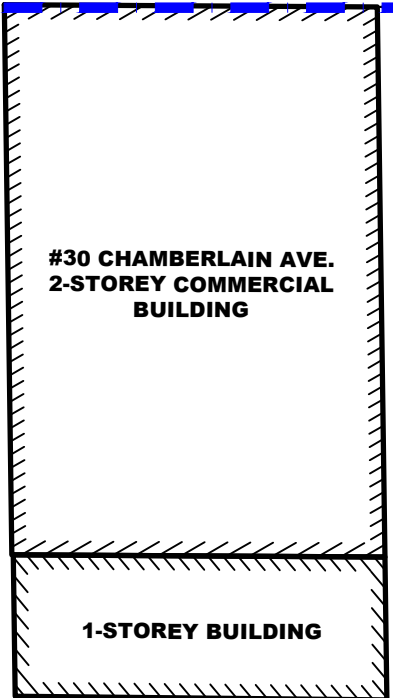
Scale:	1:250	Date:	01/2023
Drawn by:	MPG	Report No.:	PE4934-LET.02
Checked by:	MW	Dwg. No.:	PE4934-7R
Approved by:	MSD	Revision No.:

BH3-GW2 4.0-7.0m 12-Jan-23
 VOCs comply with MECP Table 3 Standards
 BH5-GW2 (DUP) 4.0-7.0m 12-Jan-23
 VOCs comply with MECP Table 3 Standards

GROUNDWATER PARAMETERS COMPLY WITH
 MECP TABLE 3 STANDARDS
