Tree Conservation Report

2940, 2944, and 2946 Baseline Road

CIMA+ file number: A001384
May 15, 2023 – Review 001

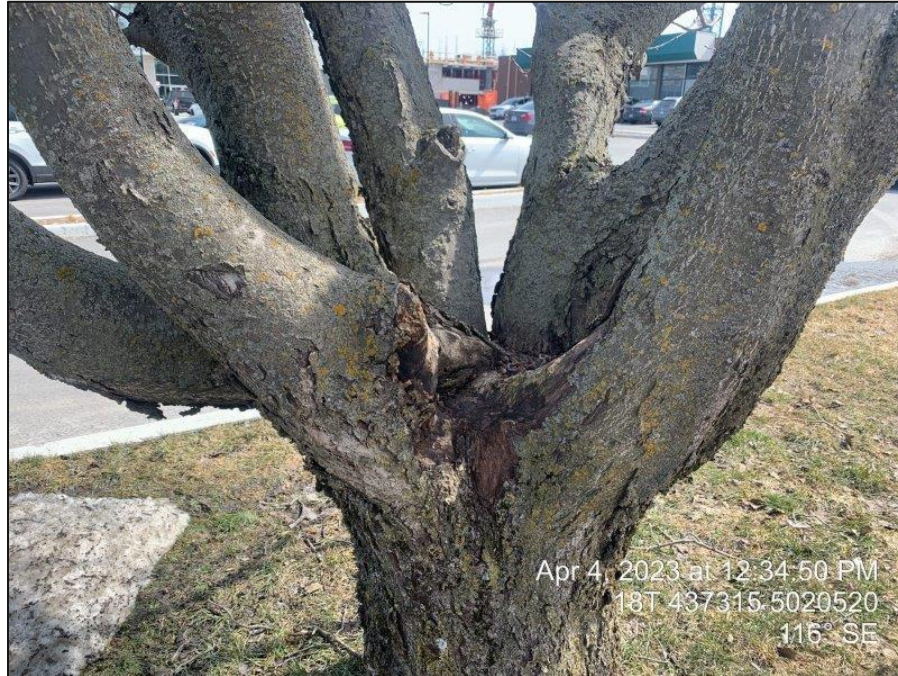
It should be noted that the 18 individual trees proposed for transplant are all newly planted saplings. It should also be noted that the one (1) oakleaf mountain ash (tree #14 - **Appendix A**) was assessed as Fair due to its poor structure and crotch decay. The city has requested this tree be retained. **Photo 1** below displays the deficiencies of this individual.

Photo 1 : View of crotch decay and poor structure of Tree #14 – Oakleaf Mountain Ash
