Tree Conservation Report

2940, 2944, and 2946 Baseline Road

CIMA+ file number: Z0017558
August 15, 2024 – Review 003

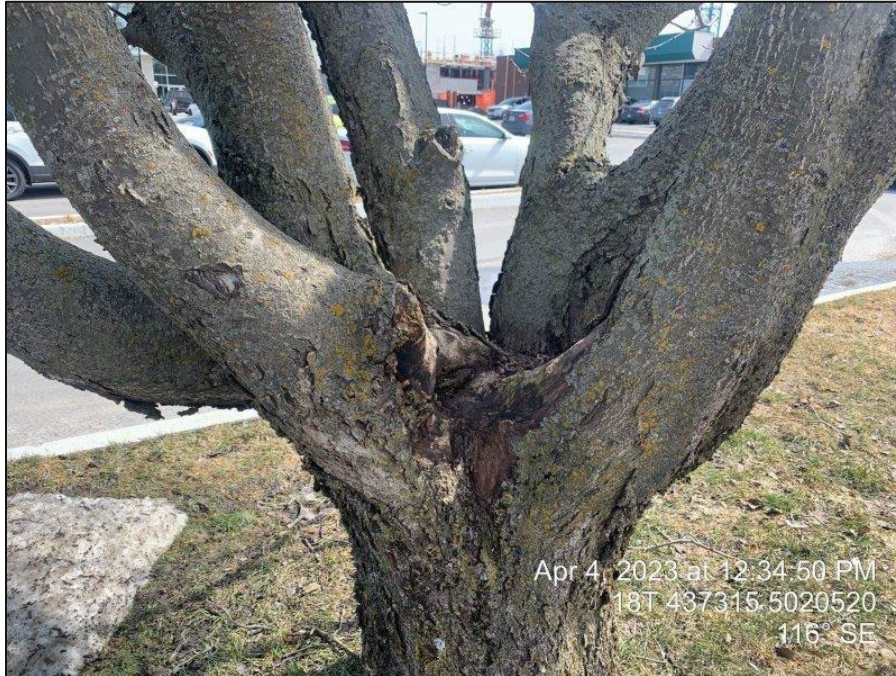
It should be noted that the 18 individual trees proposed for transplant are all newly planted saplings. It should also be noted that the one (1) oakleaf mountain ash (Tree #14 - **Appendix A**) was assessed as Fair due to its poor structure and crotch decay. The city has requested this tree be retained. **Photo 1** below displays the deficiencies of this individual.

Photo 1 : View of crotch decay and poor structure of Tree #14 – Oakleaf Mountain Ash
