June 5, 2023

RE: TREE CONSERVATION REPORT FOR 400 COVENTRY ROAD, OTTAWA

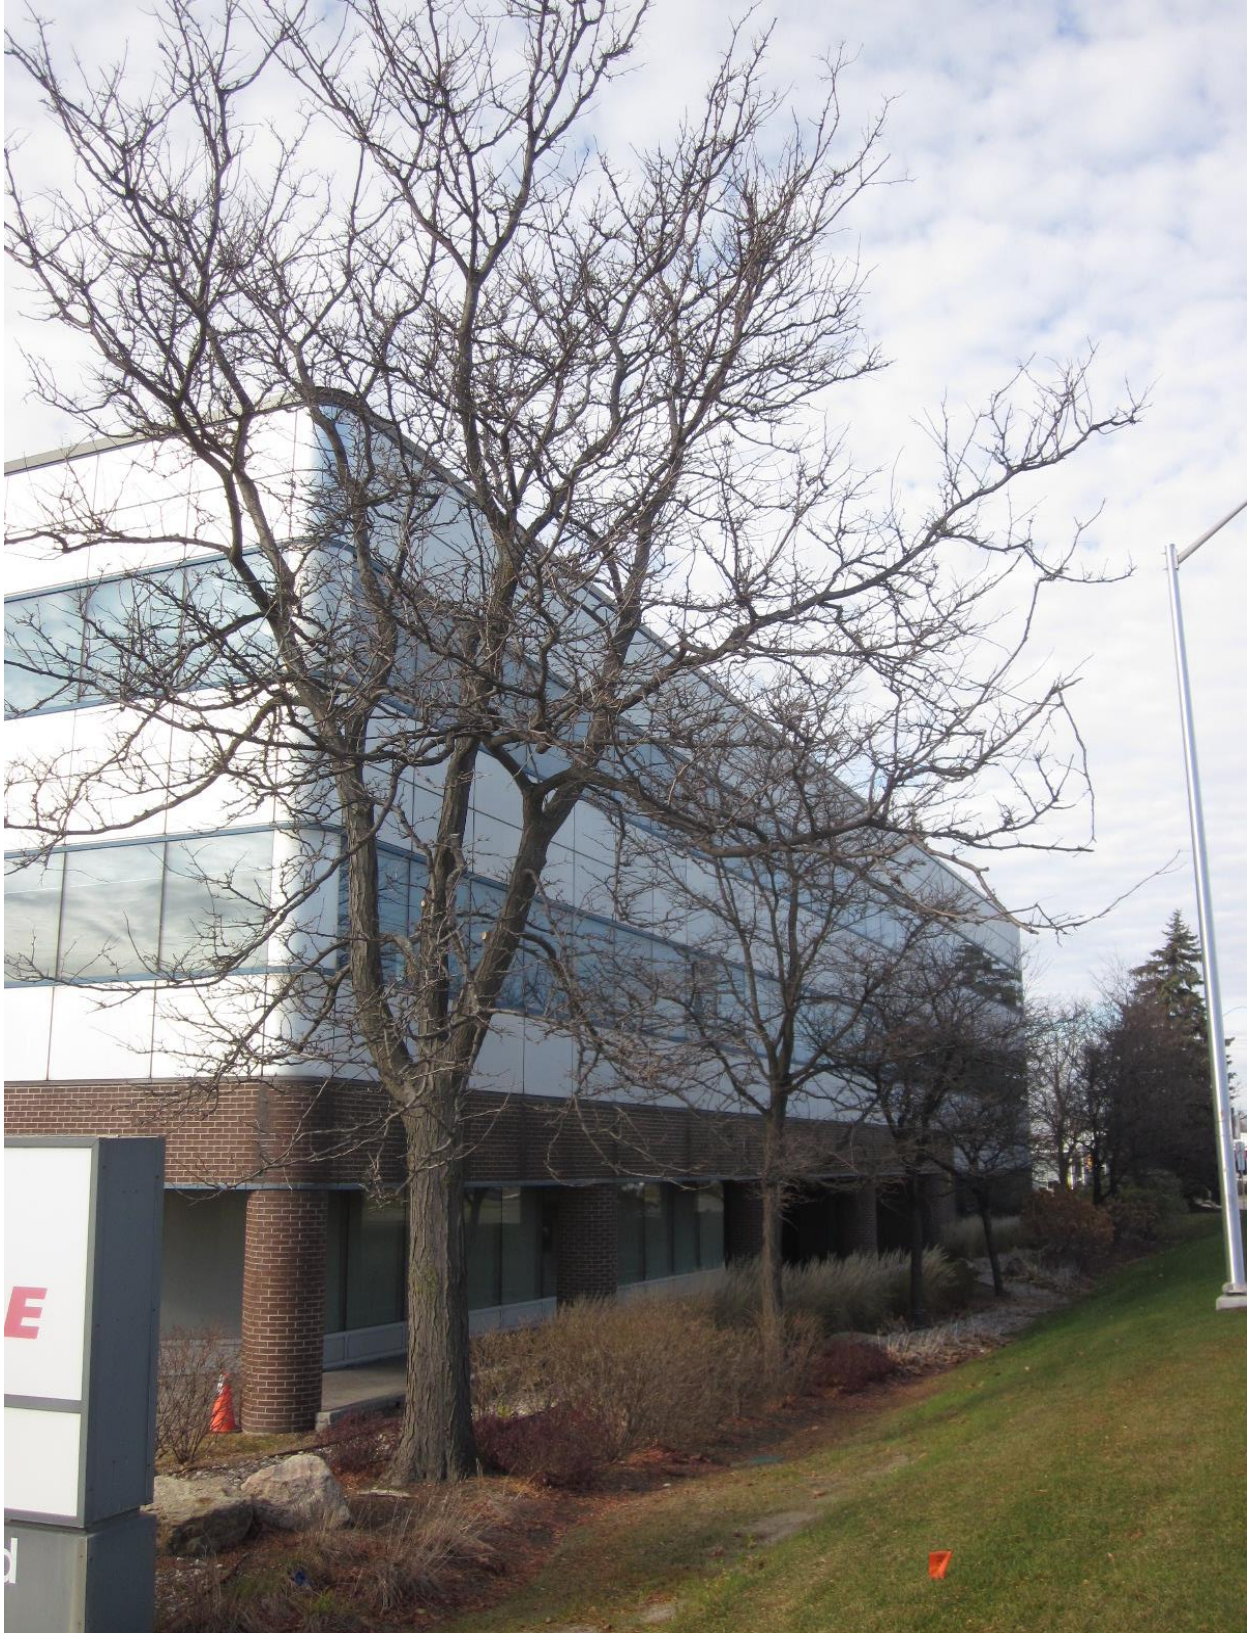
Picture 1. Trees #7-10 (left to right), private honey-locusts located at 400 Coventry Road

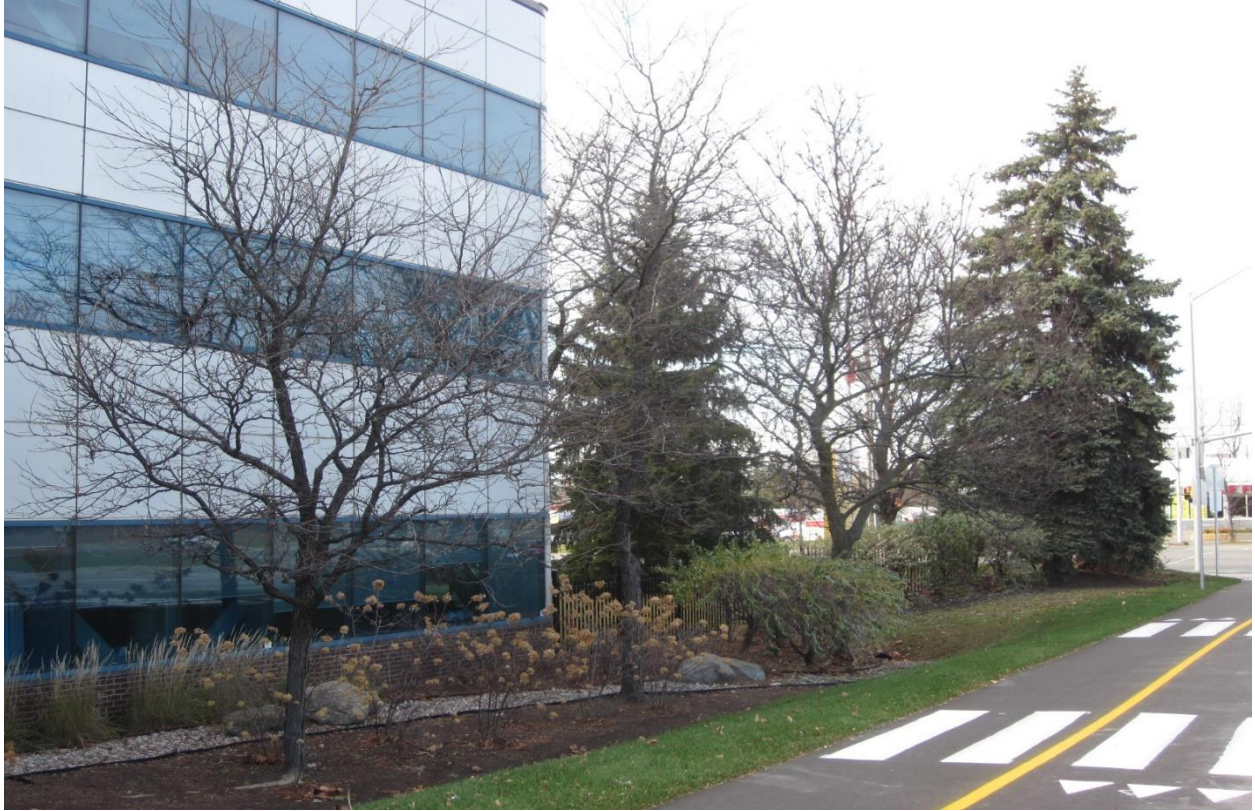
Picture 2. Trees #11-13 and 16 (left to right), located at 400 Coventry Road

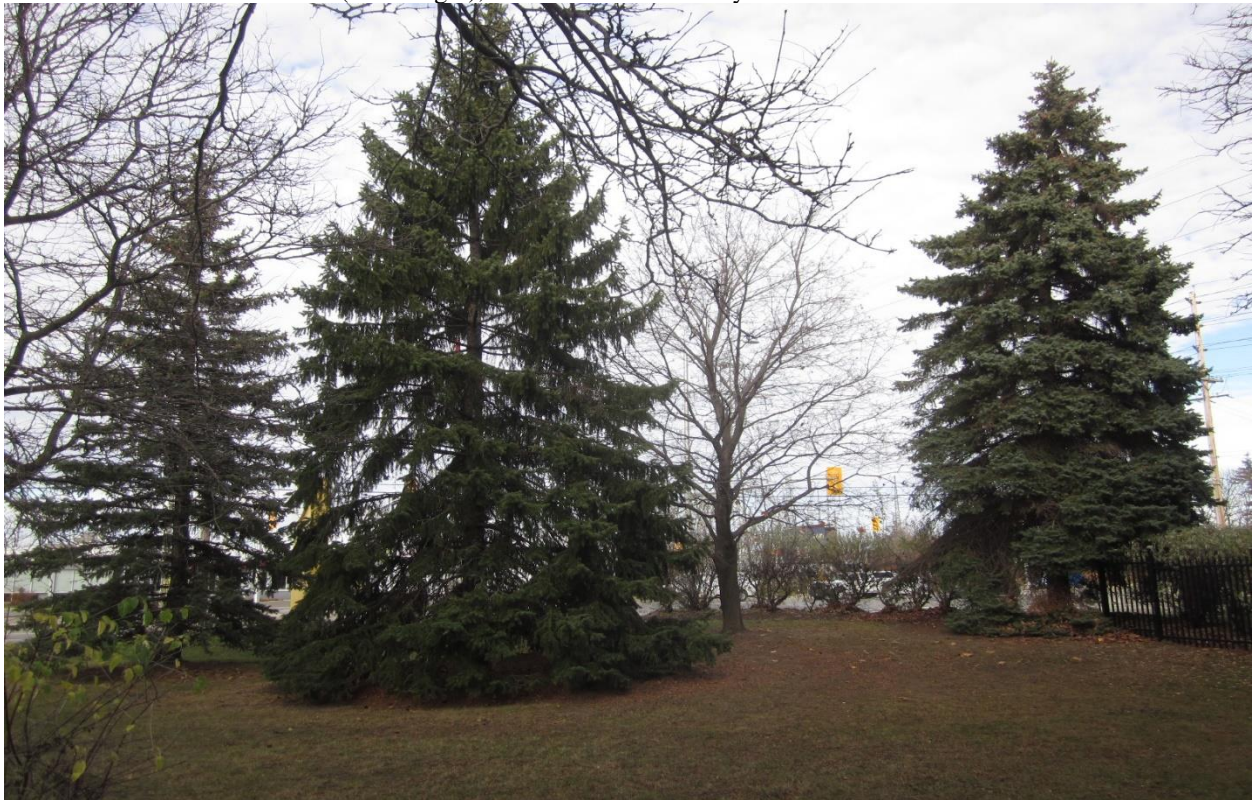
Picture 3. Trees #16-19 (right to left), located at 400 Coventry Road

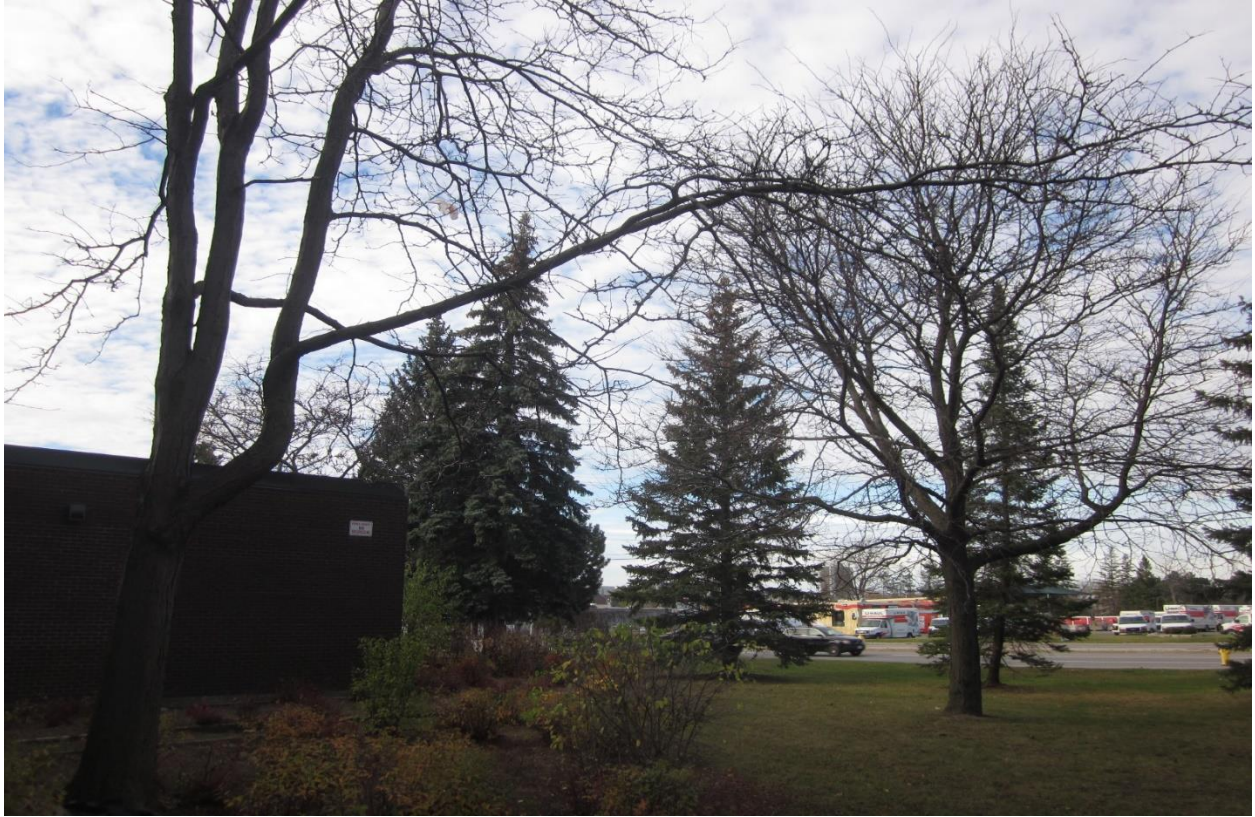
Picture 4. Trees #15 (left), 20-23 (background right to left), located at 400 Coventry Road

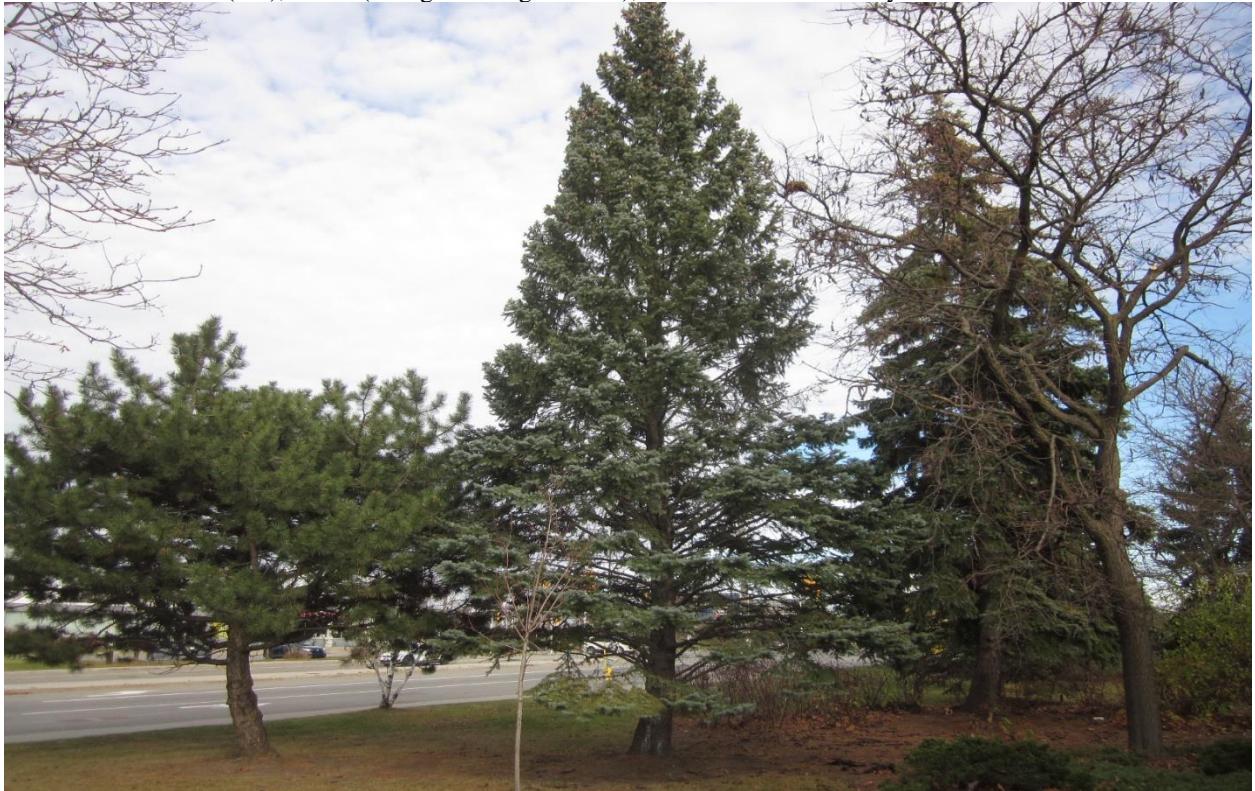
Picture 5. Tree #24 (far right), 23, 26 and 27(background right to left), located at 400 Coventry Road

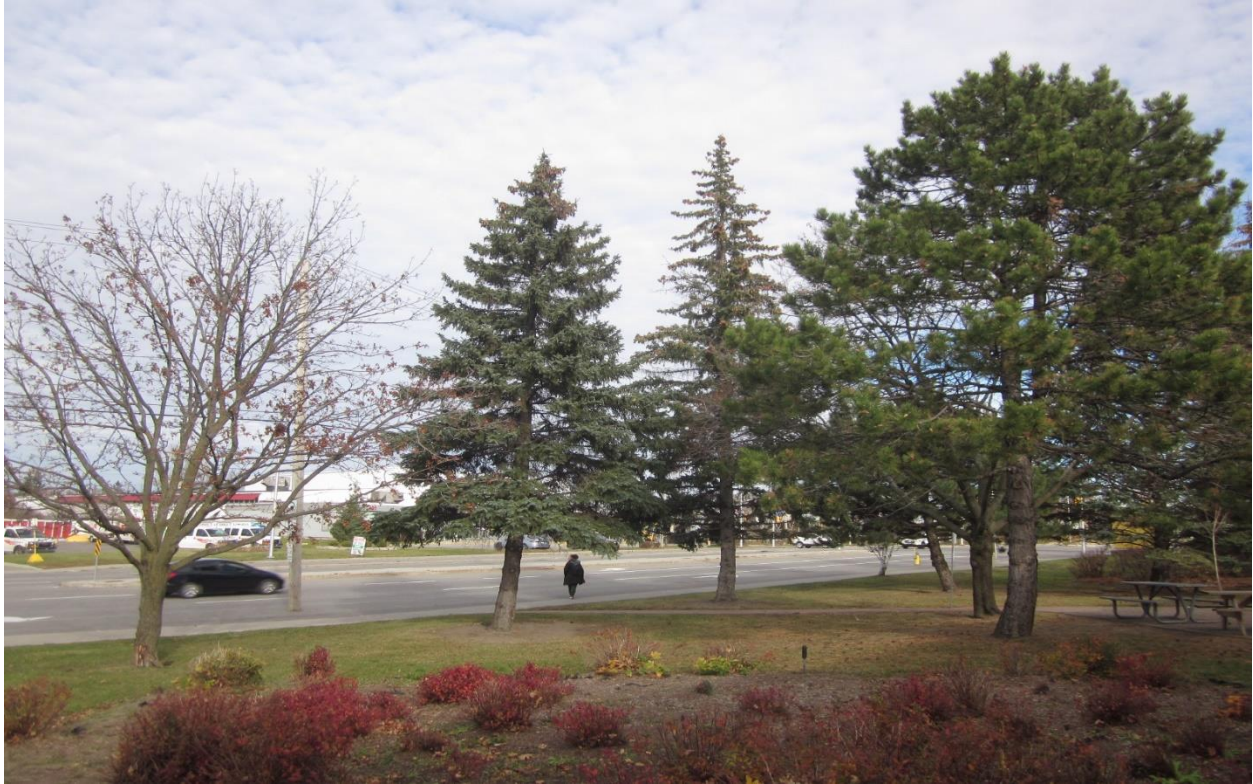
Picture 6. Trees #30 (right), 28, 31 and 32 (right to left), located at 400 Coventry Road

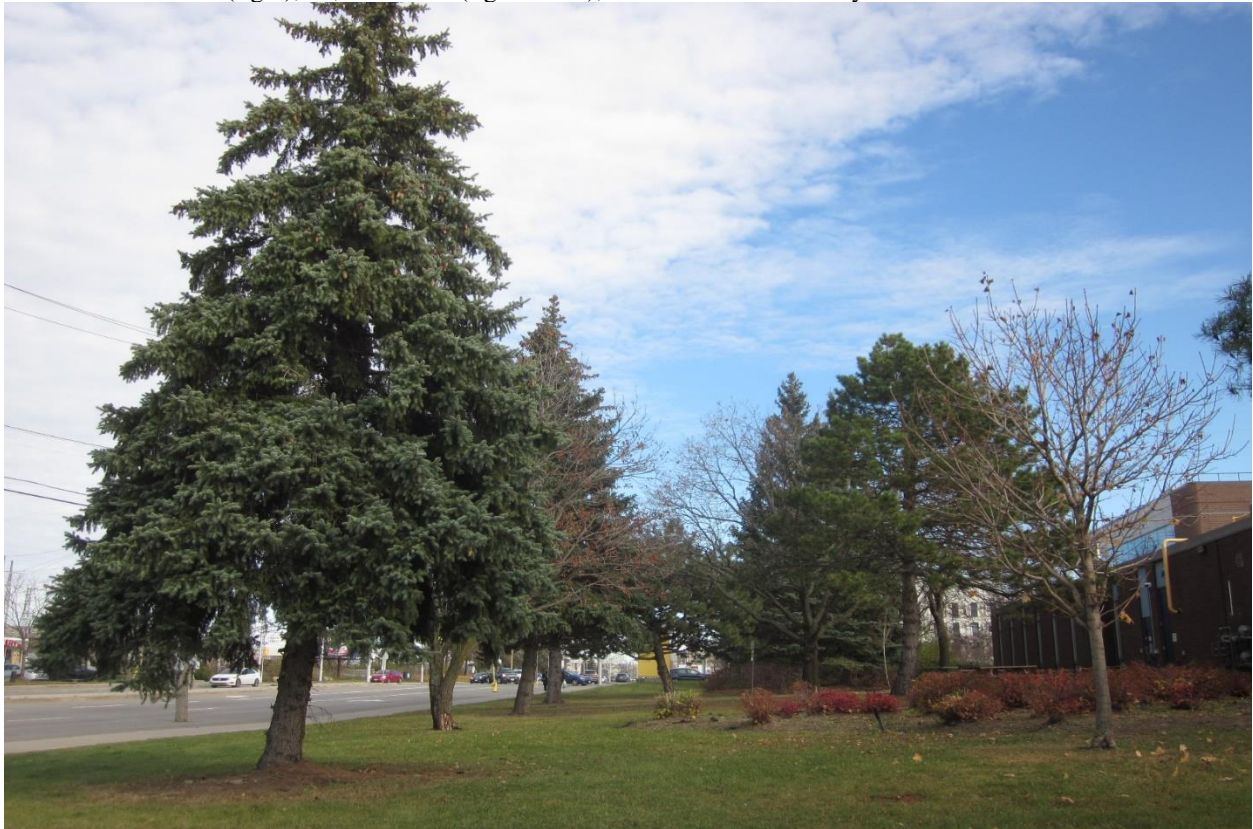
Picture 7. Trees #33 (spruce left) and 34 (maple right), located at 400 Coventry Road

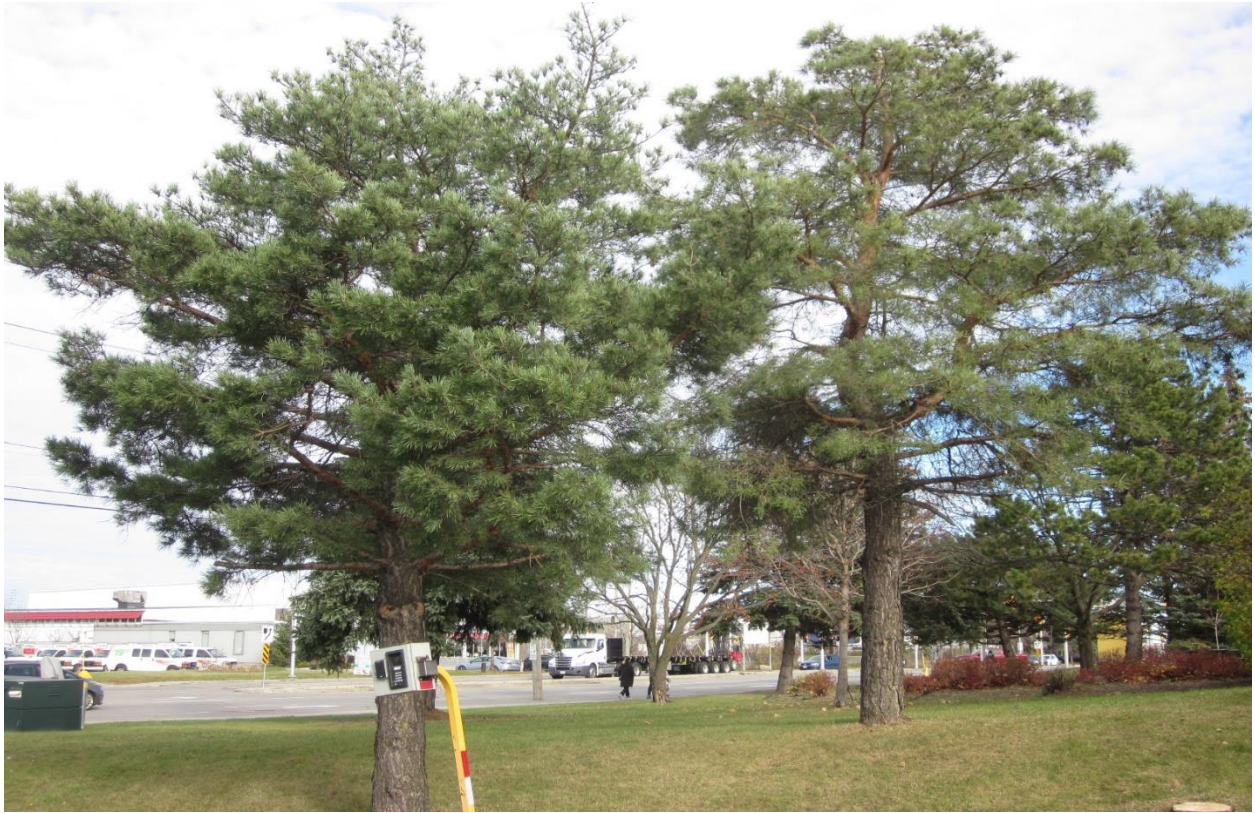
Picture 8. Trees #35 and 36 (right to left), private Scots pines located at 400 Coventry Road

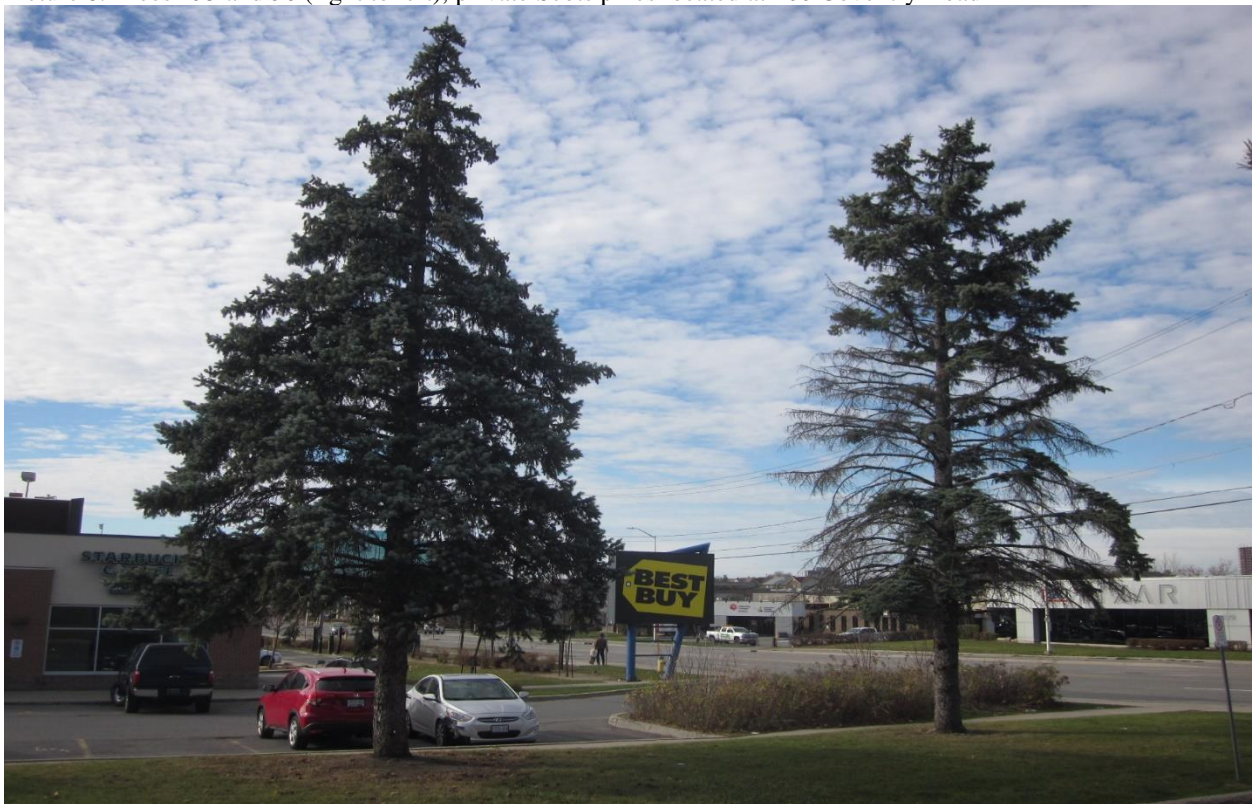
37	Colorado spruce (<i>Picea pungens</i>)	Private	35.6	Good; mature; good pyramidal form; leader divergent towards east; good crown density, growth increment and needle colour; introduced species; to be removed (conflicts with construction)
38	Colorado spruce (<i>Picea pungens</i>)	Private	36.9	Poor; competing divergent leaders near apex; poor crown density, growth increment and needle colour in lower 2/3 – in decline; introduced species; to be removed (poor condition and conflicts with construction)

Picture 9. Trees #37 and 38 (left to right), private Colorado spruce located at 400 Coventry Road
