December 16, 2022  
CO884.00

**Re: Designated Substances Survey  
5646 Manotick Main Street, Ottawa, Ontario**

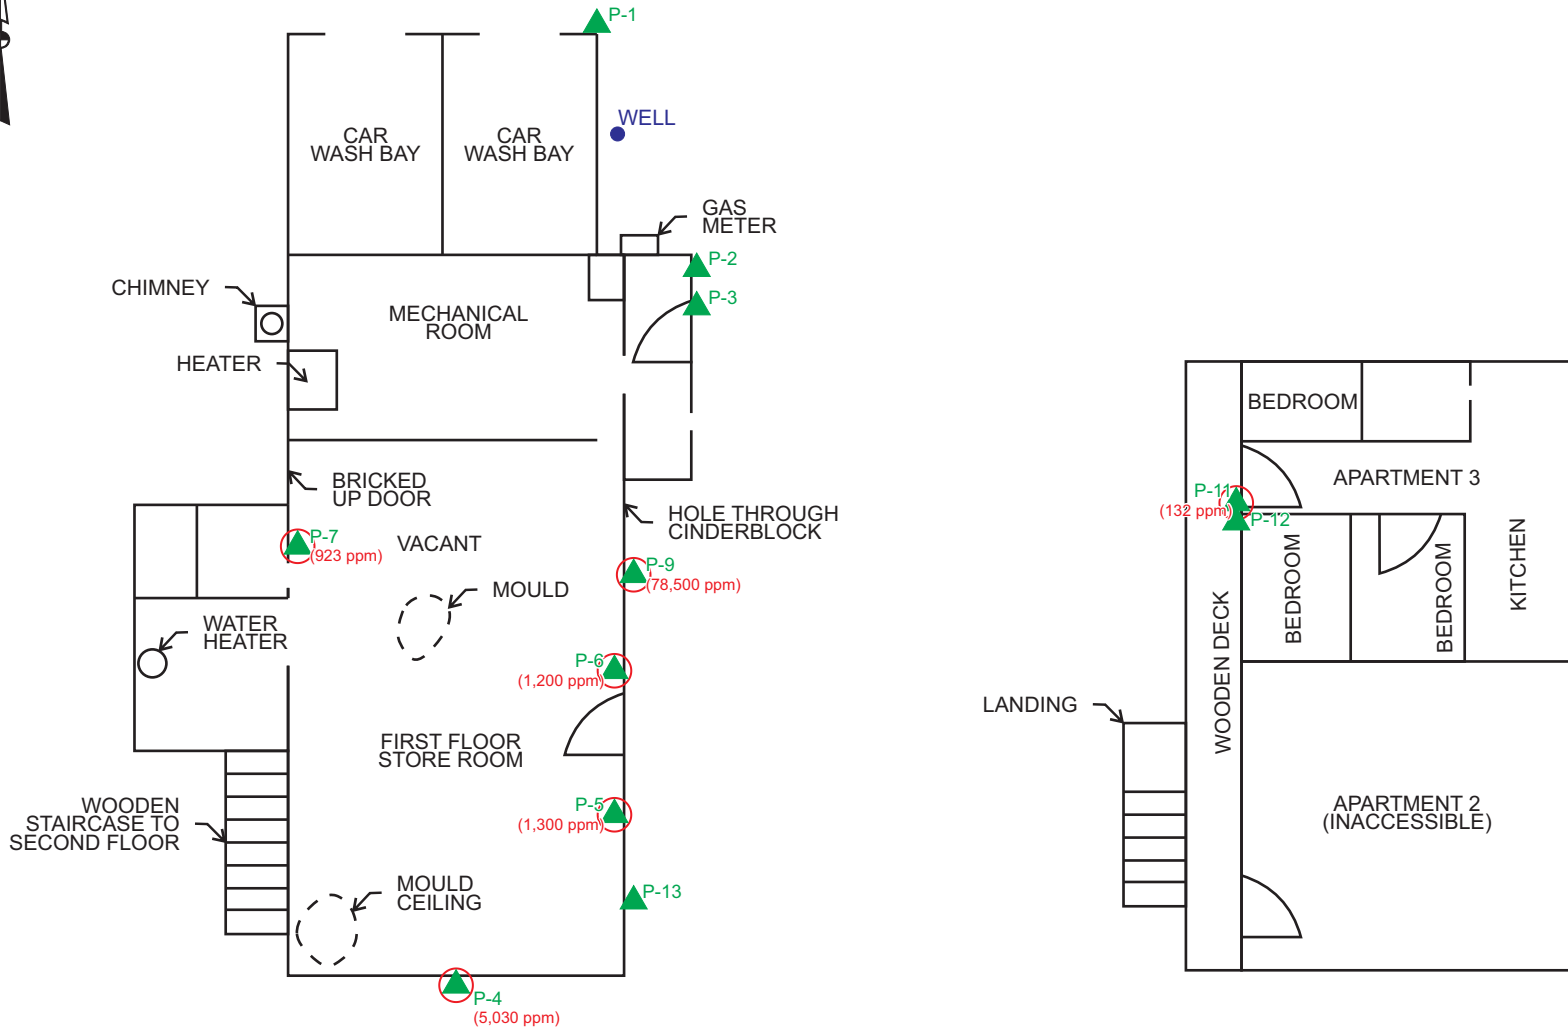
Based upon the age of the building, lead may be present on painted surfaces and in piping. Twelve samples of paint (P-1 to P-7 and P-9 to P-13) from the building were collected and submitted for laboratory analysis of lead content. Lead in paint analysis was conducted using Inductively Coupled Plasma Mass Spectroscopy (ICP/MS) according to EPA method 6020. The sample locations, paint descriptions, approximate extent of the painted surfaces, and condition of the paint are summarized in Table 2 (attached). The locations of the paint samples are shown on Figure 2. Laboratory Certificates of Analyses are attached.

- the white paint (P-4) located on the exterior at the southern and western sides of the exterior;
- beige-brown paint (P-5) located on the first floor of the building;
- grey paint (P-6) located on first floor
- green paint (P-7) located on first floor
- yellow-green paint (P-9) located on first floor
- white paint (P-11) located on wood siding on exterior of building.

Demolition and renovation contractors should ensure the use of appropriate personal protective equipment and proper dust control measures to protect themselves and the public from potential exposure by inhalation of silica dust or paint dust or chips.

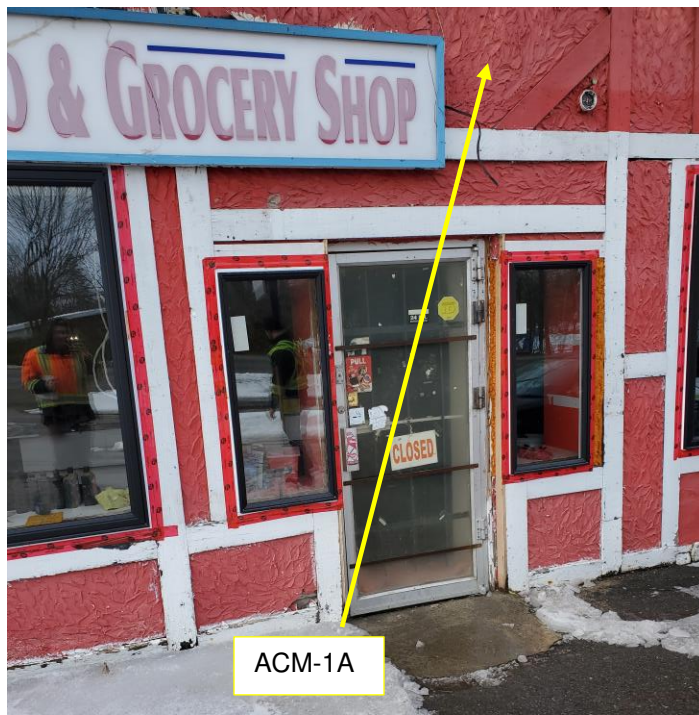
**Photo No:** 4

- ACM within the following building materials:
  - The red painted stucco present at the front exterior of the building (sample ACM-1A, non-friable, 2% Chrysotile asbestos, approximately 30 m<sup>2</sup> in area, fair to poor condition);

View of the stucco on the exterior of the building that was confirmed to be 2% chrysotile (AMCM-1A).

If any demolition, alteration or repair work that may result in disturbing ACM or potential ACM areas, a qualified asbestos abatement contractor should be retained for asbestos removal prior to undertaking the work. O. Reg. 278/05 defines three types of asbestos removal operations, which require different levels of protection, isolation and decontamination. Type 1 operations involve the lowest level of risk and include the removal of non-friable materials where the material is not damaged, or can be wetted and cut without power tools. Type 3 operations involve the highest level of risk, including removal of most types of friable materials, and require full enclosure of the area and construction of a decontamination area for workers and equipment, among other things.

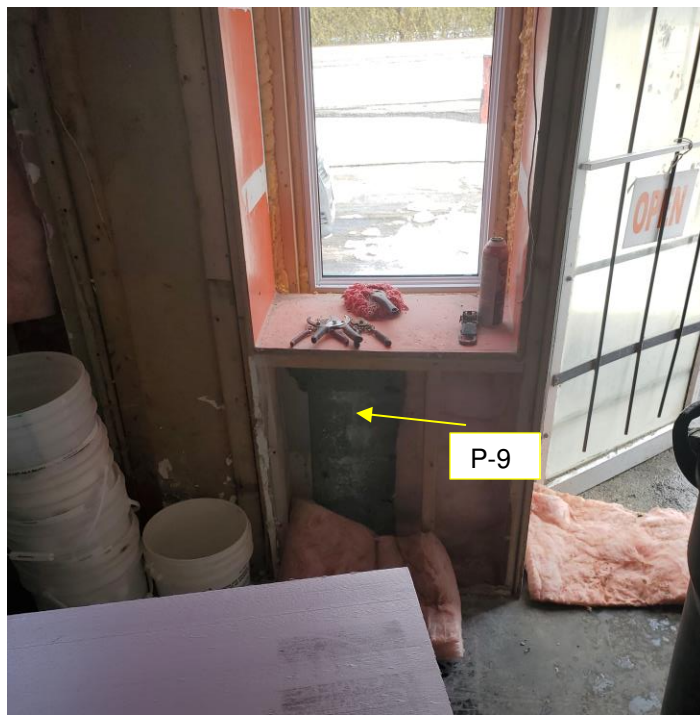
Photo No: 6

A view yellow-green paint (P-9) collected from the interior column of the first floor of the building.

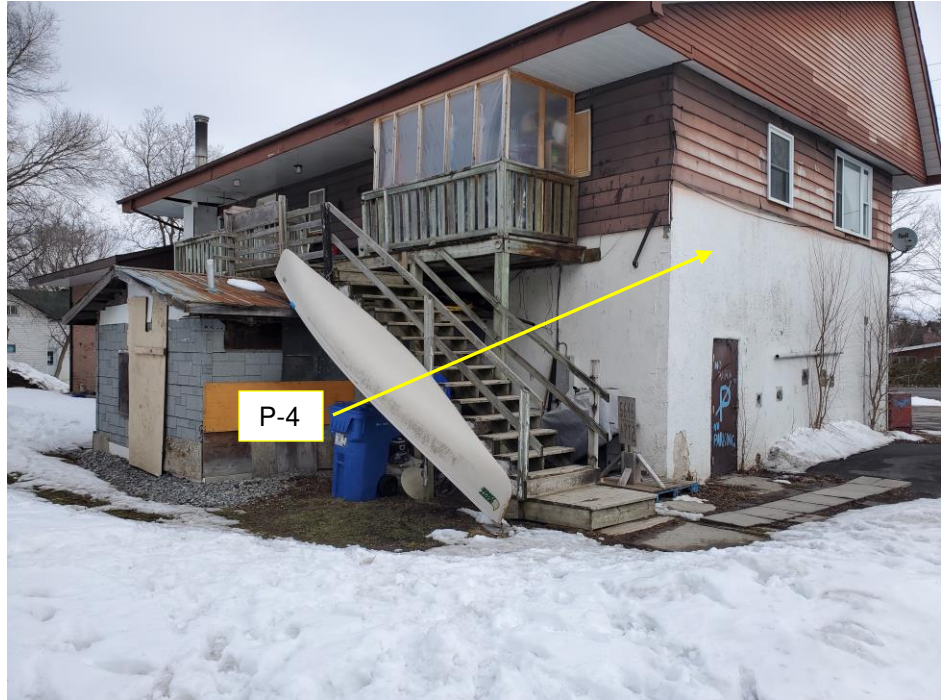
A view of exterior and side of the building. The white paint is where paint sample P-4 was collected.

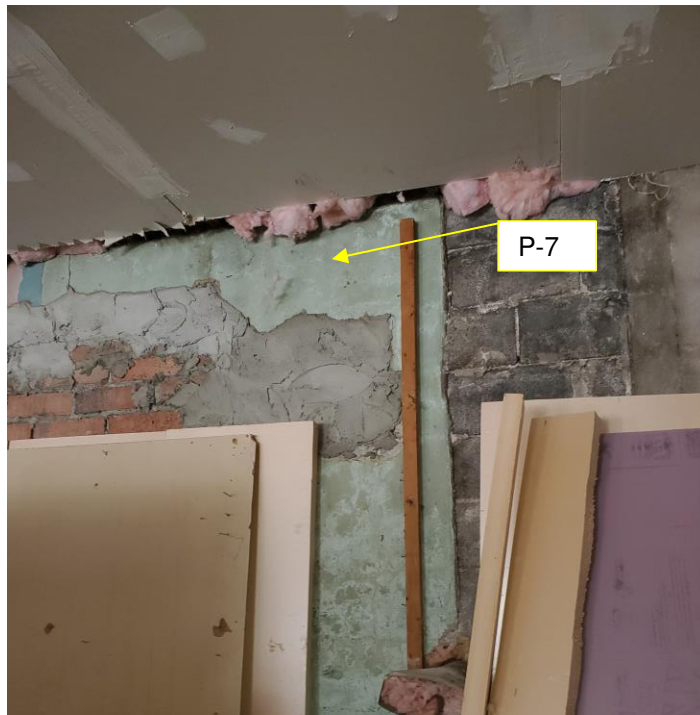
Photo No: 8

A view of the green paint (P-7) located in the first floor of the building.
