October 24, 2023
CO884.00

Ms. Jade Hawkins
595831 Ontario Inc.
650 Eagleson Road
Kanata, Ontario
K2M 1H4

**Re: Designated Substances Survey
5646 Manotick Main Street, Ottawa, Ontario**

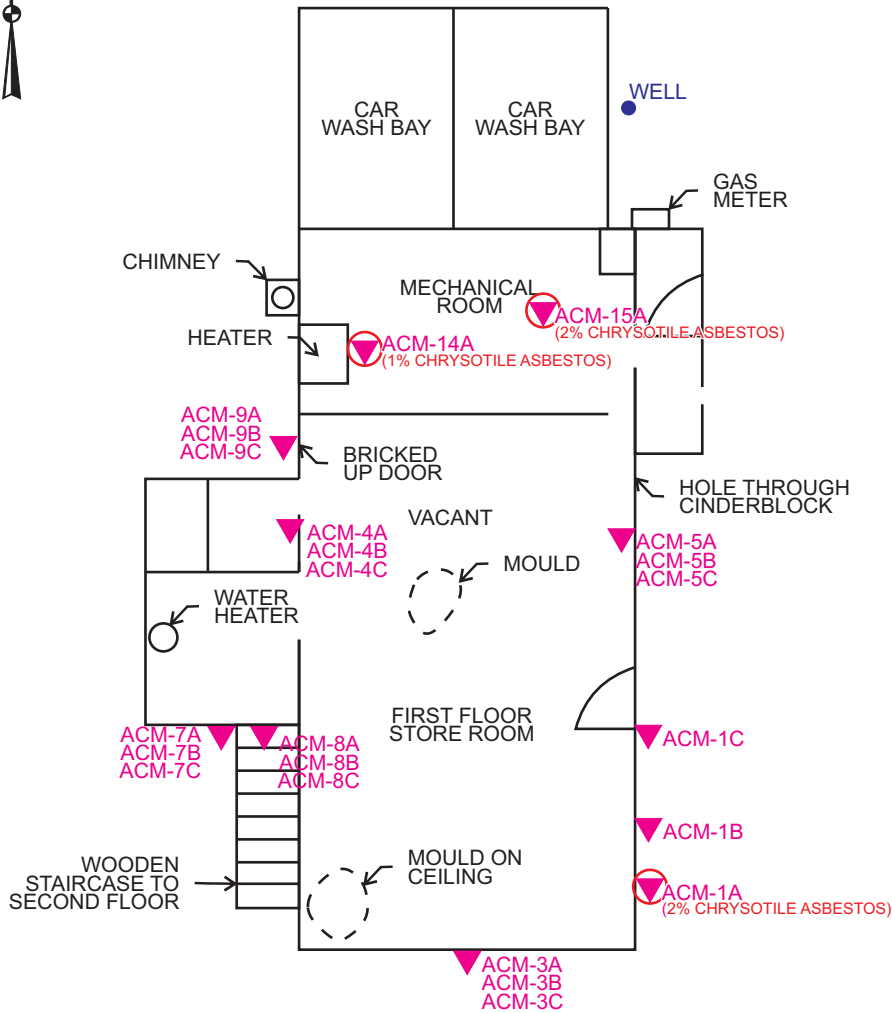
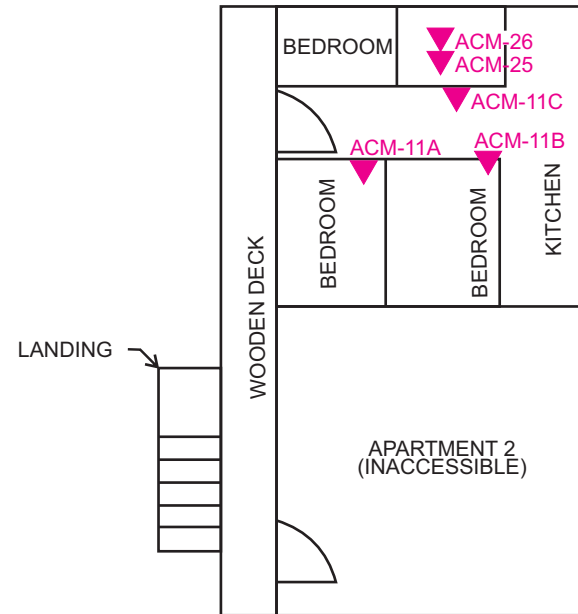
ASBESTOS SAMPLING LOCATION PLAN

The locations of the potential ACM samples, material descriptions, approximate extent, and condition are summarized in Table 1 (attached). The locations of the samples are also shown on Figure 1 (attached). Laboratory Certificates of Analyses are attached.

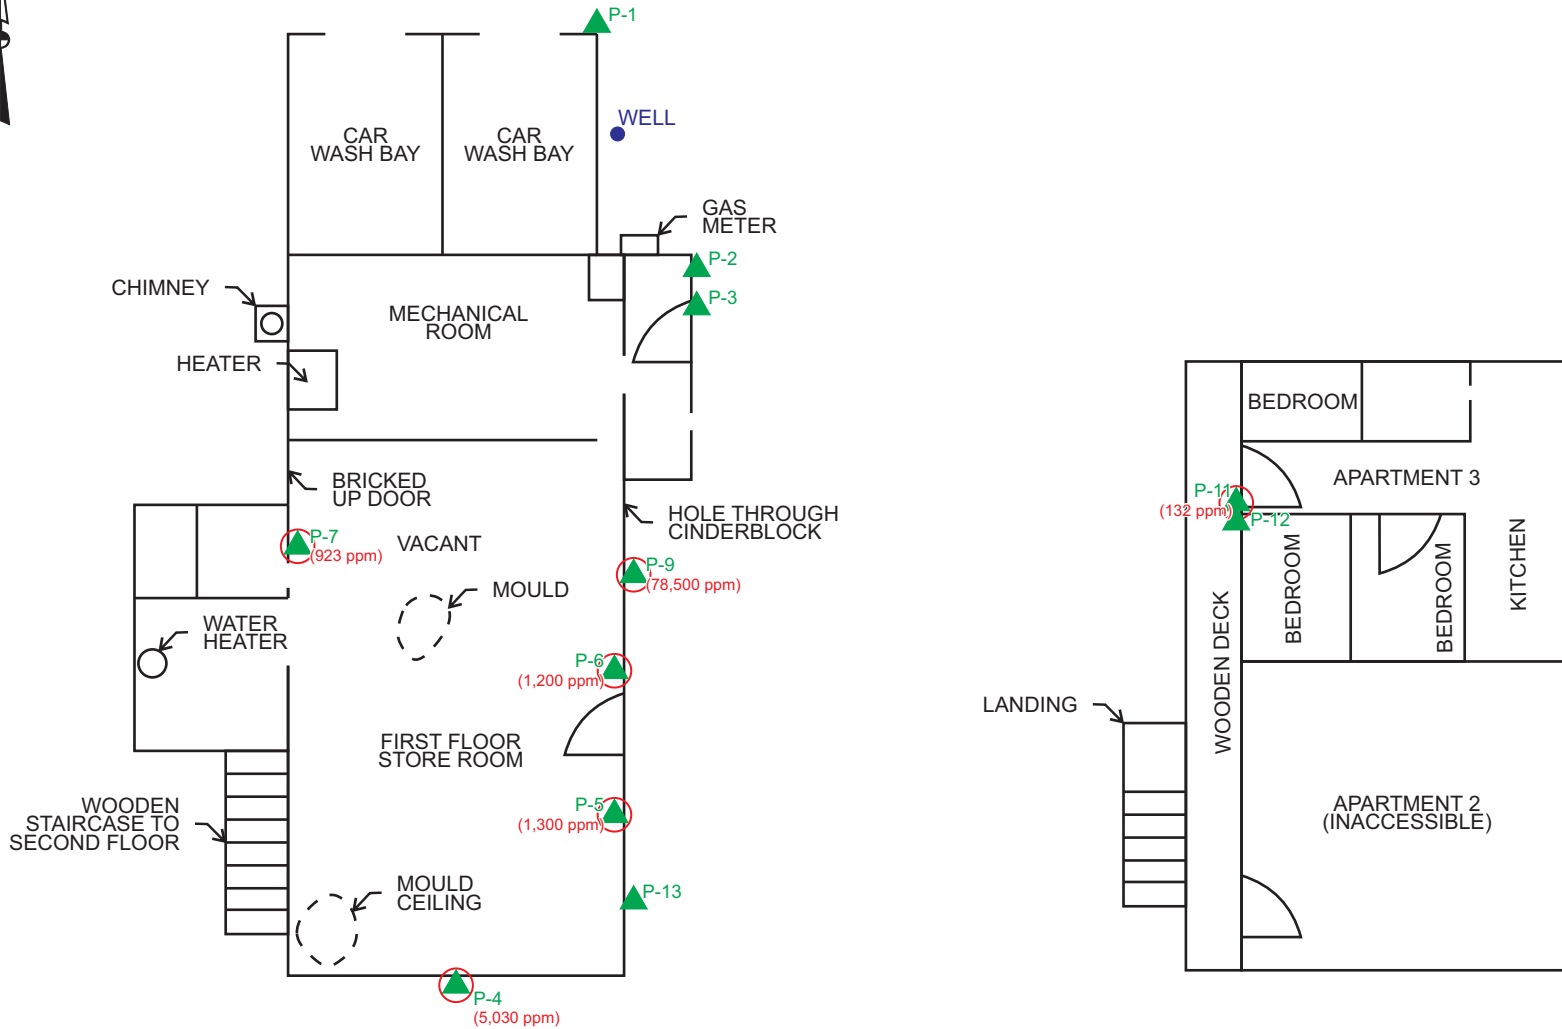
Based upon the age of the building, lead may be present on painted surfaces and in piping. Twelve samples of paint (P-1 to P-7 and P-9 to P-13) from the building were collected and submitted for laboratory analysis of lead content. Lead in paint analysis was conducted using Inductively Coupled Plasma Mass Spectroscopy (ICP/MS) according to EPA method 6020. The sample locations, paint descriptions, approximate extent of the painted surfaces, and condition of the paint are summarized in Table 2 (attached). The locations of the paint samples are shown on Figure 2. Laboratory Certificates of Analyses are attached.

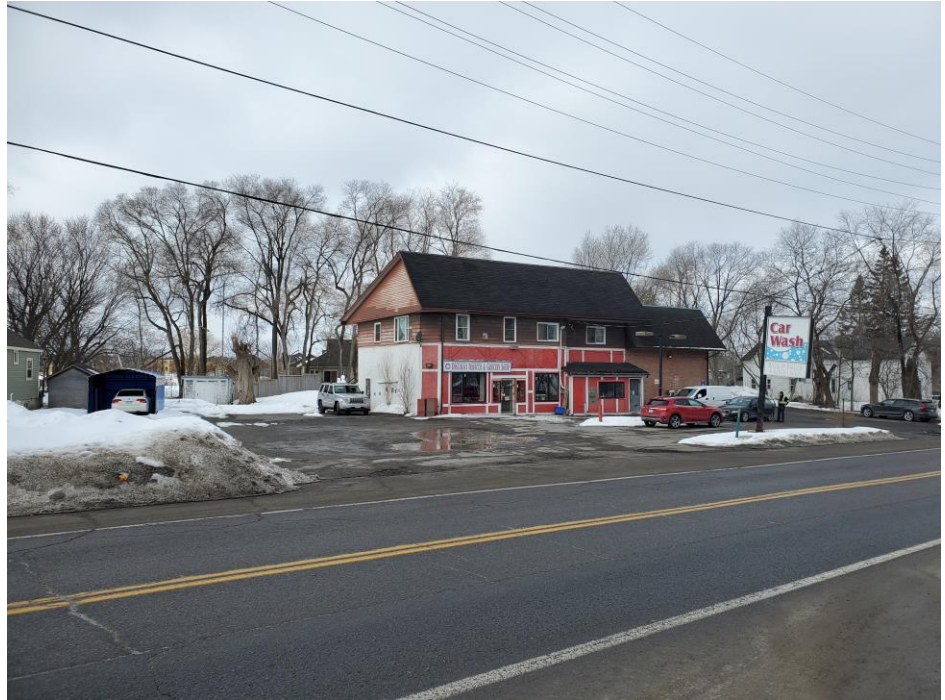
A view of the Site from the eastern side of Manotick Main Street.

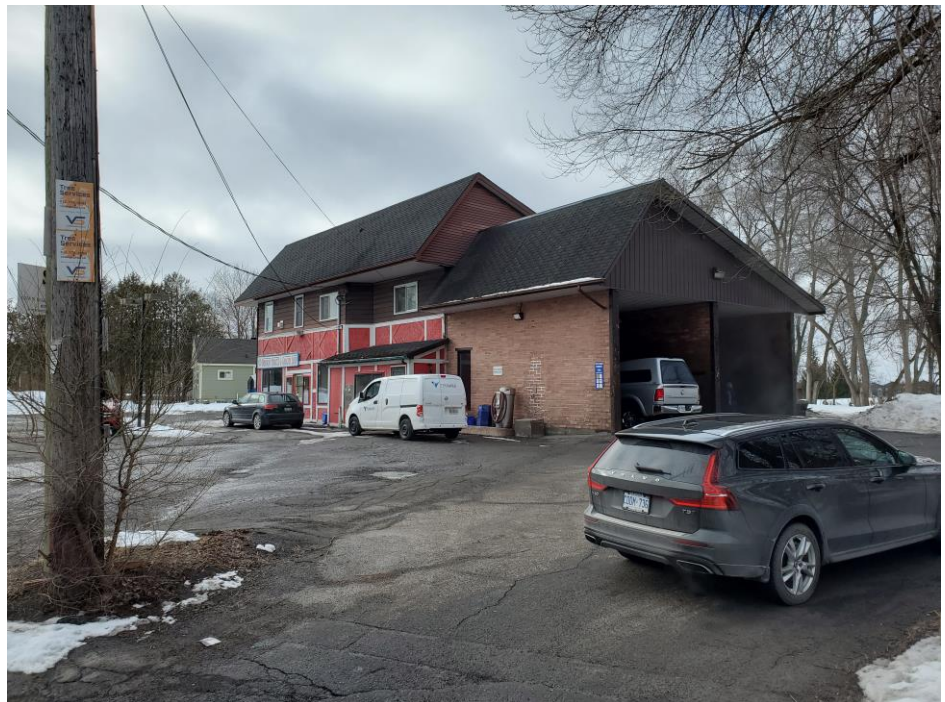
Photo No: 2

View of the Site from the northeastern portion of the Site. The two-bay car wash is visible in the foreground.

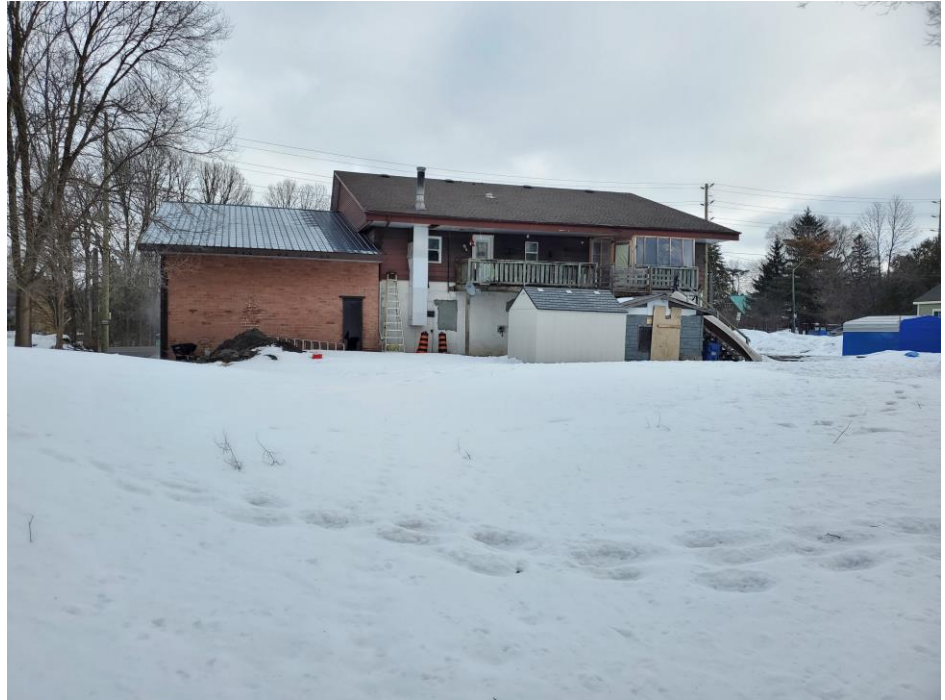
View of rear portion of the building from the southwestern portion of the Site.

The access to the two upstairs apartments are provided by the wooden staircase.

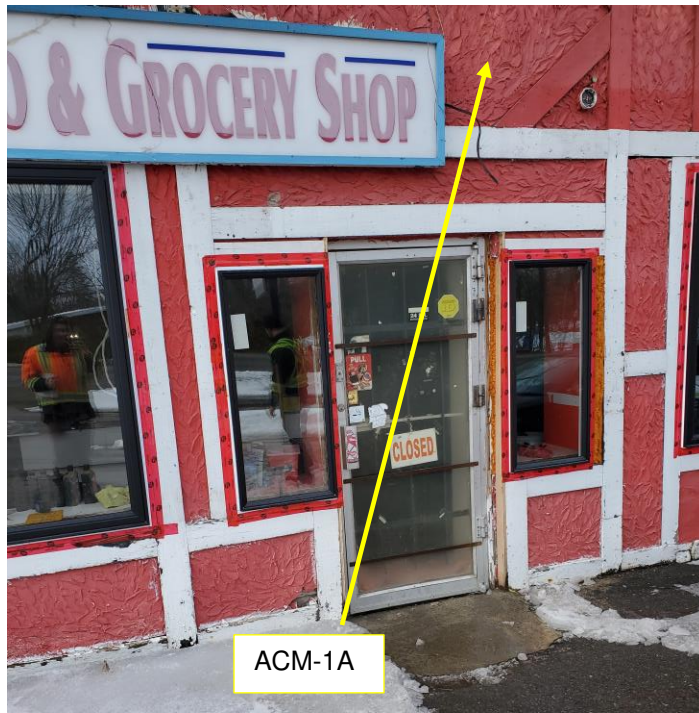
Photo No: 4

- ACM within the following building materials:
 - The red painted stucco present at the front exterior of the building (sample ACM-1A, non-friable, 2% Chrysotile asbestos, approximately 30 m² in area, fair to poor condition);

View of the stucco on the exterior of the building that was confirmed to be 2% chrysotile (AMCM-1A).

If any demolition, alteration or repair work that may result in disturbing ACM or potential ACM areas, a qualified asbestos abatement contractor should be retained for asbestos removal prior to undertaking the work. O. Reg. 278/05 defines three types of asbestos removal operations, which require different levels of protection, isolation and decontamination. Type 1 operations involve the lowest level of risk and include the removal of non-friable materials where the material is not damaged, or can be wetted and cut without power tools. Type 3 operations involve the highest level of risk, including removal of most types of friable materials, and require full enclosure of the area and construction of a decontamination area for workers and equipment, among other things.

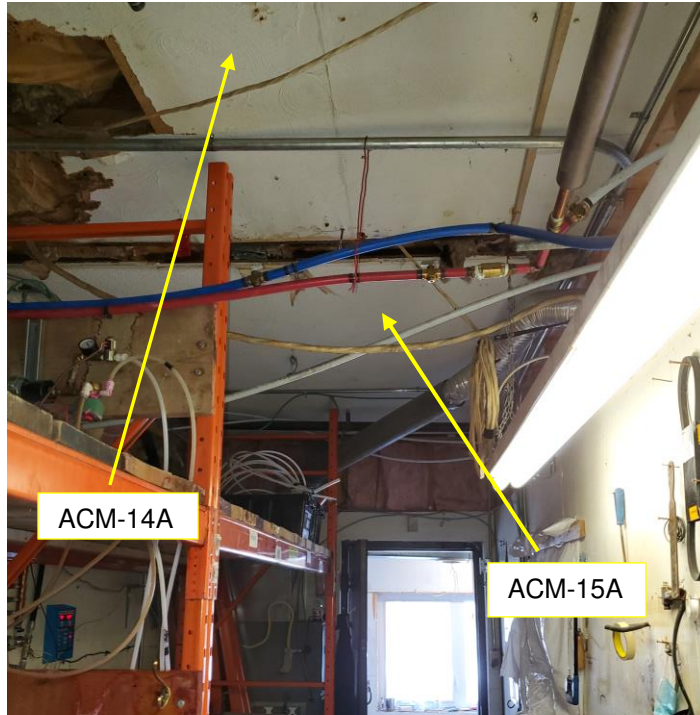
- Texture coating material on the ceiling of the carwash mechanical room the building, (sample ACM-14A, friable, 1% Chrysotile asbestos, approximately 4 m² in area, poor condition, and sample ACM-15A, friable, 2% Chrysotile asbestos, approximately 4 m² in area, poor condition); and,

A view of the texture coating of the ceiling in the mechanical room of the carwash (ACM-14A & ACM-15A).

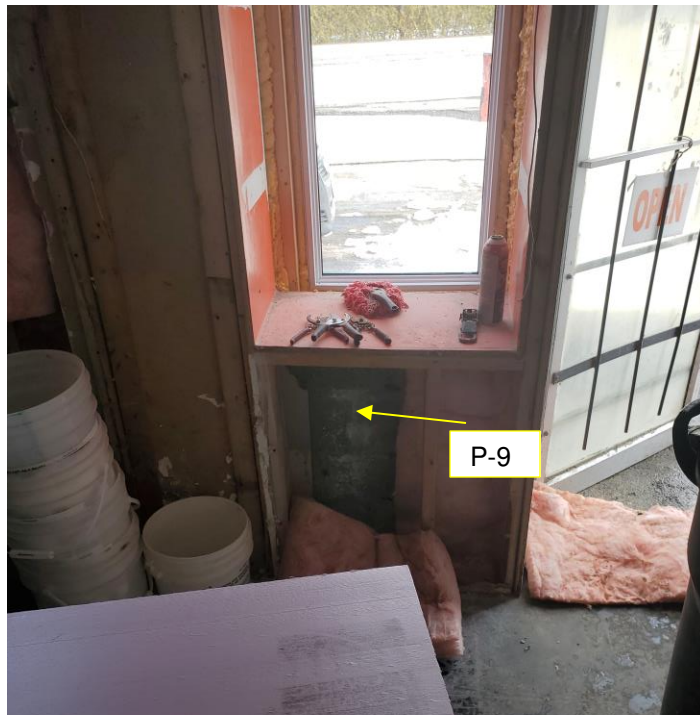
Photo No: 6

A view yellow-green paint (P-9) collected from the interior column of the first floor of the building.

Demolition and renovation contractors should ensure the use of appropriate personal protective equipment and proper dust control measures to protect themselves and the public from potential exposure by inhalation of silica dust or paint dust or chips.

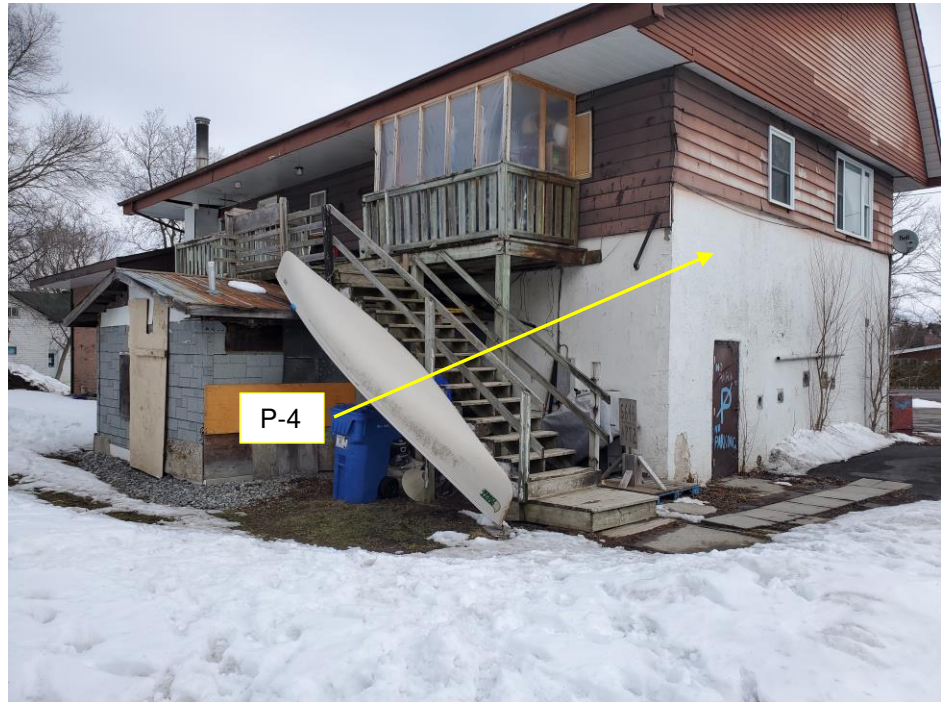
A view of exterior and side of the building. The white paint is where paint sample P-4 was collected.

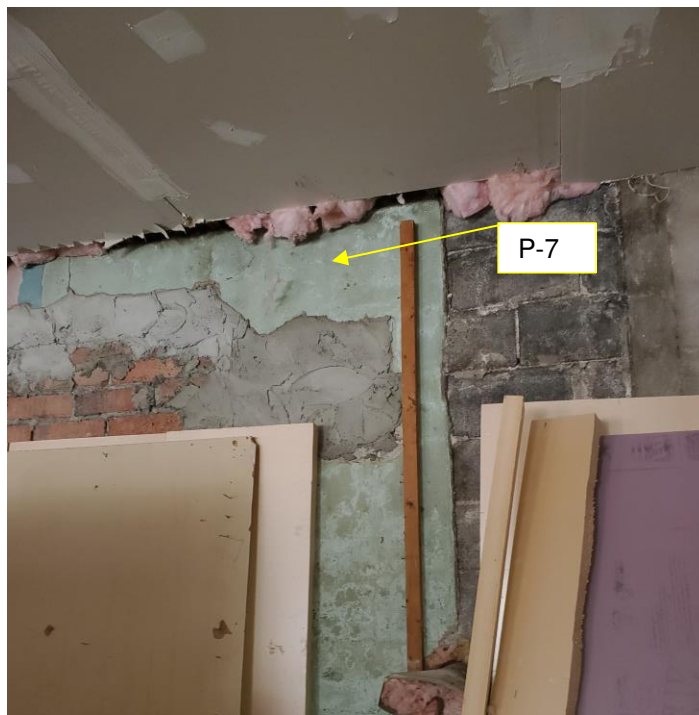
Photo No: 8

A view of the green paint (P-7) located in the first floor of the building.

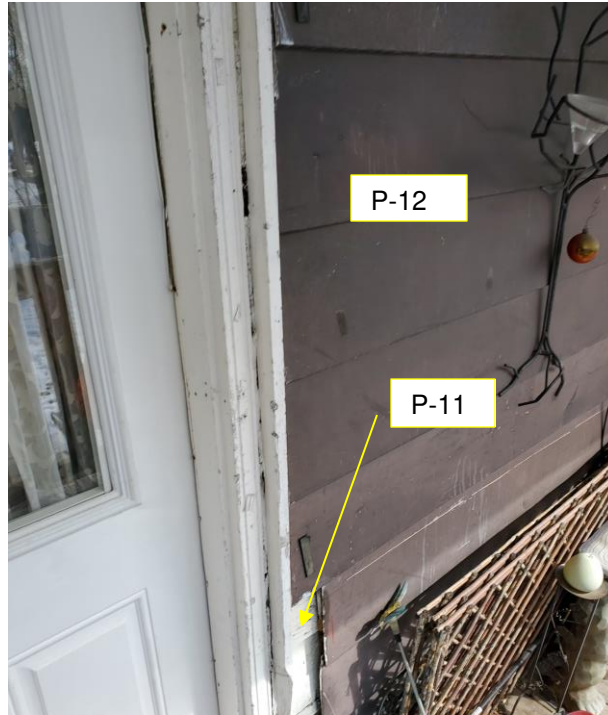
A view of white paint (P-11) and brown paint (P-12) collected from the exterior of the second story of the building.

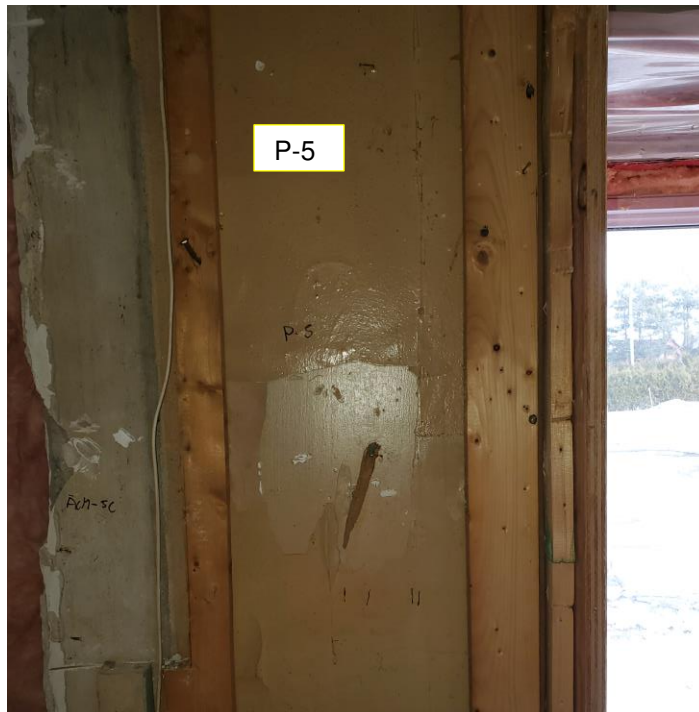
Photo No: 10

A view of beige-brown paint (P-5) collected from the interior of the building.

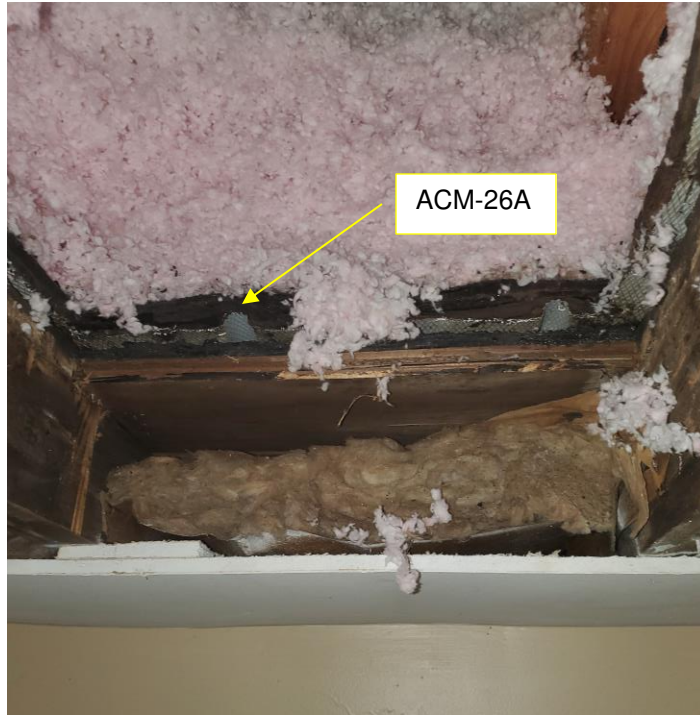
A view of insulation material in the attic of the main building.
