Tree Conservation Report

5646/5650 Manotick Main St.
Manotick, ON K4M 1B3

Prepared by:

May 4, 2023
Updated, Sept 21, 2023
Updated Dec 18, 2023
Updated Feb 21, 2024
Updated June 27, 2024

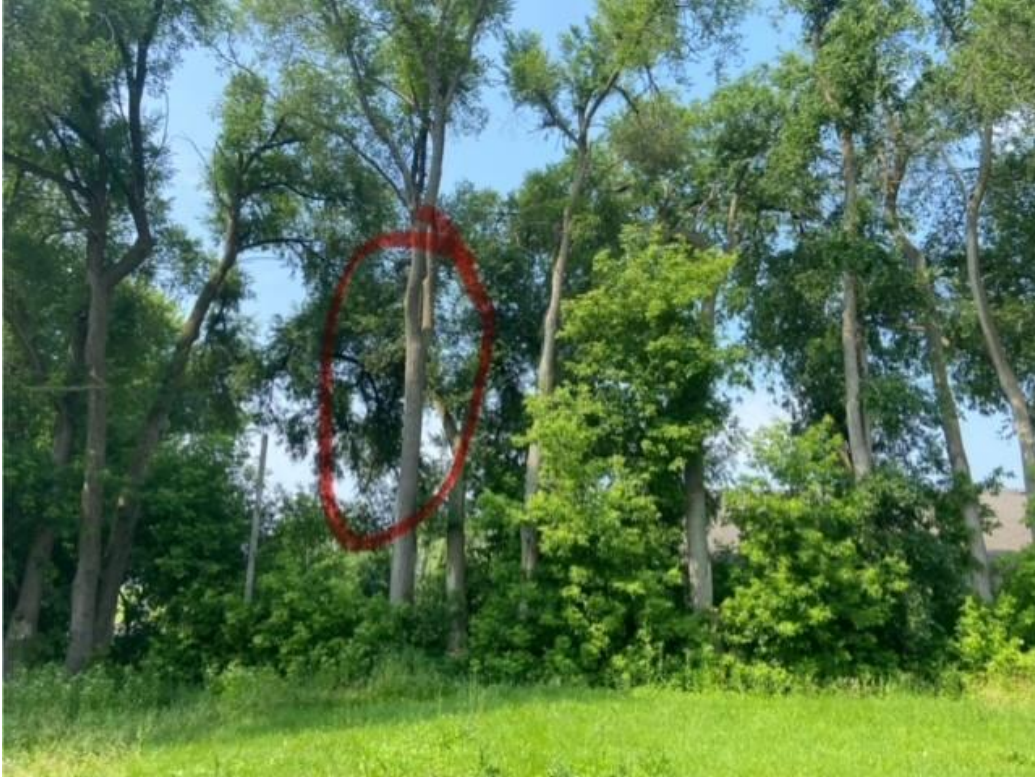
- All other trees on the property, including one elm from tree cluster 9 which is located to the north side of the standing clothesline pole DBH 69cm. See photos on page 5.

69cm DBH American Elm to be removed.

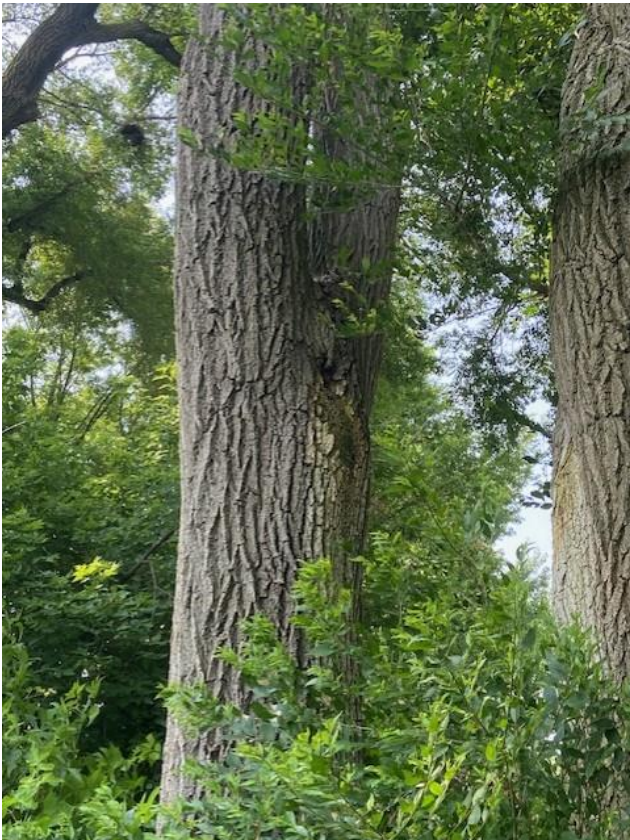
Area of rot at the main joining of two large stems on the 69cm DBH elm to be removed.
