Landslide Hazard Assessment

Proposed Multi-Storey Building

3030 Saint Joseph Boulevard
Ottawa, Ontario

Report PG6609 - 2 dated February 12, 2024

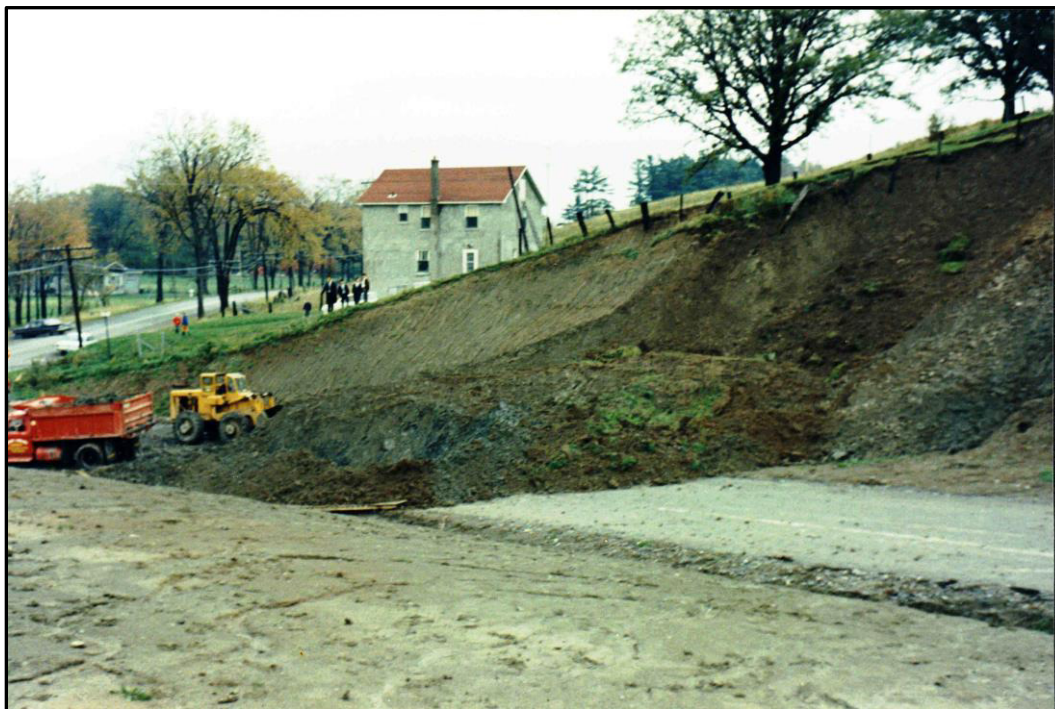
Section C was located within a former slope failure area. It is understood that a slope failure occurred along the east side of Duford Drive in the 1960s. Photographs of the slope failure were provided to Paterson for this response. Photographs 1 and 2 presented in Appendix 2 show a shallow slope failure across a limited section of overall slope face. Based on slope features noted in the photographs, such as lack of vegetation across the slope face and the soil surface in the area of Duford Drive, it appears that the slope failure occurred across a section of the slope, which had been recently re-shaped as part of the construction of Duford Drive.

The natural grade of the slope face was drastically changed during the construction of Duford Drive. It is expected that the slope failure can be directly contributed to the steepness of excavated slope face along with exposure to precipitation events before a vegetative layer could establish. It should be further noted that a vegetative layer across a slope face promotes surficial run-off during precipitation events and limits infiltration of rainwater into the slope soil. Infiltration of water from precipitation events into a slope reduces overall slope stability.

Photo 1: Localized slope failure occurring in the mid 1960s adjacent to Duford Drive. Subject site is located within the foreground of the photograph. St. Joseph Boulevard is in the background. Ground surface adjacent to Duford Drive is noted to be free of vegetation, which is indicative that construction of the subject roadway section and cutting of the subject slope was recently completed. It is suspected that the exposed slope was re-shaped to an unstable slope angle as part of the construction work at that time.

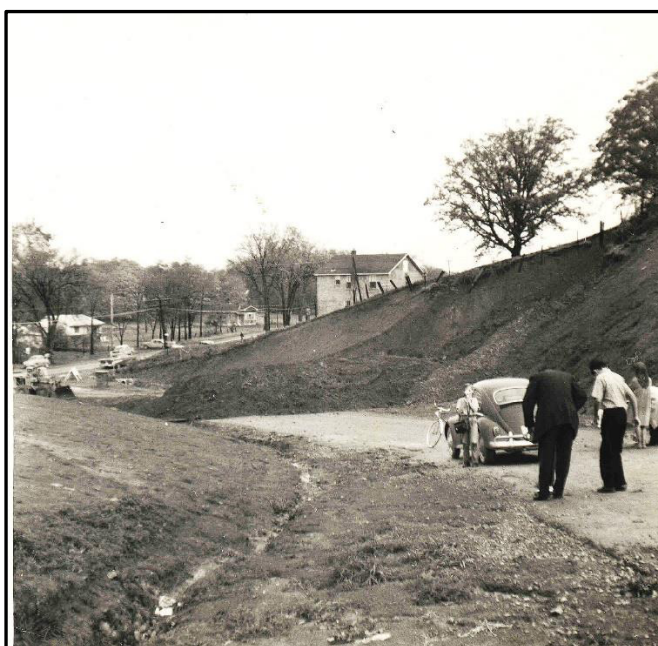
Photo 2: Same localized slope failure, which occurred in mid 1960s.

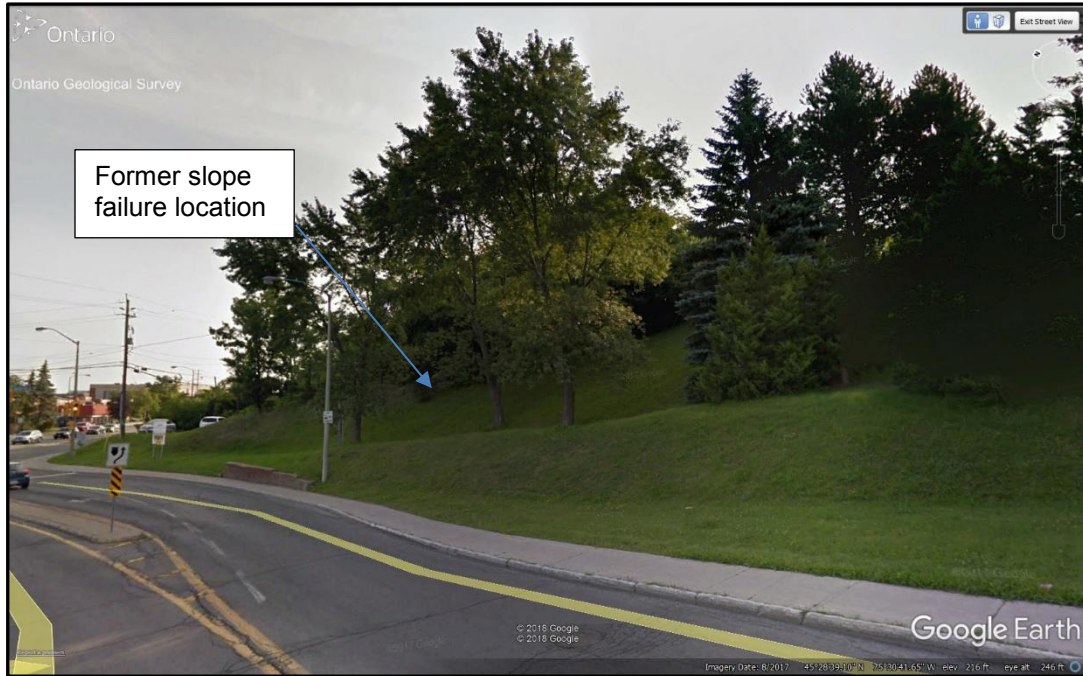
The current slope face was noted to include a terraced area along the base of the slope face in the area of the former slope failure (see Photos 3, 4 and 5 in Appendix 2). It is suspected that the terraced area was introduced after the initial slope failure to stabilize the reinstated slope. Currently, the slope face was noted to be grass covered with mature trees. No signs of slope instability were noted.

Photo 3: Street view image from Google Earth of former slope failure area (presented in Photos 1 and 2) adjacent to Duford Drive. Ground noted to be re-shaped with a terraced slope in front of reinstated slope.

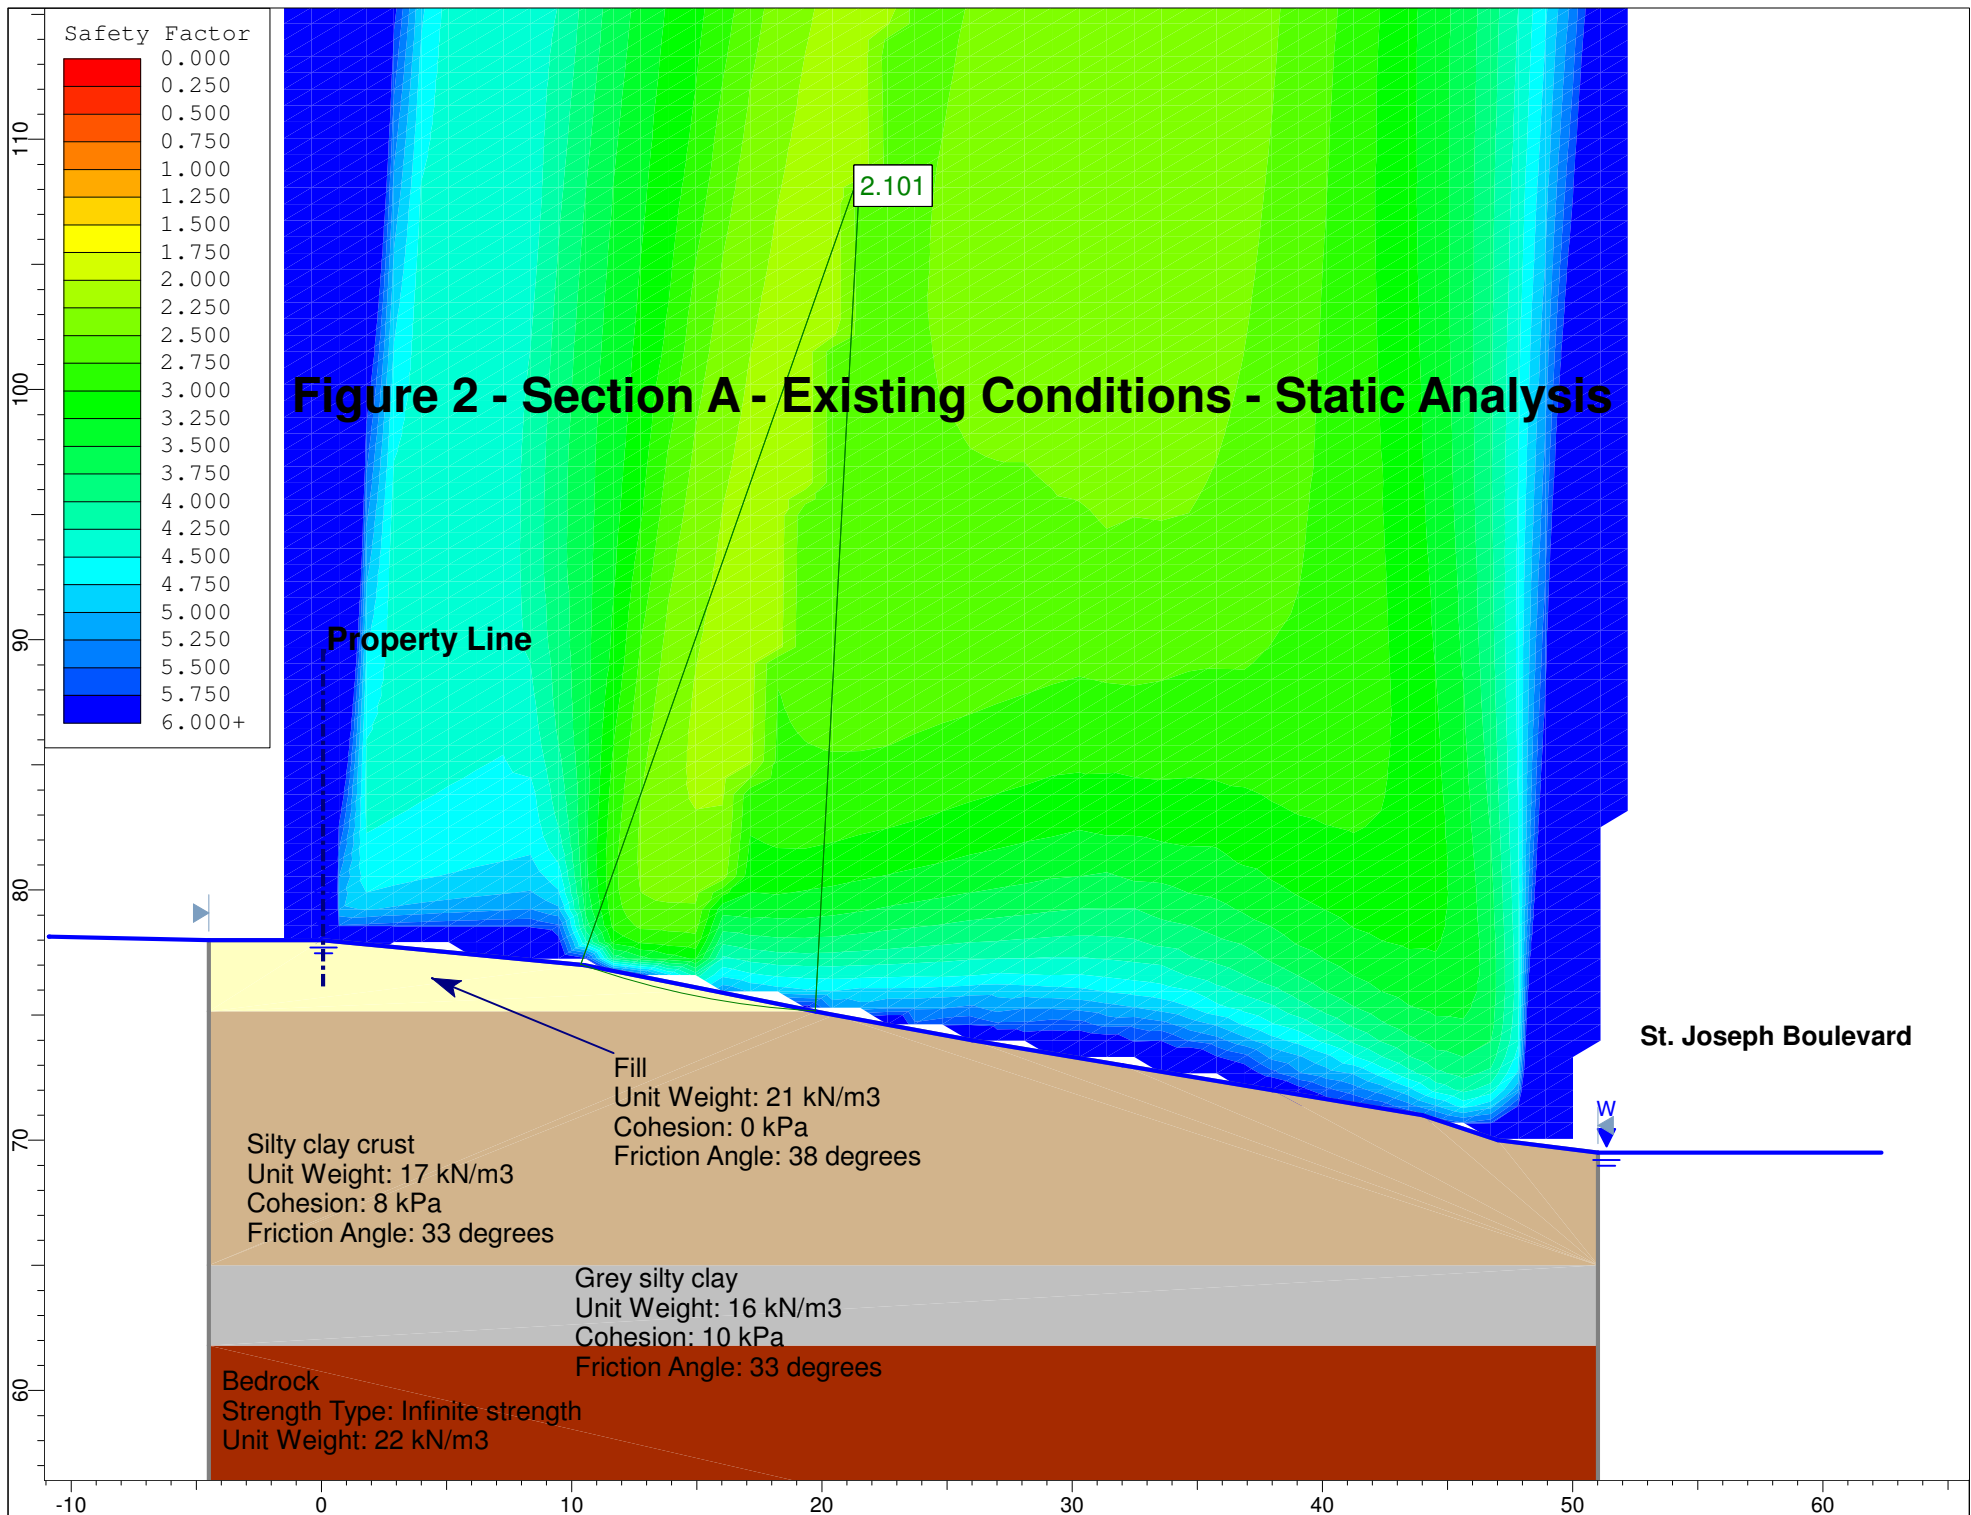
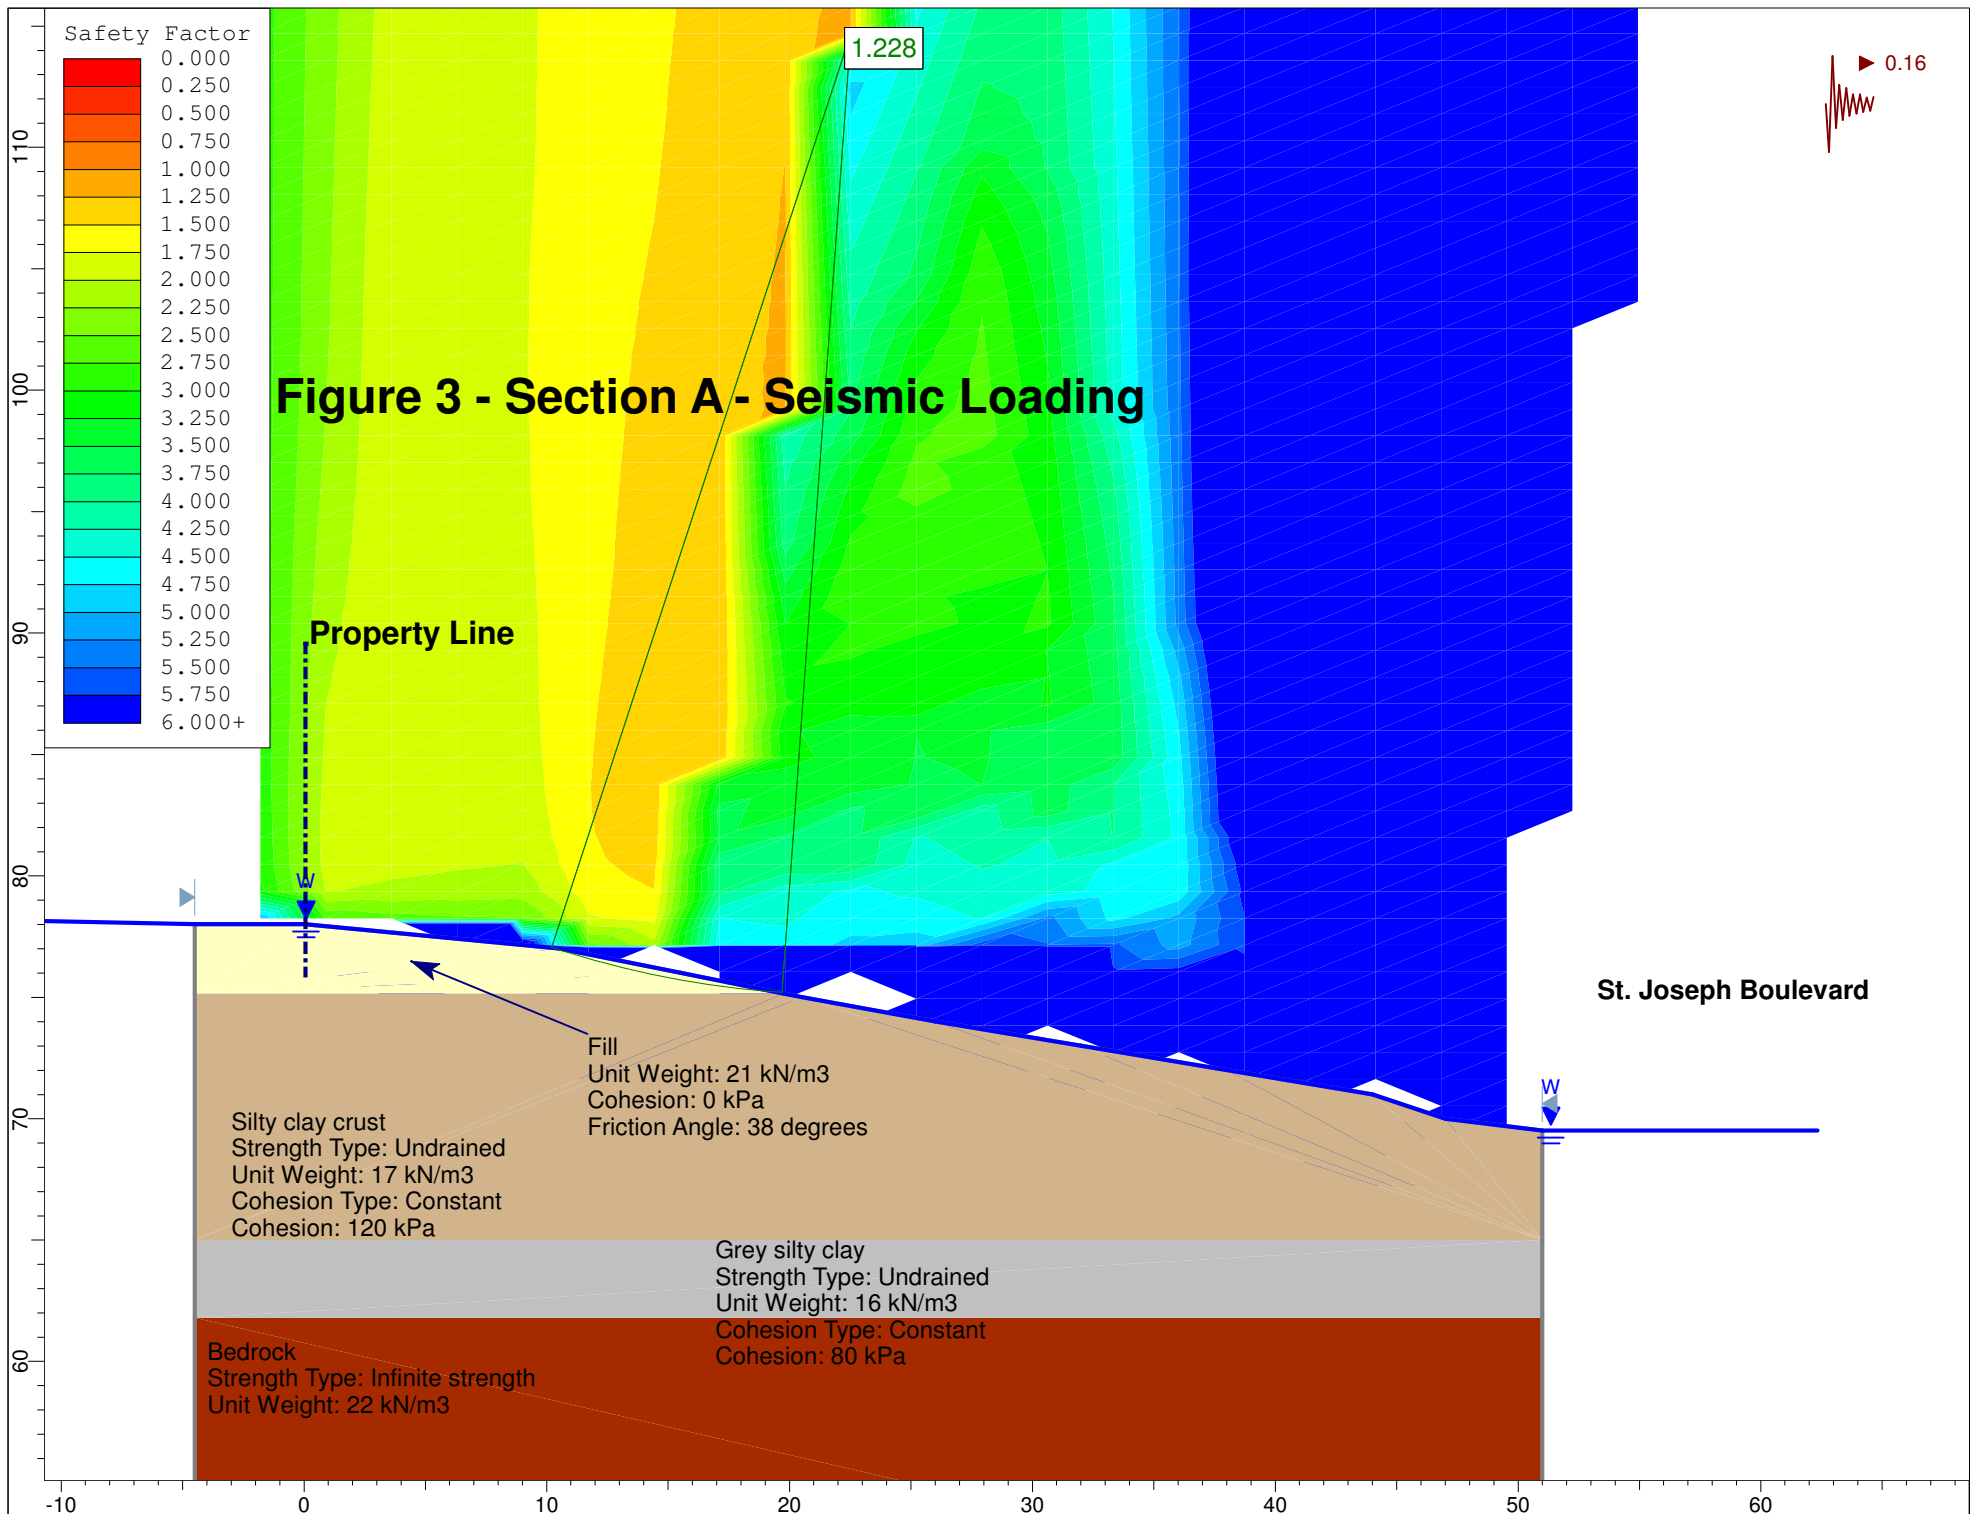
The results for the existing slope conditions at Section A and Section B are shown in Figure 2 and Figure 4 in Appendix 2. The factor of safety was found to be greater than 1.5 for Section A and B when analyzed under static conditions. It should be noted that a slope stability analysis was completed for Section A due to the steepness of the slope observed, which was considered to be a worst-case scenario for the subject site. Section B was analyzed to include the adjacent slope opposite of Duford Drive. Section C was analyzed considering the upper 2 m of the slope face to be fully saturated and the remainder of the slope is saturated below the long-term groundwater table at the former slope failure location. A global slope stability factor of safety of greater than 1.5 was determined for Section C based on our analysis.
