TREE CONSERVATION REPORT ADDENDUM

98-100 Bearbrook Road

Tree Conservation Report Addendum submitted as
Partial Requirements for a Site Plan Control
Application, June 12, 2023

Dendron Forestry Services

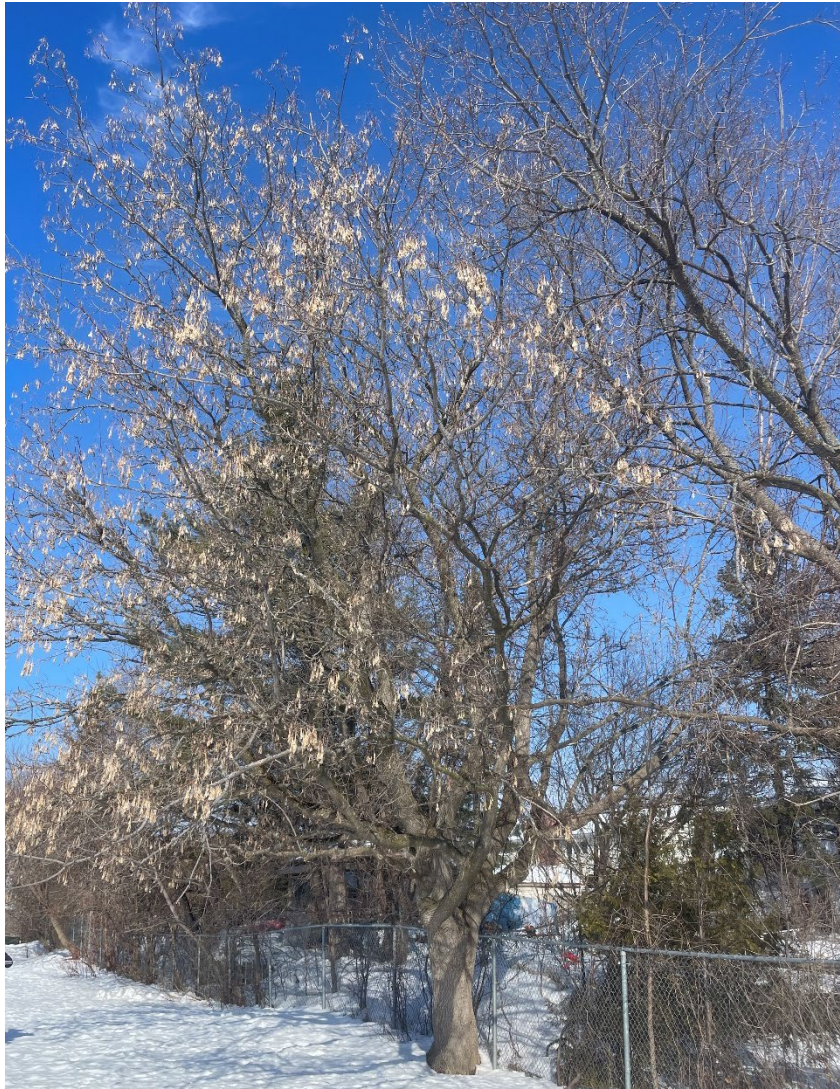
Tree 37 is set back from the property line approximately 130cm. This is 2x the tree's combined diameter¹ and therefore within the range of best practices. To ensure best outcomes for this tree and safety on site, a certified arborist is to be engaged to uncover the roots with an air spade and sever them by hand prior to excavation. This will promote faster sealing of the root wounds post construction and the arborist is able to assess the tree's stability at that time based on size and positioning of roots cut. A similar process is to be followed for **Tree 1**. This tree is close to the line of excavation but will suffer less root loss due to being positioned at the corner of the lot.

Figure 1: Manitoba maple to be retained

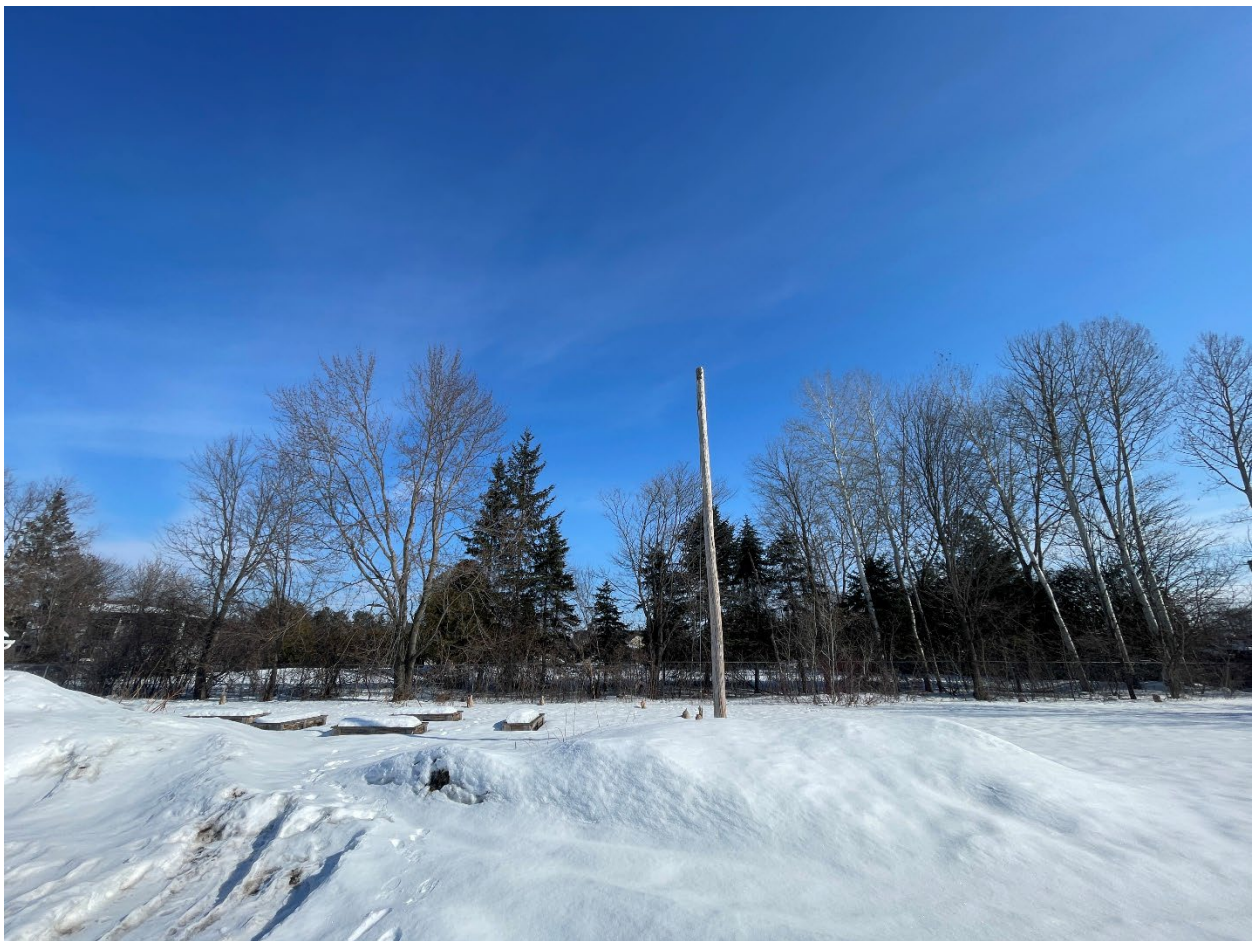
Overall, the health of the trees is fair to good; they are open-grown trees with ample rooting space. The trees show no obvious signs of decline; some have broken branches and some have small cavities, but overall, without external impacts, these trees would likely survive for many years.

Because excavation is proposed right to the property line, **Trees 23, 28, 33** and **38** will suffer significant root loss. As well as impacting the potential long-term health of these trees, excavation will come directly to the base of the trees, possibly impacting their structural integrity. Due to these reasons, it is recommended these trees be removed.

Figure 2: Maple trees along the rear of the adjacent school property at 2599 Innes

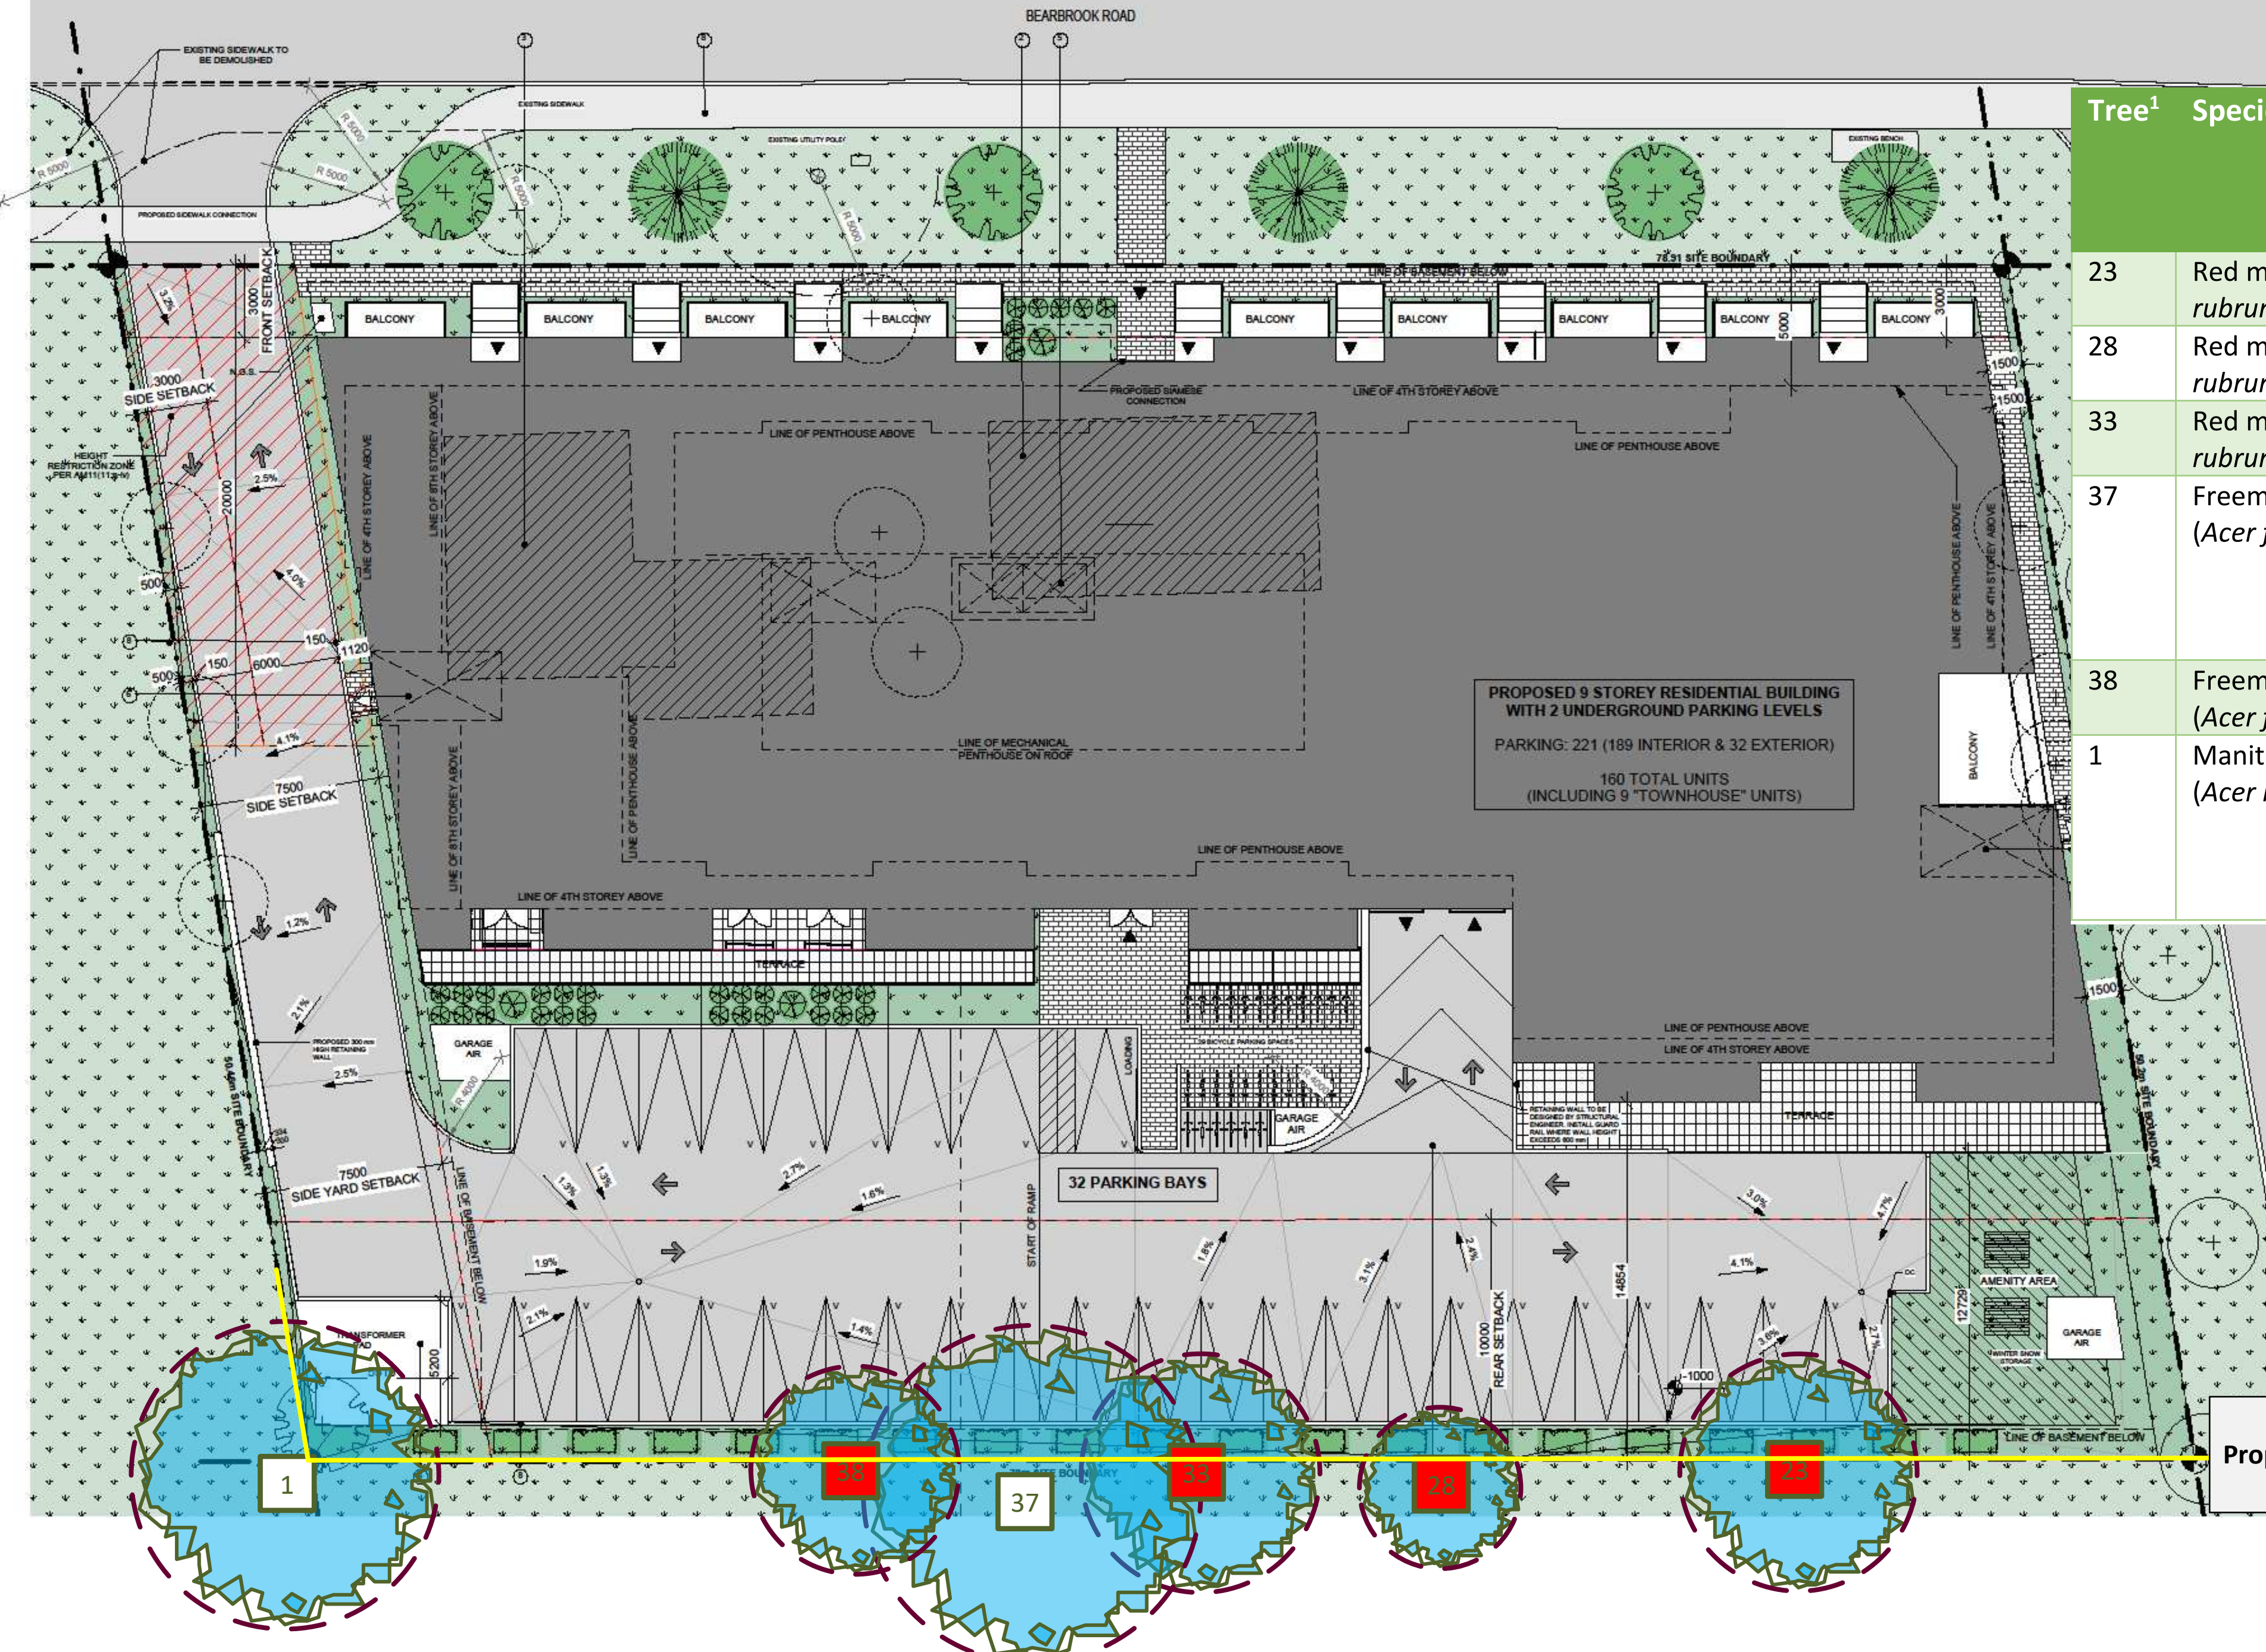
Tree ¹	Species	Diameter at breast height (dbh)	Condition	Action
23	Red maple (<i>Acer rubrum</i>)	37, 28	Fair/Good	Remove
28	Red maple (<i>Acer rubrum</i>)	31	Fair	Remove
33	Red maple (<i>Acer rubrum</i>)	46	Good	Remove
37	Freeman maple (<i>Acer freemanii</i>)	49, 43	Fair/Good	Certified arborist to uncover roots with air spade and sever roots by hand. Arborist to make determination about stability at that time.
38	Freeman maple (<i>Acer freemanii</i>)	40	Good	Remove
1	Manitoba maple (<i>Acer negundo</i>)	59	Fair	Certified arborist to uncover roots with air spade and sever roots by hand. Arborist to make determination about stability at that time.
