# TREE CONSERVATION REPORT

1058-1066 Silver Street  
and 1291-1305 Summerville Avenue

Tree Conservation Report submitted as Partial  
Requirements for a Site Plan Control Application.

**Dendron Forestry Services**

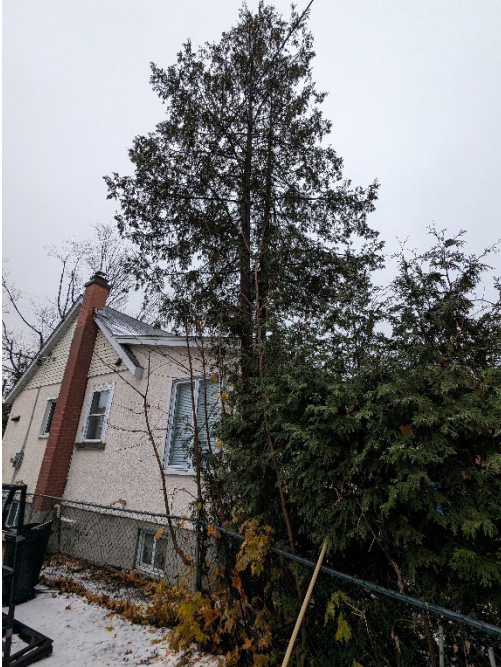
| Tree <sup>1</sup> | Species | DBH (cm) | Ownership <sup>2</sup> | Tree Condition | Action | Forester recommendation |
|---|---|---|---|---|---|---|
| 3 | Norway maple ( <i>Acer platanoides</i> ) | 47 | Private - 1062 | Fair/Poor: large branch attachment wound; asymmetrical crown | N/A | This tree has been removed. |
| 4 | Norway maple ( <i>Acer platanoides</i> ) | 43 | Private – 1062 | Fair: asymmetrical crown; lean to S (approx. 10°) | N/A | This tree has been removed. |
| 5 | Norway maple ( <i>Acer platanoides</i> ) | 18 | Private – 1062 | Poor: suppressed | N/A | This tree has been removed. |

Above right: Canopies of Trees 3-5 - private maples to be removed.

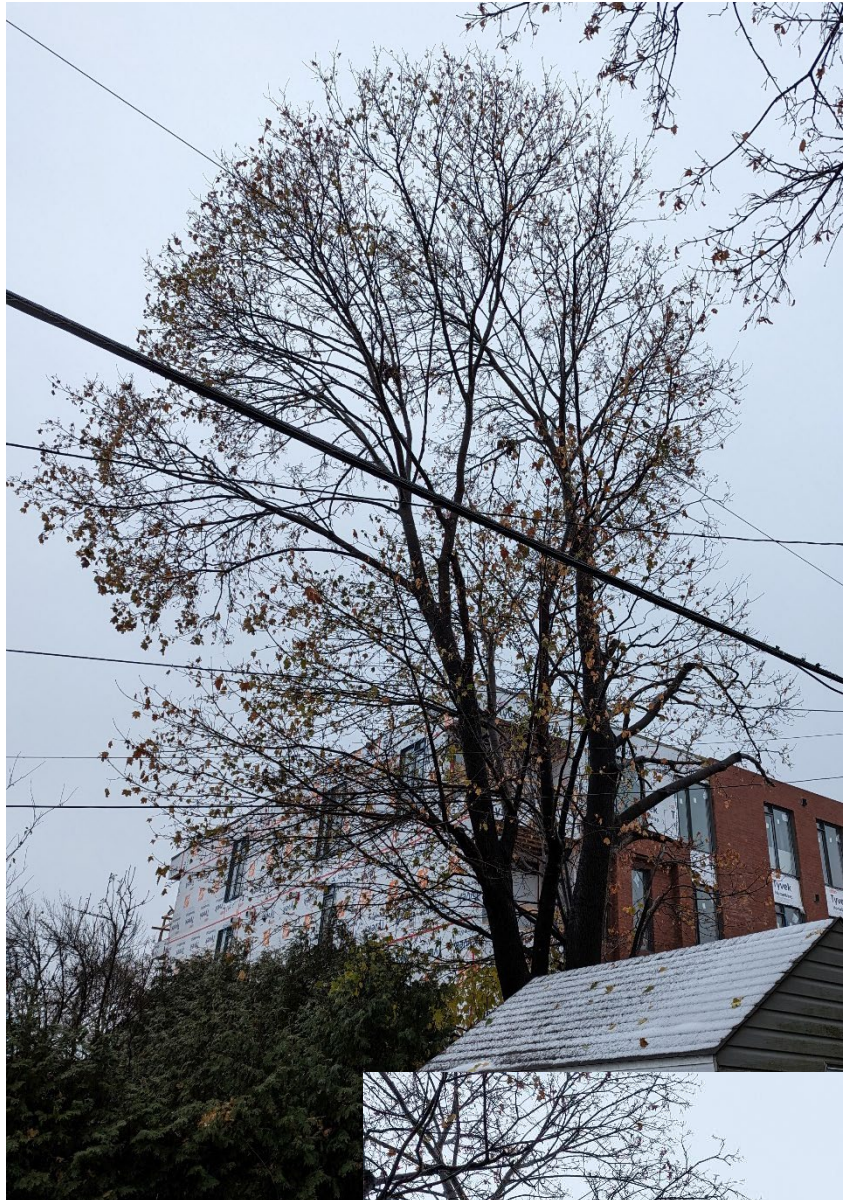
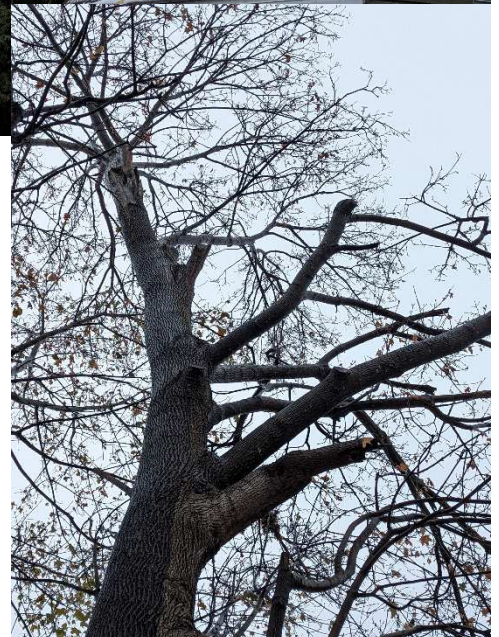
Below right: trunk and pruned branches of Tree 4

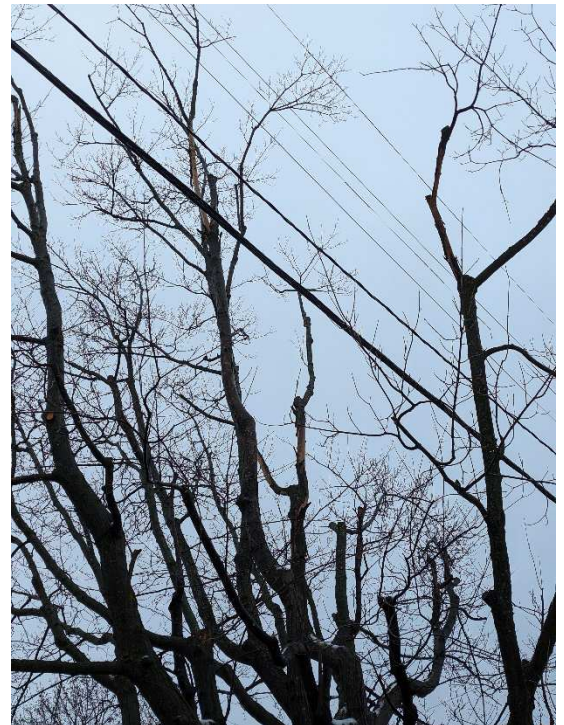
| Tree <sup>1</sup> | Species | DBH (cm) | Ownership <sup>2</sup> | Tree Condition | Action | Forester recommendation |
|---|---|---|---|---|---|---|
| 8 | Sugar maple ( <i>Acer saccharum</i> ) | 59 | City | Fair: pruned around wires; two leaders are dead | Remove | Remove due to grade changes and impacts from construction. |

**Right: Canopy of Tree 8 pruned  
around wires with some dead central  
branches.**

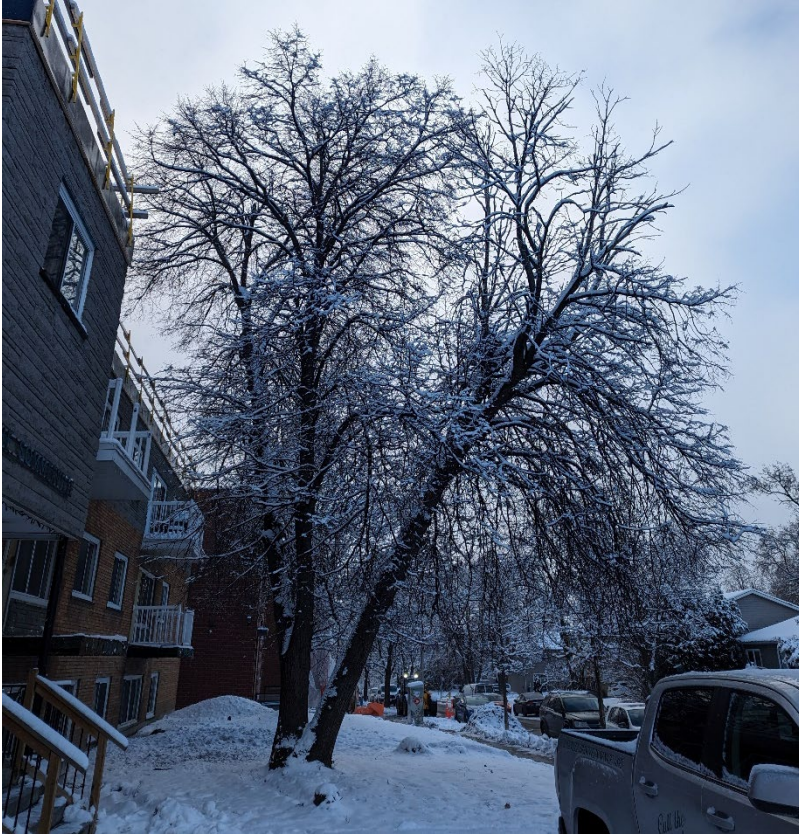
| 20 <sup>4</sup> | Norway maple ( <i>Acer platanoides</i> ) | 64 | Private – 1305 Summerville | Fair/Poor: large seams on two sides of trunk; decay in small wounds | Retain | Retain and protect as per the City of Ottawa Tree Protection Specifications (March 2021) |

Above: Tree 20 - Private linden to be retained. Recommend removing the leaning stem.

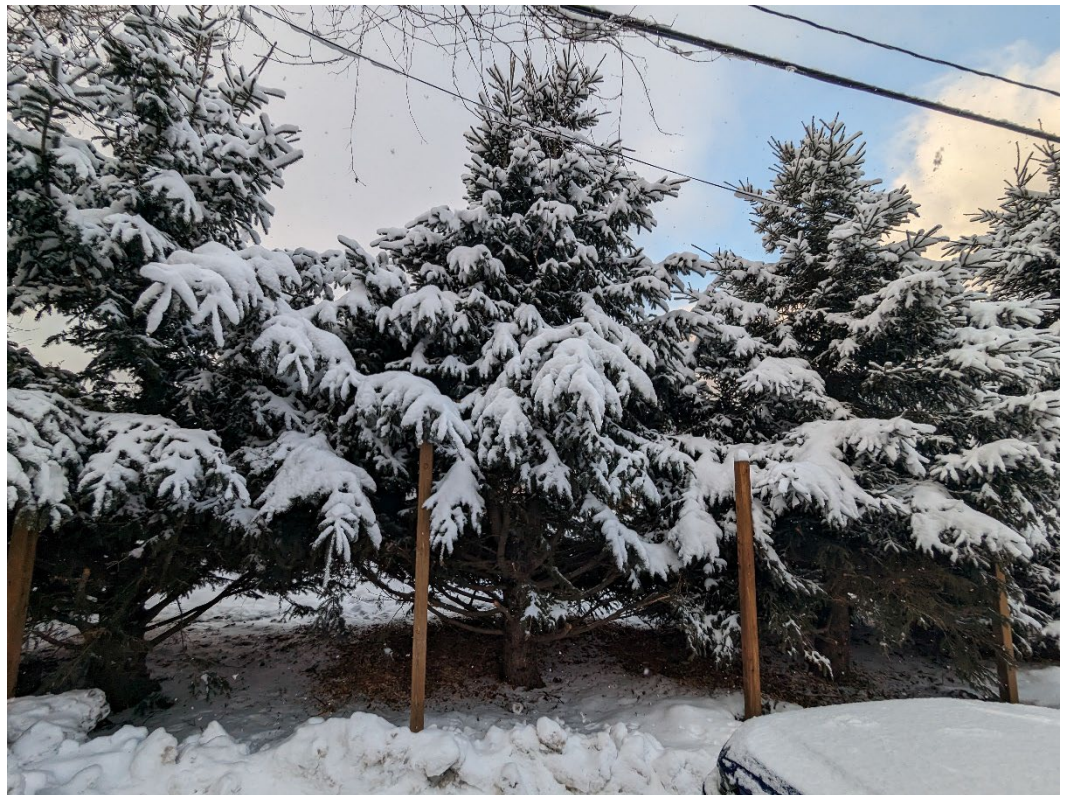
| 26 <sup>4</sup> | White spruce ( <i>Picea glauca</i> ) | 4 stems ~15cm | Adjacent – 1316 Dorchester | Good/Fair: pruned under wires – some with poor form | Retain | Retain. Care to be taken not to tear roots during replacement of parking surface. Any roots encountered are to be cleanly severed by hand. |

Right: Tree 26 – group of adjacent spruce to be retained.

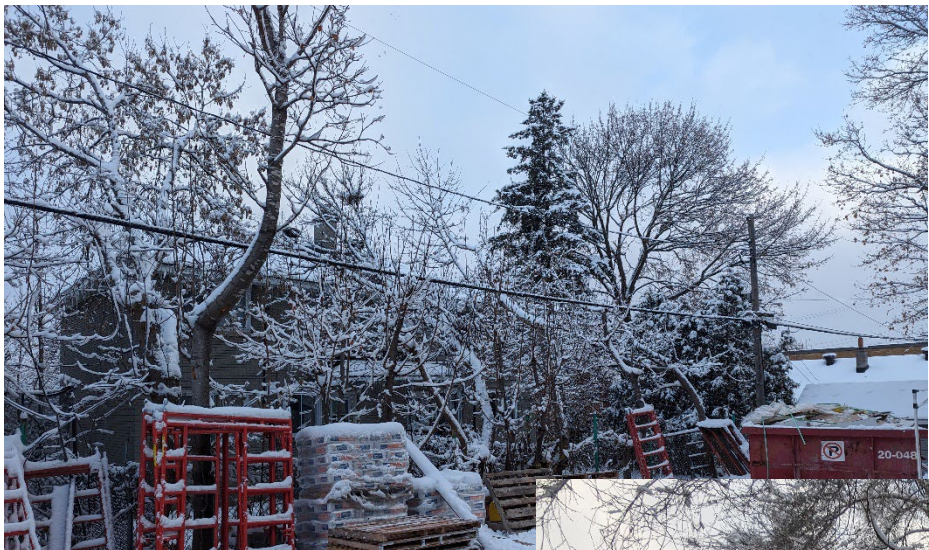
| 21 <sup>4</sup> | Manitoba maple ( <i>Acer negundo</i> ) | 21 stems 10-35cm | Boundary | All stems poor: heavily pruned under hydro wires – most branching is epicormic shoots; many with significant leans | N/A | These stems have been removed. |

Clockwise from upper left: Tree group 21 – heavily pruned Manitoba maples to be removed (crowns of Tree 1 and 2 in background).

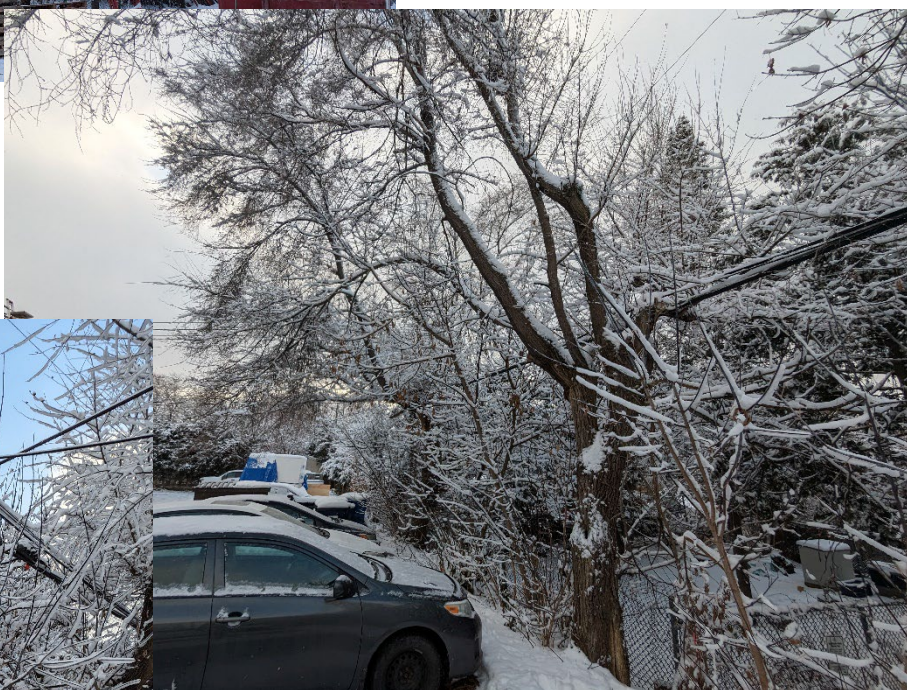
| 22 <sup>4</sup> | Siberian elm ( <i>Ulmus pumila</i> ) | 43 | Boundary | Poor: poor form; cavity in main bole; decay in wounds; broken branches; pruned around wires | N/A | This tree has been removed. |

Tree 22 – Boundary Siberian elm to be removed.

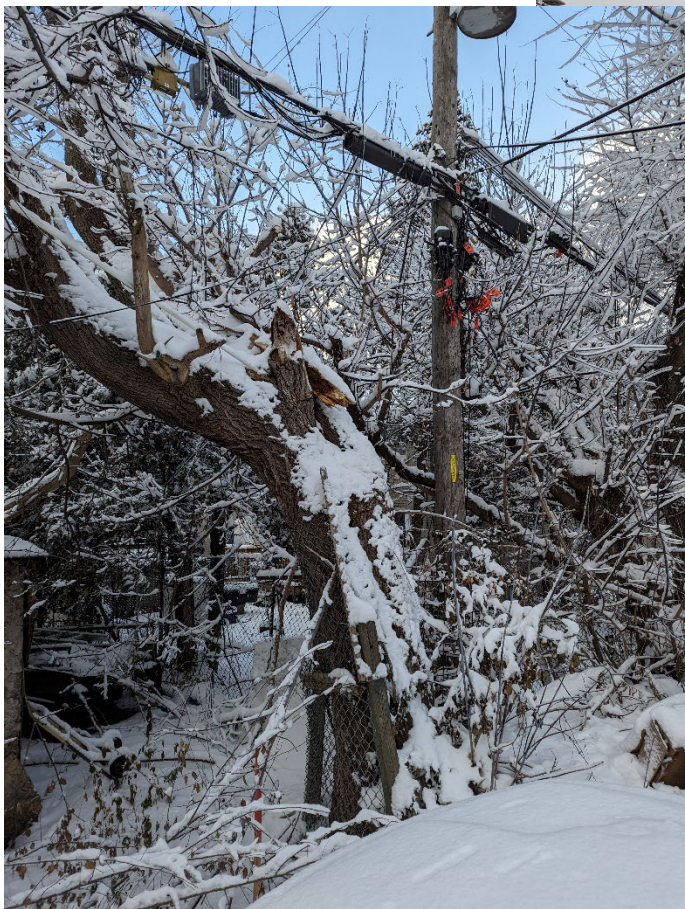
| 25 <sup>4</sup> | Siberian elm ( <i>Ulmus pumila</i> ) | 55 (estimate) | Boundary | Poor: heavy lean towards Dorchester; dead branches; poor form; growing on fence | N/A | This tree has been removed. |

Tree 25 – Boundary Siberian elm to be removed.

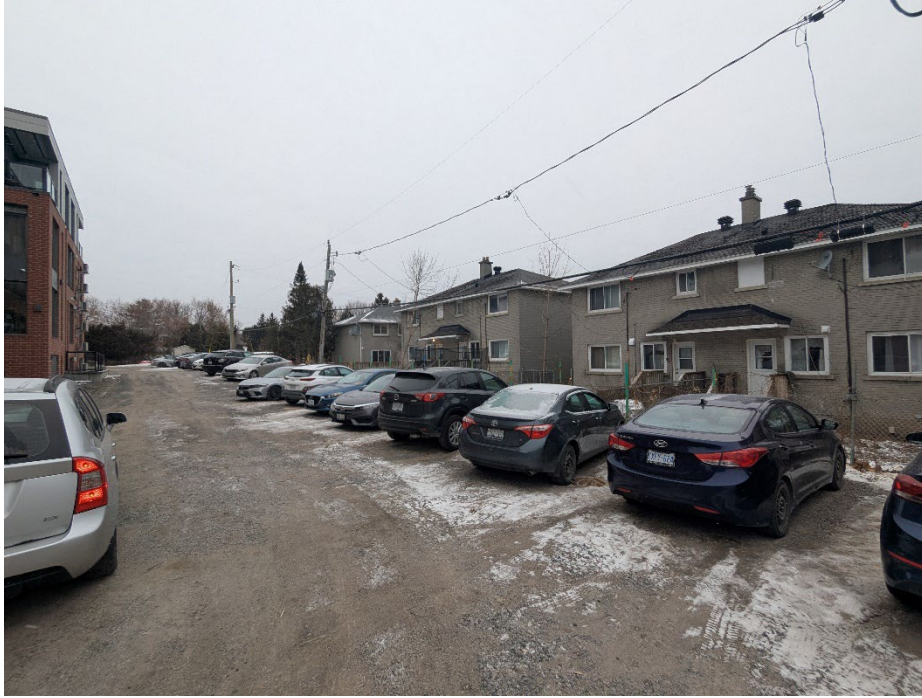
Prior to the final site visit, all of the boundary trees abutting the parking area behind the Summerville properties had been removed by Hydro. **Trees 3-5 and 21-25 have been removed.**

Above: Rear parking area behind the Summerville properties – all trees removed (photo December 23, 2024).

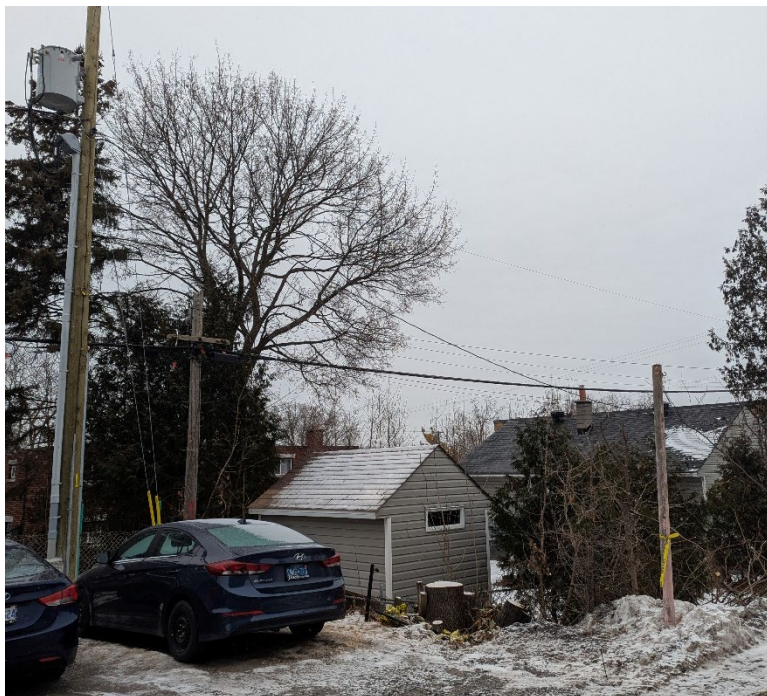
Below: stumps of Trees 3-5 (photo December 23, 2024)
