TREE CONSERVATION REPORT

1058-1066 Silver Street
and 1291-1305 Summerville Avenue

December 23, 2024

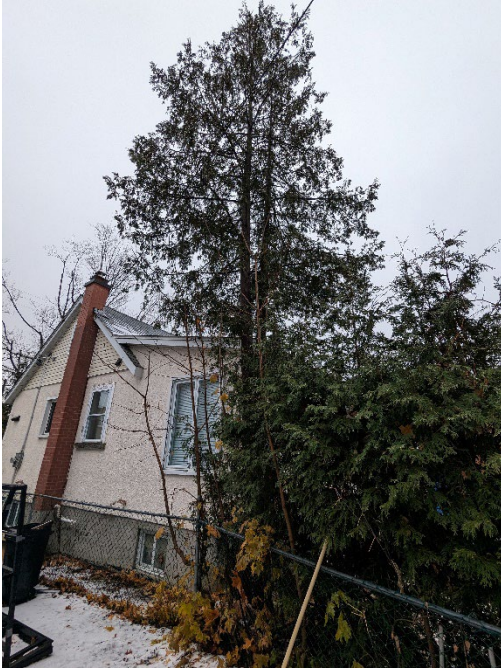
Above: Tree 6 - private cedar to be removed.

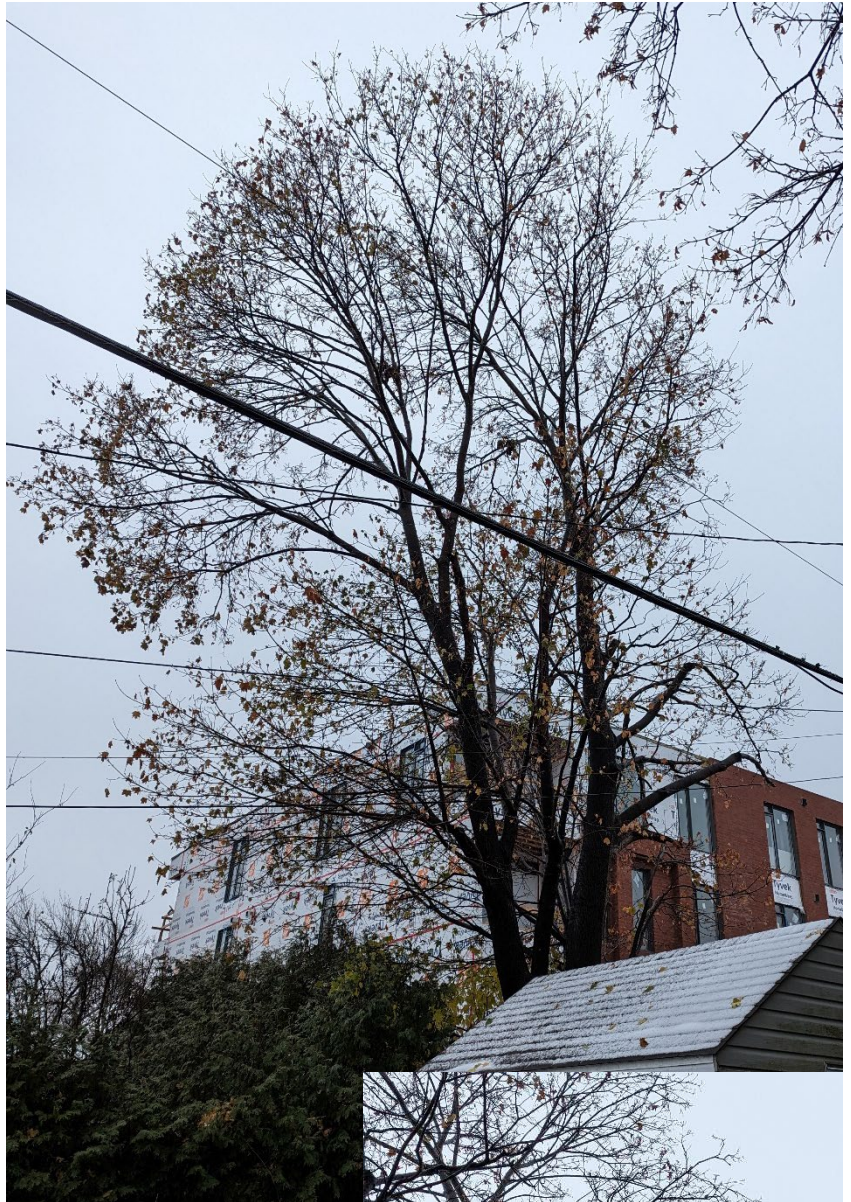
Above right: Canopies of Trees 3-5 - private maples to be removed.

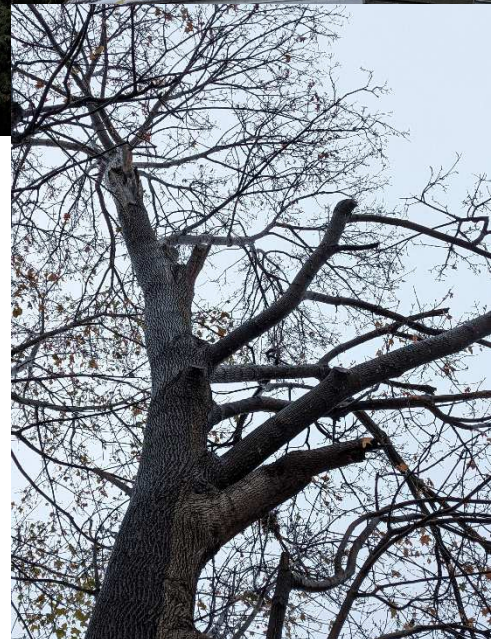
Below right: trunk and pruned branches of Tree 4

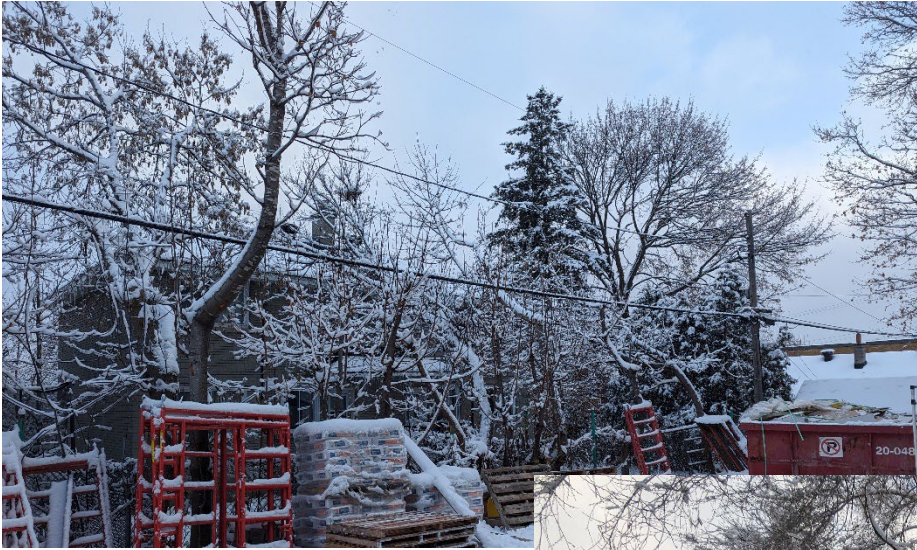
Clockwise from upper left: Tree group 21 – heavily pruned Manitoba maples to be removed (crowns of Tree 1 and 2 in background).

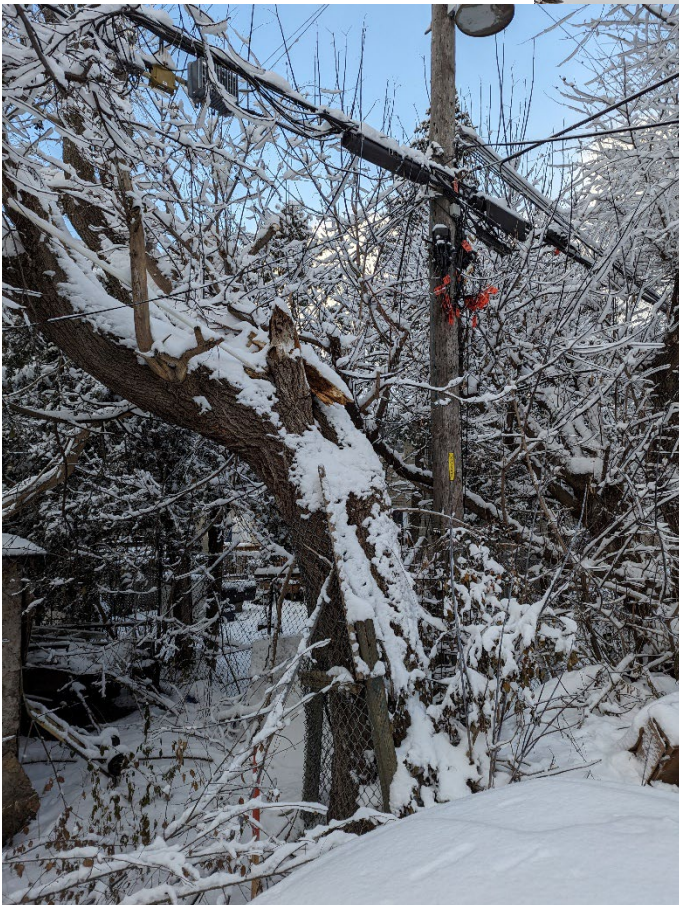
Tree 25 – Boundary Siberian elm to be removed.
