September 25, 2025 File: PE6214-LET.05

Subject: Phase I - Environmental Site Assessment Update

2506 Innes Road Ottawa, Ontario **Consulting Engineers**

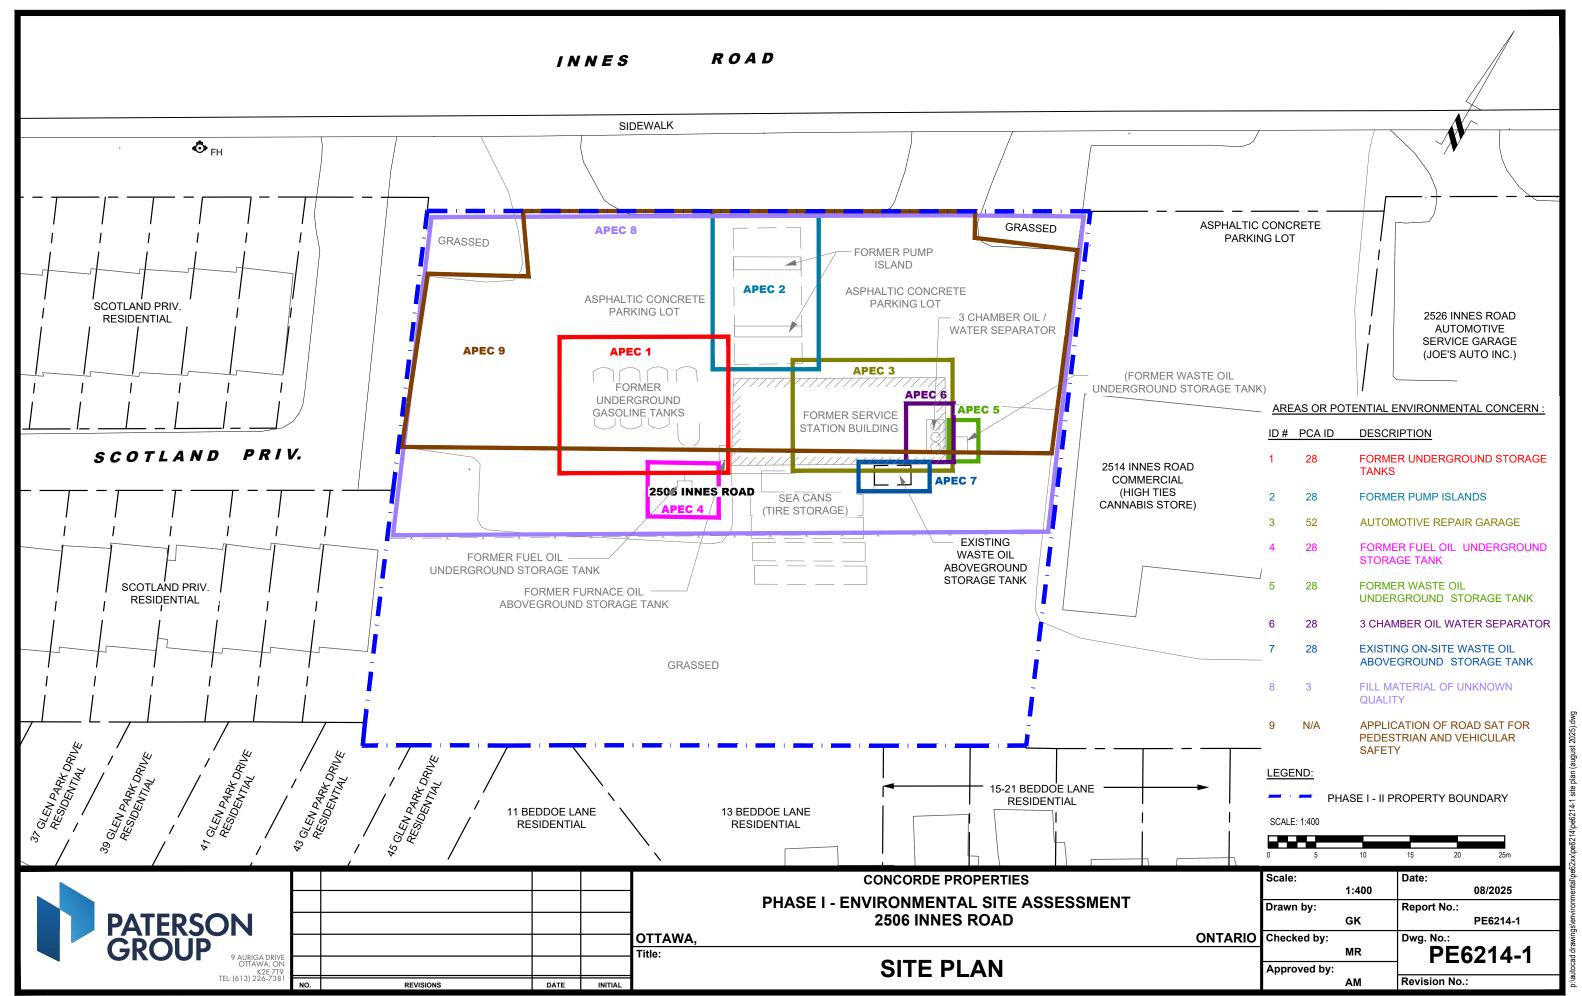
The Phase I Property is vacant and the majority of the northern portion of the property fronting Innes Road is asphalt paved concrete, with some landscaped areas on the northwest and northeast corners of the property. The southern portion of the site is landscaped as well with a treeline along the southern property boundary.

Site drainage consists of sheet flow on the asphalt paved concrete to catch basins located at the access laneways on each side of the property, and infiltration on the landscaped areas. The site topography is slightly above the grade of Innes Road, and slopes down gently towards the north in the direction of the Ottawa River.

No tanks, areas of stained pavement or stressed vegetation were observed on-site at the time of the site visit.

The Phase I Property is situated in a municipally serviced area. Underground utilities and/or structures include natural gas, municipal water, sanitary and stormwater sewers. A catch basin was noted on both the entrance and exit laneways. These will eventually be disconnected in preparation for remediation and/or redevelopment work.
