TREE CONSERVATION REPORT

2506 Innes Road

Dendron Forestry Services

May 2, 2024

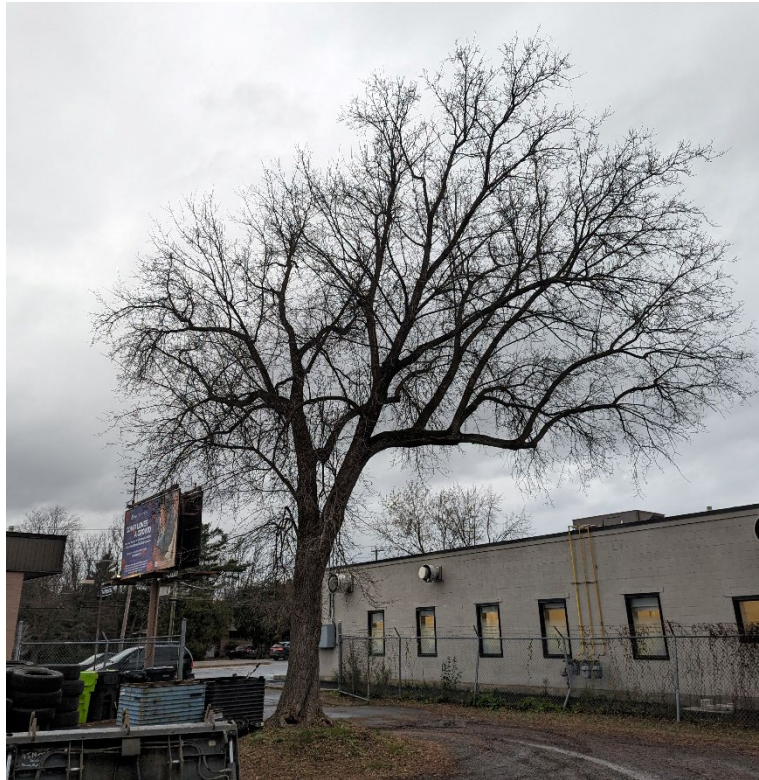
Above: Tree 1 - private manitoba maple to be removed.

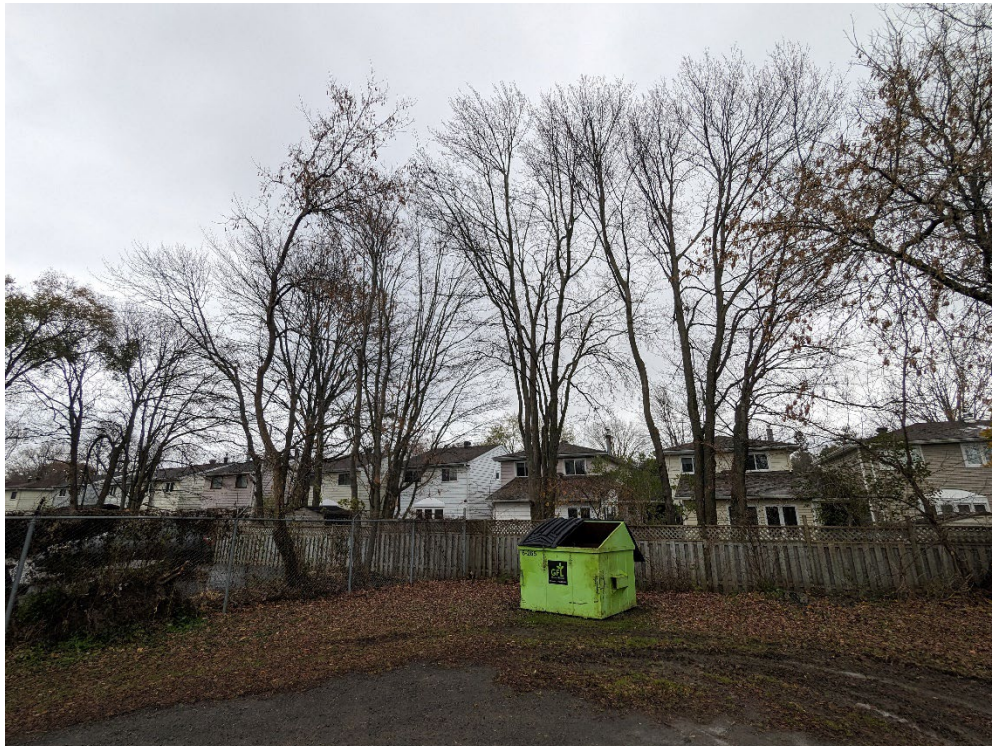
Trees 4-6 are adjacent maples of varying health and distance from the property line. Due to excavation for the proposed retaining wall and the 75cm grade change, some of these trees are expected to decline quickly and are therefore recommended for removal. However there may be a possibility to retain some stems from the groupings. To accomplish this, the following steps are recommended: that the proposed retaining wall be marked out along the ground, the DBH of each trunk be measured (they were estimated during the site visit) as well as the distance between each trunk and the line for the retaining wall; those that are further than 3x their diameter from the wall can be marked for retention. Then, when it comes time for excavation, the roots can be revealed along the line of excavation and a certified arborist can be on site to ensure that roots are properly severed and no stability concerns remain.

Below: East corner of the property, including Trees 2-6

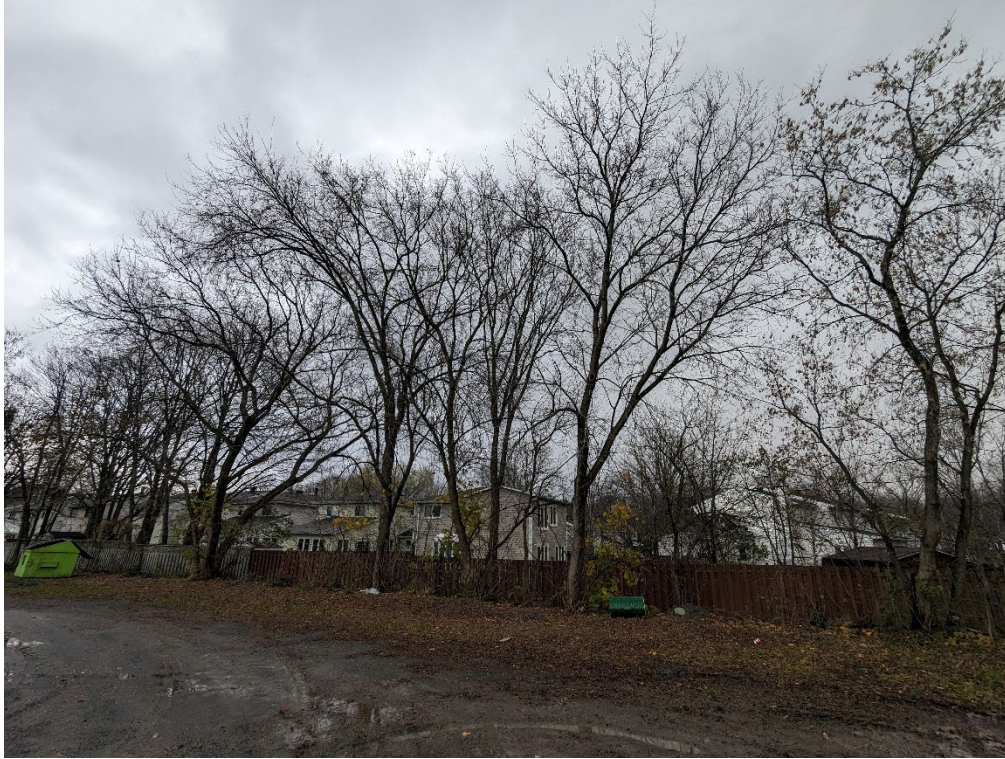
Above: Trees 4-21 along the south property line.

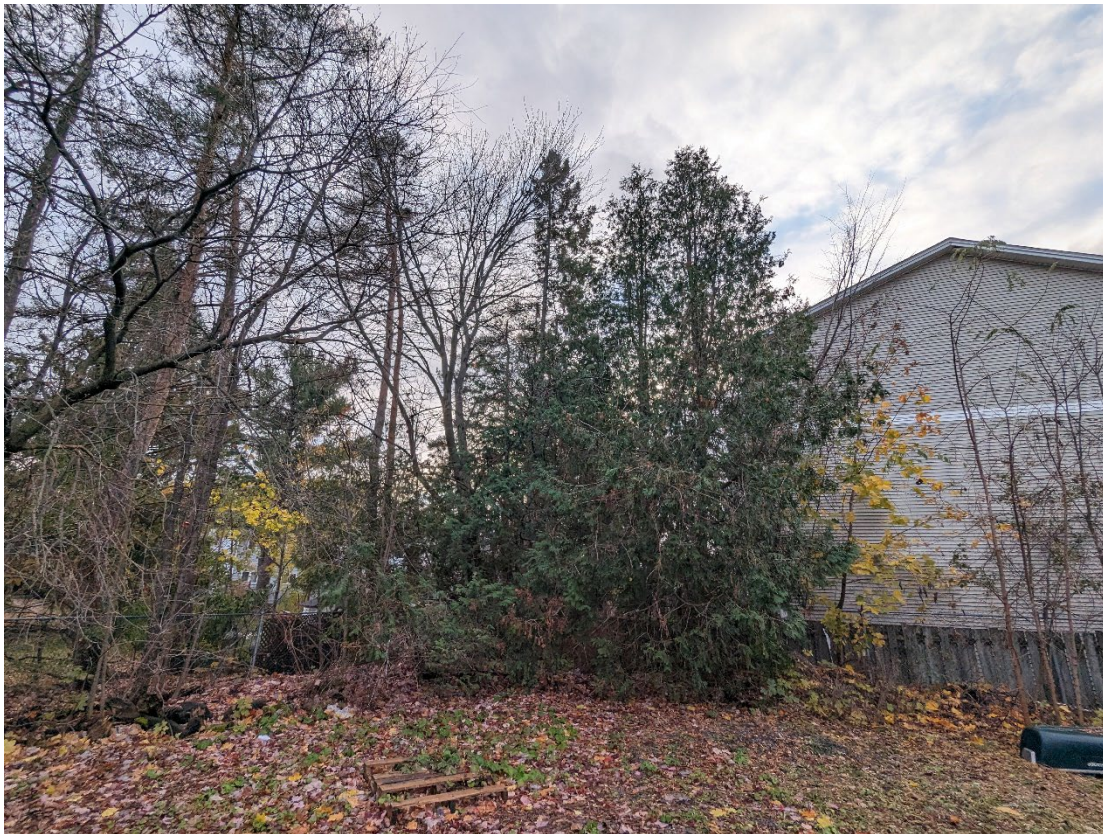
The southwest corner (**Trees 25-32**) has a high percent canopy cover due to large trees on the adjacent properties. These trees are at a lower grade from most of the subject property (approximately 10-30cm). Fencing should be erected at the edge of the proposed retaining wall, and any roots that are encountered during excavation are to be cleanly severed by hand to promote faster sealing after construction. **Tree 25** is a young Manitoba maple approximately 80cm from the proposed retaining wall. This is 4.9x its DBH, which is within best management practices for maintaining stability. What is more, Manitoba maples are known to be able to withstand construction. This tree is recommended for retention, as it could grow into a large-canopy tree in the future. **Tree 31** is a large Freeman maple on the adjacent property. The retaining wall is proposed to come approximately 4.75m from the base of the tree and remove approximately 4% of its CRZ.

Below: southwest corner of the property, including Trees 23-33

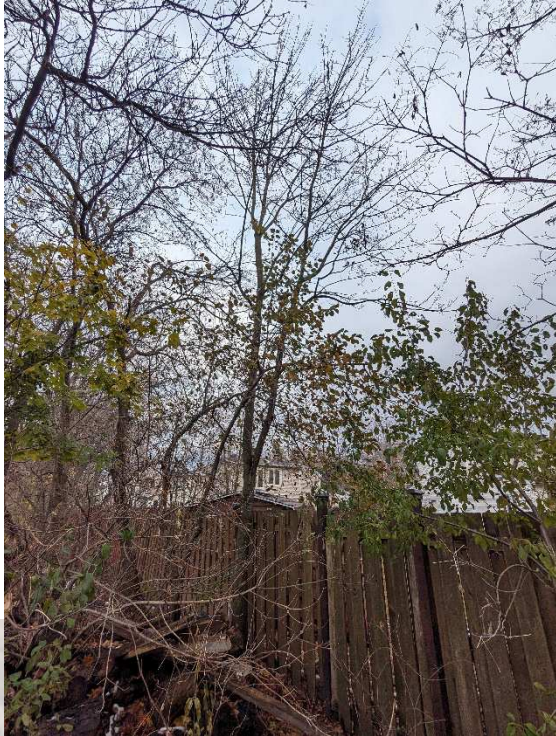
Left: Tree 22 – private maple to be removed.

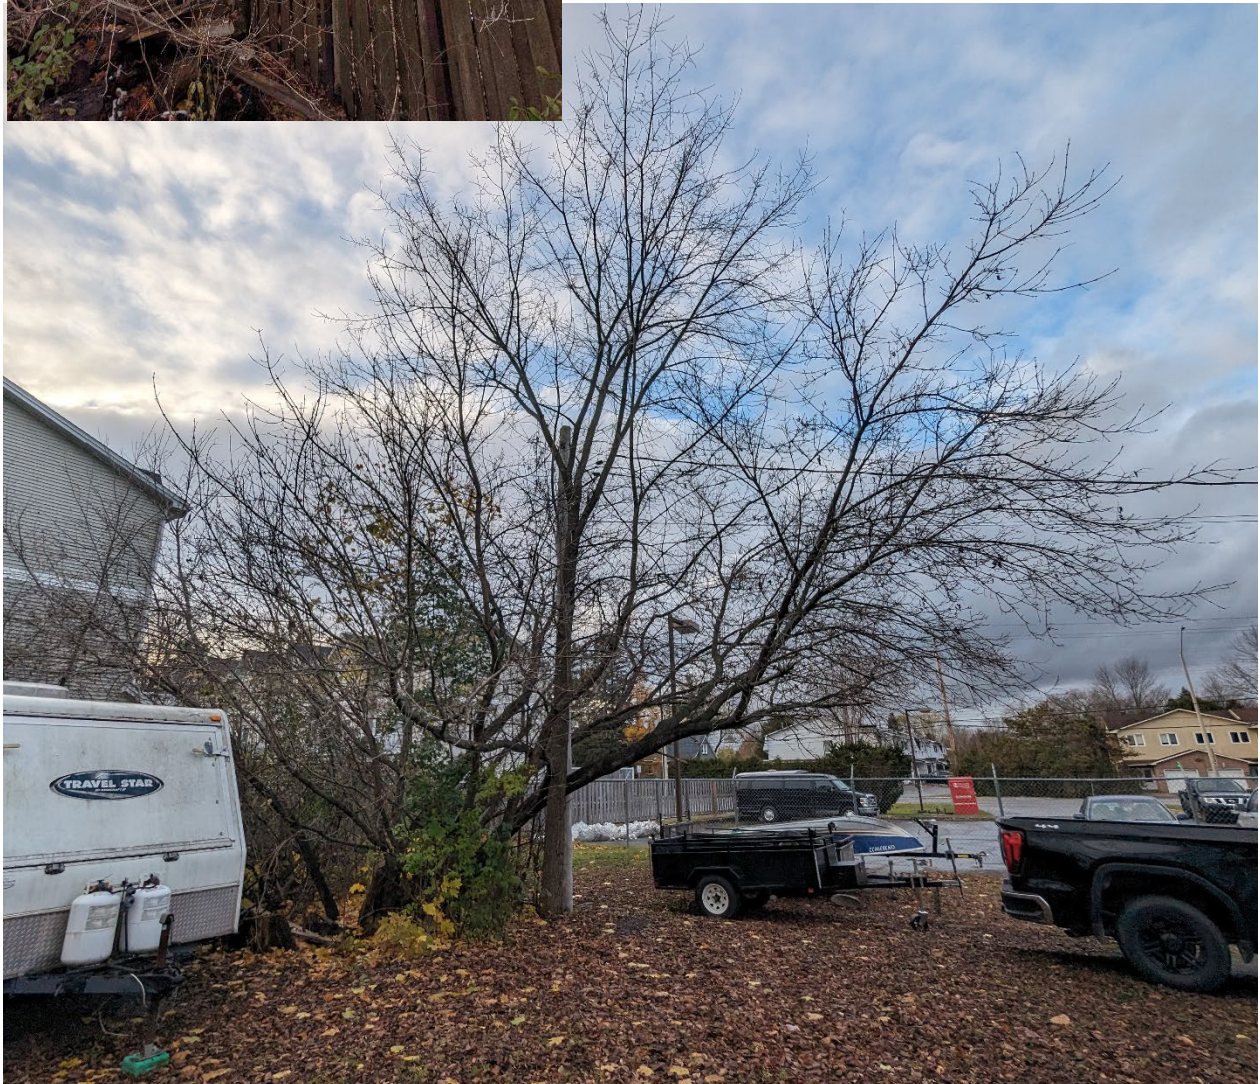
Below: Trees 34-36 - to be removed

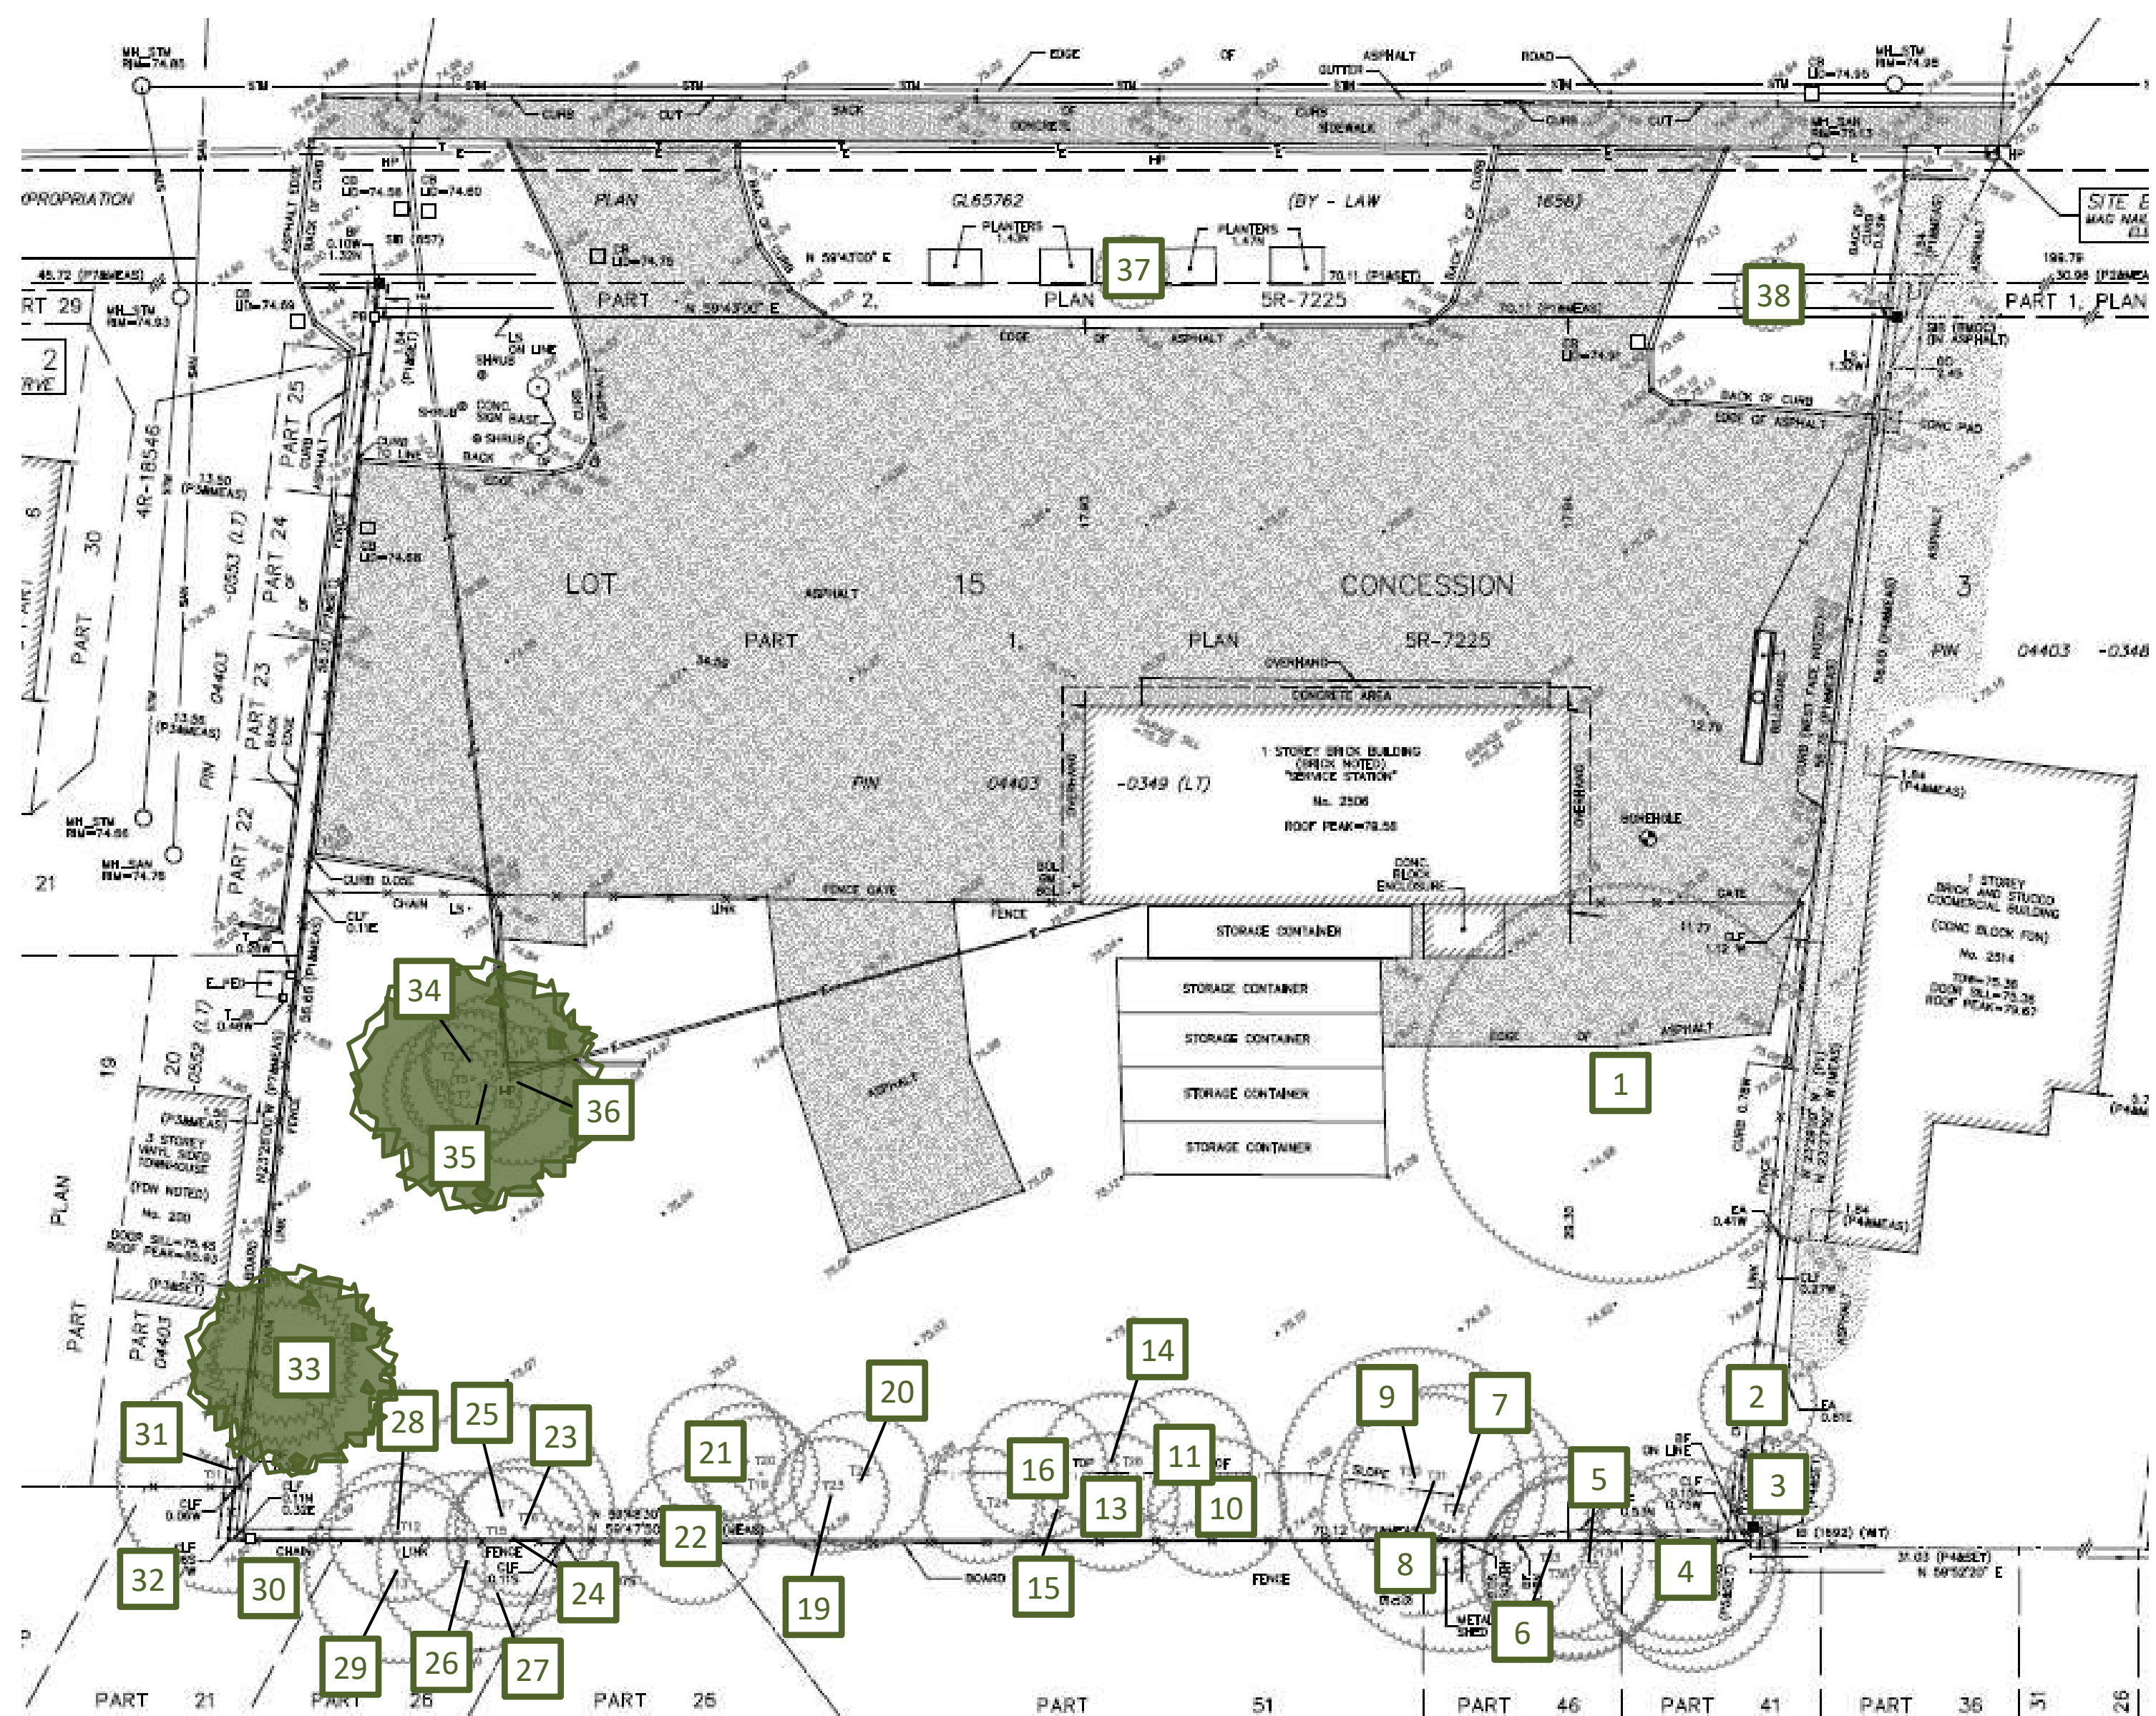
TCR Map – 2506 Innes Road
 Tree layer prepared by
 Dendron Forestry Services
 Existing Vegetation, November 16, 2023
 For more information, please contact: info@dendronforestry.ca

Tree ¹	Species	DBH (cm)	Ownership ²	Tree Condition
1	Manitoba maple (<i>Acer negundo</i>)	56	Subject property	Fair: wound on scaffold branch; pruning wounds sealing; cavities at base
2	Manitoba maple (<i>Acer negundo</i>)	27	Subject property	Poor
3	Red maple (<i>Acer rubrum</i>)	20, 15	Adjacent – 2514 Innes	Fair/Poor
4	Freeman maple (<i>Acer freemanii</i>)	20, 20, 30, 35, 25 (estimated)	Adjacent – 17 Beddoe	Fair/Poor
5	Freeman maple (<i>Acer freemanii</i>)	20	Adjacent – 15 Beddoe	Fair
6	Freeman maple (<i>Acer freemanii</i>)	15, 20, 25, 30 (estimated)	Adjacent – 15 Beddoe	Good/Fair
7	Manitoba maple (<i>Acer negundo</i>)	38, 11	Subject property	Fair/Poor: significant lean; asymmetrical crown
8	Manitoba maple (<i>Acer negundo</i>)	22	Subject property	Fair/Poor: 90 degree bend @ 3.5m
9	Manitoba maple (<i>Acer negundo</i>)	42	Subject property	Good/Fair: significant lean
10	American elm (<i>Ulmus americana</i>)	50	Subject property	Good

11	Manitoba maple (<i>Acer negundo</i>)	25	Subject property	Fair: several wounds on trunk; dead branches
12	Manitoba maple (<i>Acer negundo</i>)	28, 10	Subject property	Fair/Good: large pruning wound at base
13	American elm (<i>Ulmus americana</i>)	32	Subject property	Good
14	Manitoba maple (<i>Acer negundo</i>)	10	Subject property	Good/Fair
15	Manitoba maple (<i>Acer negundo</i>)	16, 8	Subject property	Fair: spreading form; sprouts at base
16	Manitoba maple (<i>Acer negundo</i>)	33	Subject property	Fair: significant lean; wound on trunk
17	Manitoba maple (<i>Acer negundo</i>)	29, 14	Subject property	Fair: wounds with decay; poor form
18	Manitoba maple (<i>Acer negundo</i>)	20	Subject property	Good
19	Manitoba maple (<i>Acer negundo</i>)	20	Subject property	Fair
20	Manitoba maple (<i>Acer negundo</i>)	16	Subject property	Fair: suppressed
21	Manitoba maple (<i>Acer negundo</i>)	33	Subject property	Fair: significant lean

22	Freeman maple (<i>Acer freemanii</i>)	17	Subject property	Good
23	Black cherry (<i>Prunus serotina</i>)	12	Subject property	Fair: lean corrected through growth
24	Black cherry (<i>Prunus serotina</i>)	15	Subject property	Fair/Poor: growing on fence; significant lean
25	Manitoba maple (<i>Acer negundo</i>)	17	Subject property	Fair
26	Scot's pine (<i>Pinus sylvestris</i>)	33	Adjacent – 45 Glen Park	Fair
27	Hackberry (<i>Celtis occidentalis</i>)	16, 4 (estimated)	Adjacent – 45 Glen Park	Fair: suppressed
28	Black cherry (<i>Prunus serotina</i>)	15, 12	Subject property	Fair: codominant stems @ 1.3m
29	Scot's pine (<i>Pinus sylvestris</i>)	28 (estimated)	Adjacent – 45 Glen Park	Fair: thin crown
30	Scot's pine (<i>Pinus sylvestris</i>)	30 (estimated)	Adjacent – 45 Glen Park	Fair: asymmetrical crown
31	Freeman maple (<i>Acer freemanii</i>)	50 (estimated)	Adjacent – 200 Scotland	Fair: large branch attachment wound; small cavity with decay possible; slight lean to the west

32	Scot's pine (<i>Pinus sylvestris</i>)	30 (estimated)	Adjacent – 43 Glen Park	Fair/Poor: very thin crown
33	Eastern white cedar (<i>Thuja occidentalis</i>)	12 stems 5-30	Subject property	Good/Fair
34	Norway maple (<i>Acer platanoides</i>)	13	Subject property	Good
35	Manitoba maple (<i>Acer negundo</i>)	7 stems 11-25	Subject property	Fair/Poor: spreading form
36	American elm (<i>Ulmus americana</i>)	24	Subject property	Good
37	Tree lilac (<i>Syringa reticulata</i>)	8	City	Fair
38	Serviceberry (<i>Amelanchier spp.</i>)	6	City	Fair

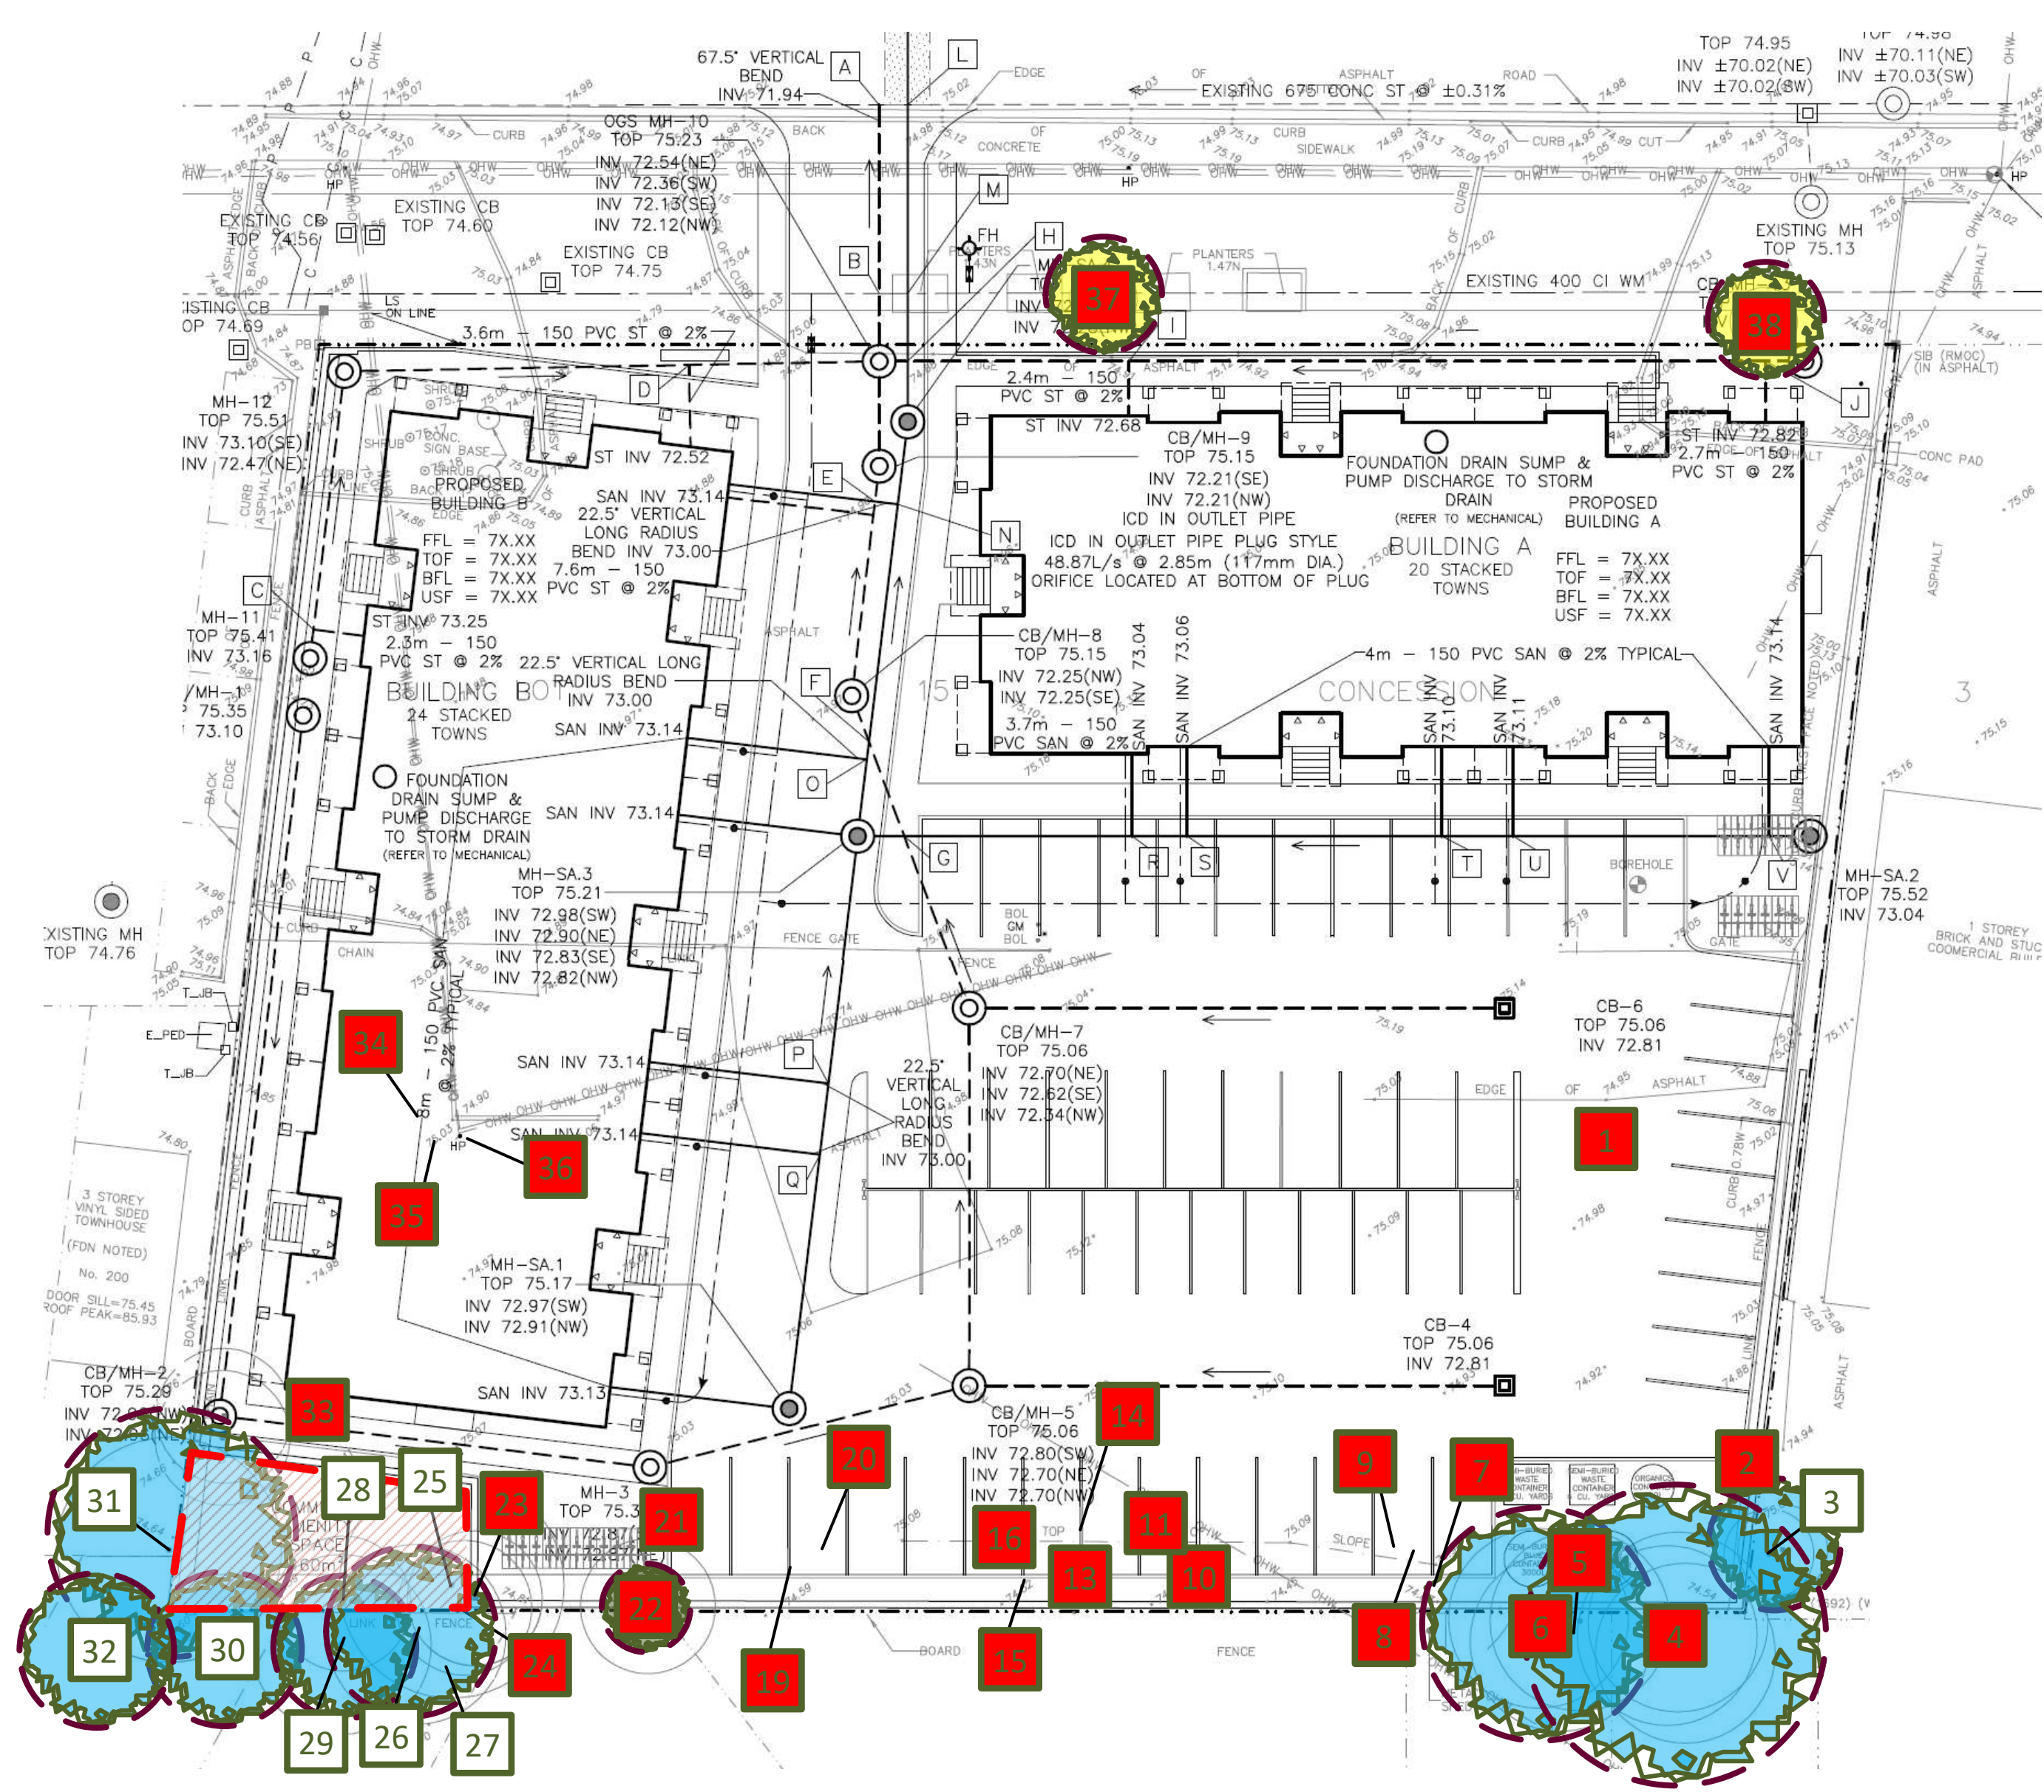
TCR Map – 2506 Innes Road
 Tree layer prepared by
 Dendron Forestry Services
 Proposed Development v2.0, May 2, 2024
 For more information, please contact: info@dendronforestry.ca

Tree#	Species	DBH (cm)	Tree Condition	Forester recommendation
1	Manitoba maple (<i>Acer negundo</i>)	56	Fair: wound on scaffold branch; pruning wounds sealing; cavities at base	Remove
2	Manitoba maple (<i>Acer negundo</i>)	27	Poor	Remove
3	Red maple (<i>Acer rubrum</i>)	20, 15	Fair/Poor	Retain and protect as per the City of Ottawa Tree Protection Specifications (March 2021). Roots are to be revealed along the line of excavation and cleanly severed by hand.
4	Freeman maple (<i>Acer freemanii</i>)	20, 20, 30, 35, 25 (estimated)	Fair/Poor	Remove due to proximity of retaining wall and grade changes. Opportunity may exist to retain individual stems from groupings.
5	Freeman maple (<i>Acer freemanii</i>)	20	Fair	Remove due to proximity of retaining wall and grade changes. Opportunity may exist to retain individual stems from groupings.
6	Freeman maple (<i>Acer freemanii</i>)	15, 20, 25, 30 (estimated)	Good/Fair	Remove due to proximity of retaining wall and grade changes. Opportunity may exist to retain individual stems from groupings.

7	Manitoba maple (<i>Acer negundo</i>)	38, 11	Fair/Poor: significant lean; asymmetrical crown	Remove
8	Manitoba maple (<i>Acer negundo</i>)	22	Fair/Poor: 90 degree bend @ 3.5m	Remove
9	Manitoba maple (<i>Acer negundo</i>)	42	Good/Fair: significant lean	Remove
10	American elm (<i>Ulmus americana</i>)	50	Good	Remove
11	Manitoba maple (<i>Acer negundo</i>)	25	Fair: several wounds on trunk; dead branches	Remove
12	Manitoba maple (<i>Acer negundo</i>)	28, 10	Fair/Good: large pruning wound at base	Remove
13	American elm (<i>Ulmus americana</i>)	32	Good	Remove
14	Manitoba maple (<i>Acer negundo</i>)	10	Good/Fair	Remove
15 ^a	Manitoba maple (<i>Acer negundo</i>)	16, 8	Fair: spreading form; sprouts at base	Remove
16	Manitoba maple (<i>Acer negundo</i>)	33	Fair: significant lean; wound on trunk	Remove
17	Manitoba maple (<i>Acer negundo</i>)	29, 14	Fair: wounds with decay; poor form	Remove
18	Manitoba maple (<i>Acer negundo</i>)	20	Good	Remove

19	Manitoba maple (<i>Acer negundo</i>)	20	Fair	Remove
20	Manitoba maple (<i>Acer negundo</i>)	16	Fair: suppressed	Remove
21	Manitoba maple (<i>Acer negundo</i>)	33	Fair: significant lean	Remove
22	Freeman maple (<i>Acer freemanii</i>)	17	Good	Remove
23	Black cherry (<i>Prunus serotina</i>)	12	Fair: lean corrected through growth	Remove
24	Black cherry (<i>Prunus serotina</i>)	15	Fair/Poor: growing on fence; significant lean	Remove
25	Manitoba maple (<i>Acer negundo</i>)	17	Fair	Retain. Approximately 80cm from wall. Roots are to be revealed and cleanly severed by hand prior to excavation. If tree becomes hazardous it is to be removed.
26	Scot's pine (<i>Pinus sylvestris</i>)	33	Fair	Retain. Any roots encountered during excavation are to be cleanly severed by hand
27 ^a	Hackberry (<i>Celtis occidentalis</i>)	16, 4 (estimated)	Fair: suppressed	Retain. Any roots encountered during excavation are to be cleanly severed by hand

28	Black cherry (<i>Prunus serotina</i>)	15, 12	Fair: codominant stems @ 1.3m	Retain. Any roots encountered during excavation are to be cleanly severed by hand
29	Scot's pine (<i>Pinus sylvestris</i>)	28 (estimated)	Fair: thin crown	Retain and protect as per the City of Ottawa Tree Protection Specifications (March 2021). Roots are to be revealed along the line of excavation and cleanly severed by hand.
30	Scot's pine (<i>Pinus sylvestris</i>)	30 (estimated)	Fair: asymmetrical crown	Retain and protect as per the City of Ottawa Tree Protection Specifications (March 2021). Any roots encountered during excavation to be cleanly severed by hand.
31	Freeman maple (<i>Acer freemanii</i>)	50 (estimated)	Fair: large branch attachment wound; small cavity with decay possible; slight lean to the west	Retain and protect as per the City of Ottawa Tree Protection Specifications (March 2021). Any roots encountered during excavation to be cleanly severed by hand.

32 ^a	Scot's pine (<i>Pinus sylvestris</i>)	30 (estimated)	Fair/Poor: very thin crown	Retain – no action required
33	Eastern white cedar (<i>Thuja occidentalis</i>)	12 stems 5-30	Good/Fair	Remove – in line with proposed building and retaining wall.
34	Norway maple (<i>Acer platanoides</i>)	13	Good	Remove
35	Manitoba maple (<i>Acer negundo</i>)	7 stems 11-25	Fair/Poor: spreading form	Remove
36	American elm (<i>Ulmus americana</i>)	24	Good	Remove
37	Tree lilac (<i>Syringa reticulata</i>)	8	Fair	Remove
38	Serviceberry (<i>Amelanchier spp.</i>)	6	Fair	Remove
