June 5, 2023

Ref. No.: 23-215-1

**RE: Phase I Environmental Site Assessment Update – 788 March Road, Ottawa, Ontario**

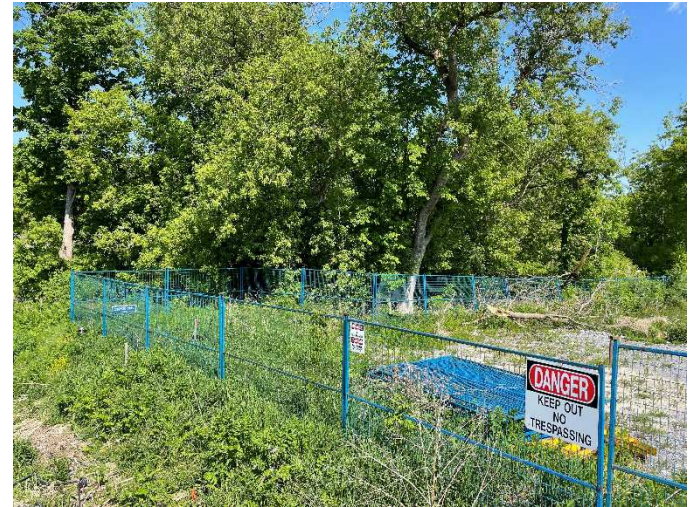
Looking at the northeast corner of the site from the access road along Klondike Road

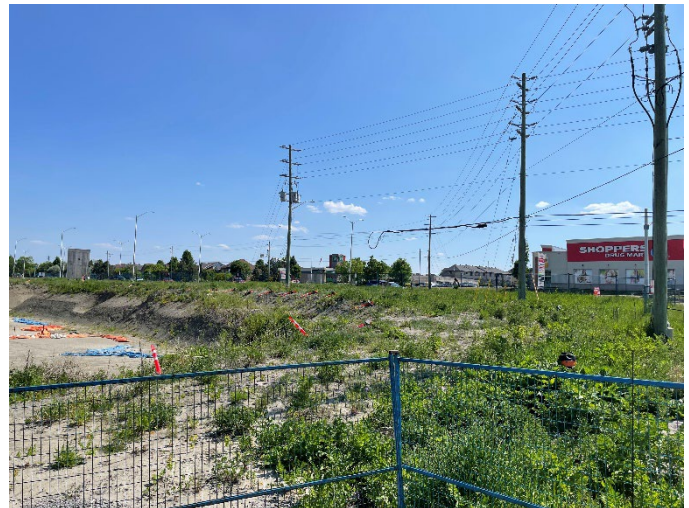
Looking west towards March Road, and the western boundary

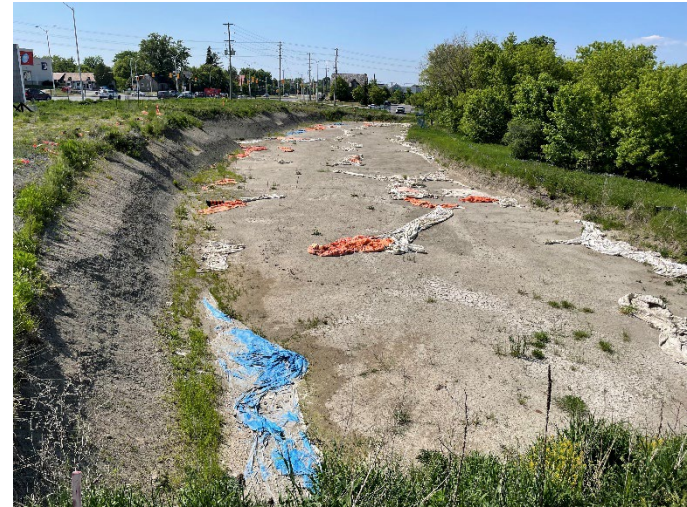
Looking north across the site from the southern boundary at the excavation area
