**Re: Slope Stability Assessment  
Proposed Residential Development  
788 March Road, Ottawa, Ontario**

This letter presents the results of a slope stability assessment carried out for a proposed residential development to be located at 788 March Road, Ottawa, Ontario.

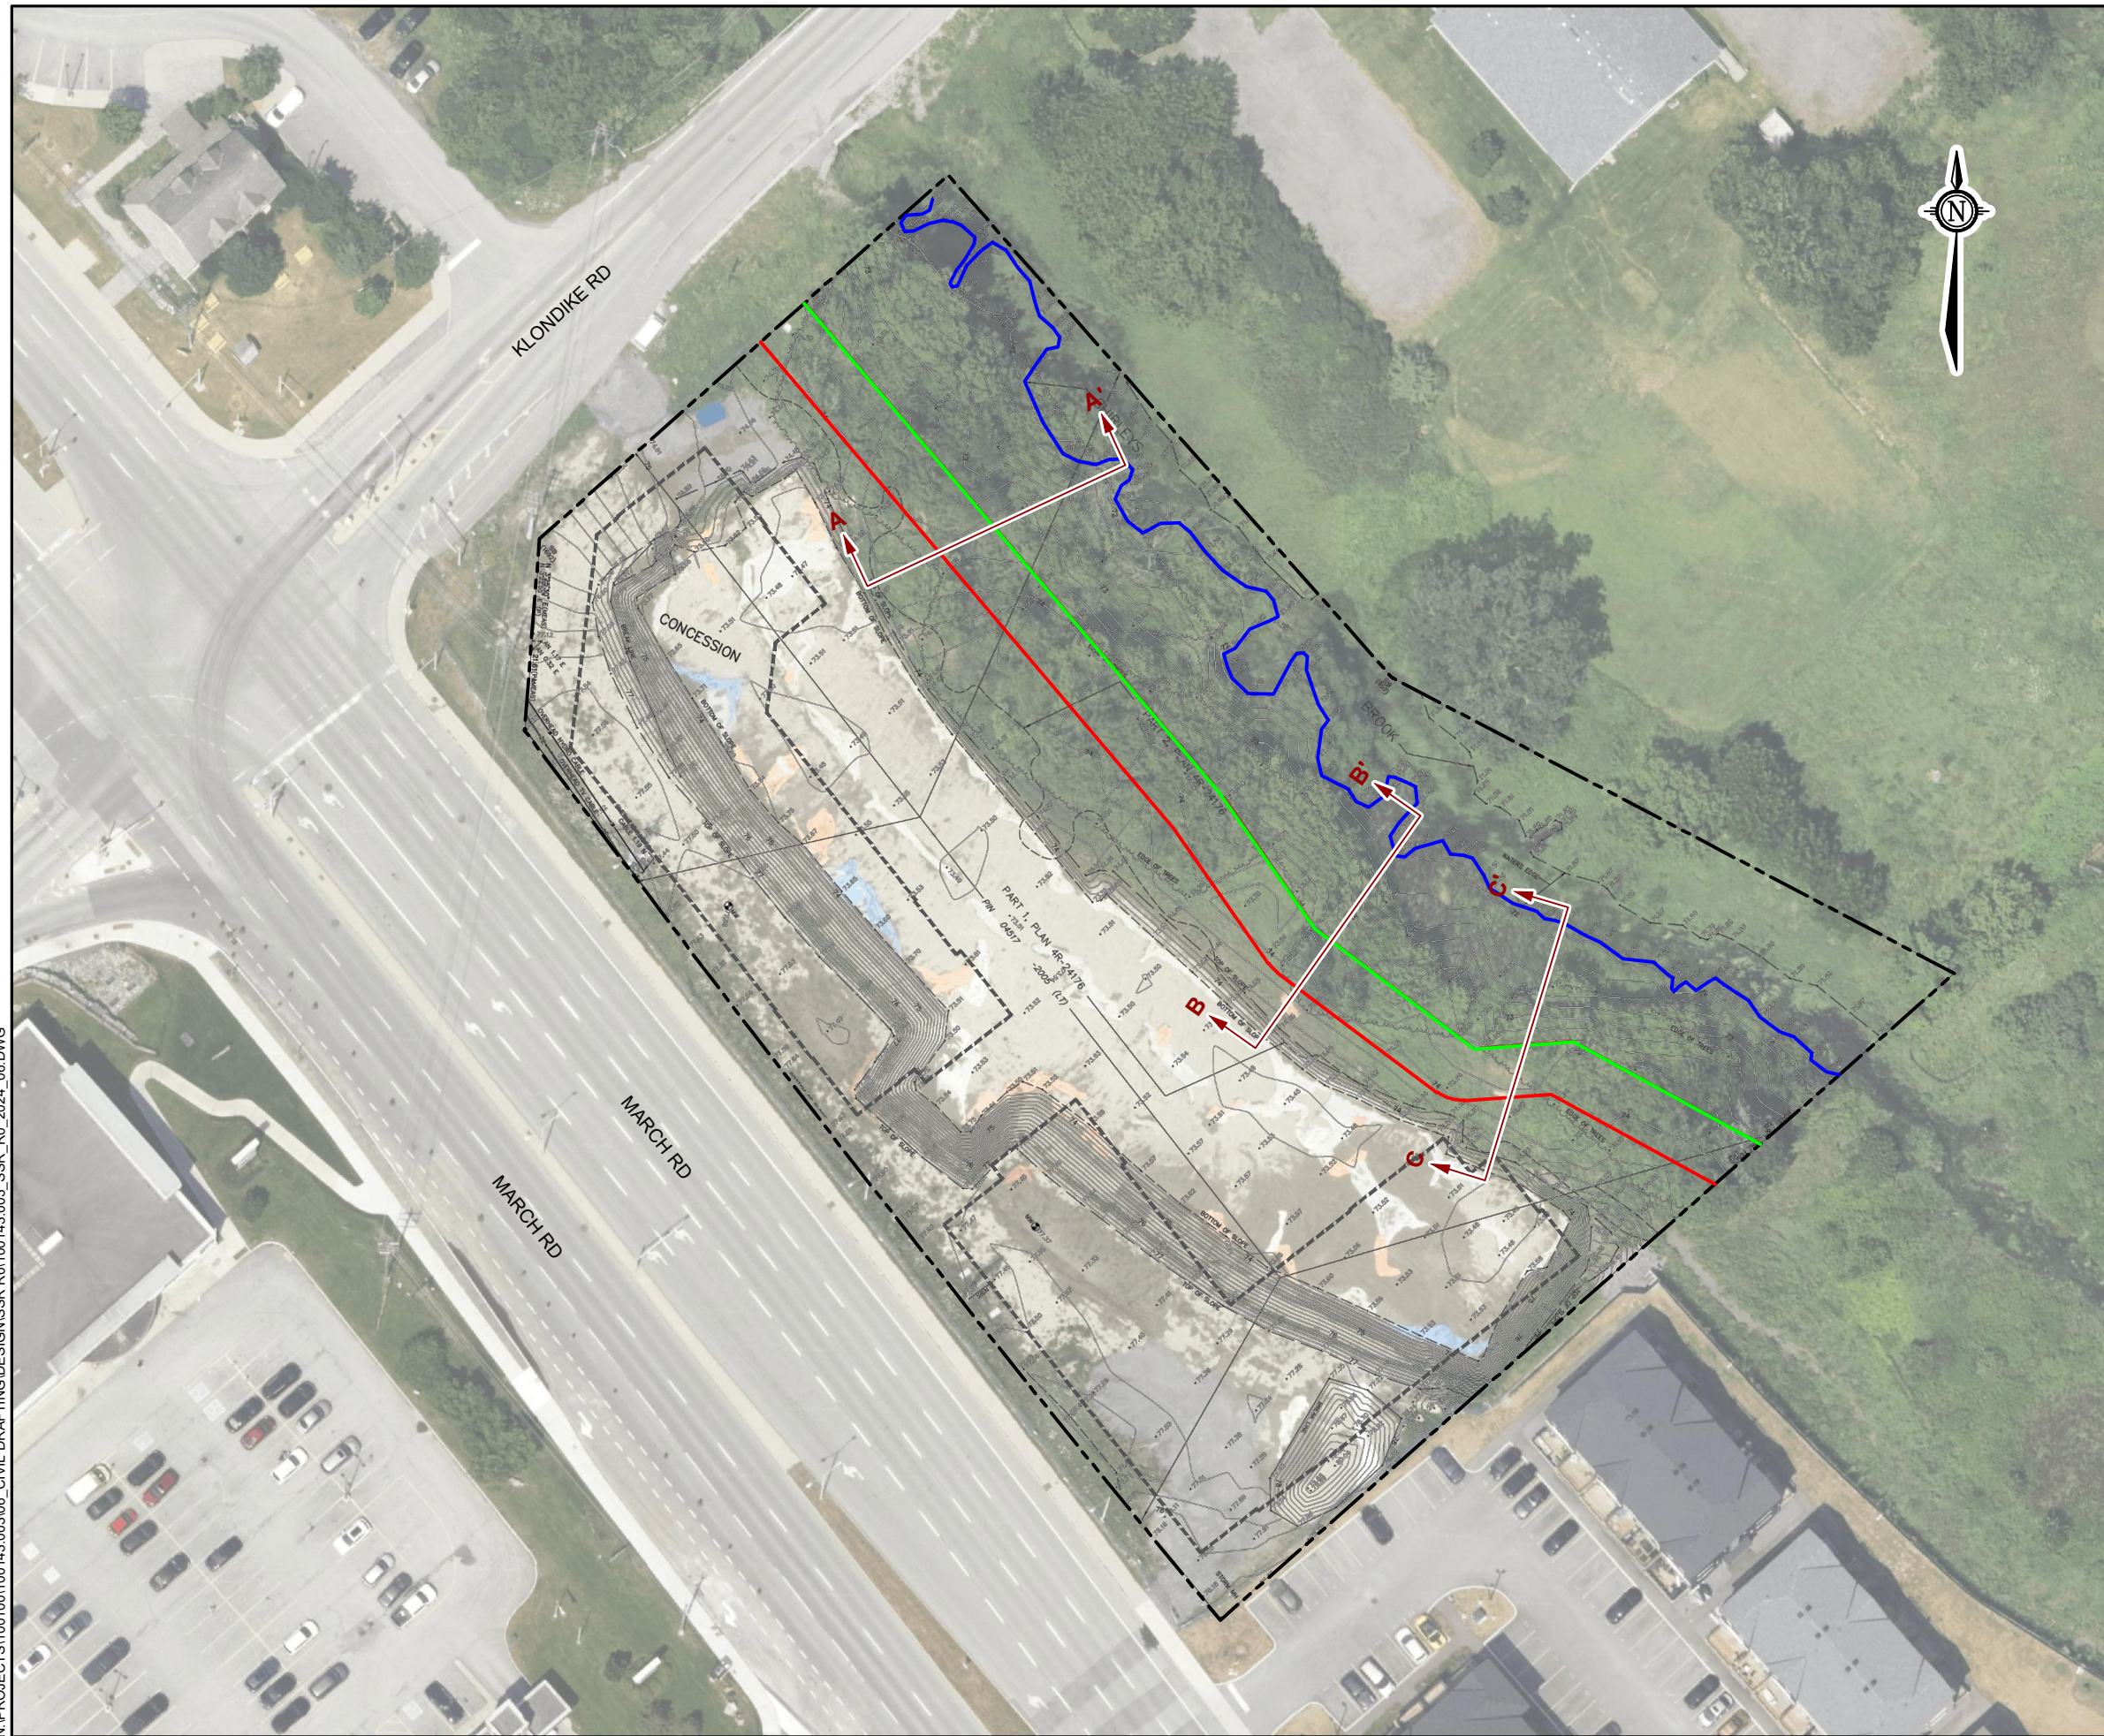
DRAWING	
<b>SITE LOCATION PLAN</b>	
CLIENT	
<b>GEOFIRMA LTD.</b>	
PROJECT	
<b>GEOTECHNICAL STUDY SLOPE STABILITY ANALYSIS 13109 -788 MARCH ROAD OTTAWA, ONTARIO</b>	
DRAWN BY	CHECKED BY
S.L.	B.C.
PROJECT NO.	REVISION NO.
100143.003	0
DATE	FIGURE NO.
JUNE 2024	<b>FIGURE 1</b>

The approximate top of slope is shown on Figure 1 along with the required toe erosion and access allowance (i.e., 8 metres).

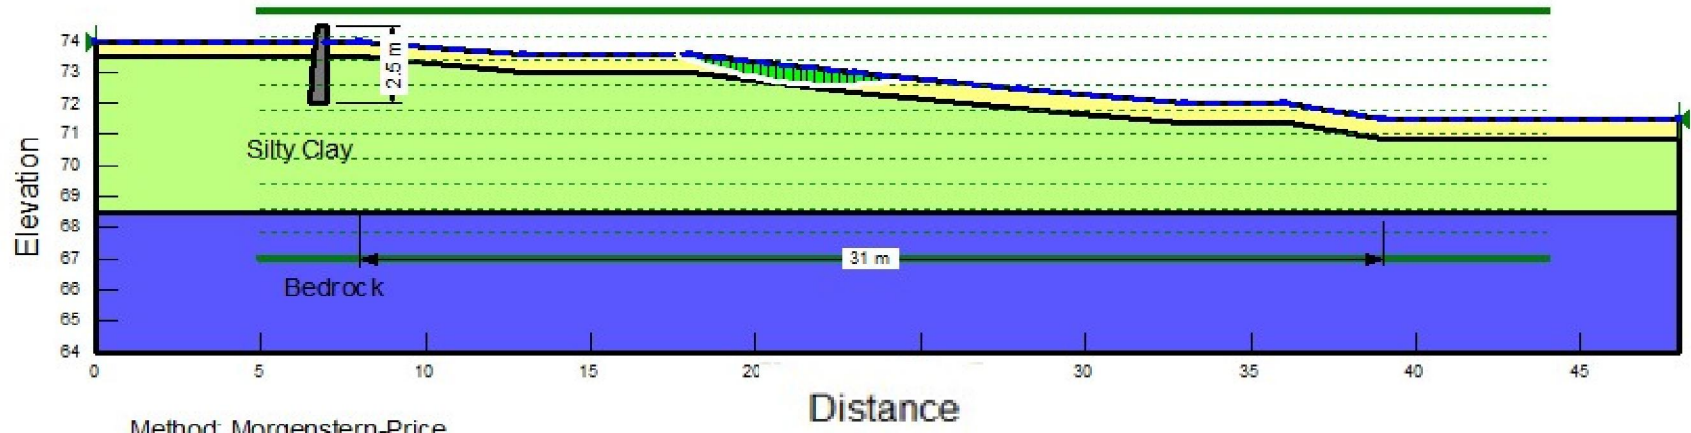
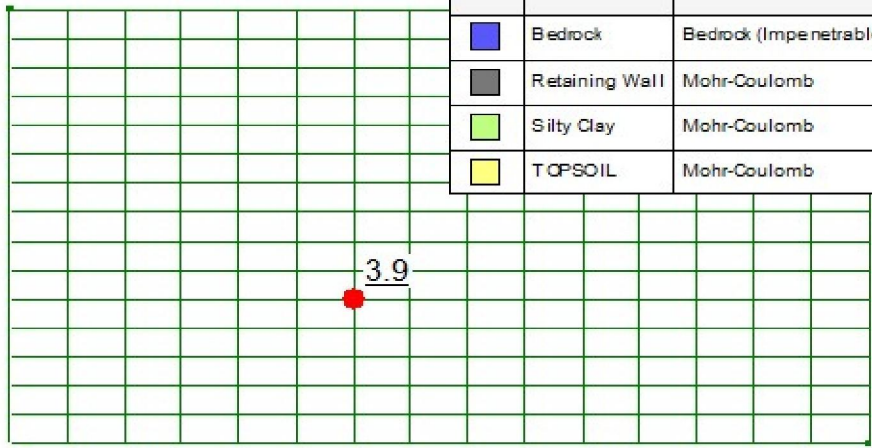
**Figure B1**

The slope stability analysis indicates that the existing slope, in its current configuration, has a global factor of safety against instability of about 3.4 and 3.3 under static and seismic loading conditions (refer to Figure B1 and B6), respectively.

As indicated in the analysis of slope section A-A’ (shown in Figures B1 and B2), the proposed retaining wall outside of the underground parking garage entrance (along the east side of the proposed development) is outside of the limit of hazard lands, and as a result is considered to have no impact to the existing slope and is also indicated to be globally stable.
