June 5, 2023

Ref. No.: 23-215-1

**RE: Phase I Environmental Site Assessment Update – 788 March Road, Ottawa, Ontario**

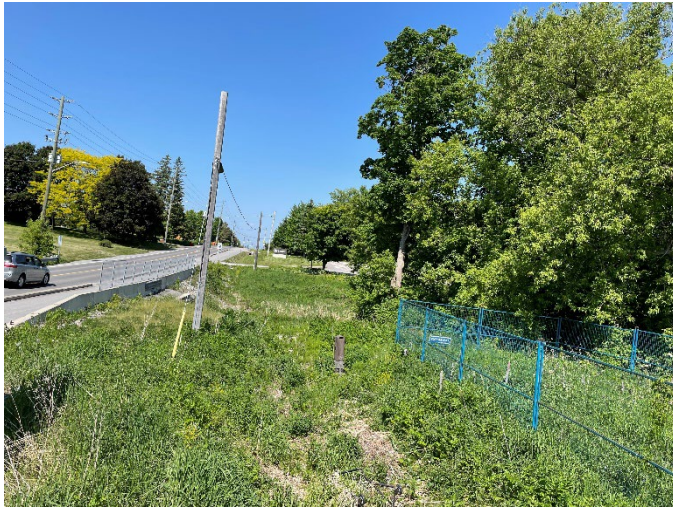
Looking east towards Shirley's Creek along the northern boundary

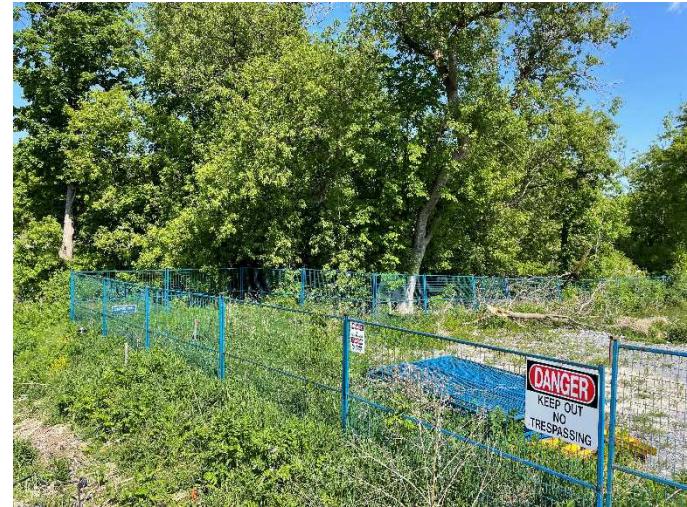
Looking at the northeast corner of the site from the access road along Klondike Road

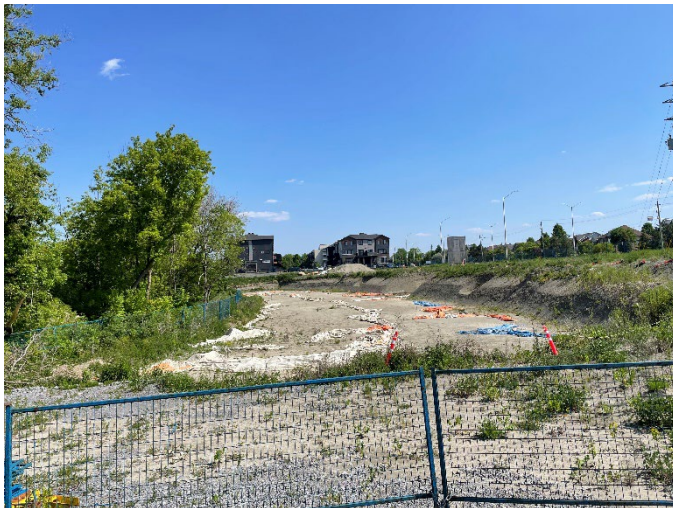
A large excavation was observed on the site in the area of the proposed building footprint. Two access roads were visible onto the property, one from March Road and one from Klondike Road. Both access roads appeared to contain imported gravel. The excavated construction area was surrounded with temporary metal construction fencing, limiting access to that area of the site. The excavation was generally flush with the landscape along the eastern edge of the building and Shirley's Brook. The western edge of the excavation was cut deep into the natural landscape as March Road is at a higher elevation than Shirley's Brook. Remnants of tarps were visible in the bottom of the excavation. Potential wooden survey markers were also visible in the bottom of the excavation and the bottom appeared smoothed and tamped flat in preparation of the building.

Looking south across the site from the access road along Klondike Road at the excavation area

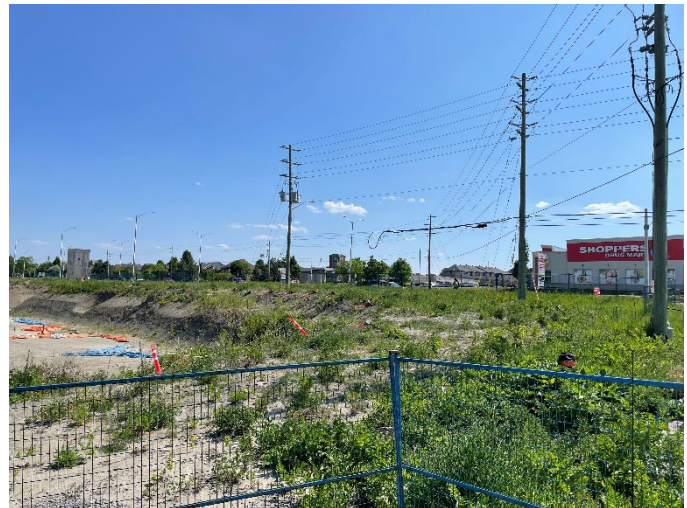
Looking west towards March Road, and the western boundary

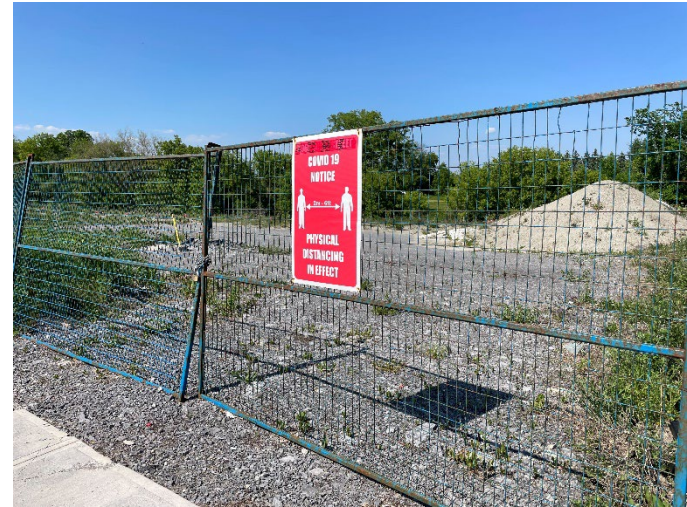
Looking east from the access road along March Road – note the large soil pile

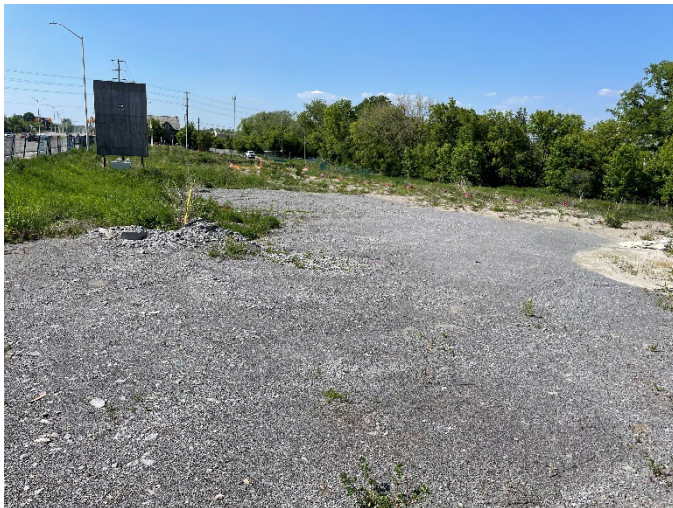
Looking north along the western boundary of the site and gravelled access area

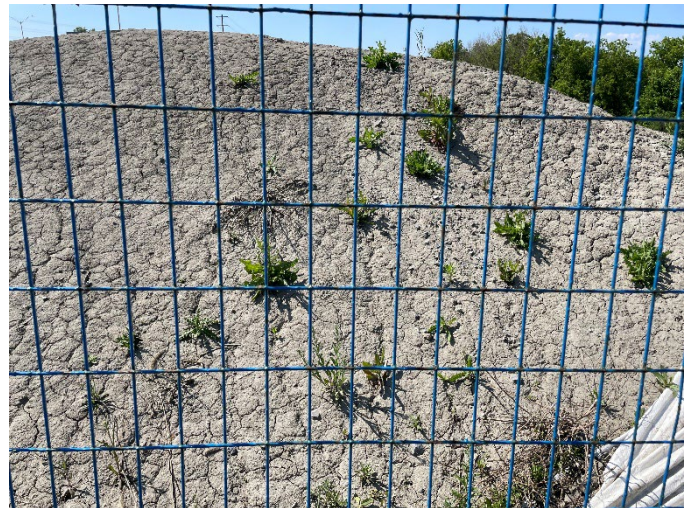
A large pile of soil was noted along the southern boundary of the site. This material appeared to consist of native silt and clay soil removed from the excavation on the site as it resembles the soil visible along the cut in the native landscape.

Close-up of the large soil pile along the southern boundary

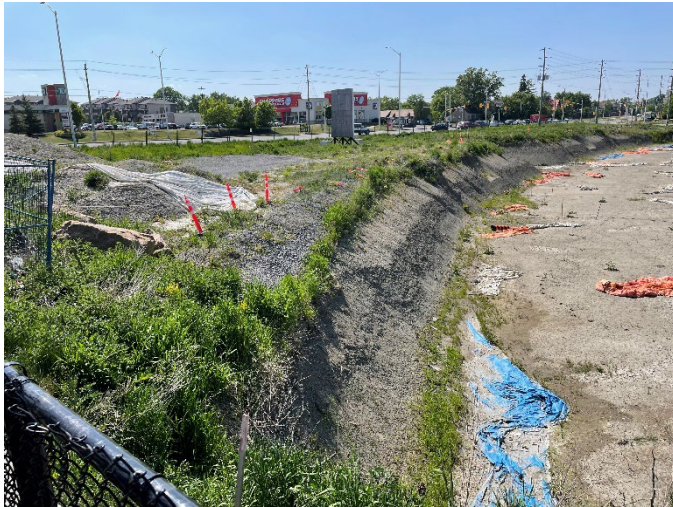
Looking northwest across the site from the southern boundary at the excavation and elevation change

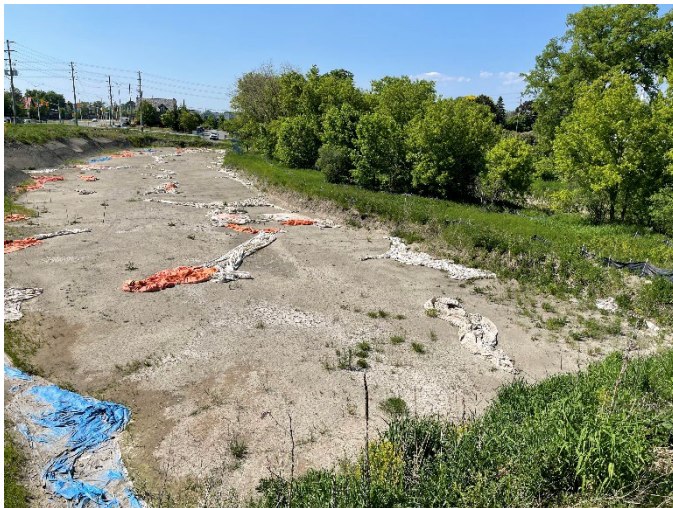
Looking northeast across the site from the southern boundary at the excavation and wooded area remaining

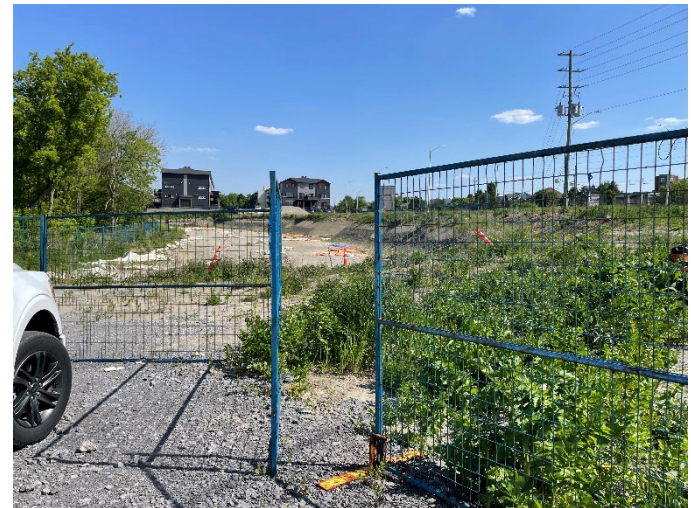
Looking south at the break in the fencing at the access road along Klondike Road
