July 15, 2024

RE: TREE CONSERVATION REPORT – 2140 BASELINE ROAD, OTTAWA

APARTMENT BUILDING
 2140 BASELINE ROAD

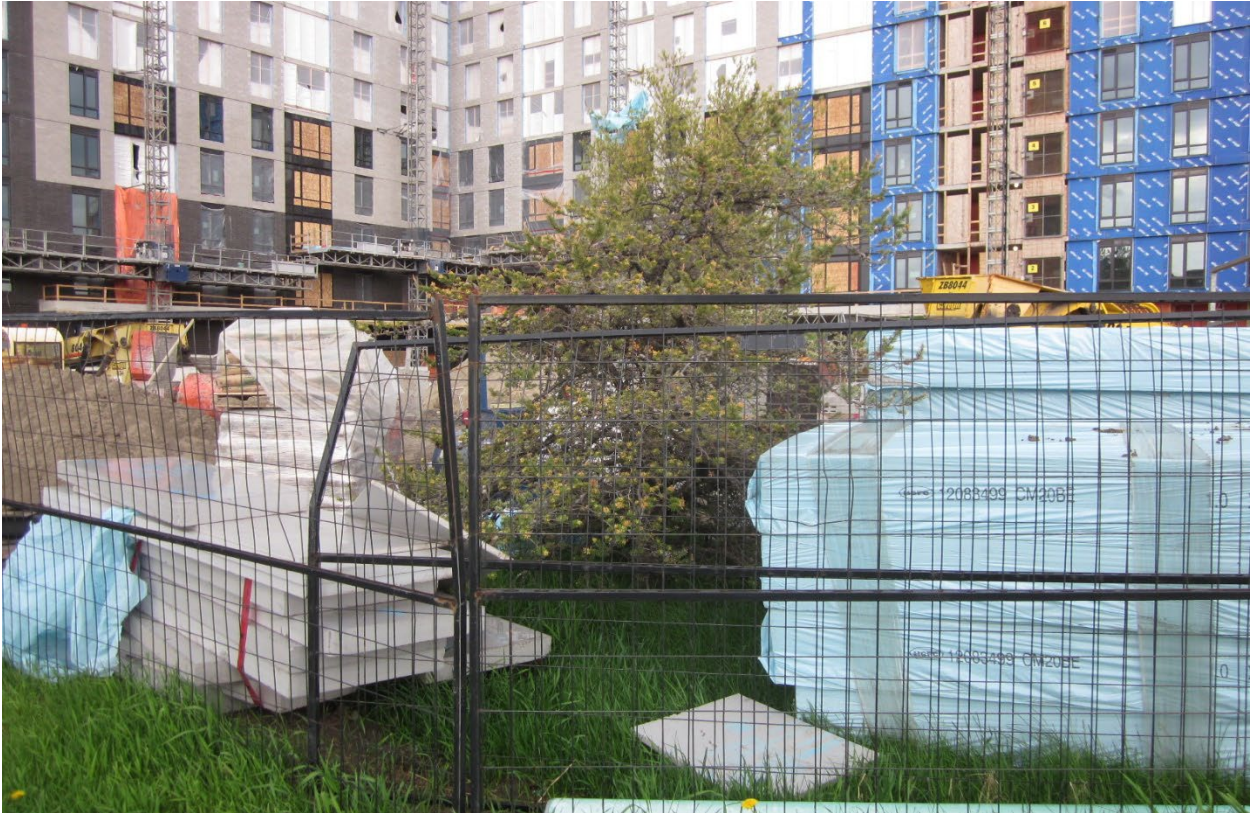
Tree No.	Tree Species	Ownership	DBH ¹ (cm)	Tree Condition, Age class & Preservation Status (to be removed or preserved and protected)
1	Jack pine (<i>Pinus banksiana</i>)	Fair	9	Fair; mature; stunted form; heavy pine needle scale infestation; native species; to be preserved and protected
2	Red oak (<i>Quercus rubra</i>)	Good	24	Poor; maturing; broad, dense crown; internal deadwood only; native species; to be preserved and protected
3	Red oak (<i>Quercus rubra</i>)	Fair	23	Poor; maturing; moderate amount of dead, declining branches on north side of crown; maturing; native species; previously removed
4	Scots pine (<i>Pinus sylvestris</i>)	Fair	17	Fair; mature; co-dominant stems at 2m; moderate pine needle scale infestation; introduced invasive species; to be preserved and protected
5	Ash (<i>Fraxinus spp.</i>)	Very poor	-	Very poor; mature; in advanced decline due to Emerald ash borer (<i>Agrilus planipennis</i>) – coppicing from base; native species; previously removed

Picture 1. Current condition of tree #1 (jack pine) at 2140 Baseline Road.

Tree #1 (jack pine): install fencing as per City of Ottawa tree protection barrier specification (see page 7); spray tree to reduce heavy infestation of pine needle scale; penetrometer tests found minimal soil compaction - remove turf within CRZ and replace with composted pine mulch spread 5-10cm deep and deep root fertilize
