# TREE CONSERVATION REPORT

1047 Richmond Road

August 23, 2024

**Address:** 1047 Richmond Road  
**Date of Report:** August 23, 2024  
**Date of Site Visit:** August 13, 2024  
**Prepared by:** Kevin Myers, ISA Certified Arborist; kevin.myers@dendronforestry.ca  
**Client:** Fengate Asset Management  
c/o Corina Sajewski; corina.sajewski@fengate.com

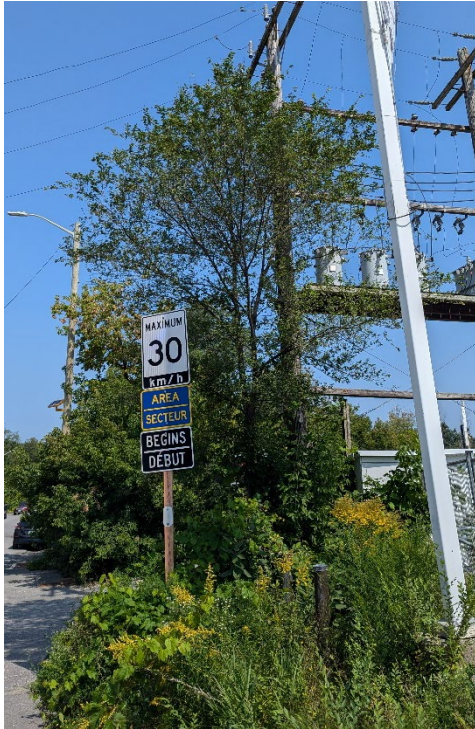
Above left: Tree 1 - City elm to be removed.

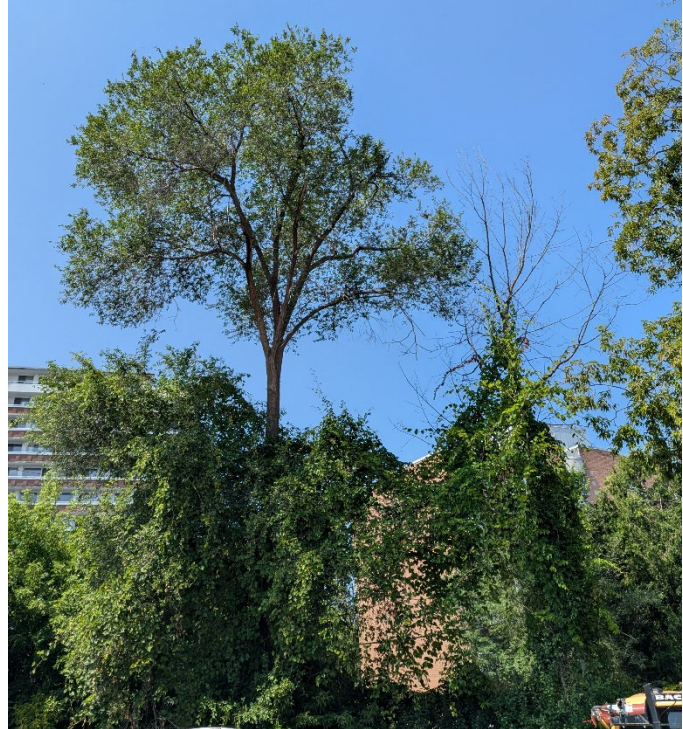
Above right: Tree 3 - boundary elm to be removed - and Tree 4 - dead elm to be removed.

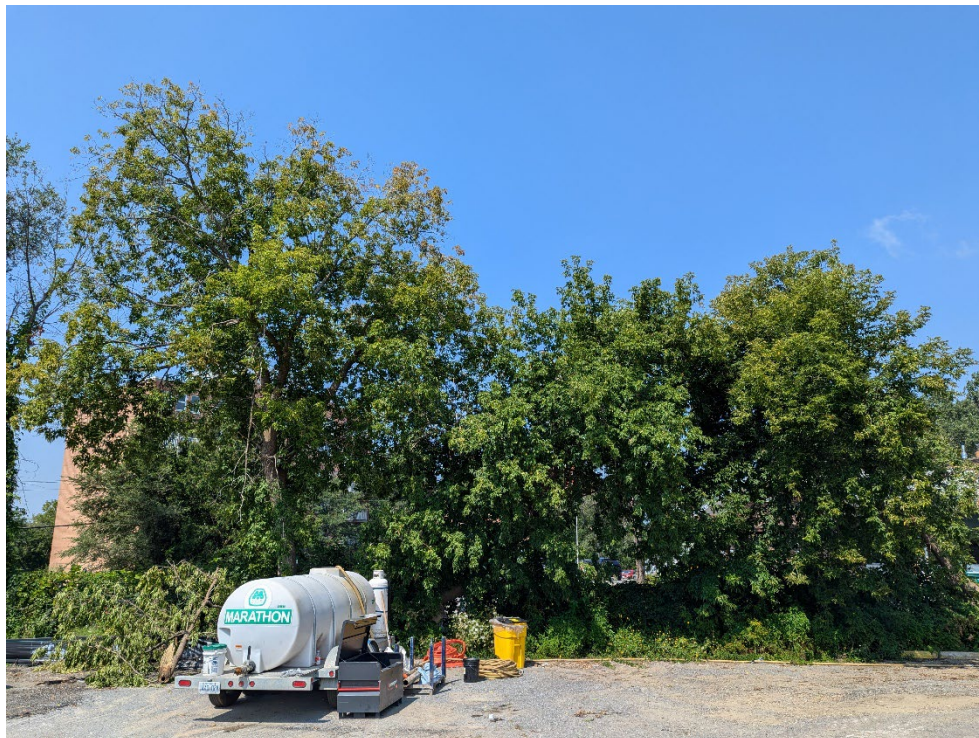
Below: Trees 5-7 – adjacent trees to be removed.

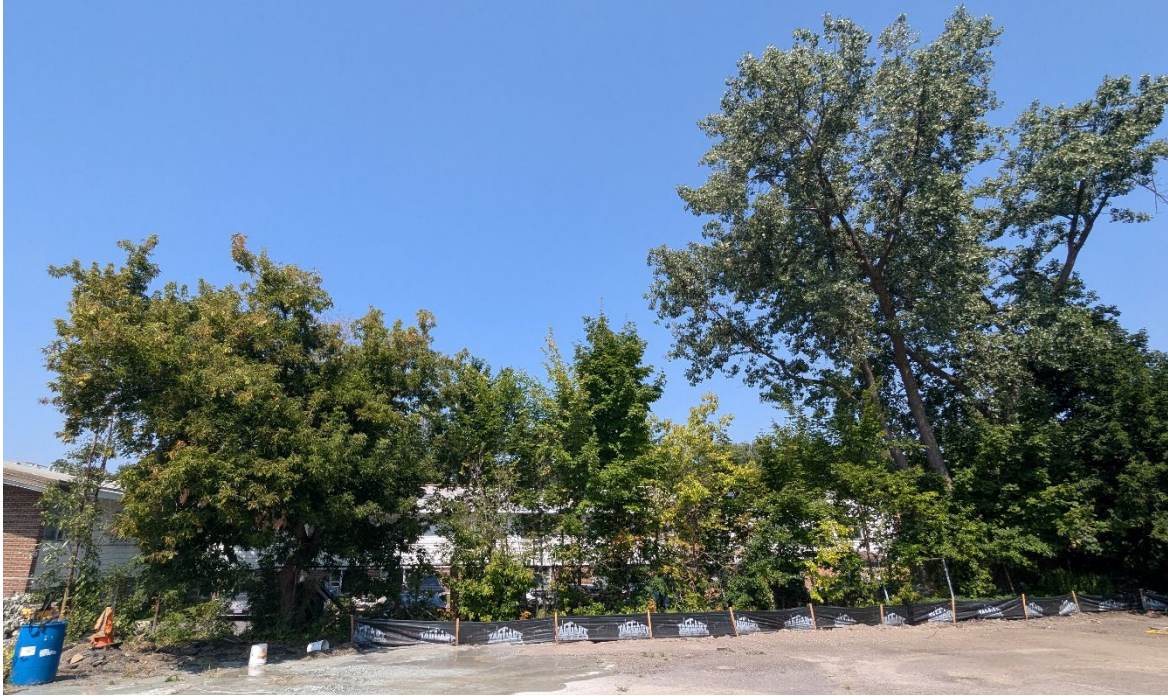
Above: Trees 8-15 and G1.

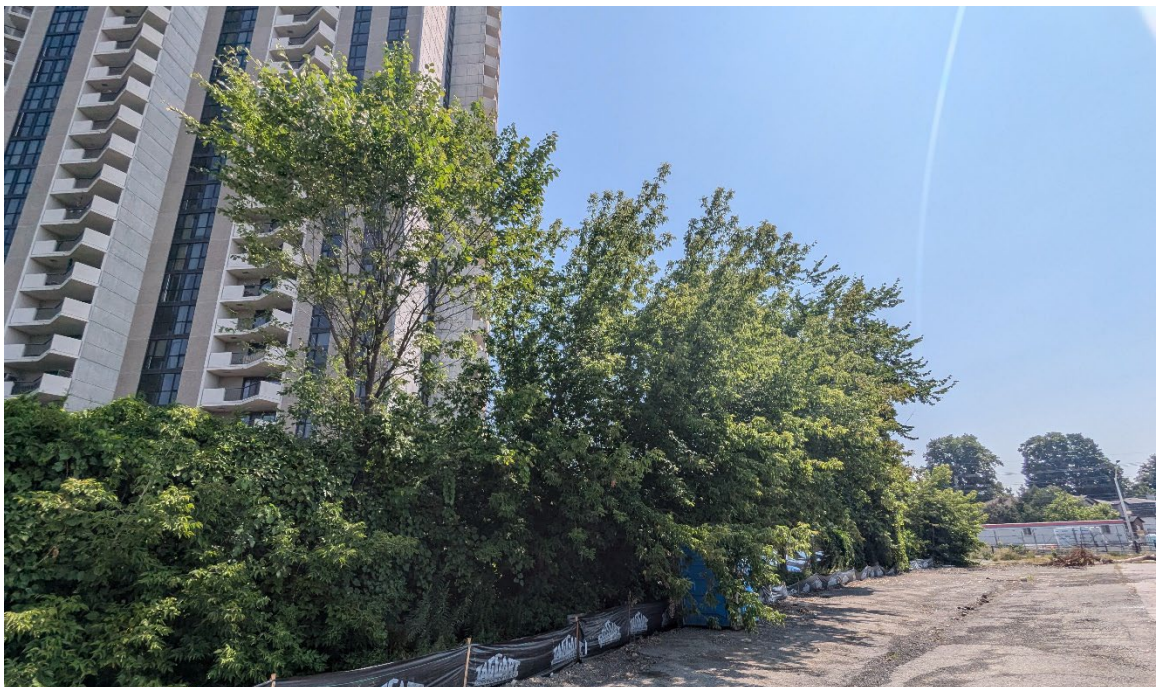
Below: Trees 16-20

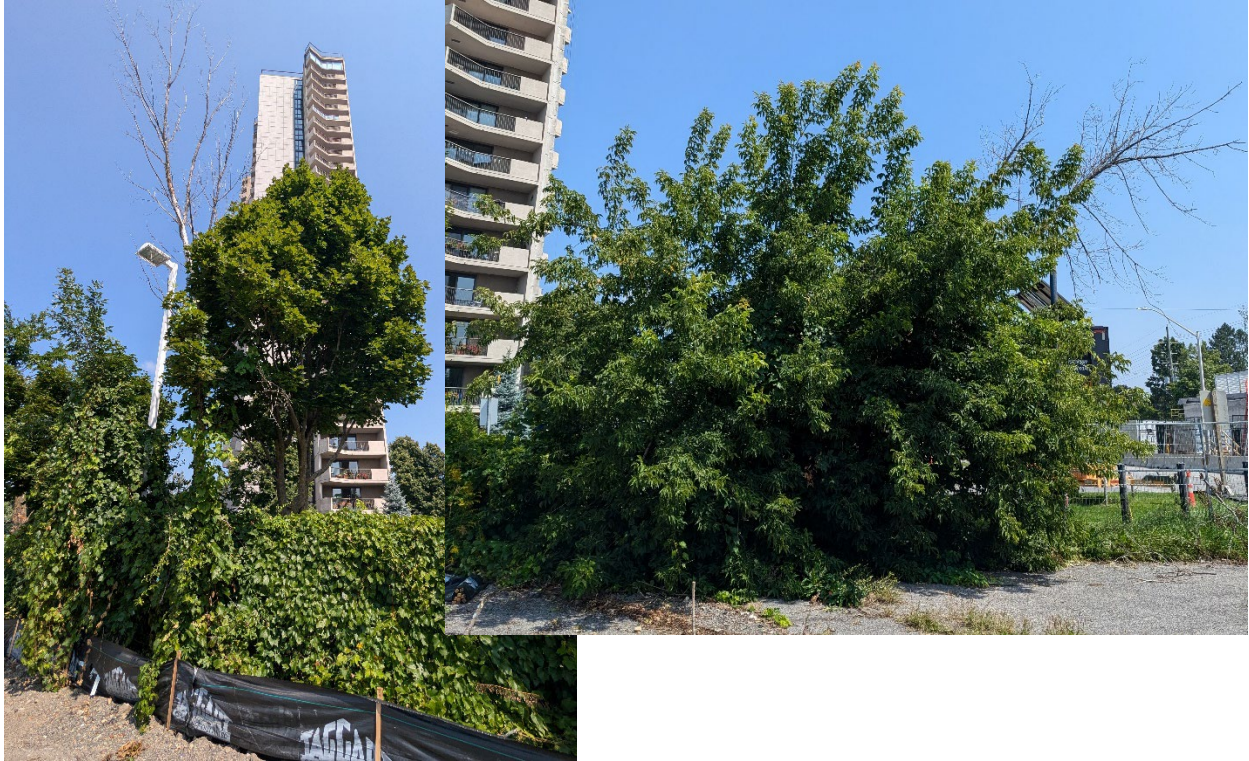
Above left: Tree 23 - dead ash to be removed - and Tree 24 - adjacent Norway maple.

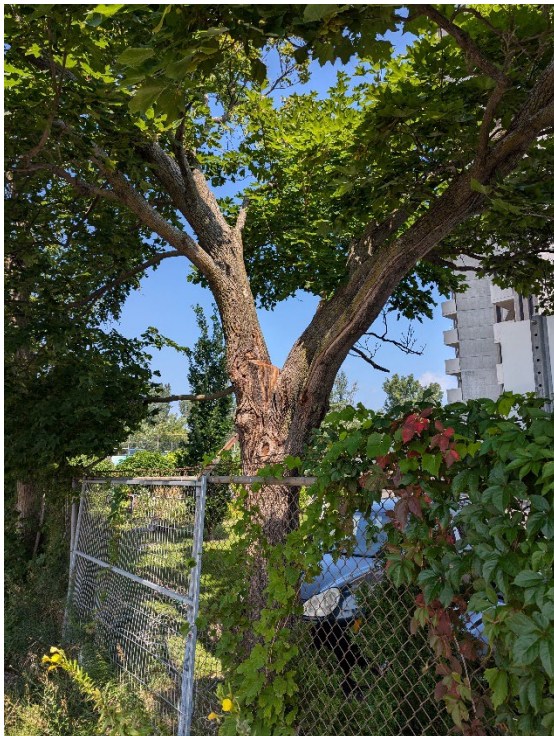
Below right: trunk of Tree 21.

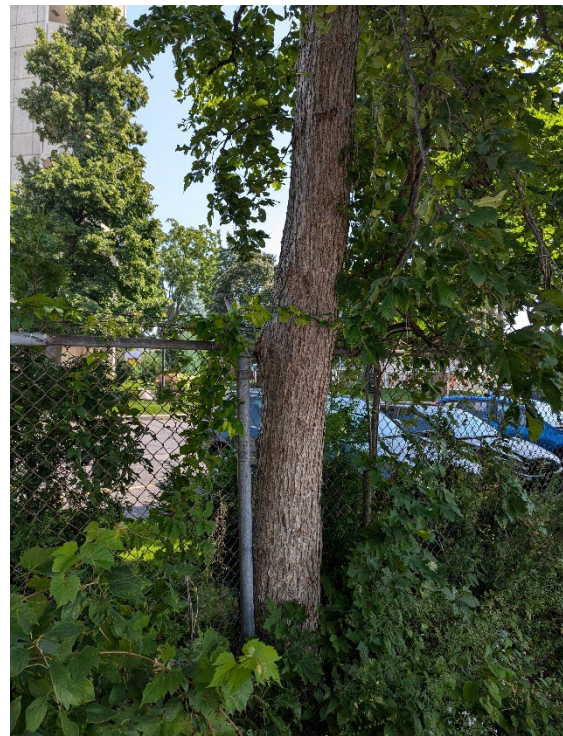
Below left: Tree 22 – adjacent Norway maple.
