## Phase I Environmental Site Assessment Update

6622 Bank Street, Ottawa, Ontario

**CAMM Heavy Machinery Movers**Final Report

August 26, 2024 02407549.000

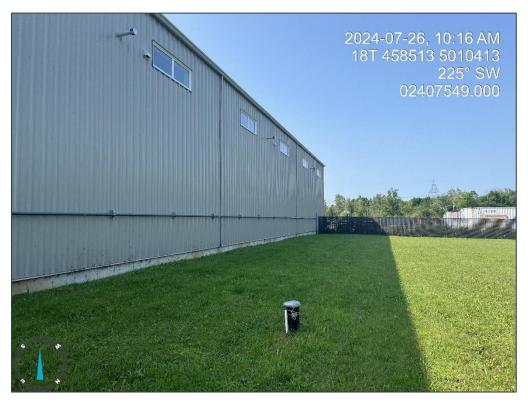
During the Site reconnaissance, Englobe observed one potable drinking water supply well north of the warehouse building.

Photograph 9: Potable Water Supply Well (6622 Bank Street).
