Tree Conservation Report Addendum

Submitted as part of Site Plan Control Application

Address: 415 Hunt Club
Date of Report: November 25, 2024
Date of Site Visit: August 15, August 23, November 18, and November 22, 2024
Prepared by: Astrid Nielsen, RPF, ISA Certified Arborist®
Client: Costco Headquarters
Contact: Jasmine Paoloni, P-Squared Concepts, planning@p2concepts.ca

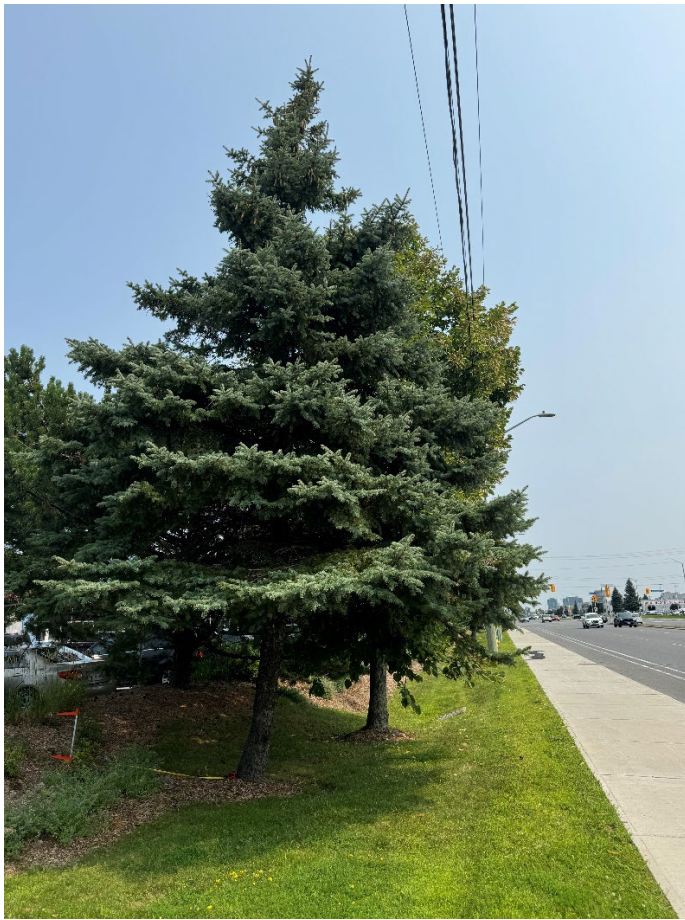
16	Colorado spruce (<i>Picea pungens</i>)	25 cm	City	Good/fair; lean at base	Remove: excavation for foundation to occur less than a metre from trunk; conflict with new building and hydro lines
17	Basswood (<i>Tilia americana</i>)	28 cm	City	Fair; leaves skeletonized, possibly by Japanese beetle	Remove: excavation for foundation to occur less than a metre from trunk; conflict with new building and hydro lines
27	Basswood (<i>Tilia americana</i>)	33 cm	City	Good/fair; lean	Remove: excavation for foundation to occur less than a metre from trunk; conflict with new building and hydro lines
28	Basswood (<i>Tilia americana</i>)	34 cm	City	Good	Remove: excavation for foundation to occur less than a metre from trunk; conflict with new building and hydro lines
29	Basswood (<i>Tilia americana</i>)	30 cm	City	Good	Remove: excavation for foundation to occur less than a metre from trunk; conflict with new building and hydro lines

The proposed building will include a foundation that will require an excavation setback of 1.5 m from the foundation (as determined by the geotechnical engineers). The excavation would extend to within approximately 0.5 to 1.0 m from the city trees along Hunt Club (16, 17, 27, 28 and 29) and will cause significant root loss, possibly causing structural instability in some of the trees.

Figure 1: Trees 16 and 17, city-owned Colorado spruce and basswood

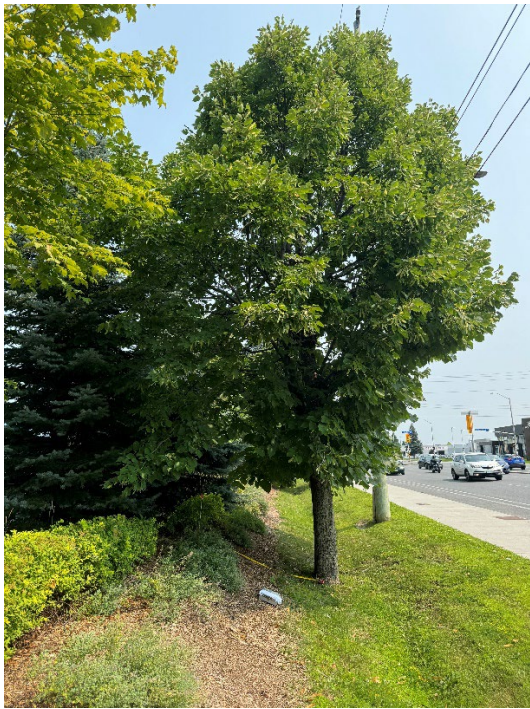
More importantly, however, is the conflict that the new building will have with the tree crowns, especially as they grow larger. All these trees are considered large-growing trees and can grow to double their current diameter, and more in crown area. Their crowns are currently restricted along Hunt Club as they were planted too close to the hydro lines and they will likely soon be pruned (possibly topped) by hydro crews as they expand in this direction. The building will be set back 2-2.5 m from the trees on the south side, leaving little space for their crowns. They would grow against the new building and require regular maintenance pruning. Furthermore, if scaffolding is required for the building construction, up to ½ of the crowns of the closer trees may require removal. Based on this limited spacing, retention of these trees is not recommended.

Figure 3: Tree 29, city owned basswood close to hydro lines

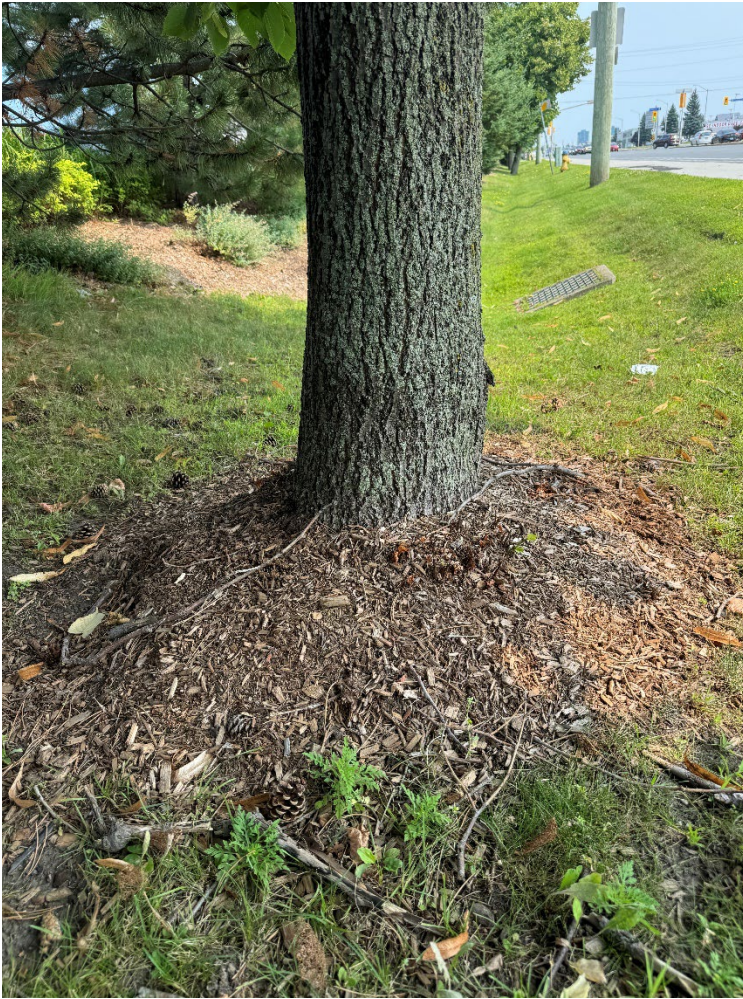
The city-owned trees (trees 16-29) are generally in good condition, but most had mulch piled high up against their trunks, commonly referred to as “volcano mulching”. This type of mulching retains moisture at the base of the tree and can lead to basal decay. Volcano mulching is prevalent along the site and should be removed from those trees that will be retained and avoided in future landscaping maintenance. Mulching can be helpful for trees as it retains moisture and nutrients, but it must be placed at a distance from the tree and avoid being in direct contact with the trunk. *Update: the mulch was removed from the base of the trees during the site visit on November 18, 2024.*

Figure 4: Example of volcano mulching prevalent throughout the site. Placing mulch directly along the tree trunk can lead to basal decay in trees.
