Tree Conservation Report Addendum

Submitted as part of Site Plan Control Application

Address: 415 Hunt Club
Date of Report: August 26, 2024
Date of Site Visit: August 15 and A`, 2024
Prepared by: Astrid Nielsen, RPF, ISA Certified Arborist ®
Client: Costco Headquarters
Contact: Jasmine Paoloni, P-Squared Concepts, planning@p2concepts.ca

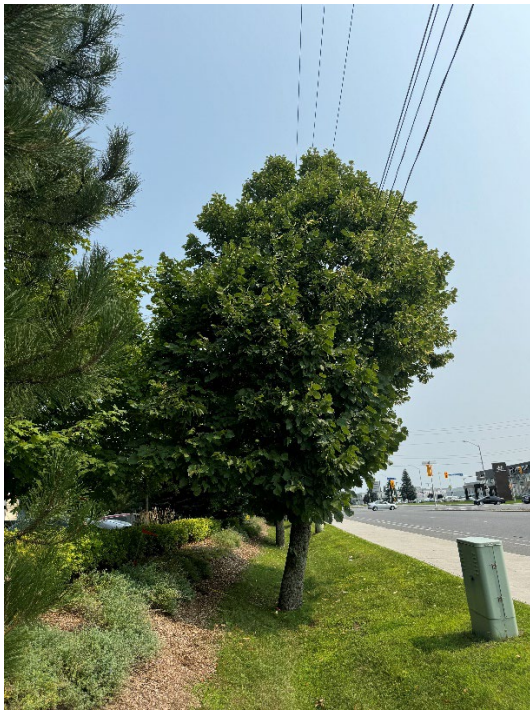
The proposed building will include a foundation that will require an excavation setback of 1.5 m from the foundation (as determined by the geotechnical engineers). The excavation would extend to within approximately 0.5 to 1.0 m from the city trees along Hunt Club (16, 17, 27, 28 and 29) and will cause significant root loss, possibly causing structural instability in some of the trees.

Figure 2: Tree 27, city-owned basswood leaning towards road and hydro lines

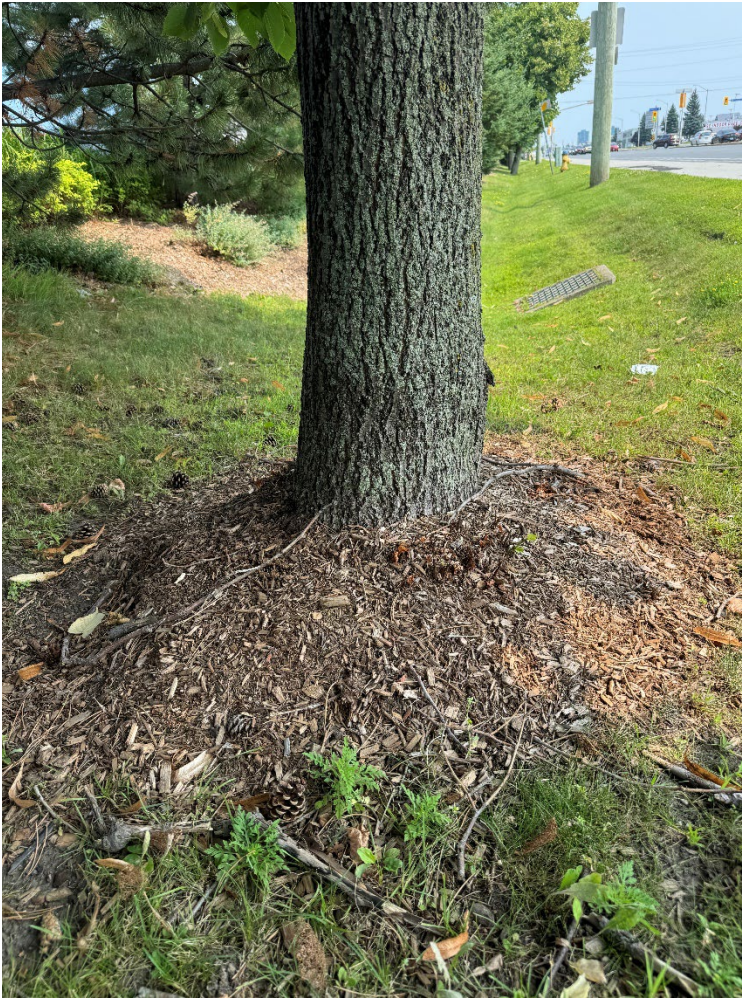
The city-owned trees (trees 16-29) are generally in good condition, but most had mulch piled high up against their trunks, commonly referred to as “volcano mulching”. This type of mulching retains moisture at the base of the tree and can lead to basal decay. Volcano mulching is prevalent along the site and should be removed from those trees that will be retained and avoided in future landscaping maintenance. Mulching can be helpful for trees as it retains moisture and nutrients, but it must be placed at a distance from the tree and avoid being in direct contact with the trunk.

Figure 4: Example of volcano mulching prevalent throughout the site. Placing mulch directly along the tree trunk can lead to basal decay in trees.
