STORM & SANITARY SEWERS
CCTV INSPECTION REPORT

Report: HYD-23153

Completion date: May 26th 2023

Project: Tower 3, Orleans- ON

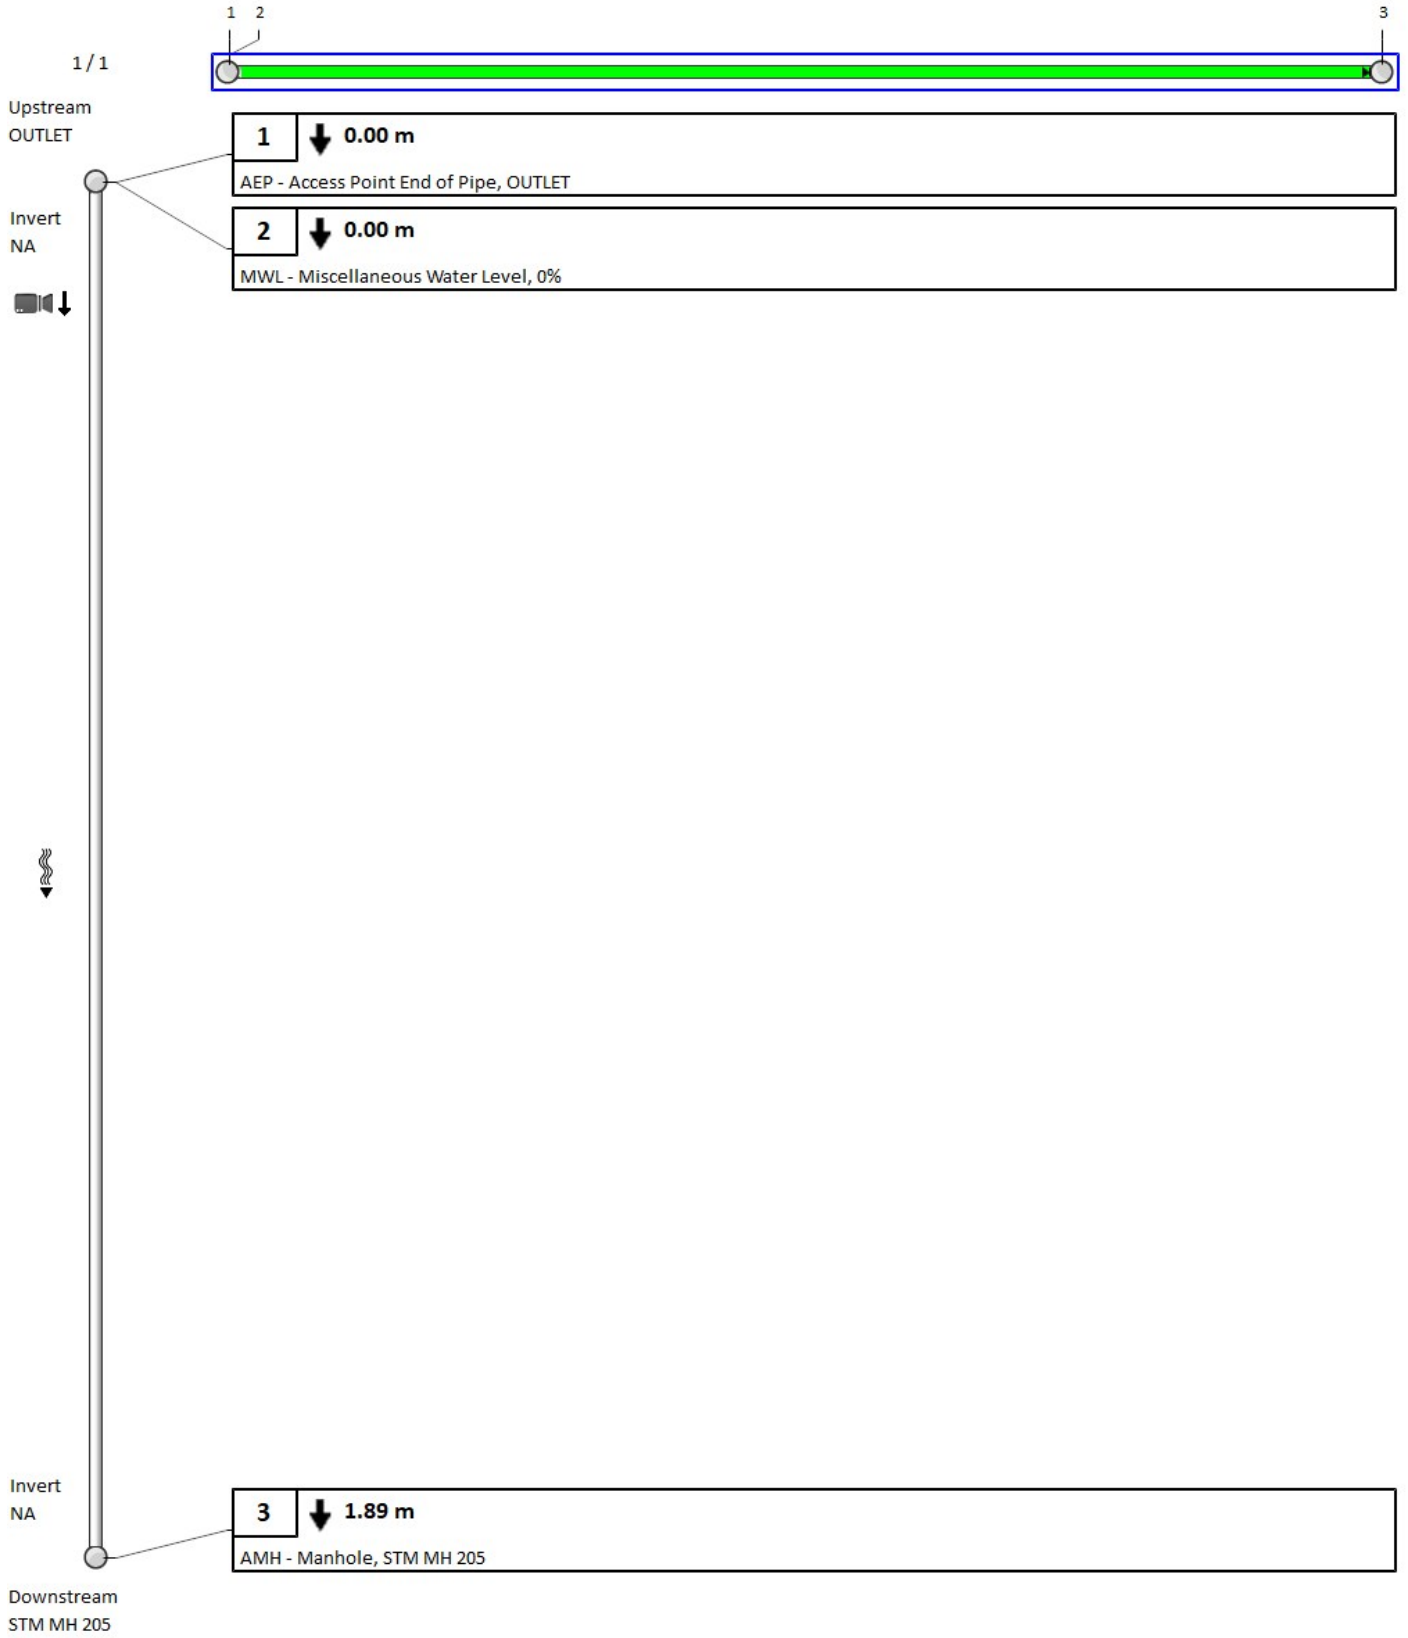
Pipe: OUTLET STM MH 205	Direction of inspection: OUTLET --> STM MH 205
Direction of flow: OUTLET --> STM MH 205	Direction: Direction of flow

Pipe Use: Stormwater Pipe	Surveyed Length: 1.89
Height: 450	Total length: 1.89
Width:	Joint length:
Shape: Circular	Rim/Inv.:
Material: Concrete Pipe (non-reinforced)	Grade/Inv.:
Lining:	Rim/Grade:
Coating Method:	Rim/Inv.:
Year Constructed:	Grade/Inv.:
Year renewed:	Rim/Grade:

Peak: 0	Peak: 0	Peak: 0	Consequence:
Quick rating: 0000	Quick rating: 0000	Quick rating: 0000	Likelihood: 1
Score: 0	Score: 0	Score: 0	Risk:
Index: 0	Index: 0	Index: 0

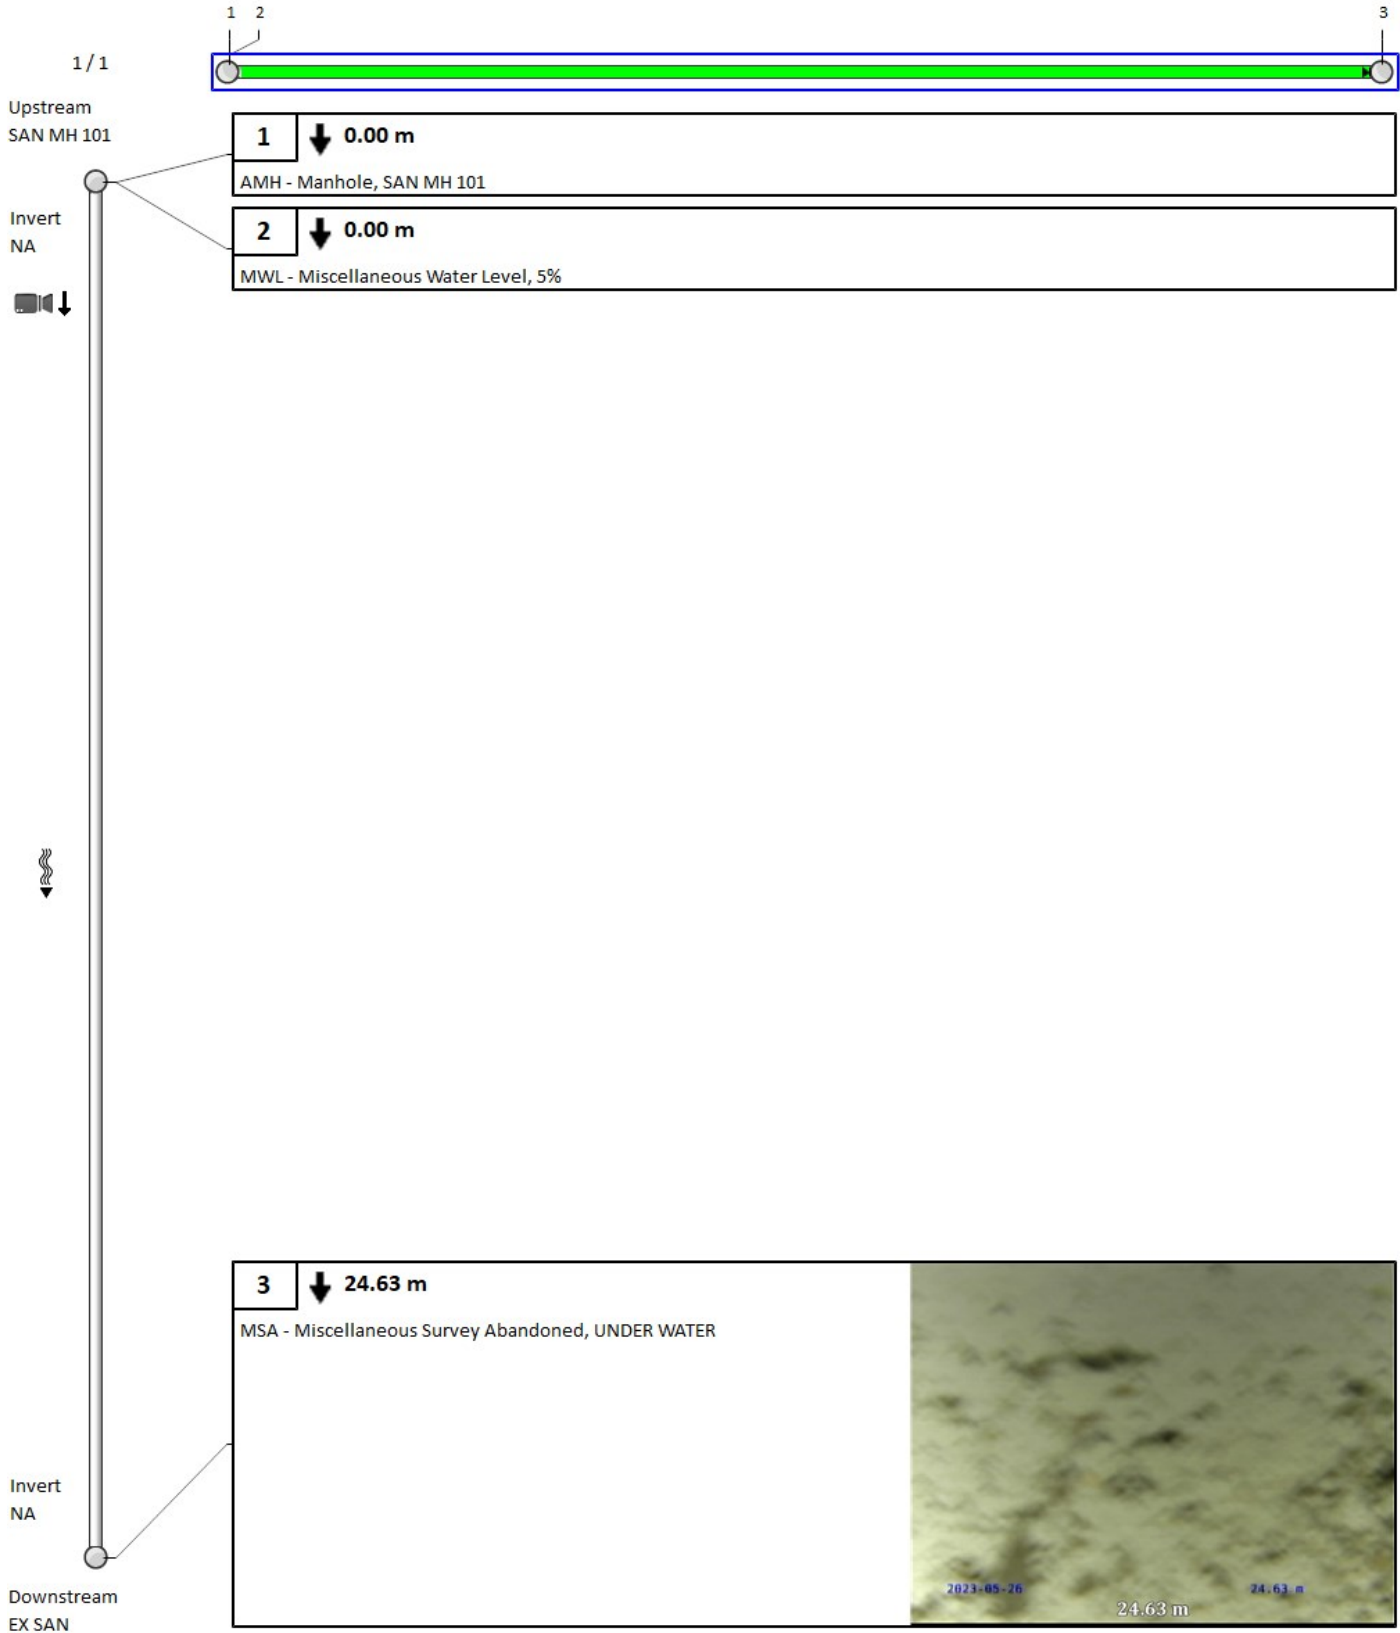
Pipe: SAN MH 101 EX SAN	Direction of inspection: SAN MH 101 --> EX SAN
Direction of flow: SAN MH 101 --> EX SAN	Direction: Direction of flow

Pipe Use: Sanitary Sewage Pipe	Surveyed Length: 24.63
Height: 300	Total length: 24.63
Width:	Joint length:
Shape: Circular	Rim/Inv.:
Material: Polyvinyl Chloride	Grade/Inv.:
Lining:	Rim/Grade:
Coating Method:	Rim/Inv.:
Year Constructed:	Grade/Inv.:
Year renewed:	Rim/Grade:

Structural rating	O&M rating	Overall rating	Failure
Peak: 0	Peak: 0	Peak: 0	Consequence:
Quick rating: 0000	Quick rating: 0000	Quick rating: 0000	Likelihood: 1
Score: 0	Score: 0	Score: 0	Risk:
Index: 0	Index: 0	Index: 0

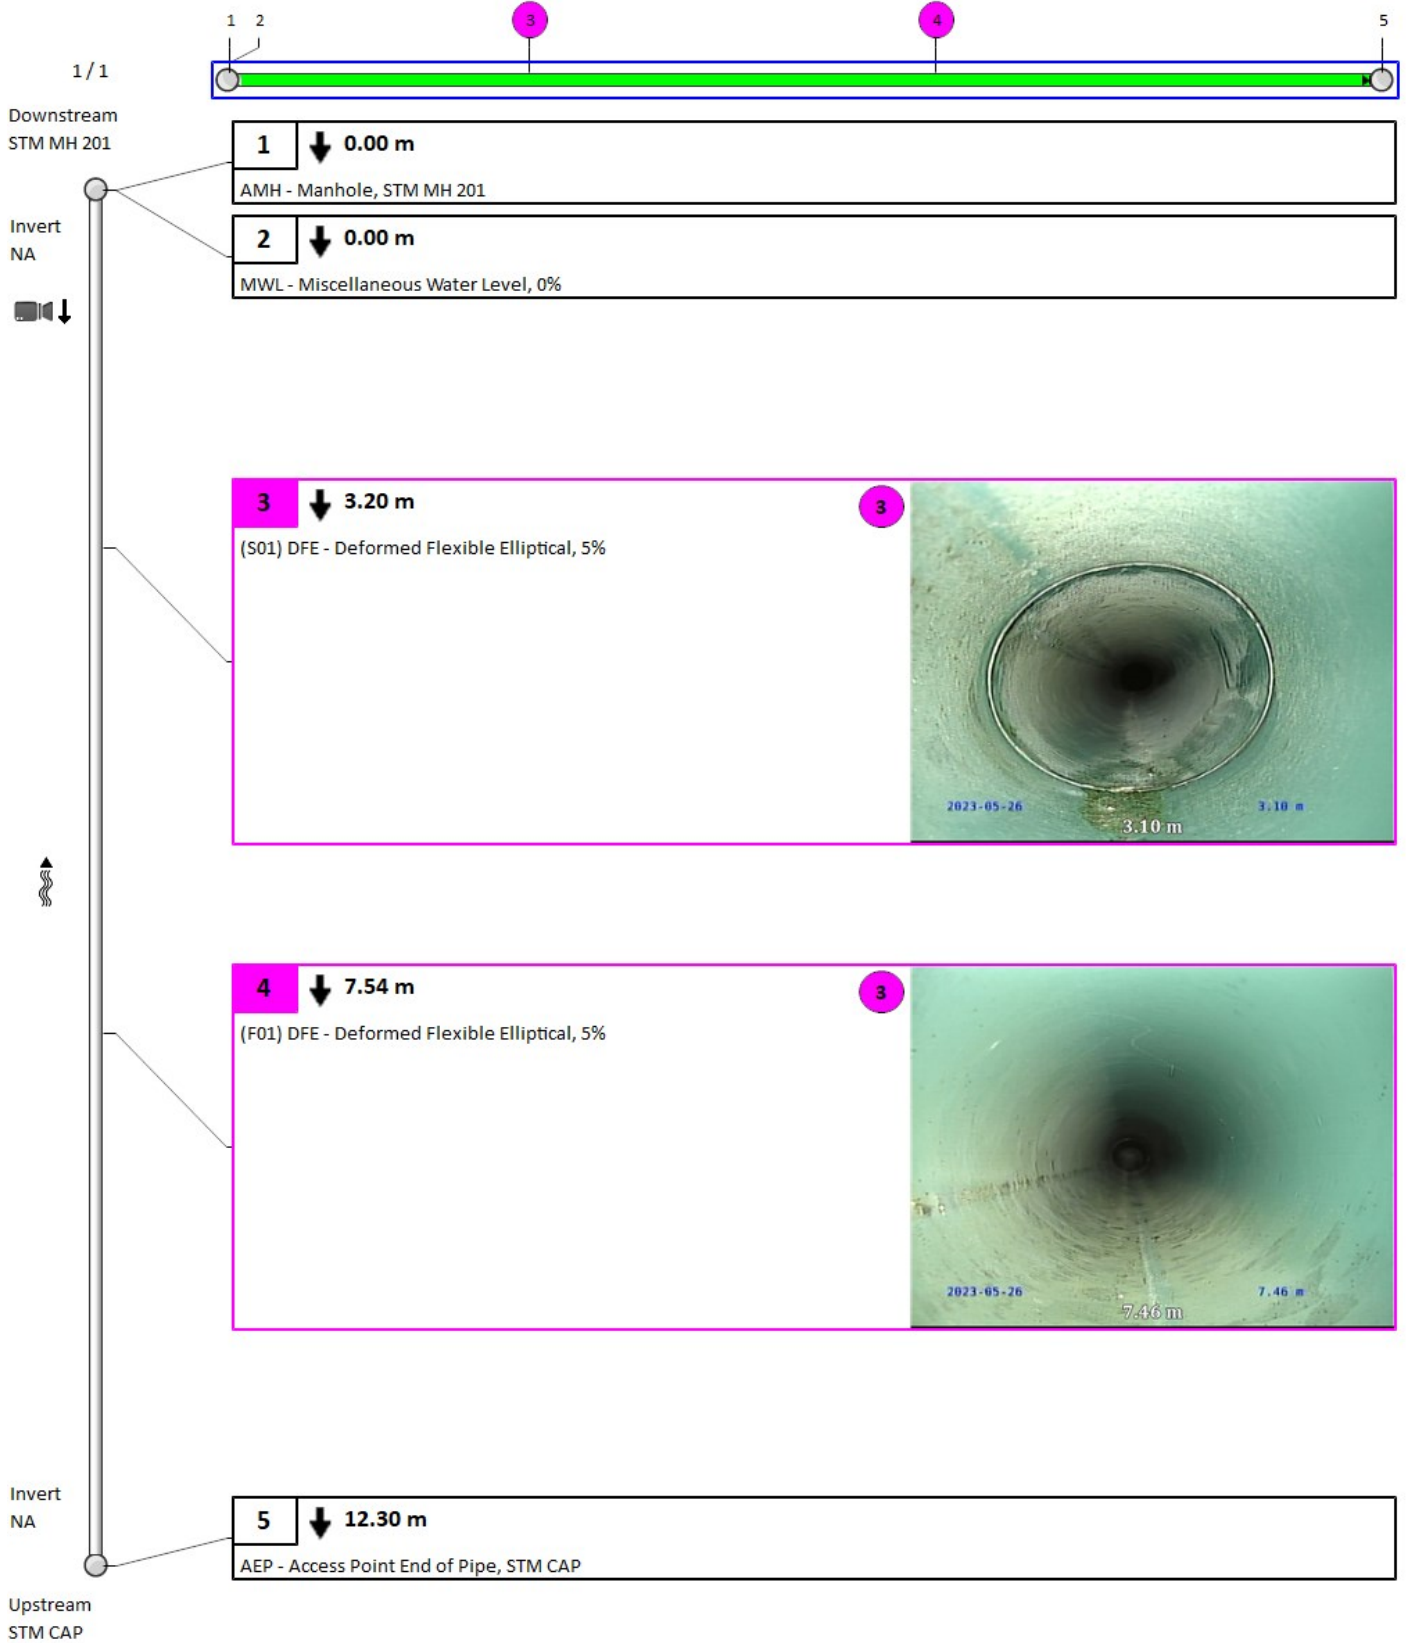
Pipe: STM CAP STM MH 201	Direction of inspection: STM MH 201 --> STM CAP
Direction of flow: STM CAP --> STM MH 201	Direction: Against flow

Pipe Use: Stormwater Pipe	Surveyed Length: 12.3
Height: 200	Total length: 12.3
Width:	Joint length:
Shape: Circular	Rim/Inv.:
Material: Polyvinyl Chloride	Grade/Inv.:
Lining:	Rim/Grade:
Coating Method:	Rim/Inv.:
Year Constructed:	Grade/Inv.:
Year renewed:	Rim/Grade:

Structural rating	O&M rating	Overall rating	Failure
Peak: 3	Peak: 0	Peak: 3	Consequence:
Quick rating: 3300	Quick rating: 0000	Quick rating: 3300	Likelihood: 3.3
Score: 9	Score: 0	Score: 9	Risk:
Index: 3	Index: 0	Index: 3

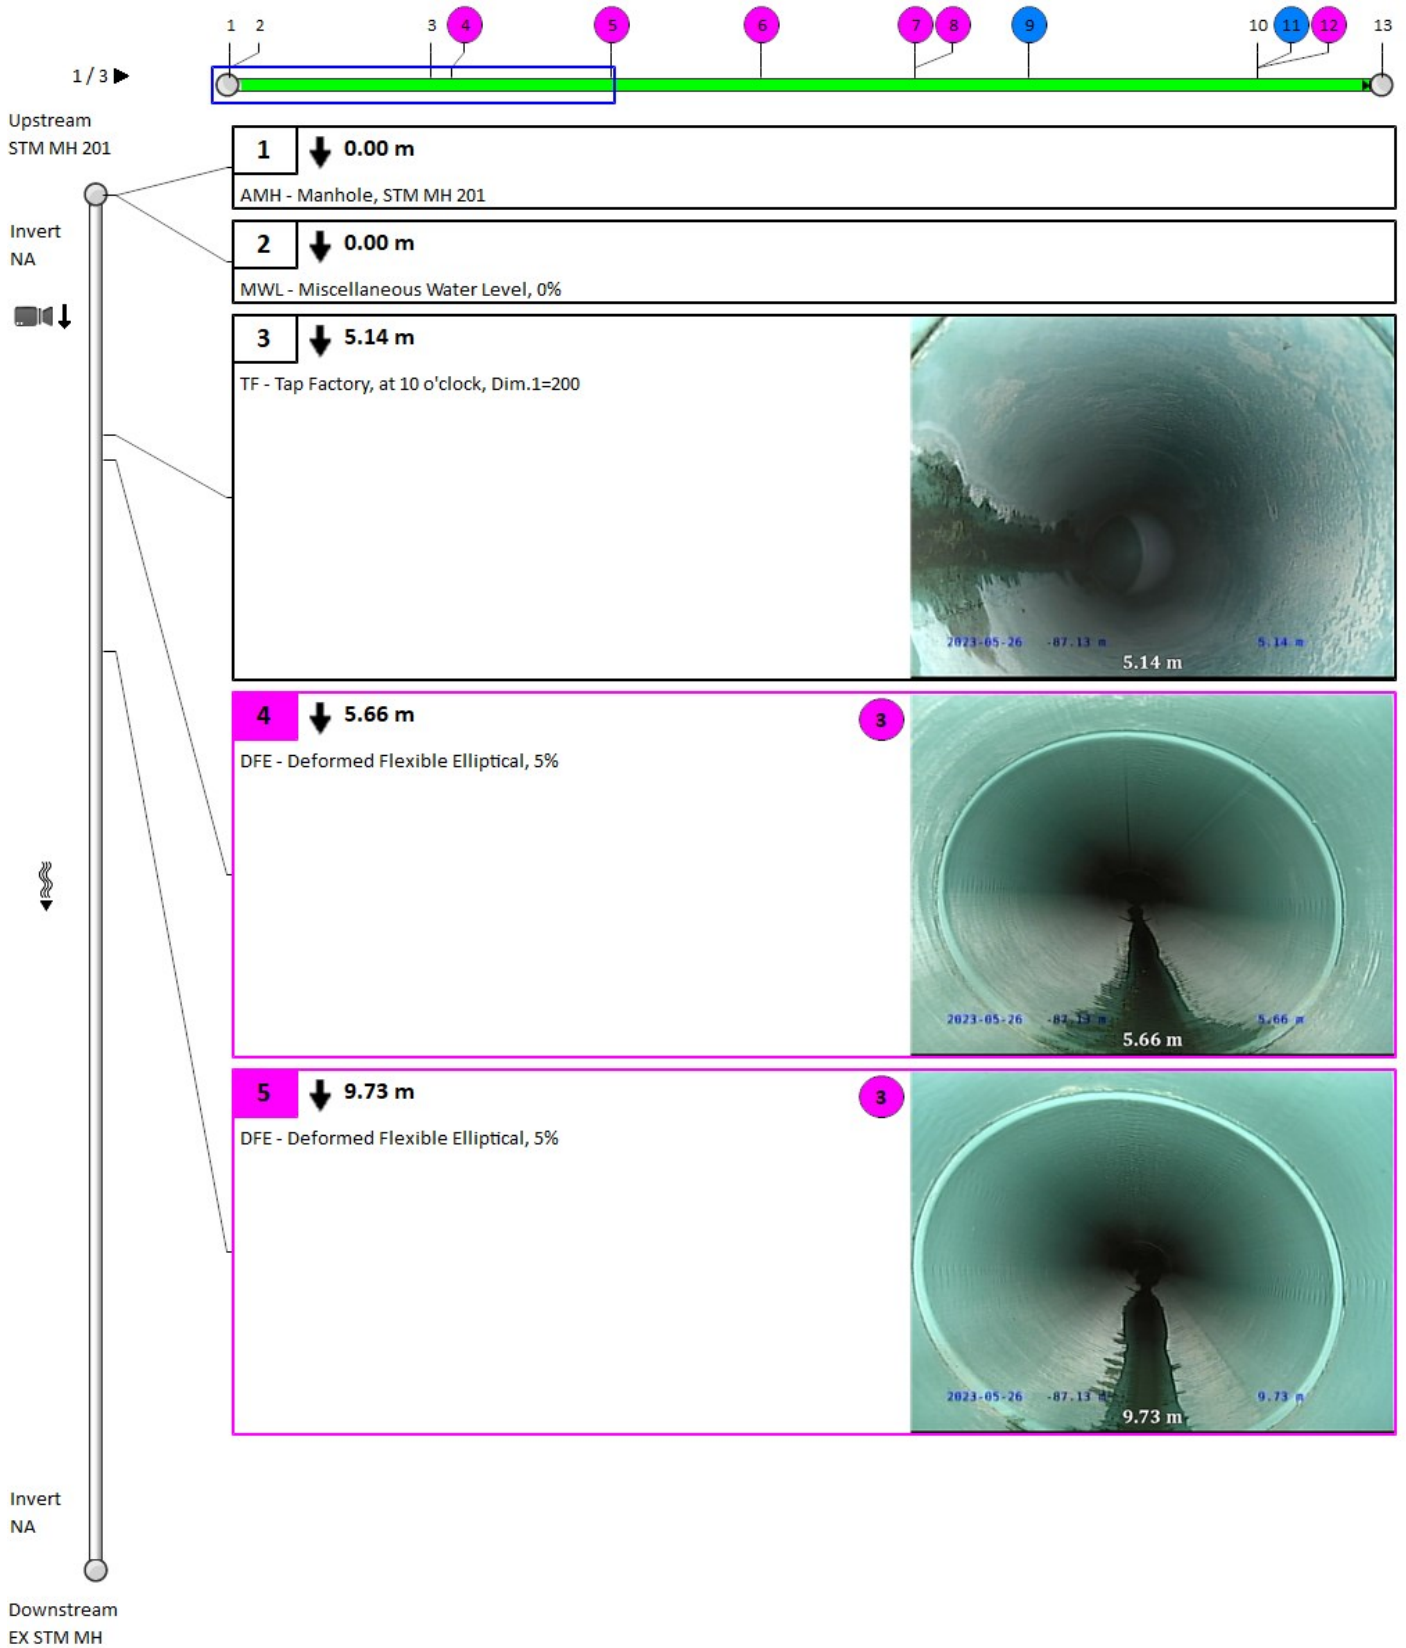
Pipe: STM MH 201 EX STM MH	Direction of inspection: STM MH 201 --> EX STM MH
Direction of flow: STM MH 201 --> EX STM MH	Direction: Direction of flow

Pipe Use: Stormwater Pipe	Surveyed Length: 29.33
Height: 375	Total length: 29.33
Width:	Joint length:
Shape: Circular	Rim/Inv.:
Material: Polyvinyl Chloride	Grade/Inv.:
Lining:	Rim/Grade:
Coating Method:	Rim/Inv.:
Year Constructed:	Grade/Inv.:
Year renewed:	Rim/Grade:

Structural rating	O&M rating	Overall rating	Failure
Peak: 3	Peak: 0	Peak: 3	Consequence:
Quick rating: 3A24	Quick rating: 0000	Quick rating: 3A24	Likelihood: 4
Score: 41	Score: 0	Score: 41	Risk:
Index: 2.7	Index: 0	Index: 2.7

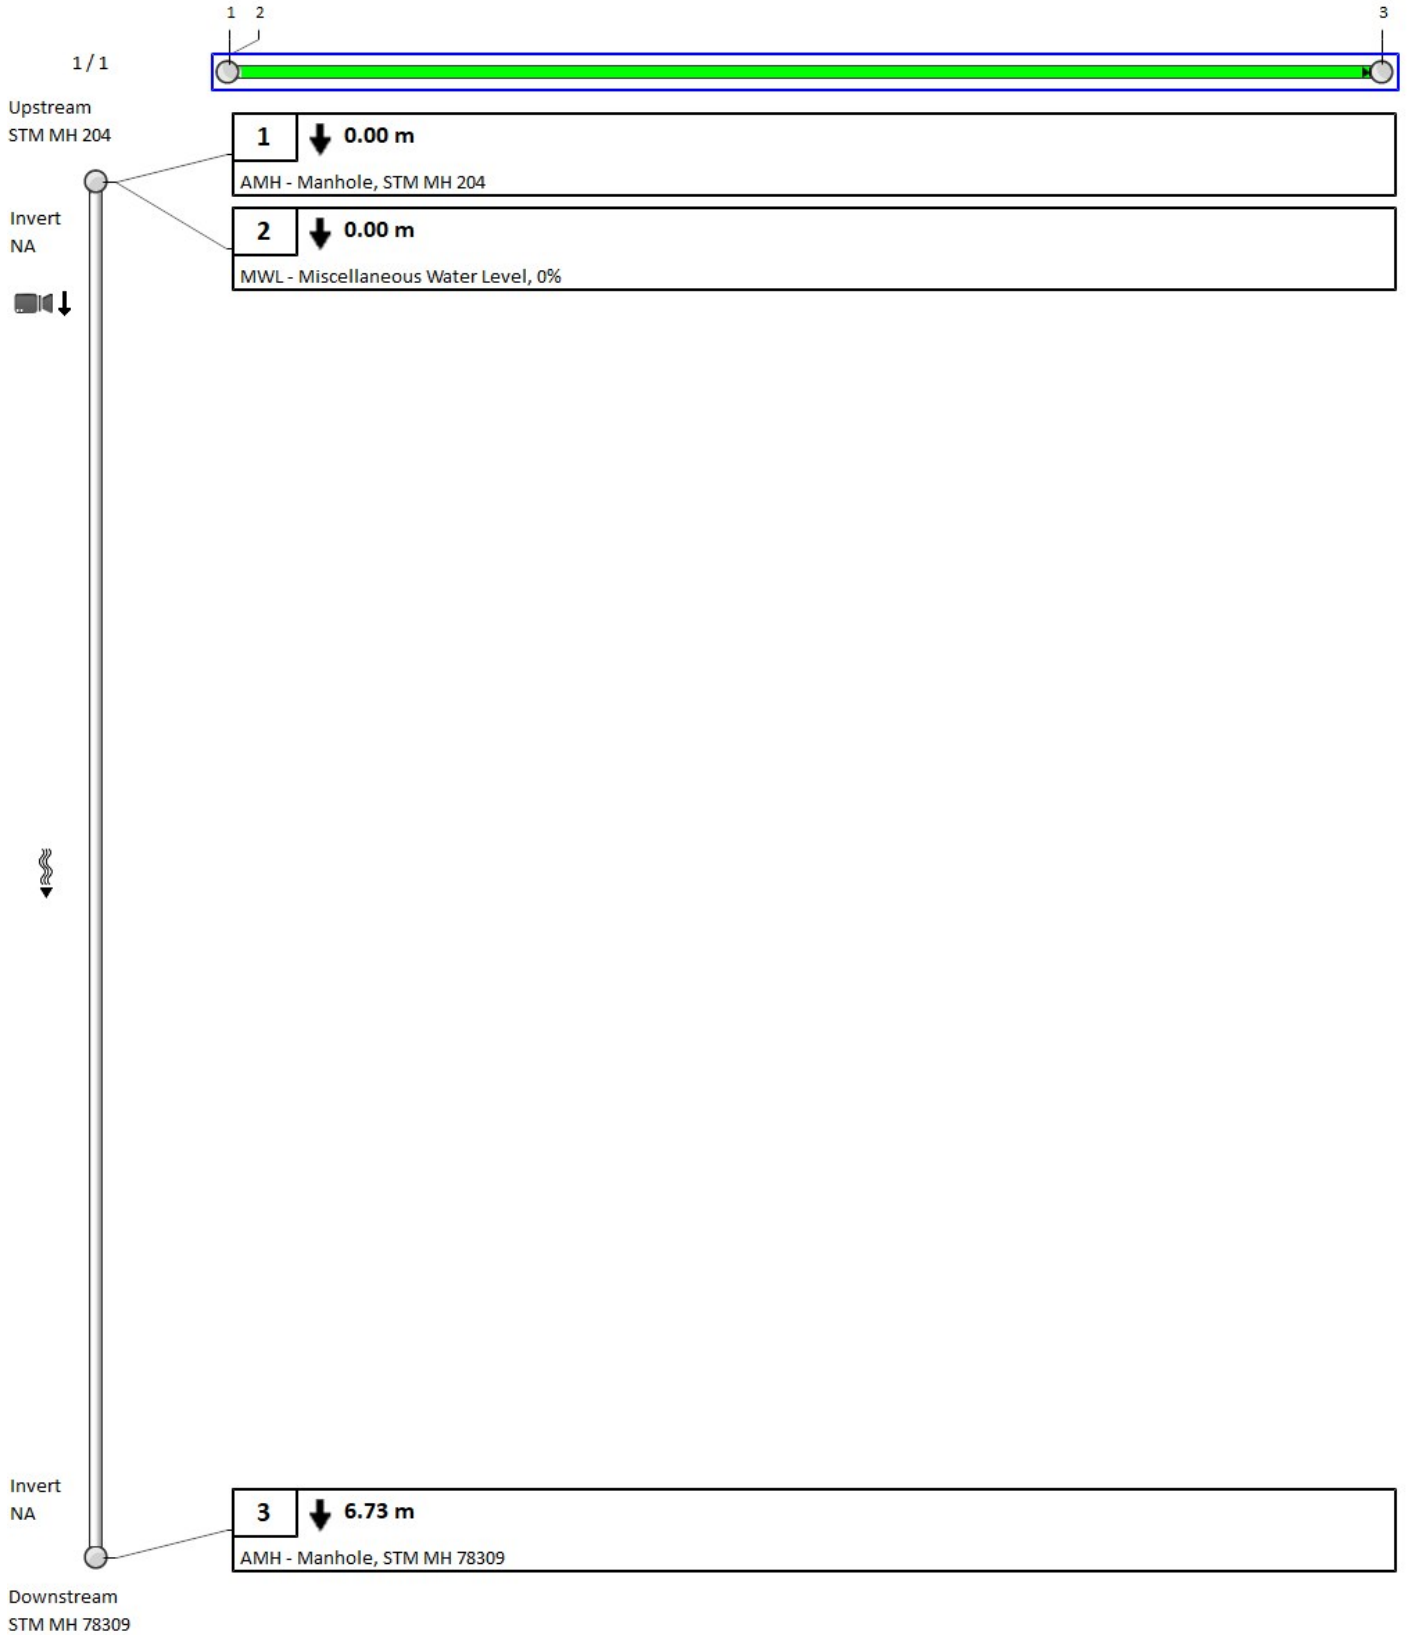
Pipe: STM MH 204 STM MH 78309	Direction of inspection: STM MH 204 --> STM MH 78309
Direction of flow: STM MH 204 --> STM MH 78309	Direction: Direction of flow

Pipe Use: Stormwater Pipe	Surveyed Length: 6.73
Height: 525	Total length: 6.73
Width:	Joint length:
Shape: Circular	Rim/Inv.:
Material: Concrete Pipe (non-reinforced)	Grade/Inv.:
Lining:	Rim/Grade:
Coating Method:	Rim/Inv.:
Year Constructed:	Grade/Inv.:
Year renewed:	Rim/Grade:

Peak: 0	Peak: 0	Peak: 0	Consequence:
Quick rating: 0000	Quick rating: 0000	Quick rating: 0000	Likelihood: 1
Score: 0	Score: 0	Score: 0	Risk:
Index: 0	Index: 0	Index: 0

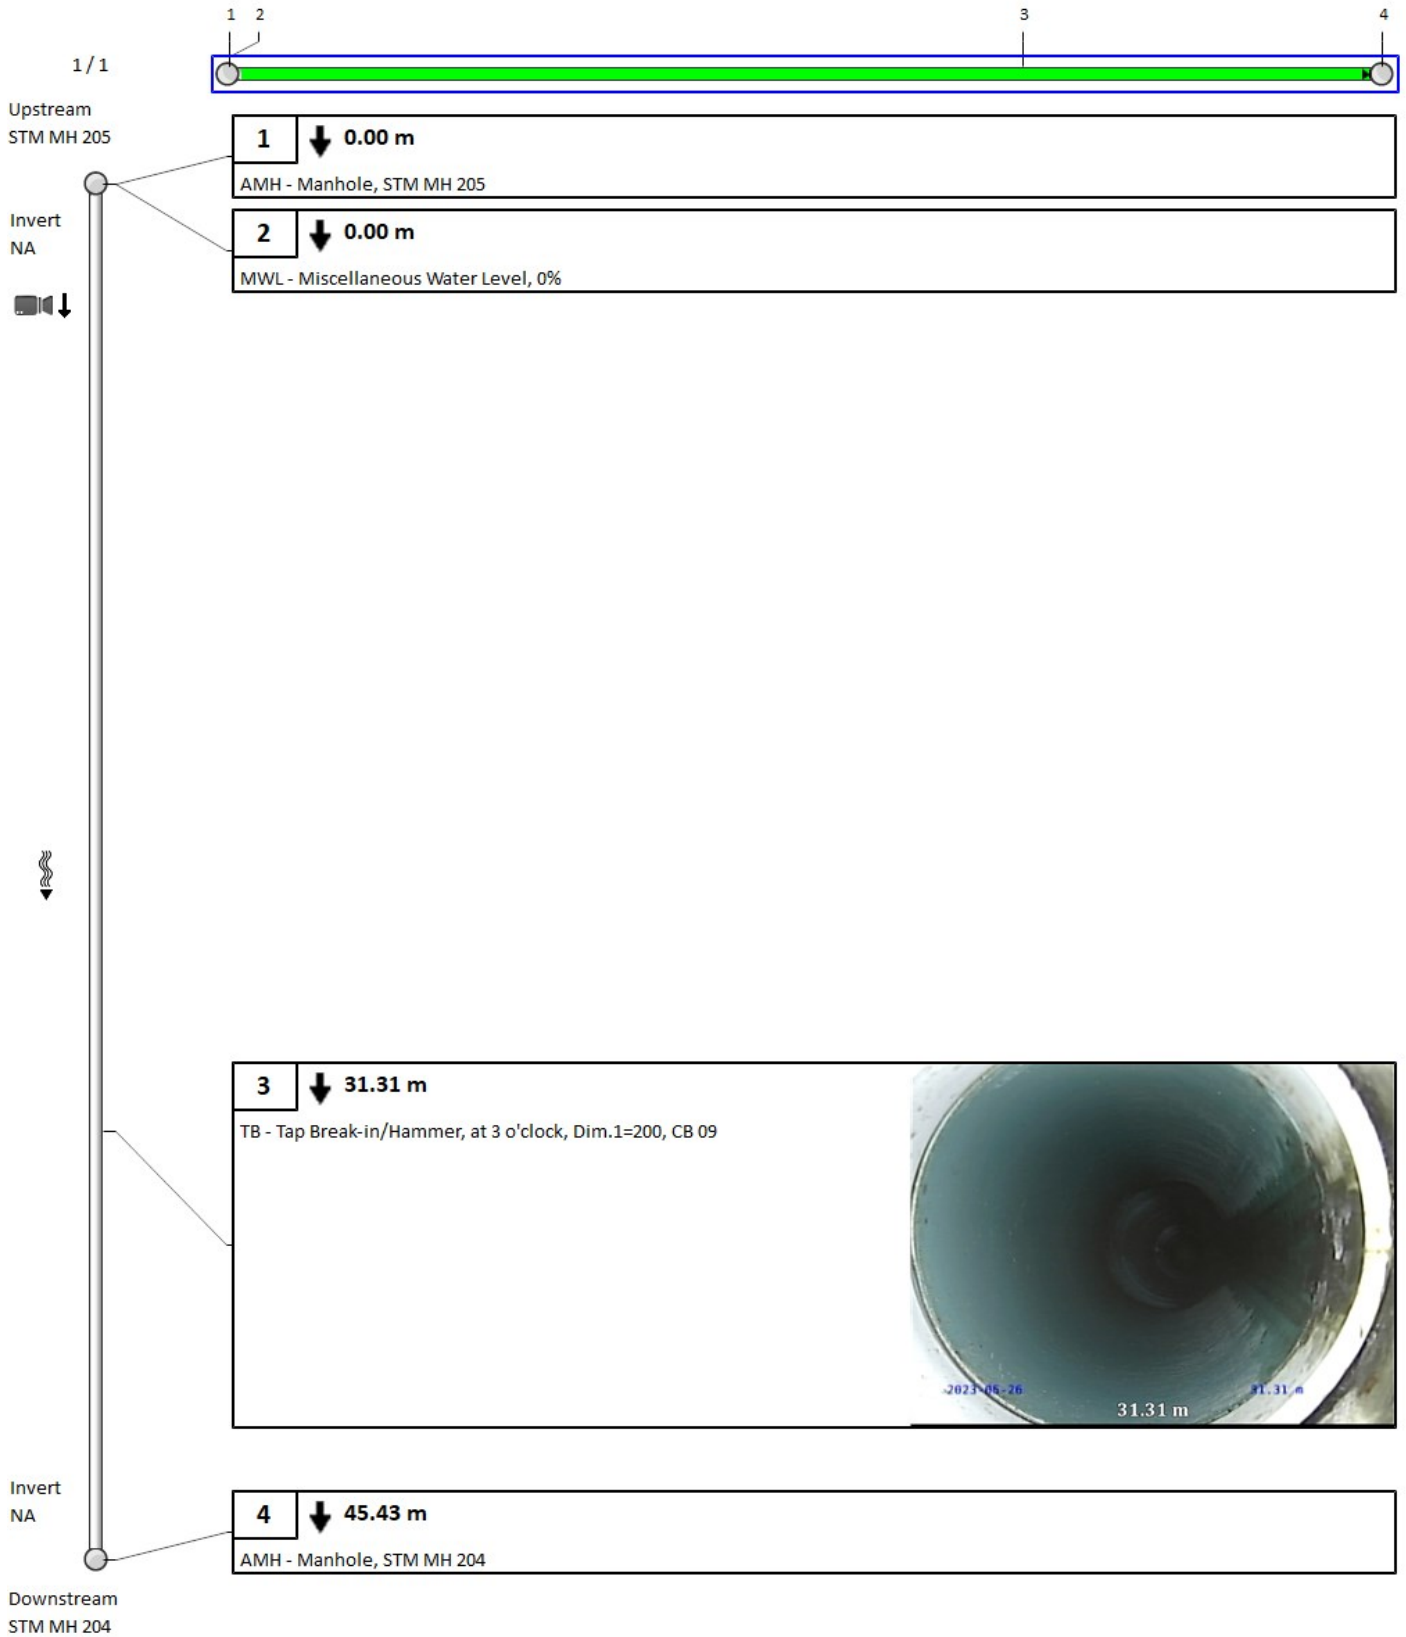
Pipe: STM MH 205 STM MH 204	Direction of inspection: STM MH 205 --> STM MH 204
Direction of flow: STM MH 205 --> STM MH 204	Direction: Direction of flow

Pipe Use: Stormwater Pipe	Surveyed Length: 45.43
Height: 525	Total length: 45.43
Width:	Joint length:
Shape: Circular	Rim/Inv.:
Material: Concrete Pipe (non-reinforced)	Grade/Inv.:
Lining:	Rim/Grade:
Coating Method:	Rim/Inv.:
Year Constructed:	Grade/Inv.:
Year renewed:	Rim/Grade:

Structural rating		O&M rating		Overall rating		Failure	
Peak: 0	Quick rating: 0000	Peak: 0	Quick rating: 0000	Peak: 0	Quick rating: 0000	Consequence:	Likelihood: 1
Score: 0	Index: 0	Score: 0	Index: 0	Score: 0	Index: 0	Risk:
