# Landslide Hazard Assessment

**Proposed Residential Development**

2983, 3053 and 3079 Navan Road Ottawa, Ontario

Prepared for EXP Services Inc. (c/o 12714001 Canada Inc.)

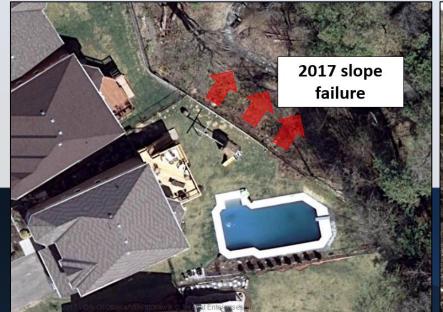
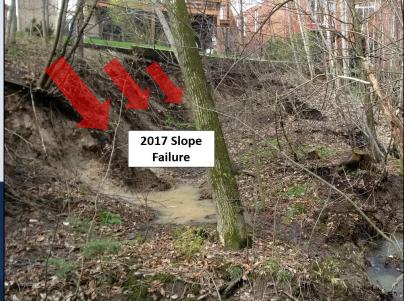
- 2017 slope failure
- Emergency repair: rock fill material
- Blue Willow Class Environmental Assessment initiated in 2020
- Rupture de pente en 2017
- Réparation d'urgence (enrochement)
- Évaluation environnementale municipale de portée générale du parc Blue Willow entreprise en 2020

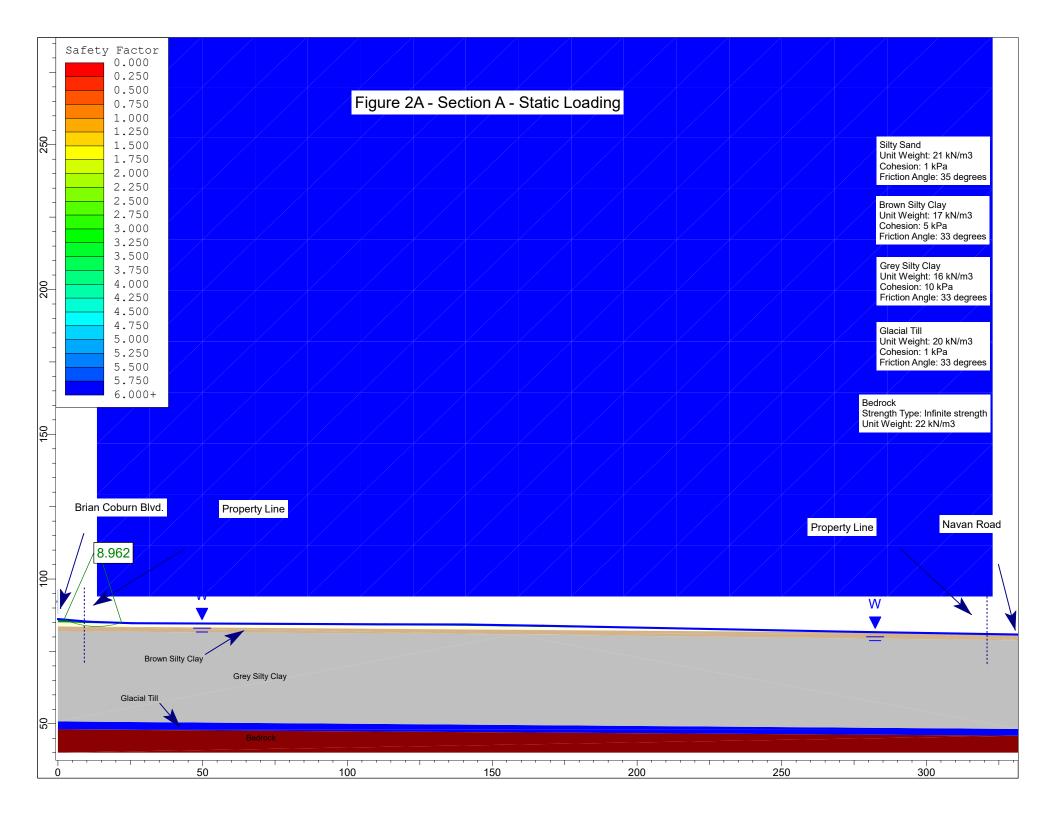
The results of the static analysis for the proposed slope under fully saturated conditions (worst-case-scenario) are shown in Figure 2A and 3A attached to the current report. The minimum analysed slope stability factor of safety under fully saturated conditions (worst case scenario) were calculated to be greater than 1.5.

As a result, the two slope cross-sections analyzed were all above the recommended Factor of Safety of 1.5 and are considered stable under static conditions.

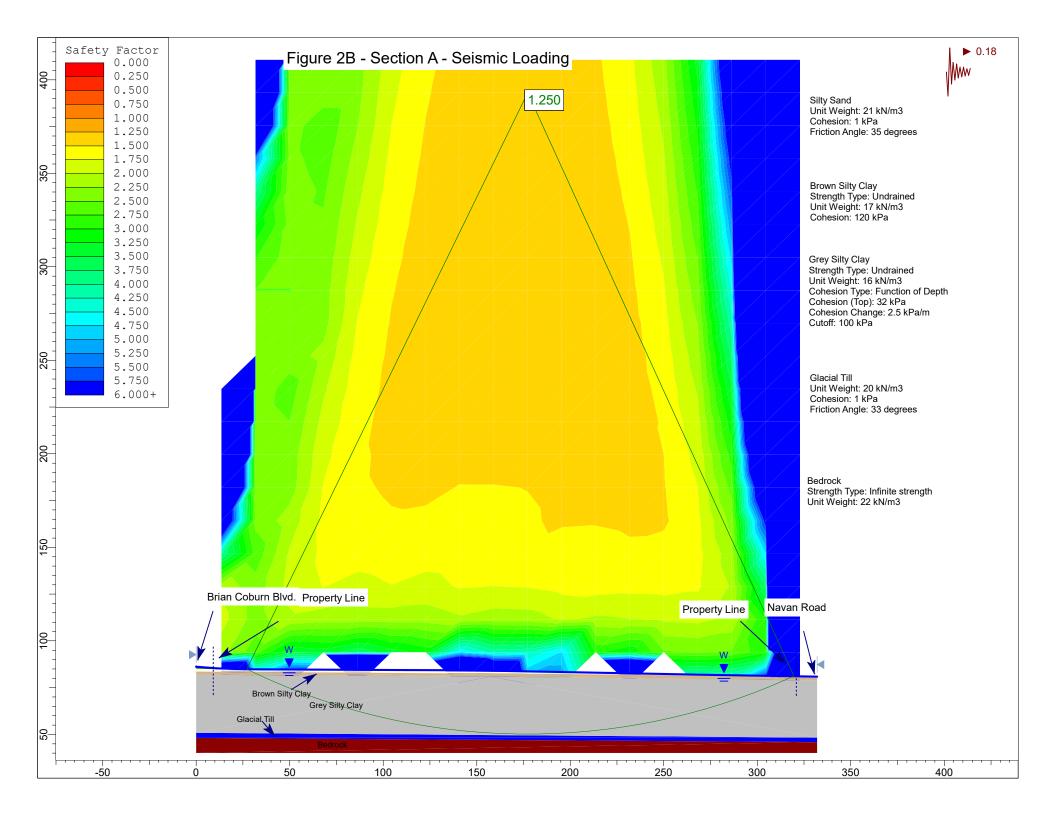
The results of the analysis including seismic loading fully saturated conditions (worst-case-scenario) are shown in Figure 2B and 3B attached to the current report.

The overall slope stability factor of safety at the three slope cross-sections when considering seismic loading was found to be greater than 1.1 which is considered to be stable under seismic loading.
