Muncaster  
Environmental  
Planning Inc.

**RE: 2983 Navan Road (at Brian Coburn Boulevard)**  
**Block 16 (Gas Station) - Review of Boundary Trees - Updated**

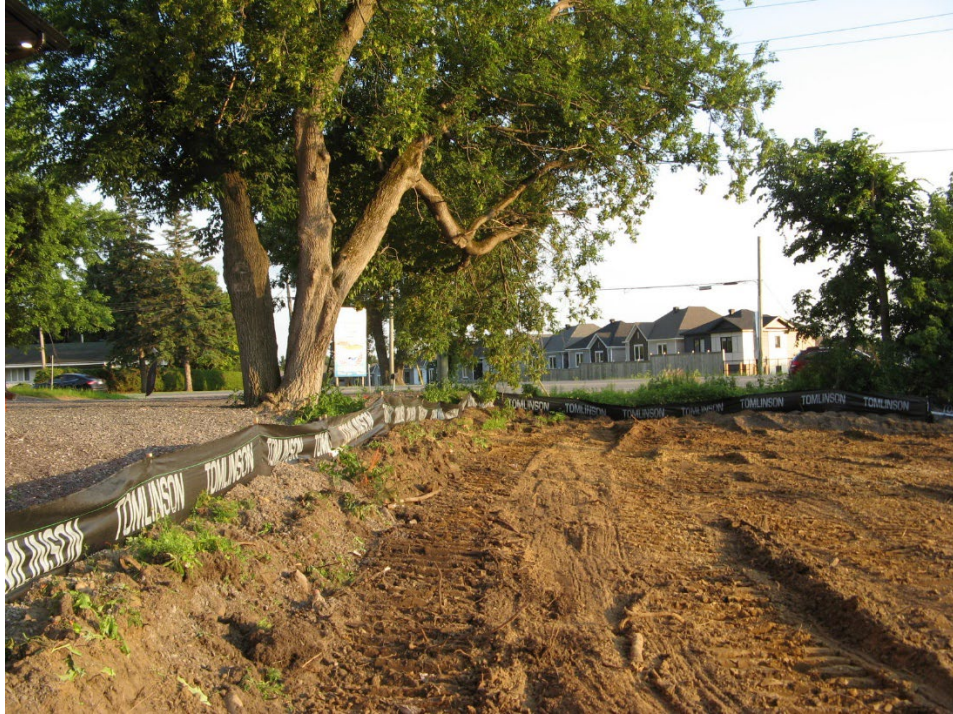
*Photo 3 – Silt fencing and initial regrading adjacent to Tree ‘A’.  
View looking south to Navan Road*

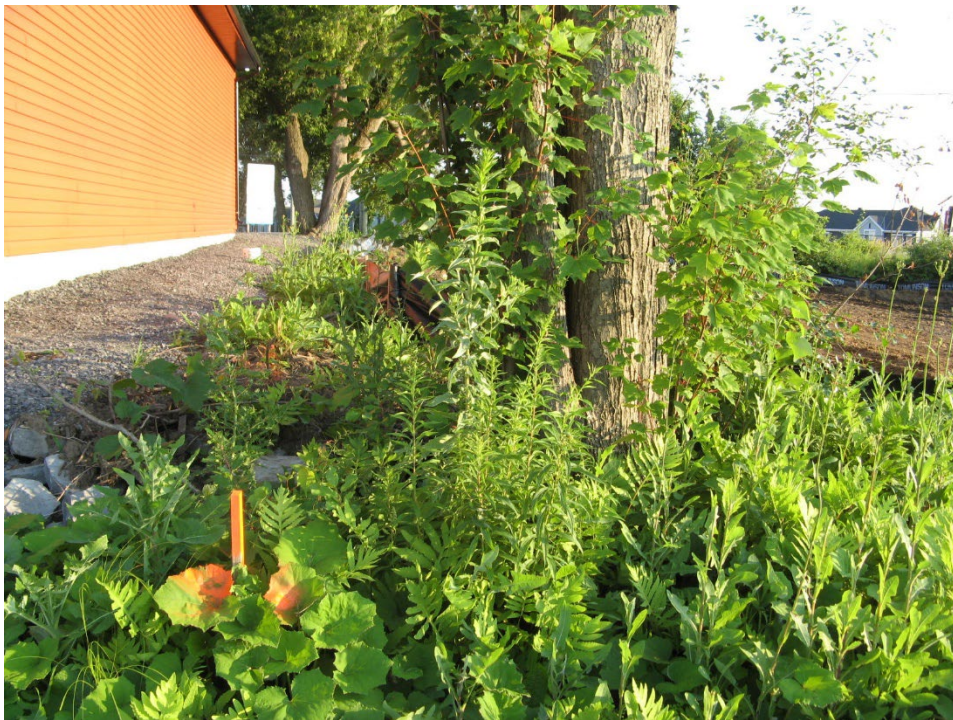
| Tree Letter | Species | dbh (cm) | Condition and Comments | Location |
|---|---|---|---|---|
| B | Red maple | 42 | Appears to be in good condition, with good leaf-out. Protected with silt fencing during initial regrading and no root exposure of note observed. | On-site, to be removed (Photo 4) |

*Photo 4 - Tree ‘B’, showing on-site location relative to stake on property line.  
View looking south*

Trees 'B' and 'E' are on-site but were not removed as the trees could not be accessed at the time of the tree removal. This material has now been removed and the trees will be removed as part of the subdivision development.

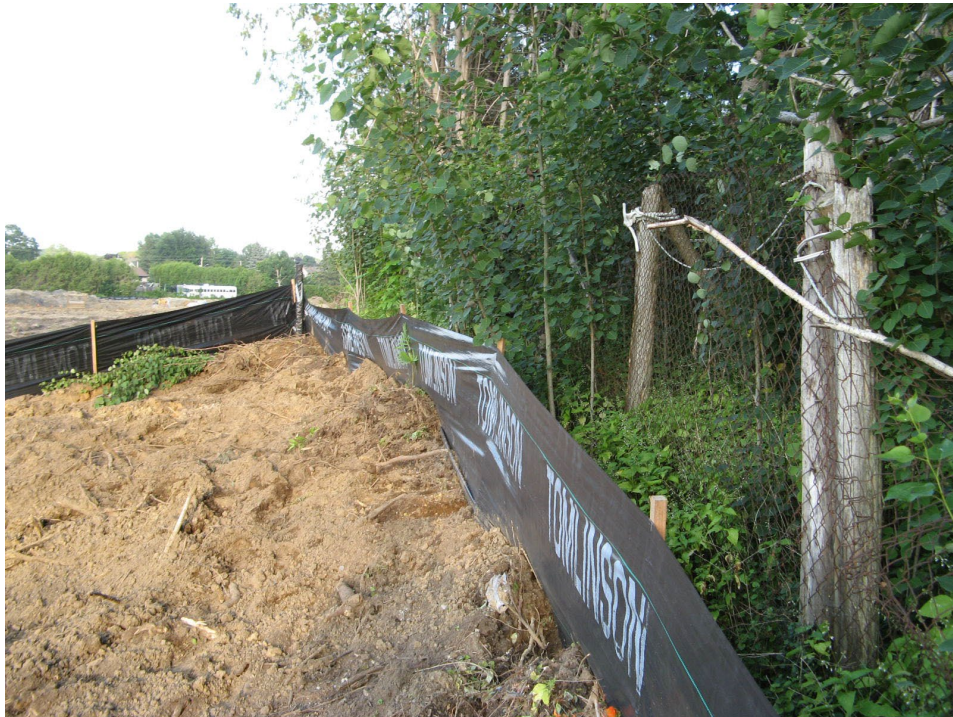
*Photo 5 – Typical initial regrading and silt fencing adjacent to the rear (north) of 2993 and 2997 Navan Road. View looking east*

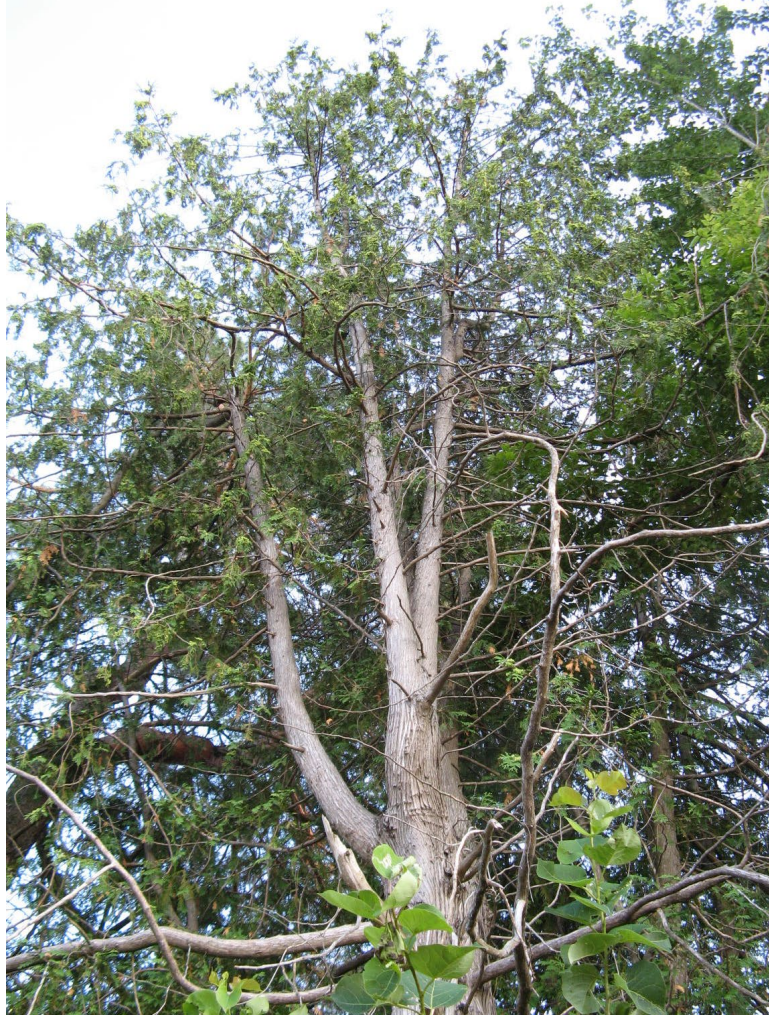
| Tree Letter | Species | dbh (cm) | Condition and Comments | Location |
|---|---|---|---|---|
| F | White cedar (Photo 6) | 42 | Some exposure of roots up to 4 cm following adjacent on-site initial regrading. Lacks a dominant leader and many of the lateral branches have poor needle coverage. | 2.5m south of site, with additional 60cm to silt fencing |

*Photo 6 – White cedar Tree ‘F’ at the rear of 2997 Navan Road. View looking south*

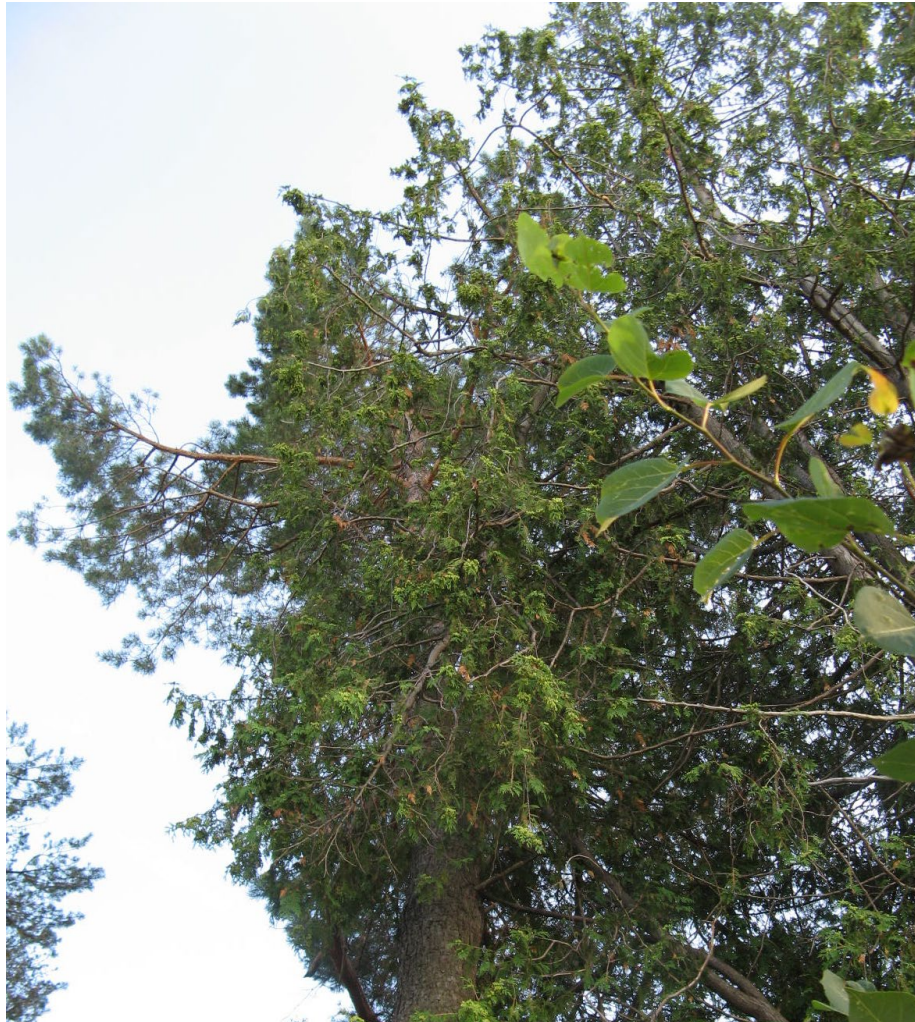
| Tree Letter | Species | dbh (cm) | Condition and Comments | Location |
|---|---|---|---|---|
| G | Scot's pine (Photo 7) | 40 | Good needle coverage and structure, with some trunk leaning. No root exposure of note after adjacent on-site initial regrading | 3cm south of site, with additional 70cm to silt fencing |

*Photo 7 – Scot's pine Tree 'G' at the rear of 2997 Navan Road. View looking southeast*
