Landslide Hazard Assessment

Proposed Residential Development

2983, 3053 and 3079 Navan Road
Ottawa, Ontario

Report PG6142-1 Revision 2 dated January 30, 2025

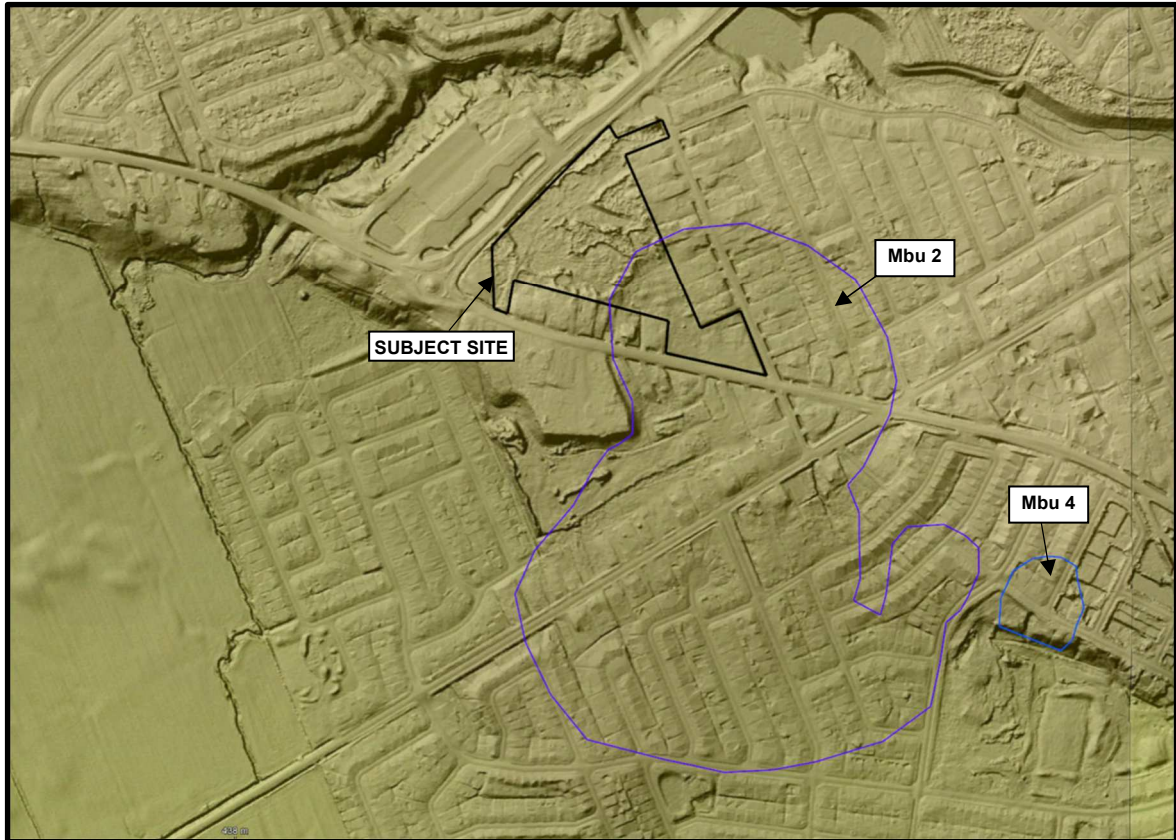
Figure 1 – LiDAR Image of Subject Site and closest documented landslides.

Given the above, there are several other landslide scars in relatively close proximity to the subject site which could indicate landslide susceptibility in the area of the subject site based on historical landslide inventory. Therefore, it is considered appropriate to increase the baseline probability for landslides to occur throughout the subject site by a factor of 2 in Section 4.3 – Hazard Assessment of this report.

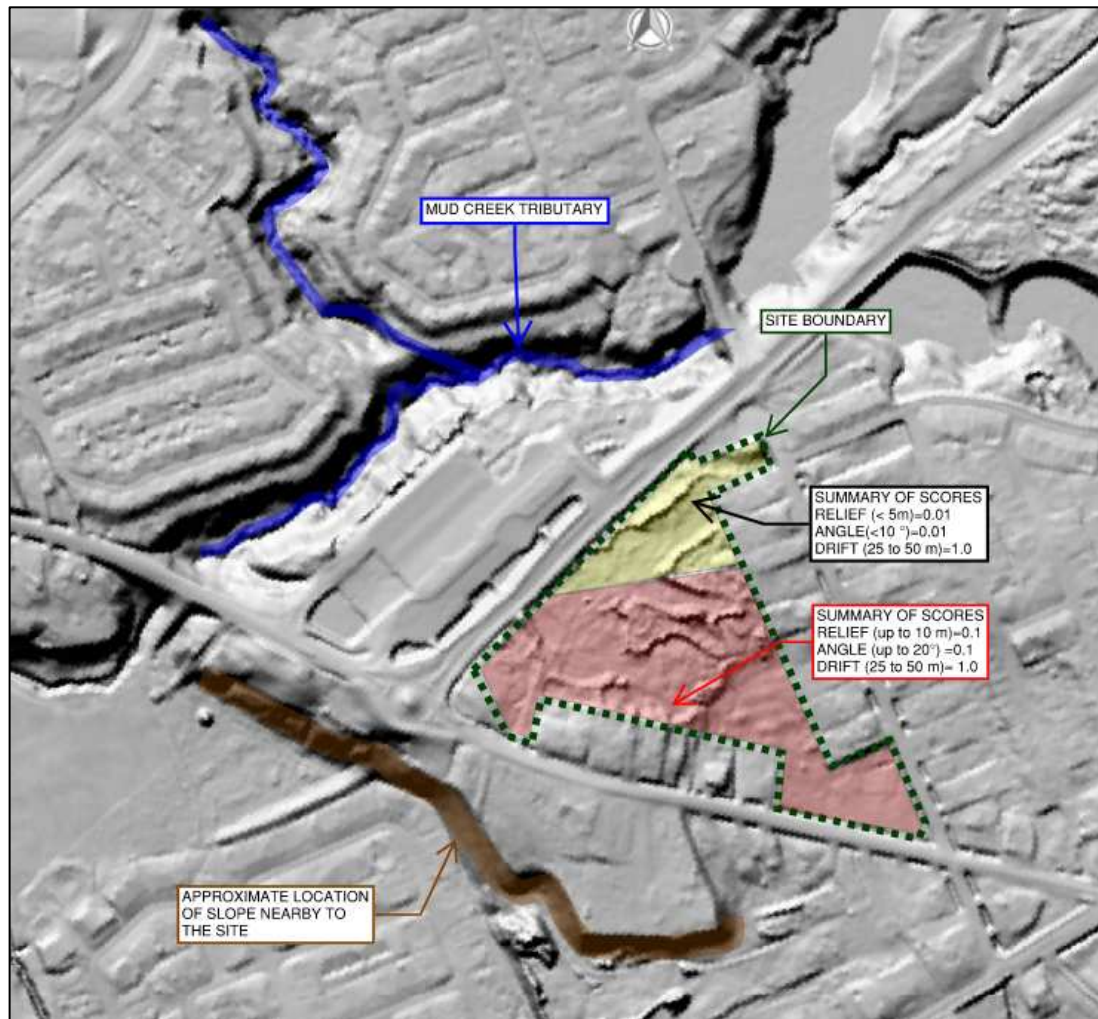
Figure 3 - Summary of Drift Thickness, Surface Relief, and Slope Angle Weight Factors

Based on this, the probability for a landslide to occur throughout the subject site would be the cumulative site-specific probability which has been adjusted for the drift thickness, topographic relief and slope angle weight factors applicable throughout each portion of the subject site. Since these attributes vary along the property, the associated weight would be modified for each considered portion of the site, and as discussed in Section 4.2.2 of this report.

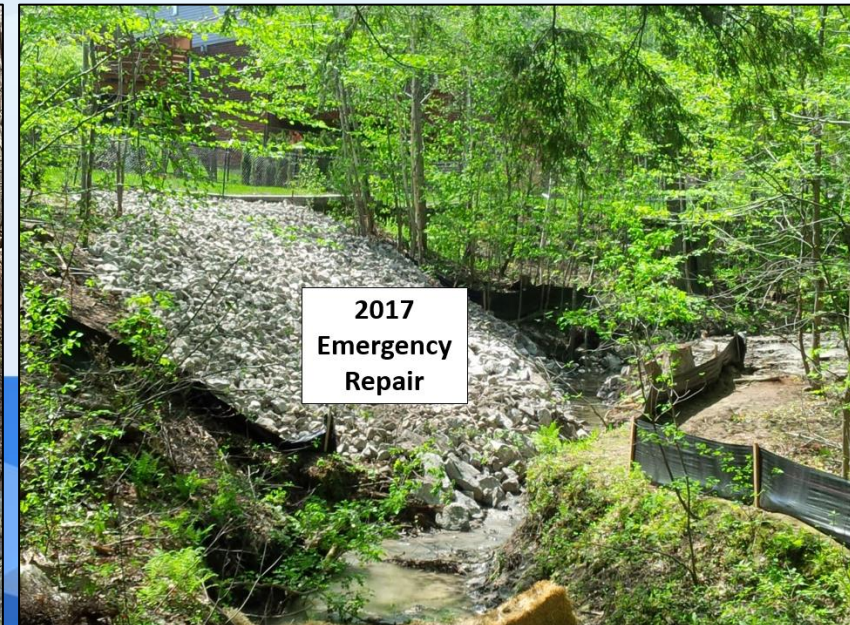
- 2017 slope failure
- Emergency repair: rock fill material
- Blue Willow Class Environmental Assessment initiated in 2020
- Rupture de pente en 2017
- Réparation d'urgence (enrochement)
- Évaluation environnementale municipale de portée générale du parc Blue Willow entreprise en 2020

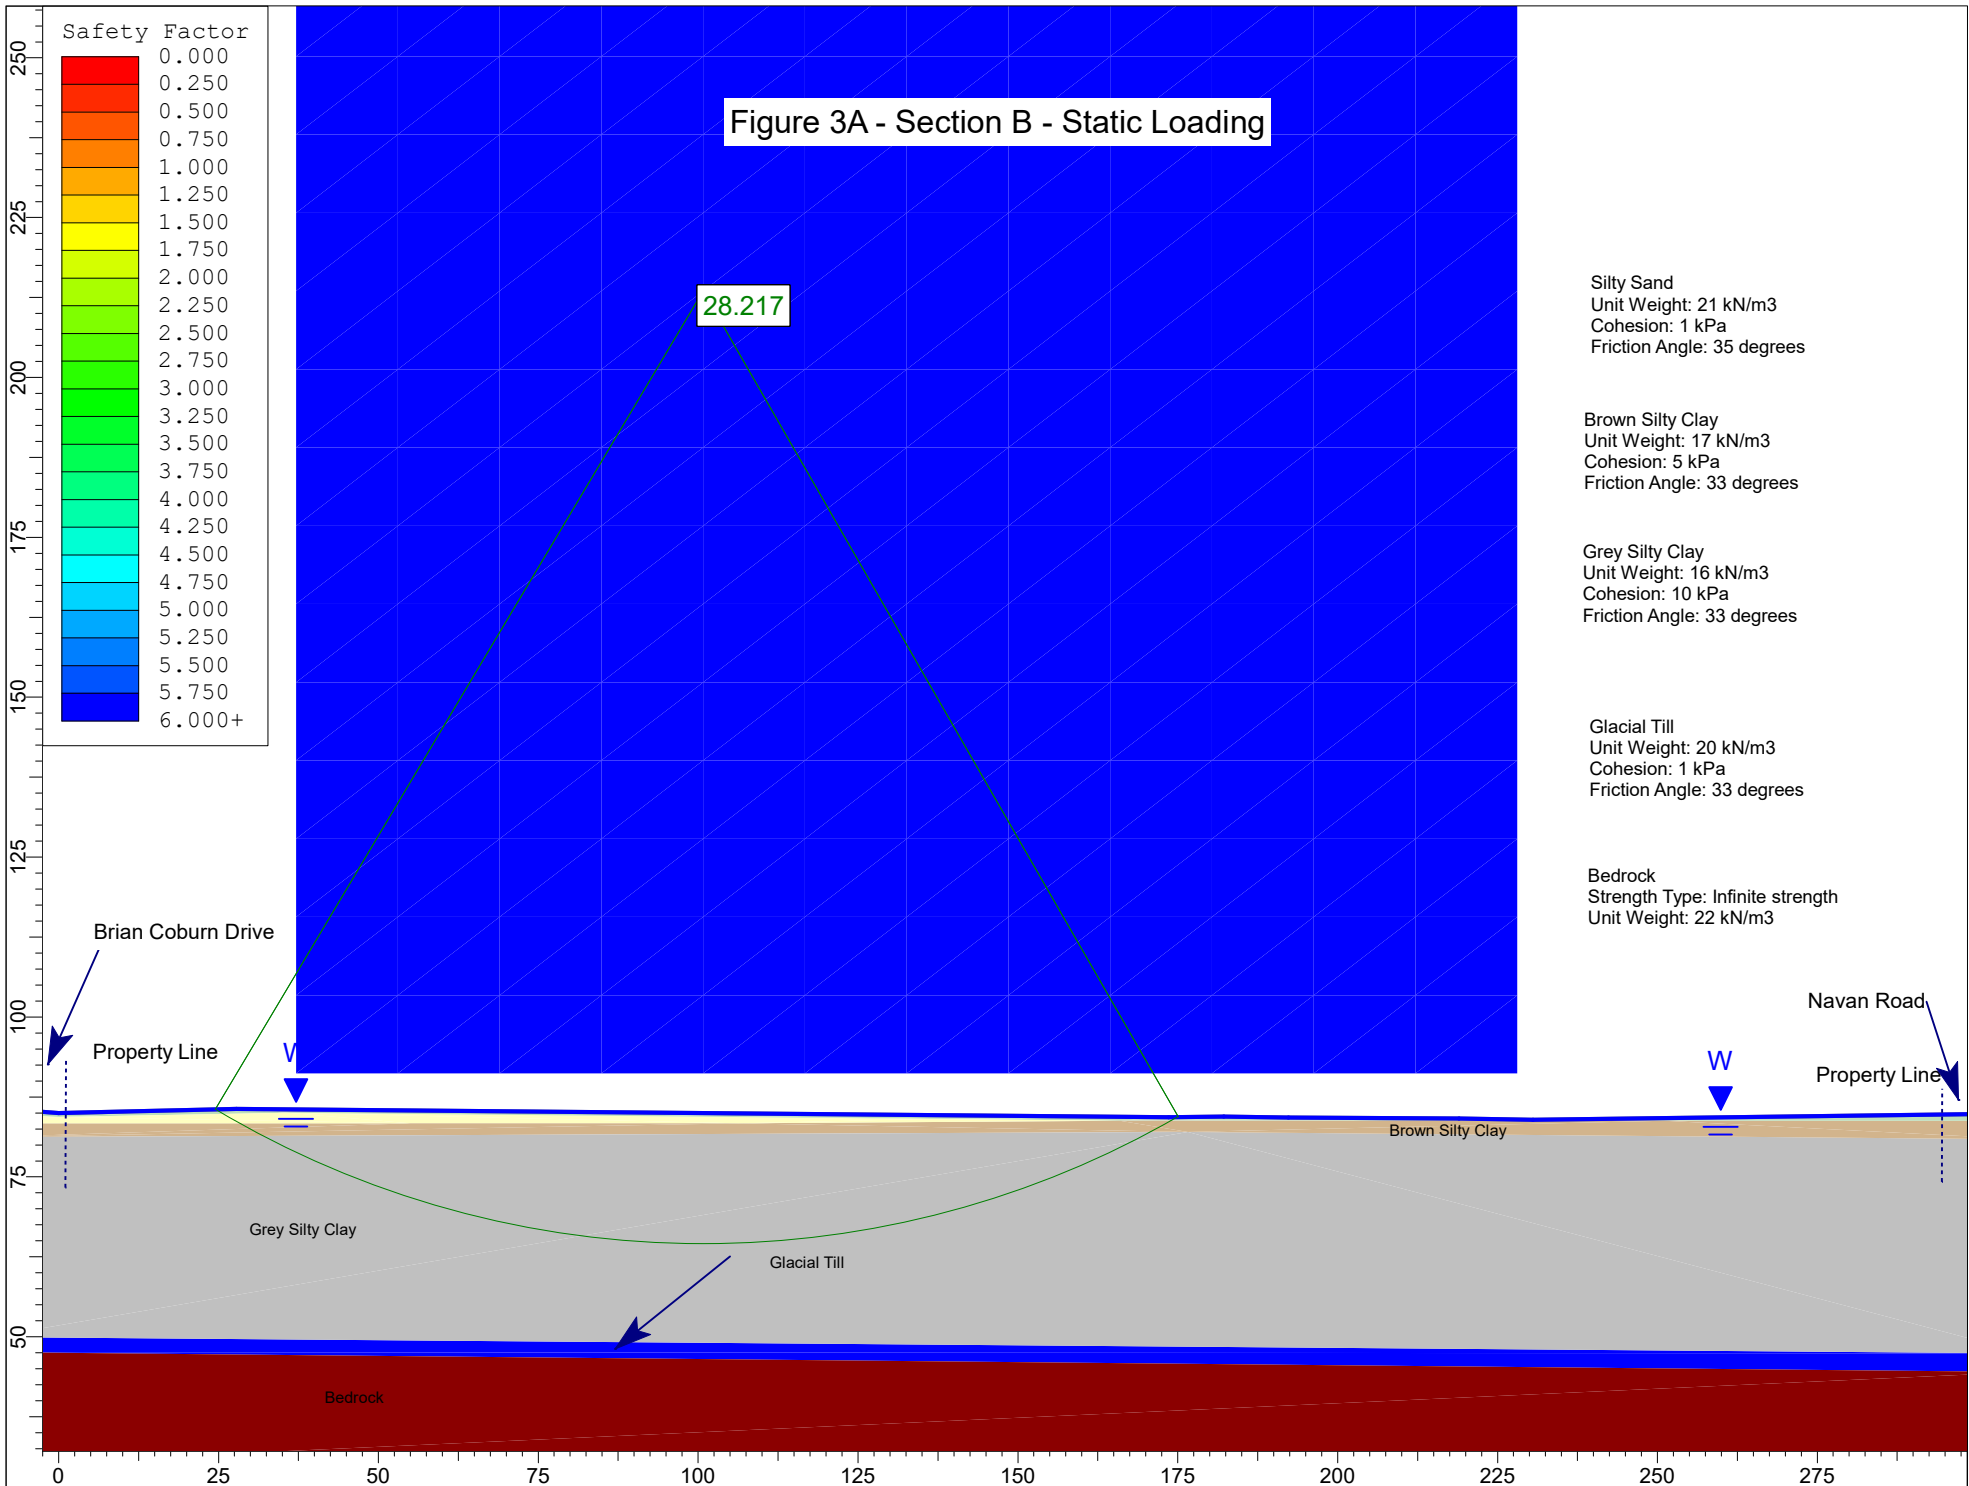
Figure 3A - Section B - Static Loading

The results of the static analysis for the proposed slope under fully saturated conditions (worst-case-scenario) are shown in Figure 2A and 3A attached to the current report. The minimum analysed slope stability factor of safety under fully saturated conditions (worst case scenario) were calculated to be greater than 1.5.

As a result, the two slope cross-sections analyzed were all above the recommended Factor of Safety of 1.5 and are considered stable under static conditions.

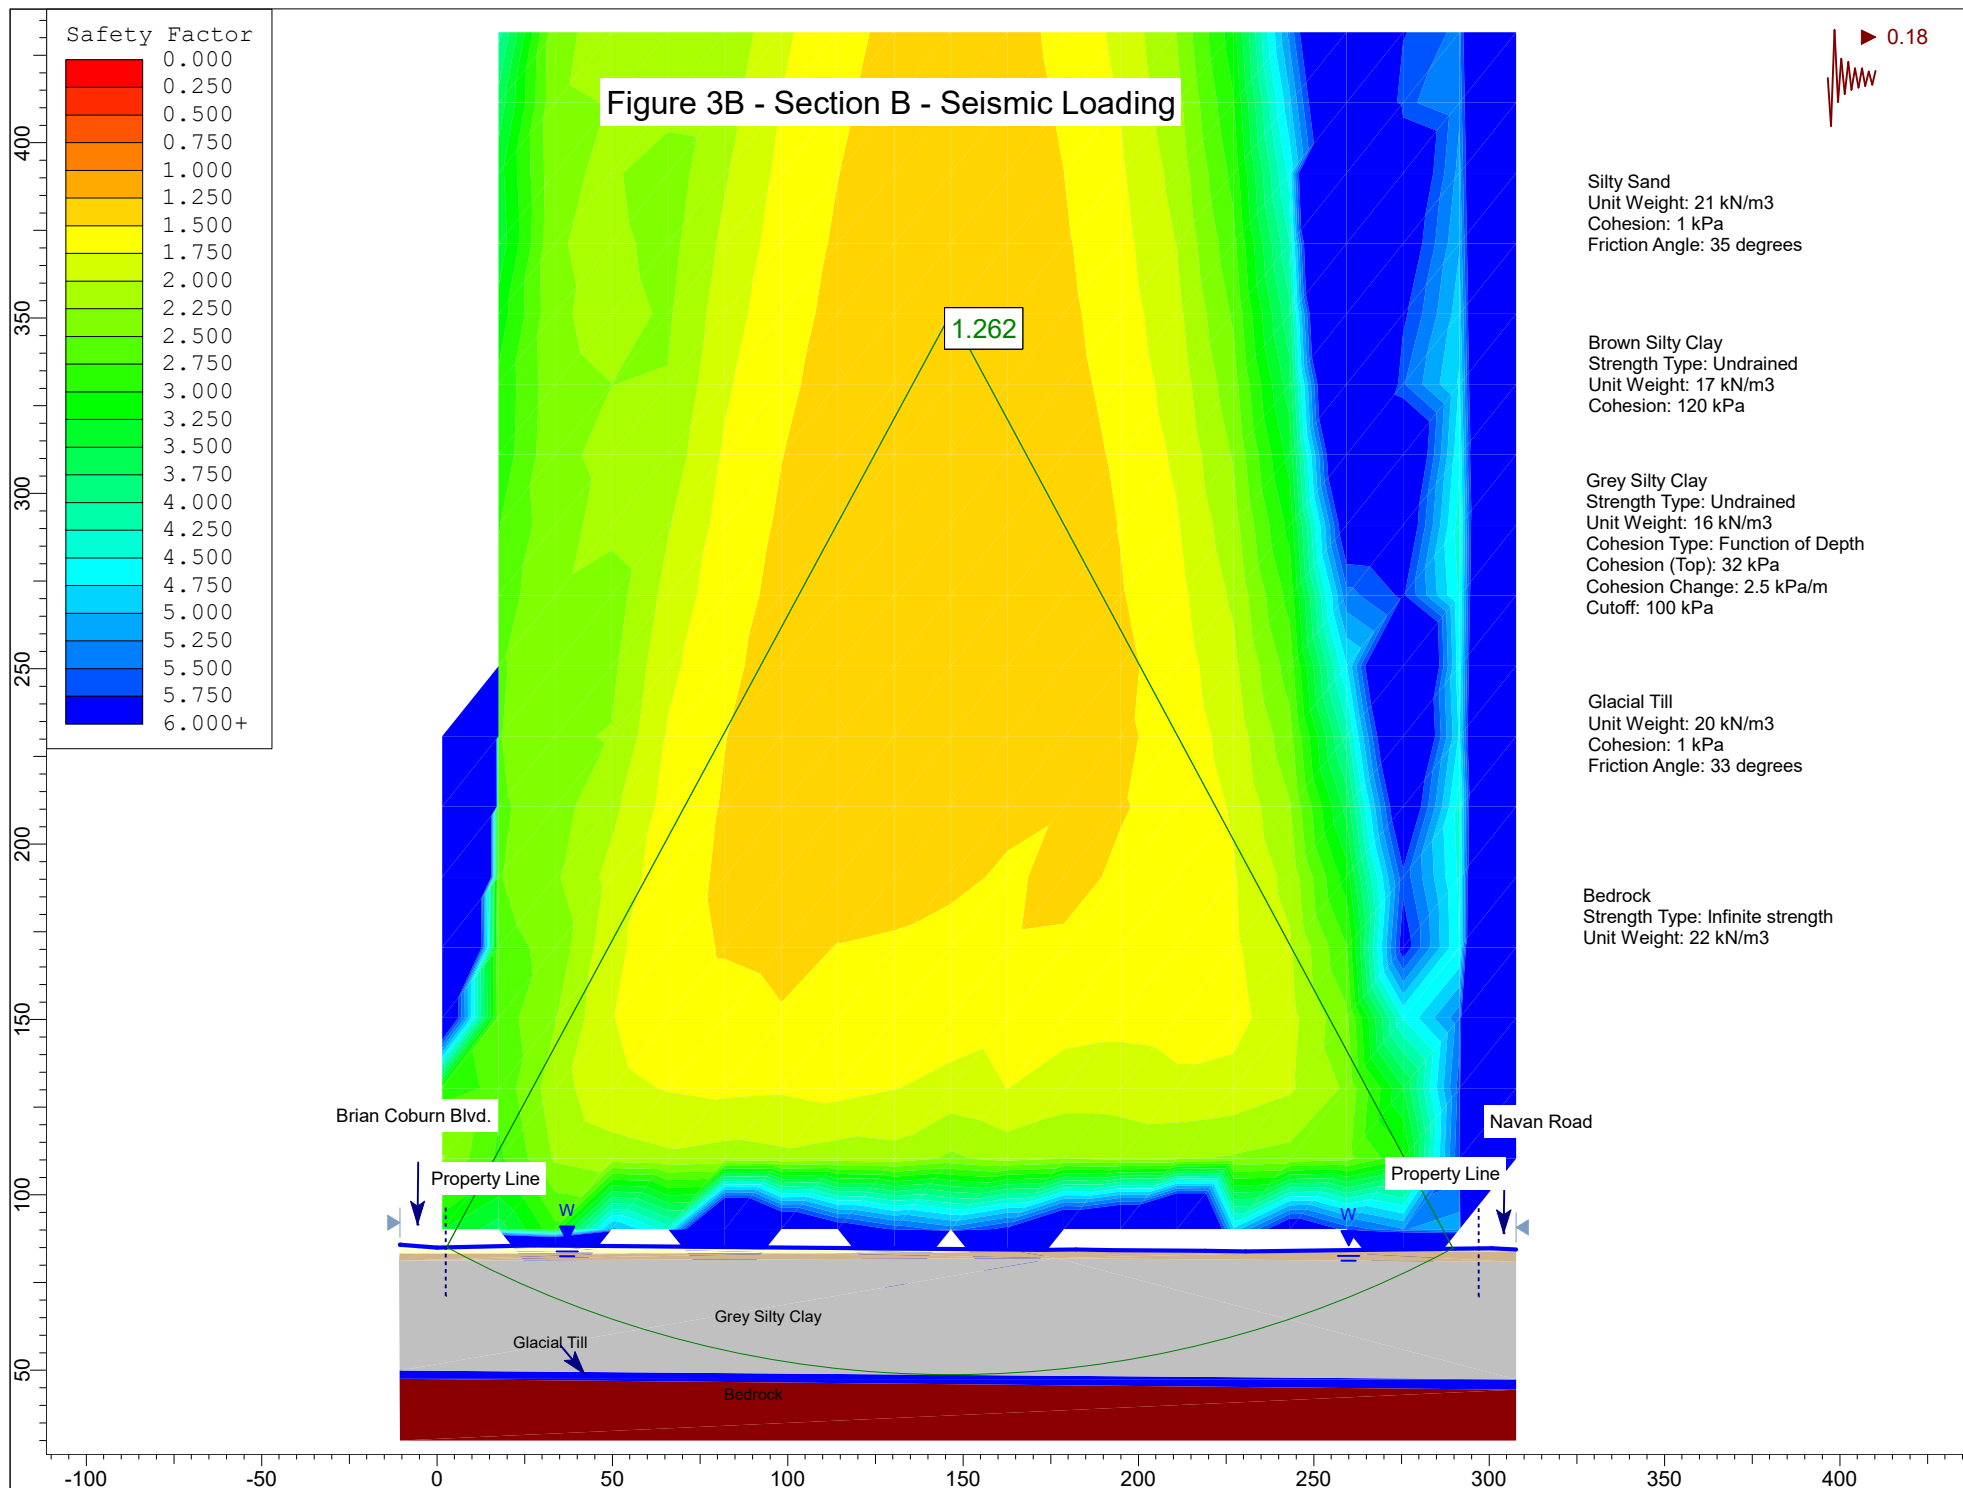
The results of the analysis including seismic loading fully saturated conditions (worst-case-scenario) are shown in Figure 2B and 3B attached to the current report.

The overall slope stability factor of safety at the three slope cross-sections when considering seismic loading was found to be greater than 1.1 which is considered to be stable under seismic loading.
