**TREE CONSERVATION REPORT FOR 1DOOR4CARE TREATMENT CENTRE
401 SMYTH ROAD, CITY OF OTTAWA, ONTARIO**

Issued for Construction
Date: August 16, 2024
File: C23080

Tree Conservation Report for
CHEO 1D4C Treatment Facility, City of Ottawa

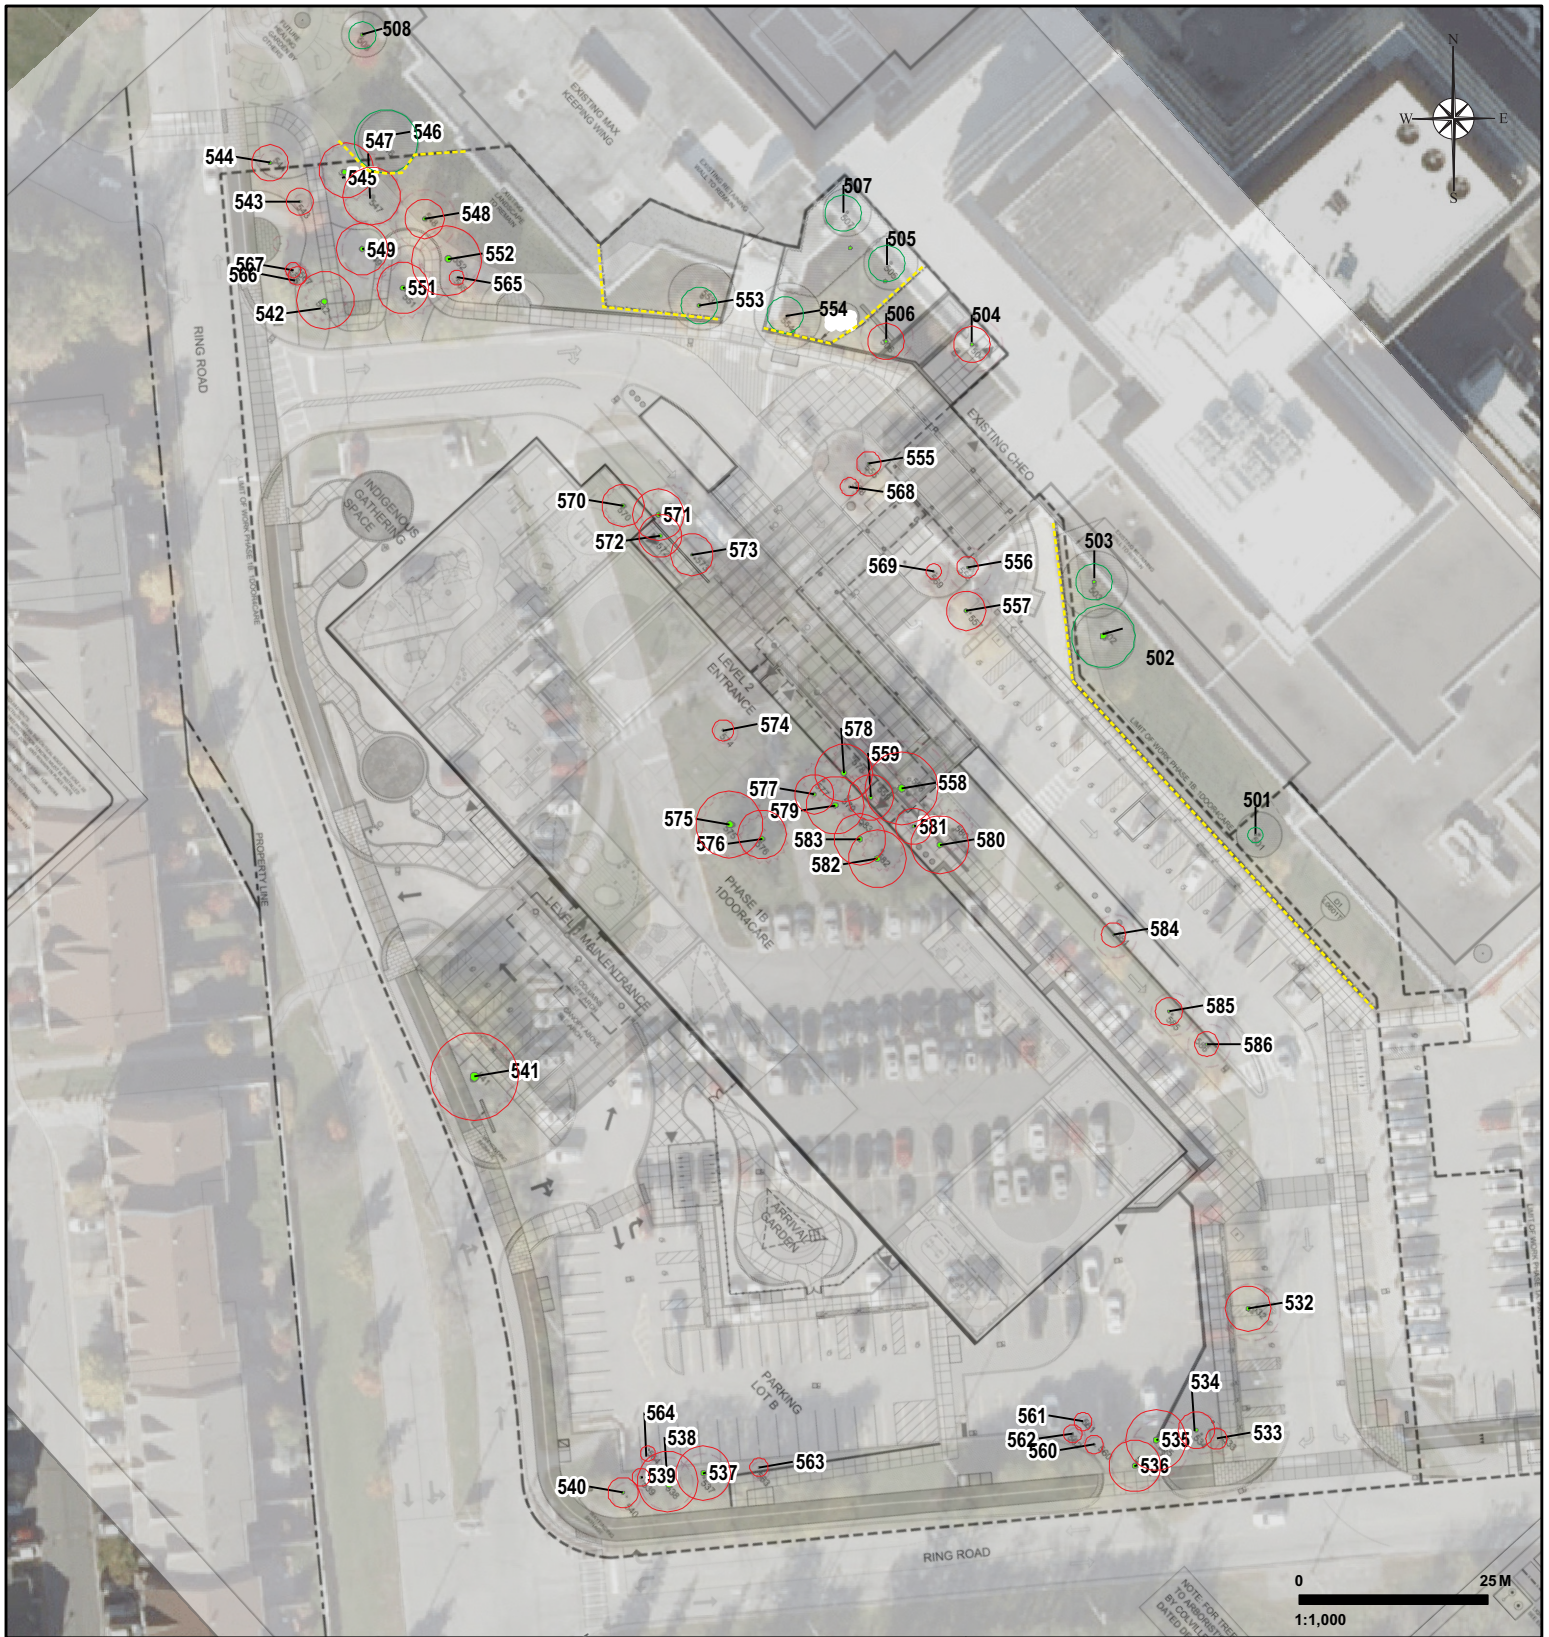
Figure #2 - Tree Inventory and CRZ for
1DOOR4CARE Treatment Centre

Detailed information and recommendations for each tree inventoried is provided within Appendix A. Mapping in Appendix B shows all trees inventoried on and adjacent the Subject Lands and Critical Root Zones (CRZ). Tree protection fencing and limits of construction are also shown on Mapping in Appendix B. A selection of site photographs taken during field inventories are provided in Appendix C.

- ◆ A limit of work fence/ tree hoarding should be installed along the CRZ of trees to be retained.
- ◆ Where work within the CRZ cannot be avoided for trees recommended to be retained, mitigation measures described in the above tree care recommendations should be followed to reduce potential damage to the tree.

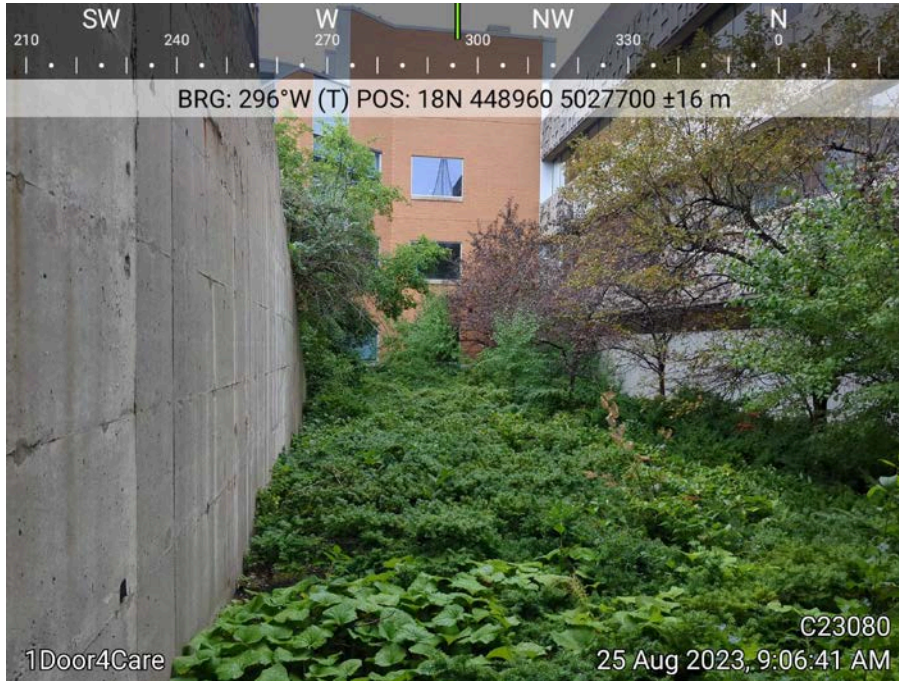
Photo 1: Landscaping adjacent existing hospital below drop off area.

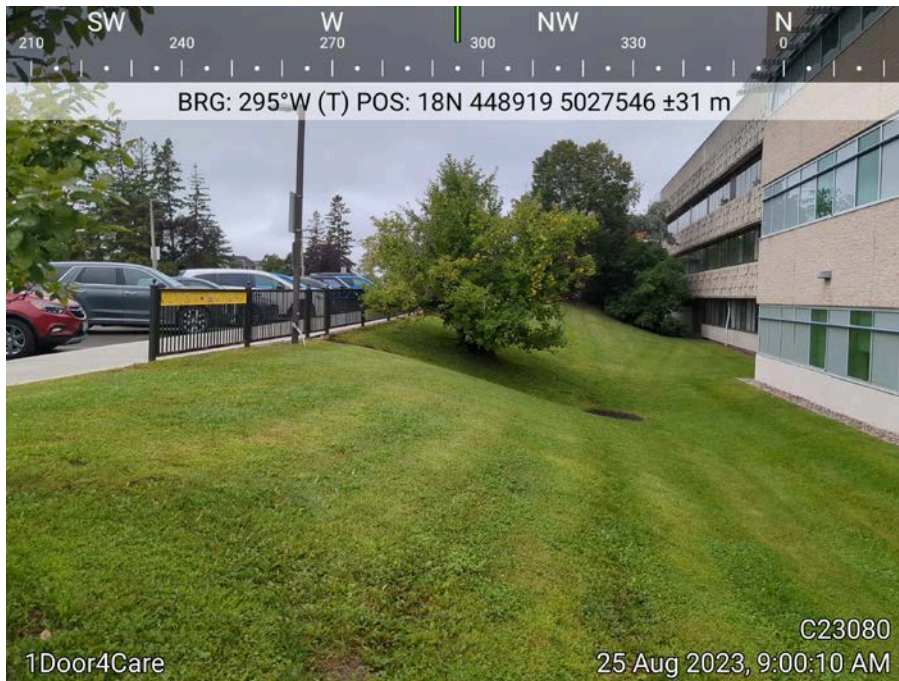
Photo 2: Viewing northwest at manicured area north of drop off area.

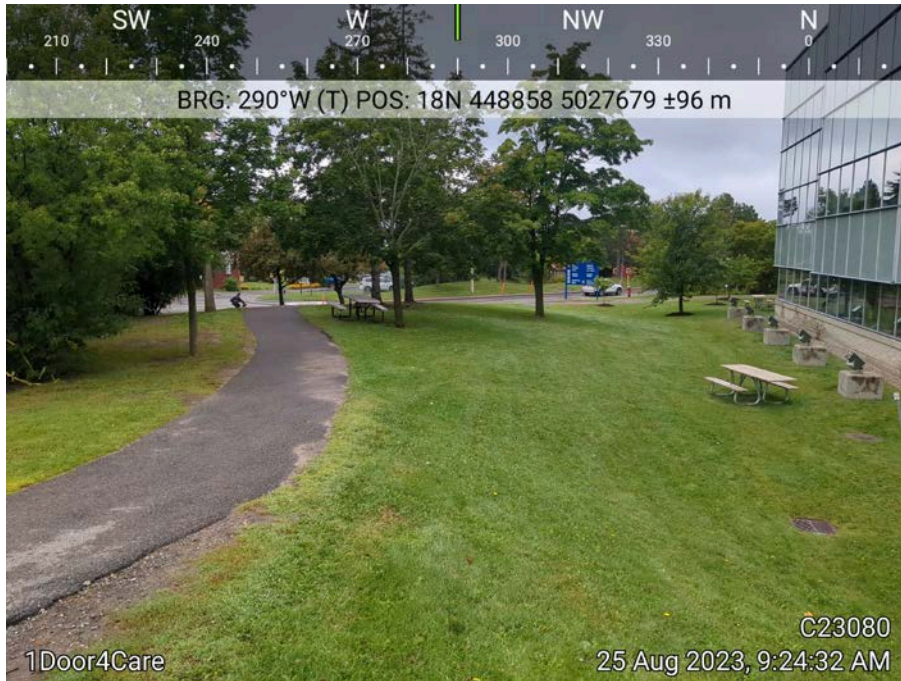
Photo 3: Trees adjacent walking path on northwest portion of proposed development

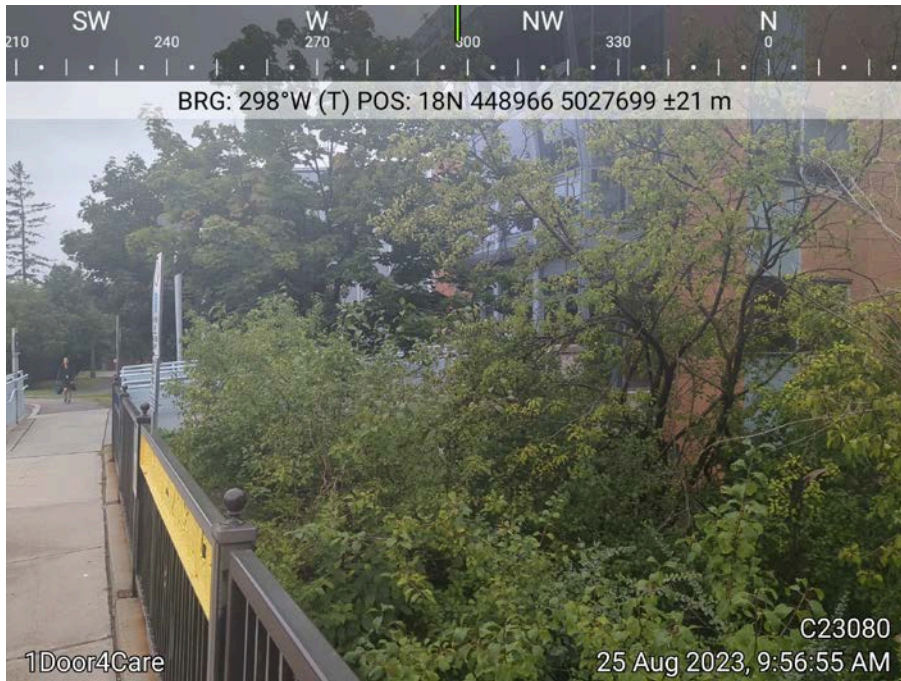
Photo 4: Vegetation adjacent existing hospital staff access

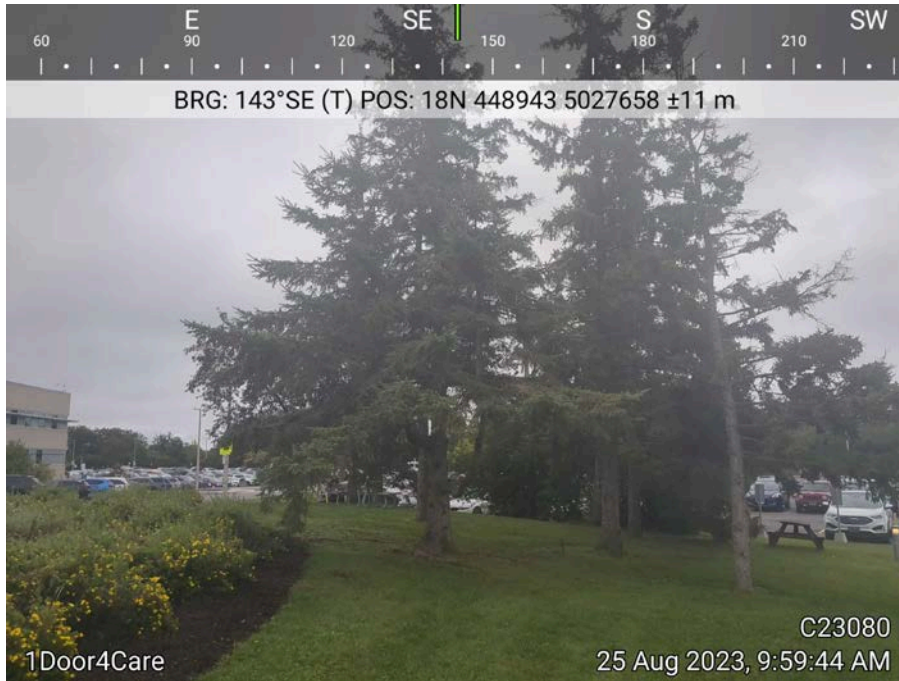
Photo 5: View of trees to be removed in footprint of new building.

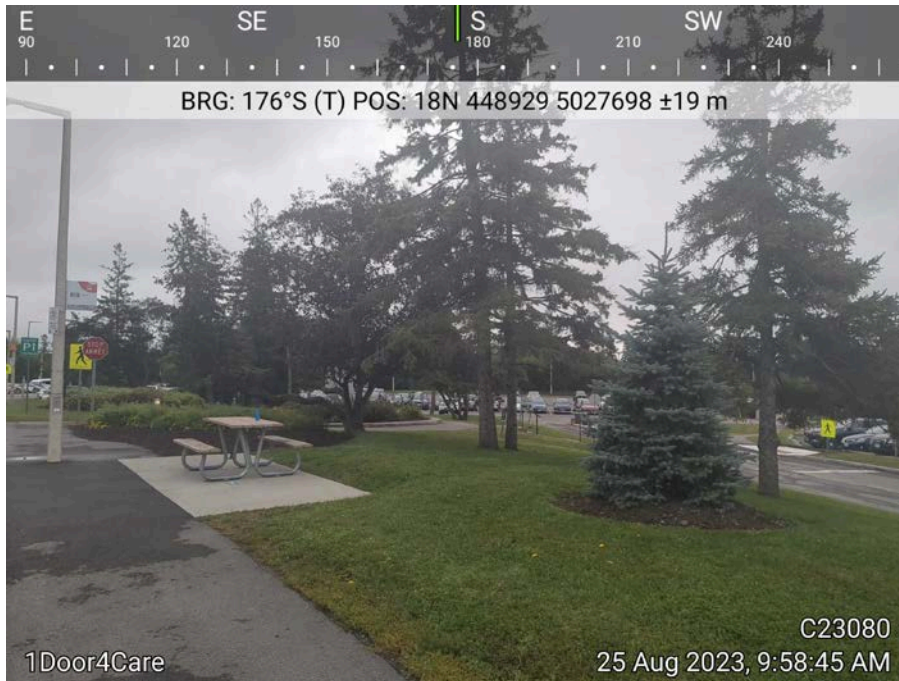
Photo 6: View of landscaped trees southeast of existing patient drop off door.

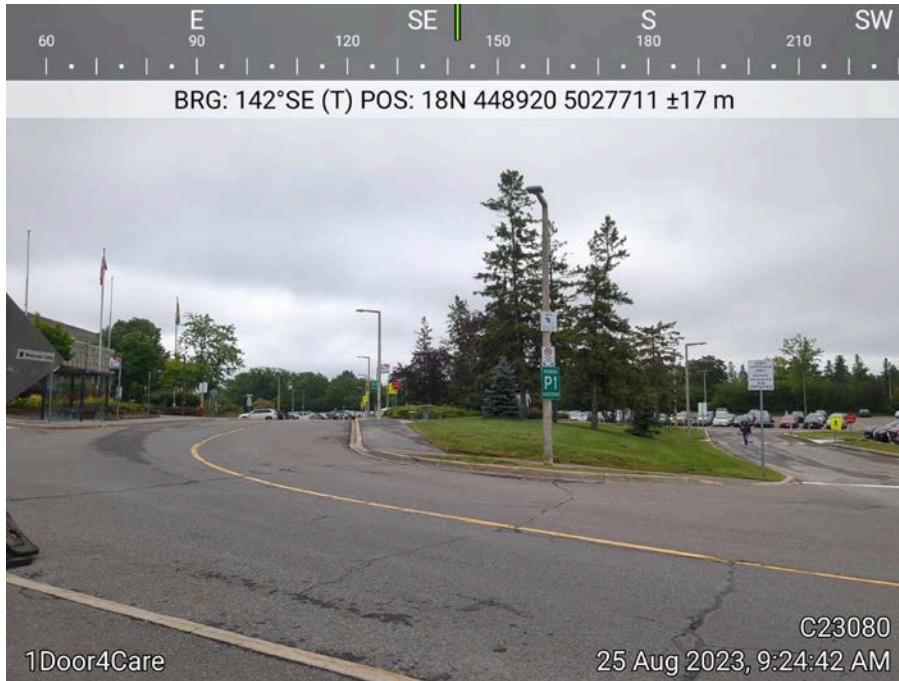
Photo 7: View of trees to be removed southwest of patient drop off door.

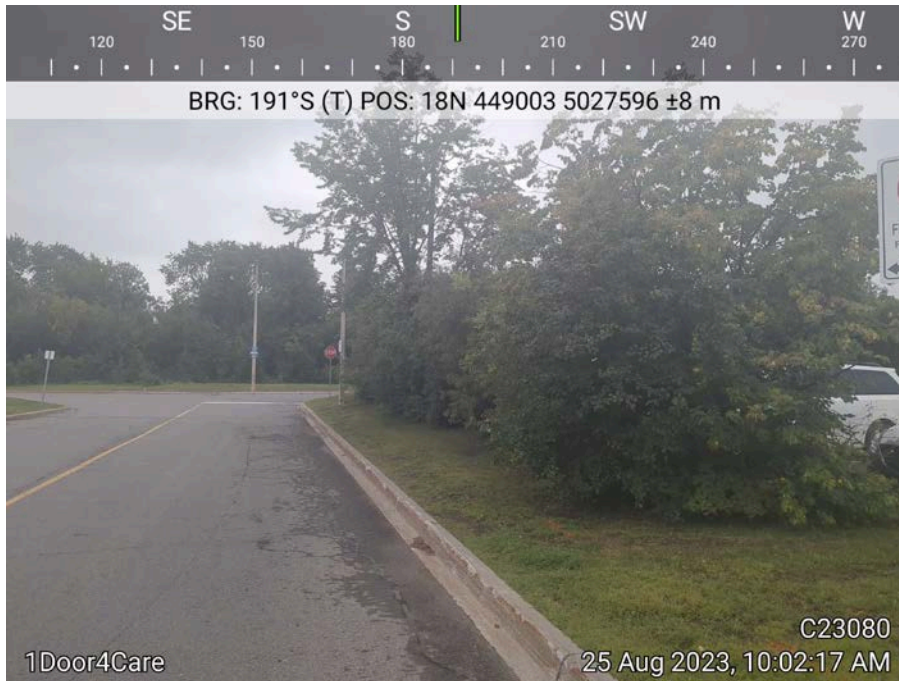
Of the trees to be removed, nine (9) are invasive common buckthorn. A significant amount of smaller common buckthorn was also observed within the thickets adjacent to Ring Road on the southern and western edges of the Subject Lands. Small thickets of Buckthorn were also observed along the northern edge of the Subject Lands.

Photo 8: View of trees and vegetation in hedgerow adjacent Ring Road.

- ◆ Any Common Buckthorn or other invasive tree species observed during construction should be removed and replaced with native species where possible.

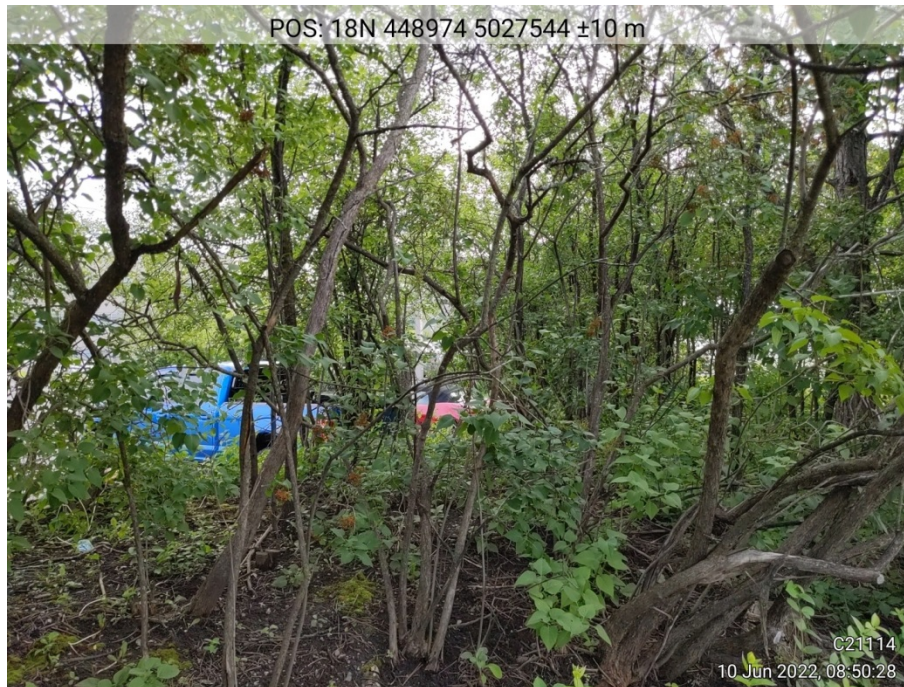
Photo 9: Example of vegetation conditions within hedgerow along Ring Road.

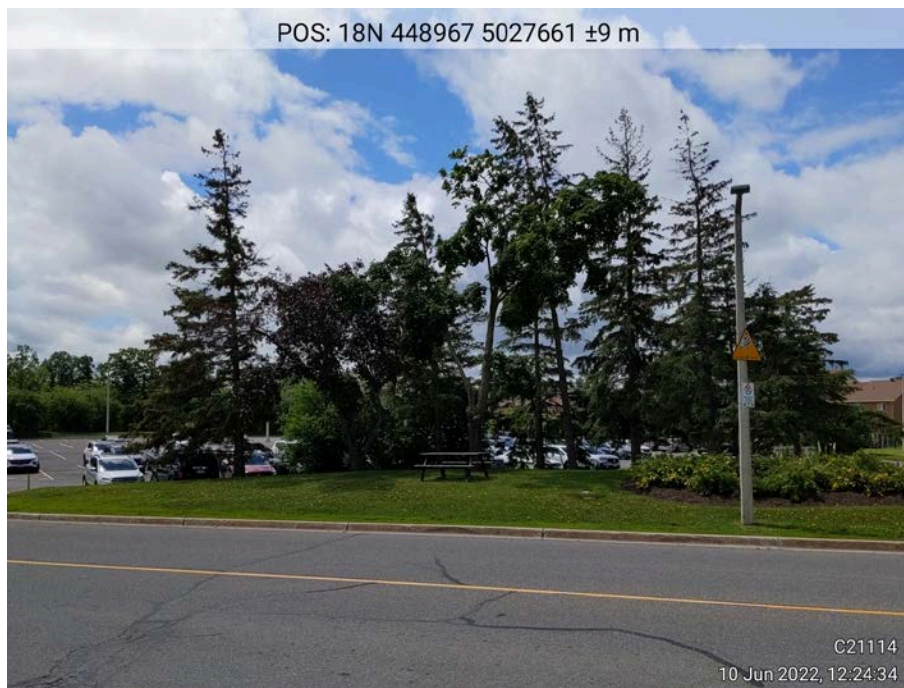
Photo 10: Cluster of trees in landscaped area southwest of CHEO main entrance.

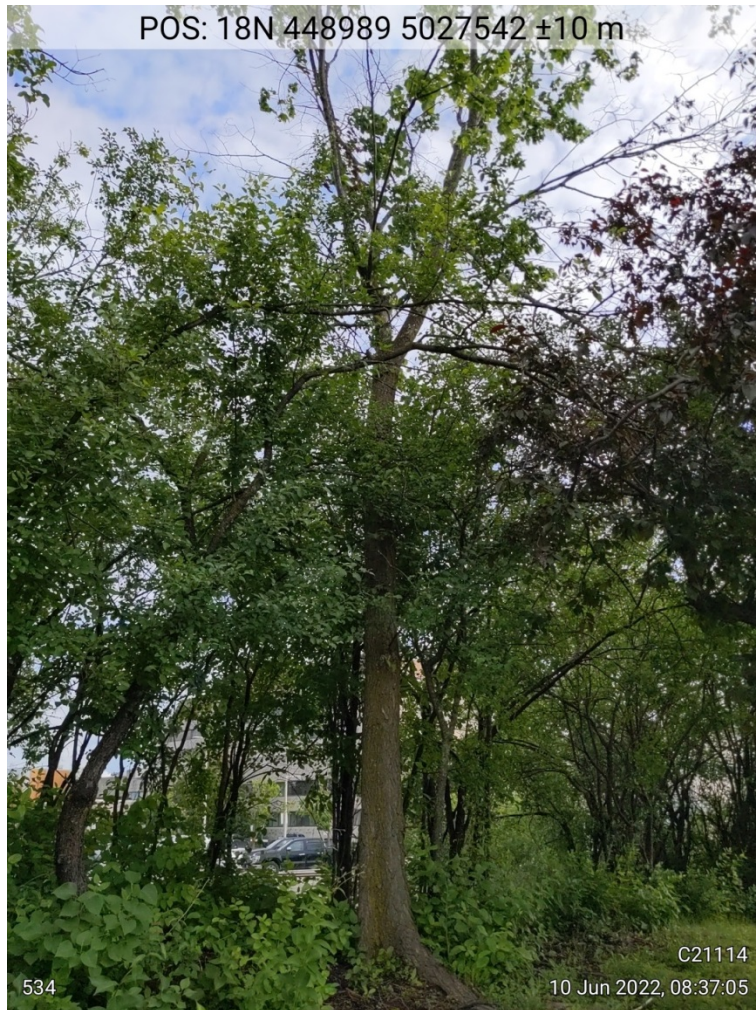
| Tag # | Species | Scientific Name | Location | DBH (cm) | Critical Root Zone (CRZ) (cm) | Dripline | Health | Recommendation | Field Notes/Condition Comments | Zone | Northing | Easting |
|---|---|---|---|---|---|---|---|---|---|---|---|---|
| 534 | American Elm | <i>Ulnus americana</i> | Treatment Facility | 24 | 240 | 4 | Fair/Poor | Remove, construction | 60% canopy dieback | 18T | 5027552.34 | 448994.68 |

Photo 11: Tree #534 in poor/fair condition with significant canopy dieback.

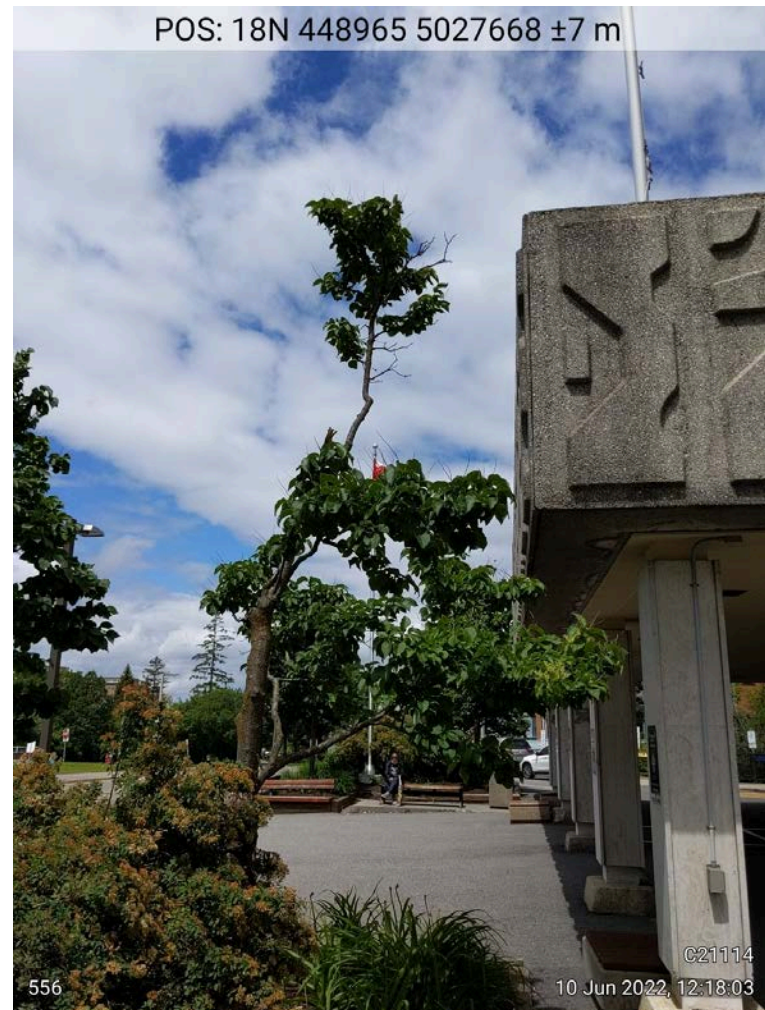
| Tag # | Species | Scientific Name | Location | DBH (cm) | Critical Root Zone (CRZ) (cm) | Dripline | Health | Recommendation | Field Notes/Condition Comments | Zone | Northing | Easting |
|---|---|---|---|---|---|---|---|---|---|---|---|---|
| 556 | Japanese Lilac | <i>Syringa reticulata</i> | Treatment Facility | 14 | 140 | 2 | Fair/Poor | Remove, construction | Significant frost damage, reduced canopy. | 18T | 5027670.48 | 448963.15 |

Photo 12: Tree #556 adjacent CHEO main entrance, fair condition with reduced canopy.

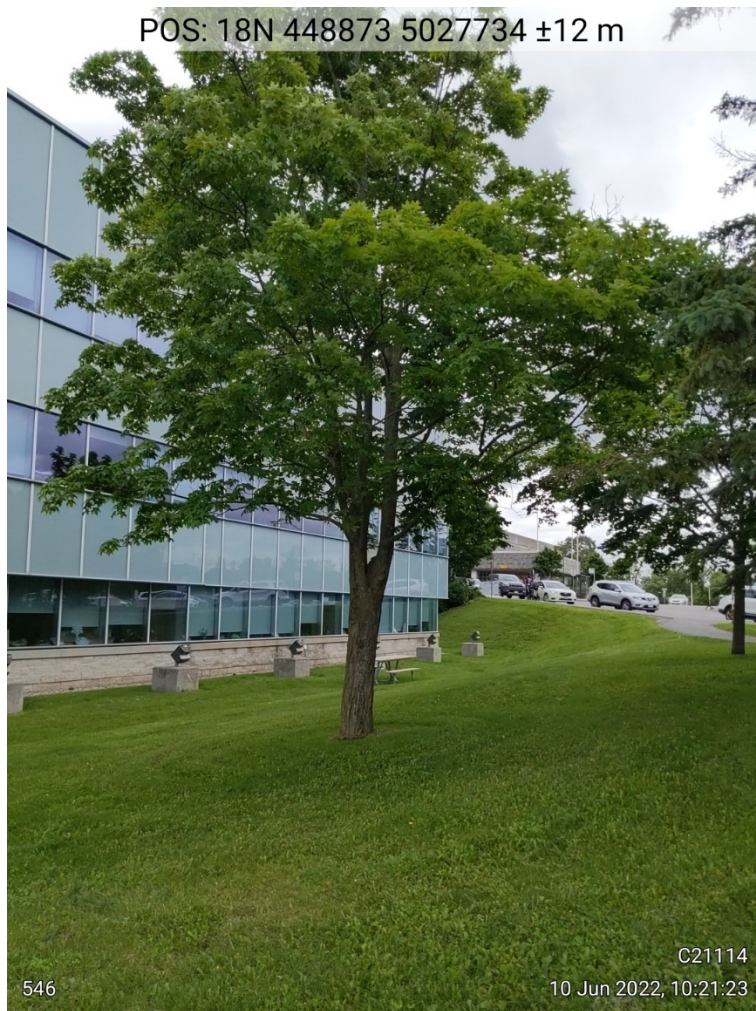
| Tag # | Species | Scientific Name | Location | DBH (cm) | Critical Root Zone (CRZ) (cm) | Dripline | Health | Recommendation | Field Notes/Condition Comments | Zone | Northing | Easting |
|---|---|---|---|---|---|---|---|---|---|---|---|---|
| 546 | Sugar Maple | <i>Acer saccharum</i> | Treatment Facility | 42 | 420 | 5 | Good/Fair | Retain | Union at 1.5m, codominant | 18T | 5027727.87 | 448885.80 |

Photo 13: Tree #546, weak union at 1.5 metres.

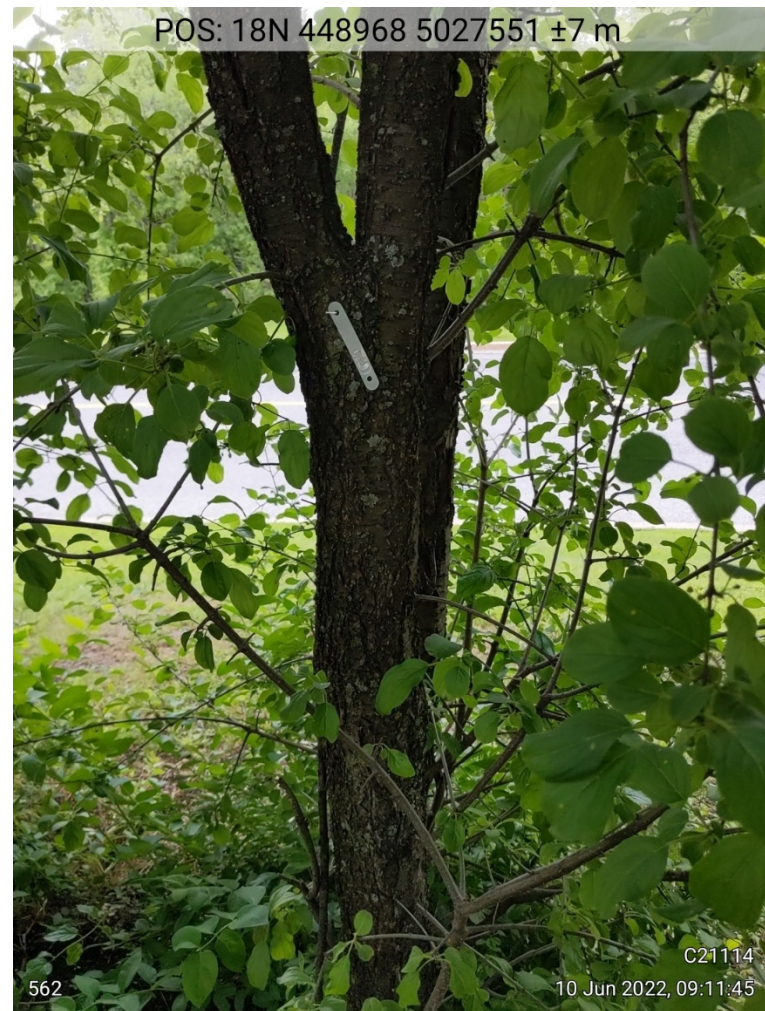
Photo 14: Tree #562, example of larger DBH Common Buckthorn present in hedgerows around parking area.
