File: PE5609-LET.02

Subject: Phase I – Environmental Site Assessment Update

Letter of Opinion

1015-1045 Dairy Drive, Ottawa, Ontario

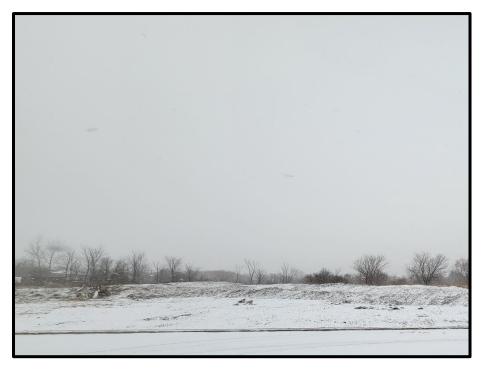
Photograph 1: View of the northern portion of the Phase I Property, facing south.

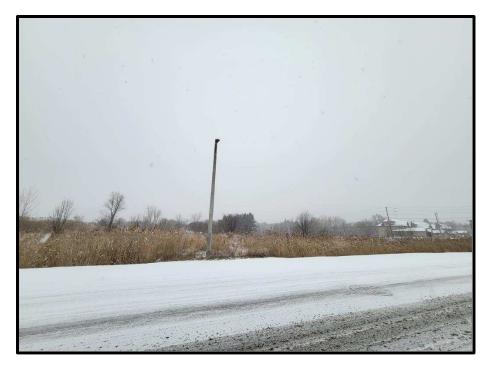
Photograph 2: View of the central portion of the Phase I Property, facing south.

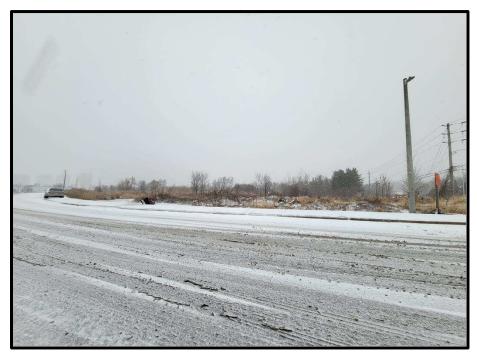
Photograph 3: View of the southern portion of the Phase I Property, facing south.
