re: Slope Stability Review
Proposed Warehouse Building
96 Bill Leatham Drive, Ottawa

date: March 7, 2024

file: PG6668-MEMO.01

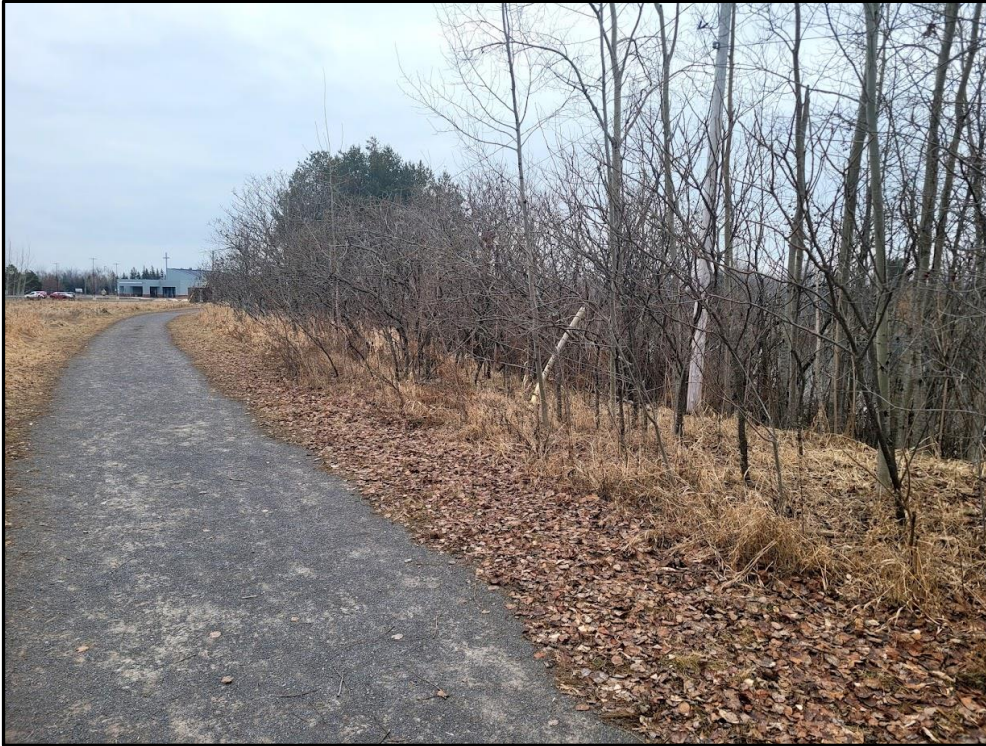
Photo 1: Photograph of the observed top of slope.

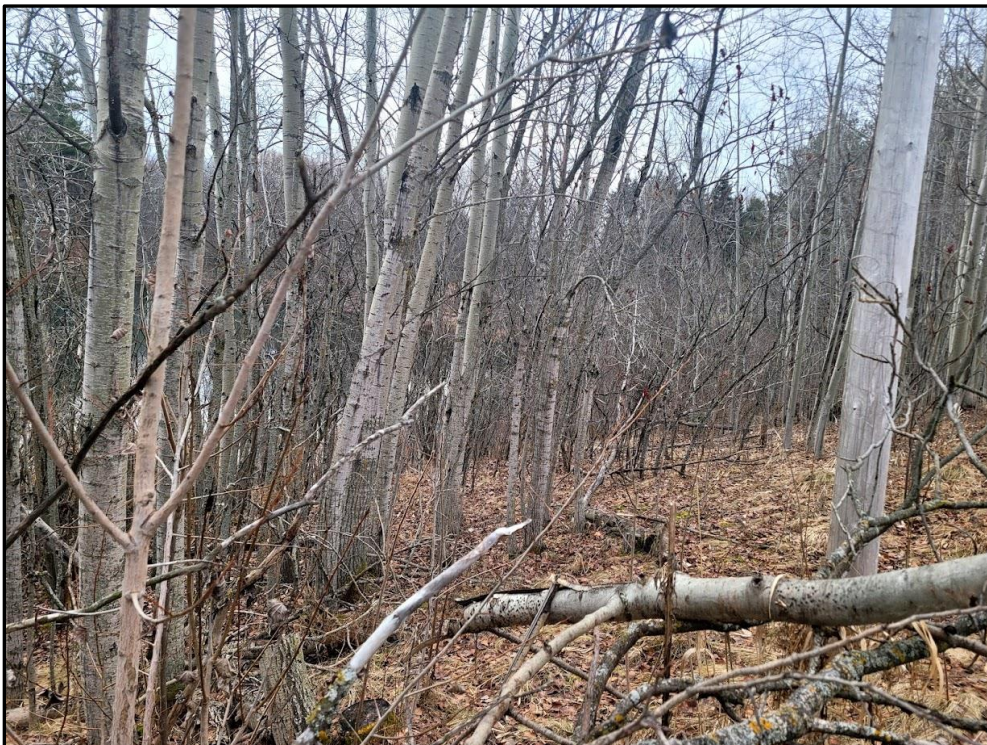
Photo 2: Photograph of the observed slope. The slope can be observed to be densely vegetated.

It should be noted that based on the city of Ottawa slope stability guidelines, toe erosion allowance can be reduced if remedial work is implemented to prevent erosion activities at the toe of the given slope. Furthermore, existing vegetation on the slope face should not be removed as it contributes to the stability of the slope and reduces erosion. If the existing vegetation needs to be removed, it is recommended that a 100 to 150 mm of topsoil mixed with a hardy seed and/or an erosional control blanket be placed across the exposed slope face.

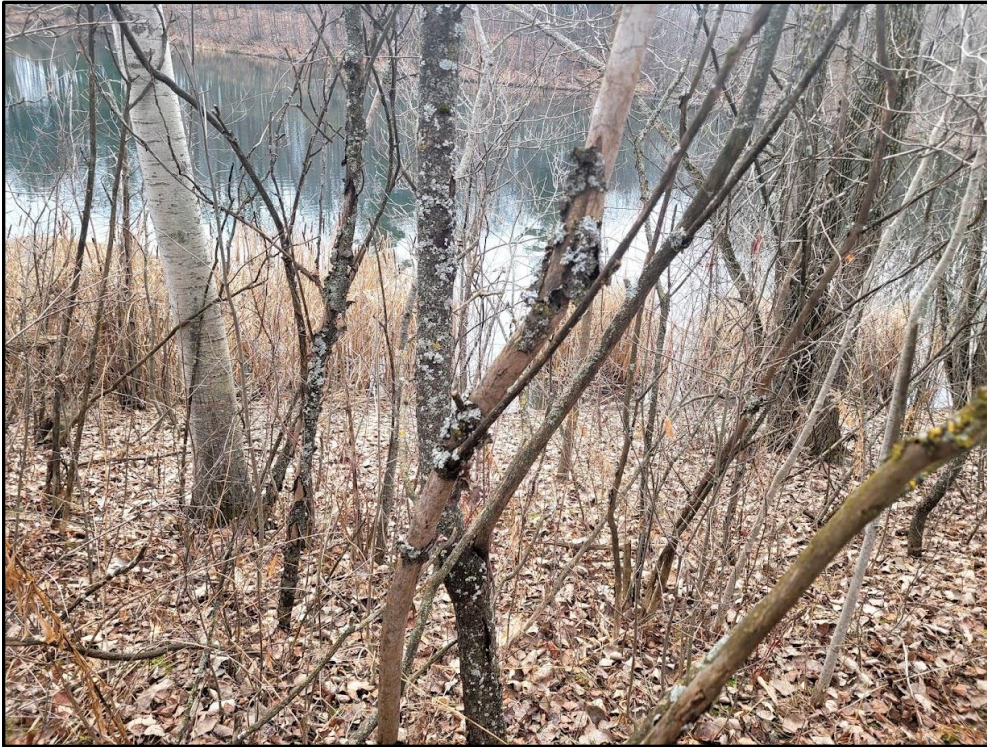
Photo 3: Photograph of the observed slope at the elevation of the pond.

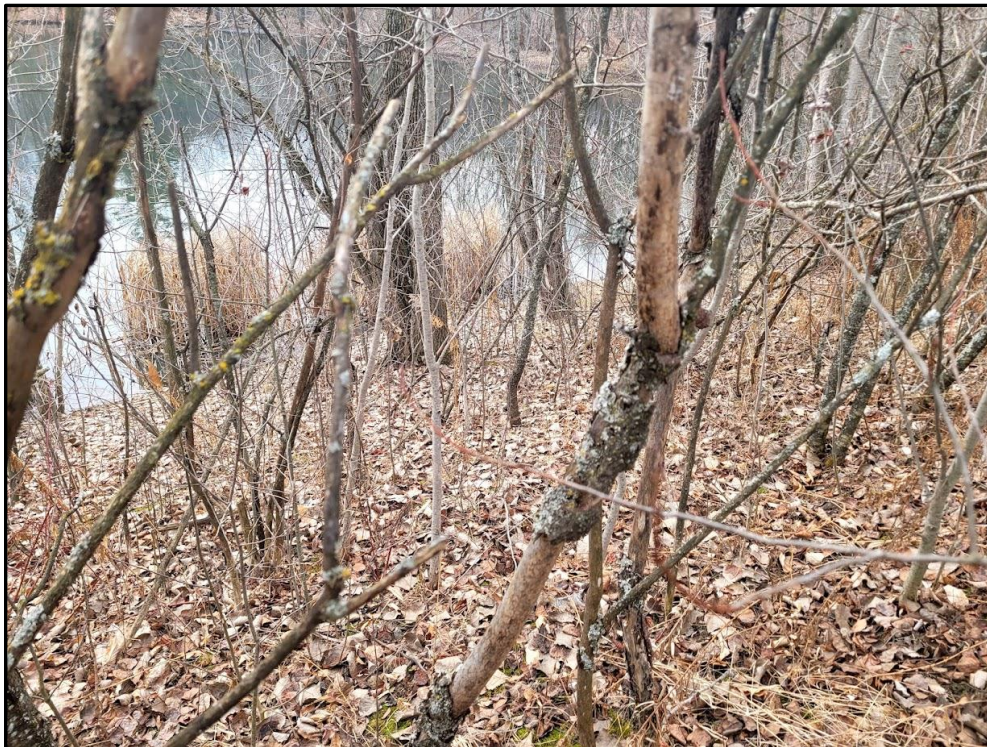
Photo 4: Photograph of observed slope at the elevation of the pond.

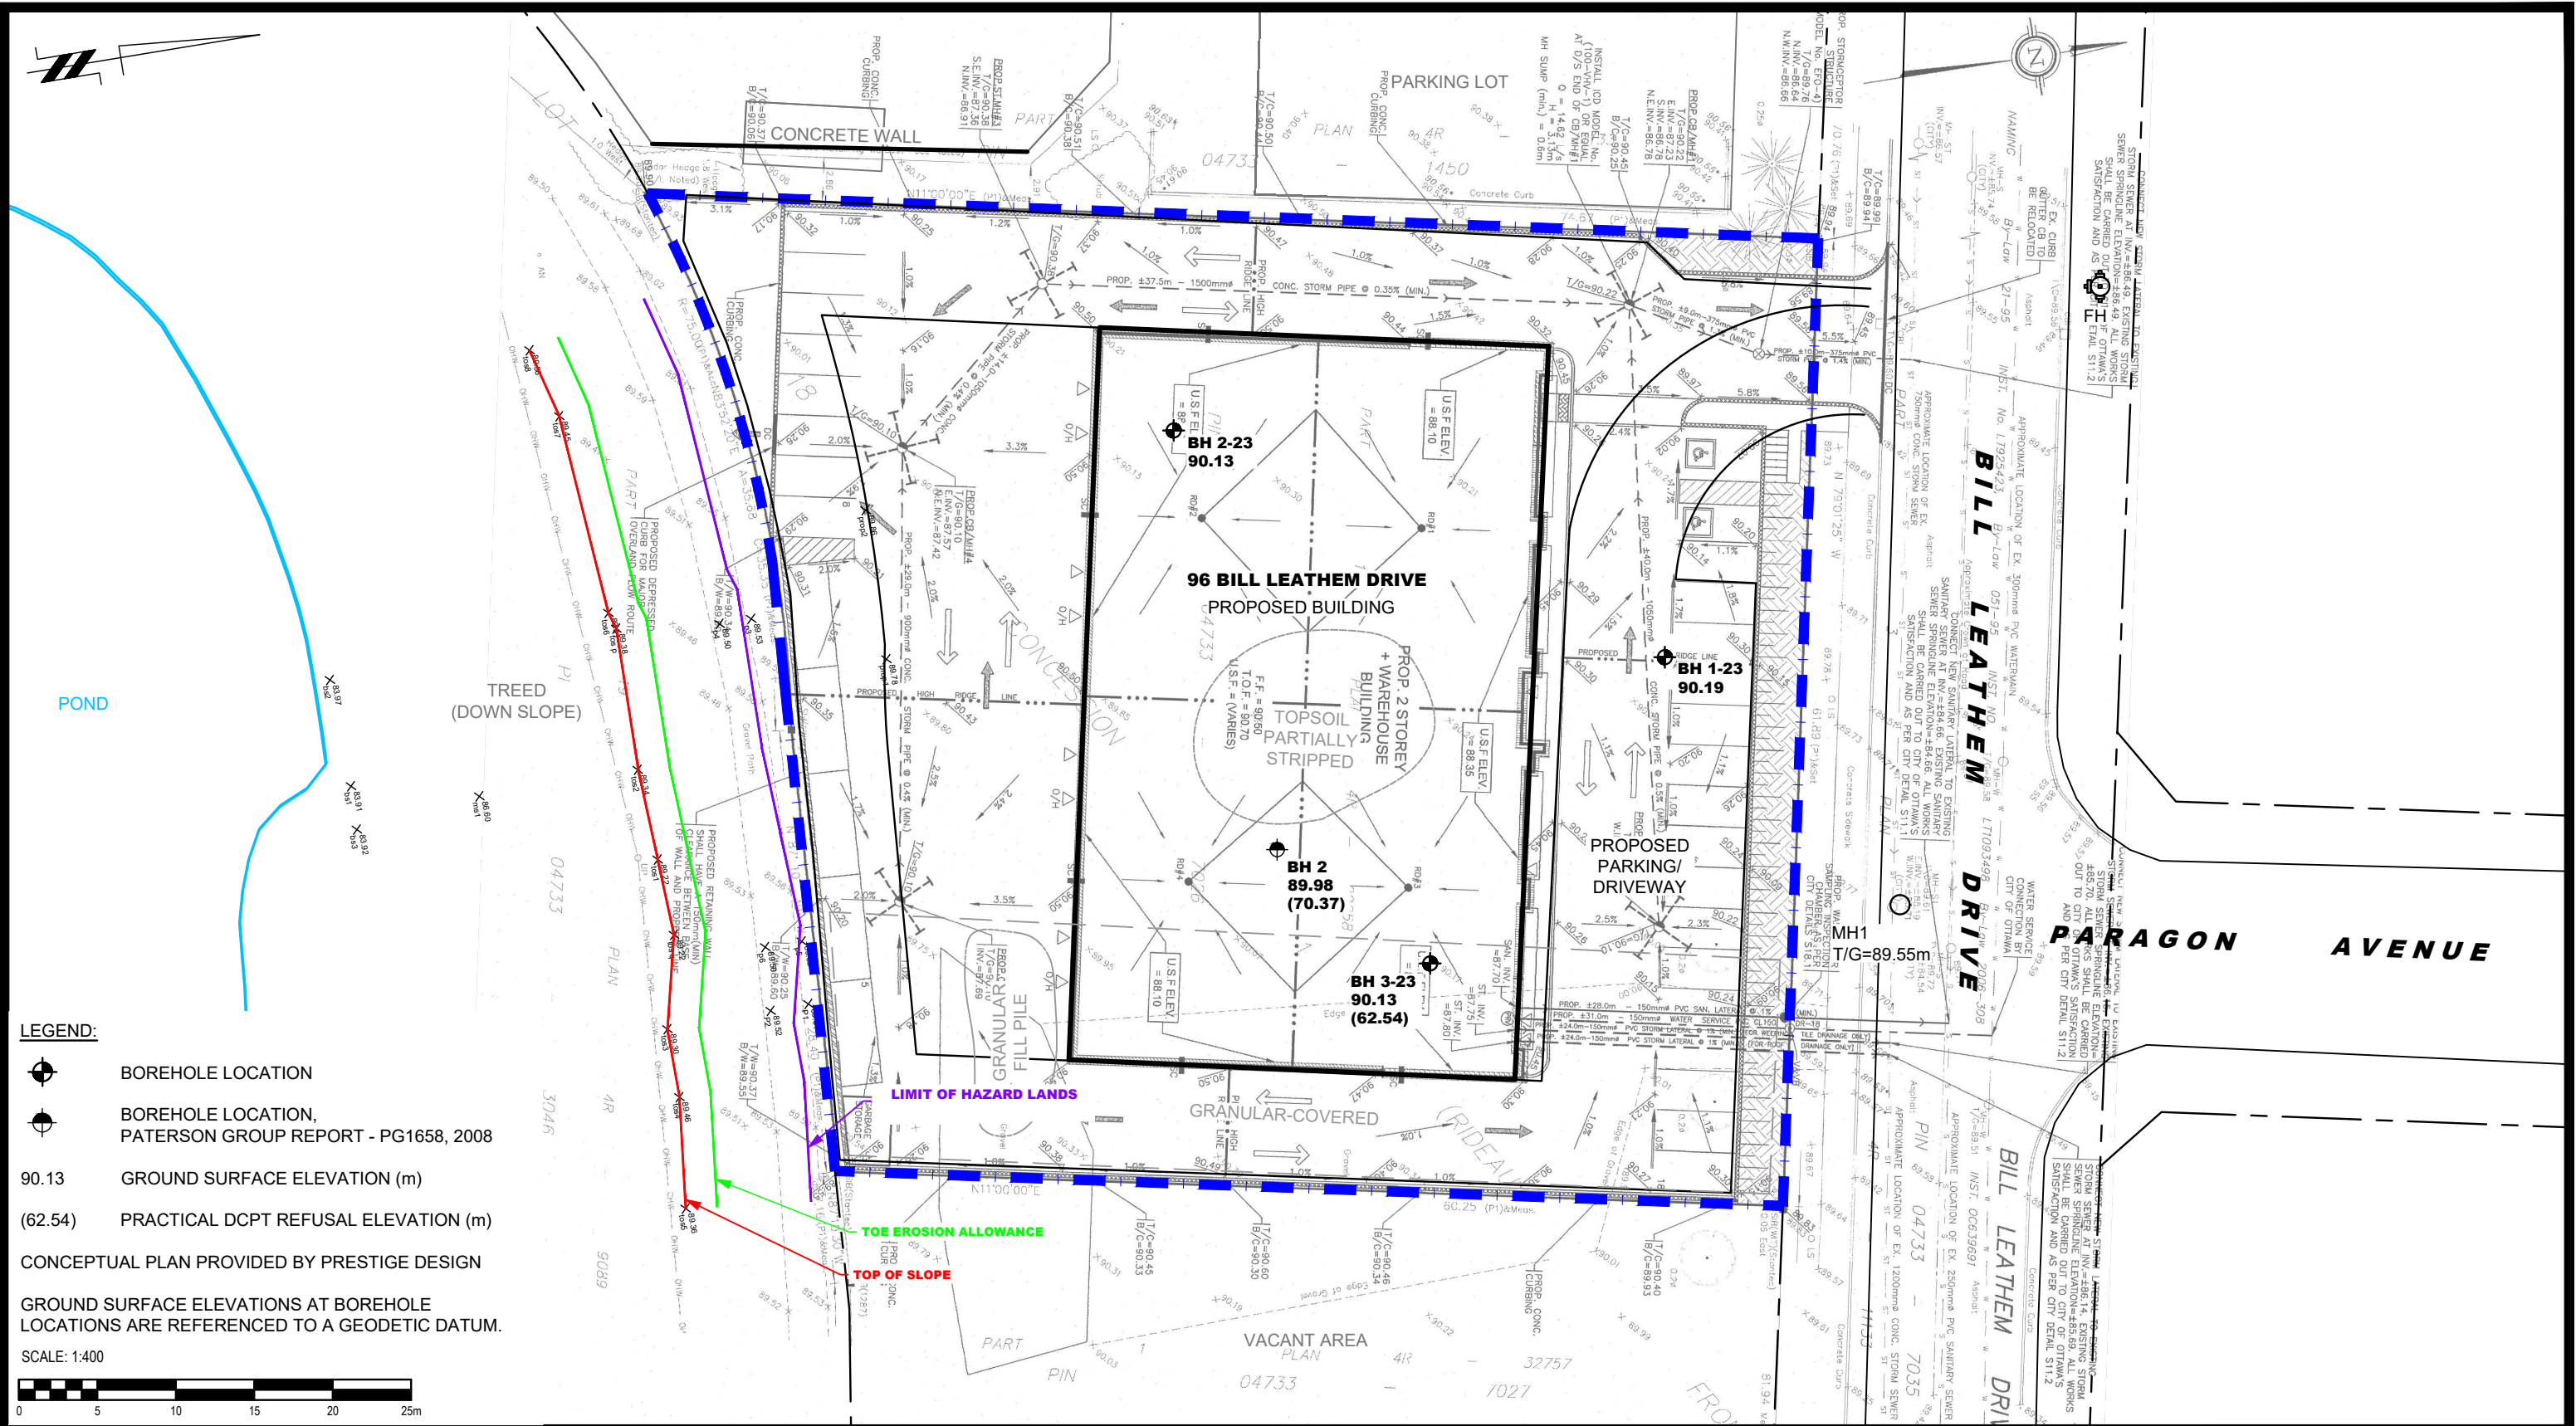
LIMIT OF HAZARD LANDS PLAN

Based on our findings, the existing slope along the Clarke Bellinger SWM facility is at an angle of 3H :1V or shallower and thus, as per the Natural Hazards Training Manual, Policy 3.1 of the Ministry of Natural Resources (MNR) guidelines, a quick setback review can be used for the site. Thus, considering the water feature is an engineered SWM pond and that the slope is vegetated with no significant signs of erosion, a stable slope allowance will not be required. However, a toe erosion allowance of 2 m in addition to an access allowance of 6 m will be applicable from the top of the slope.

Based on our cursory review, the “Limit of Hazard Lands” (8 m from the top of slope) is outside the property limits of the subject site and as such no restriction to limit of hard lands are applicable within the site.
