May 2, 2024 Ref. No. CO947.01

Rohit Communities Ontario Inc. C/O Adil Kodian 15 Fitzgerald Road Ottawa, ON, Canada K2H 9G1

Slope Stability Assessment Report Wateridge Village, Blocks 5 and 6, Ottawa, Ontario

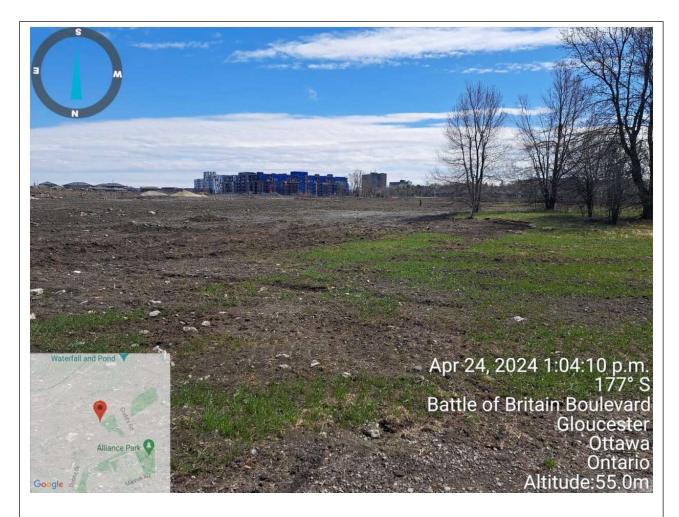
Standing at north side of Block 6 and looking towards south: No indications of existing slope greater or equal to 2 m in height or any settlement.

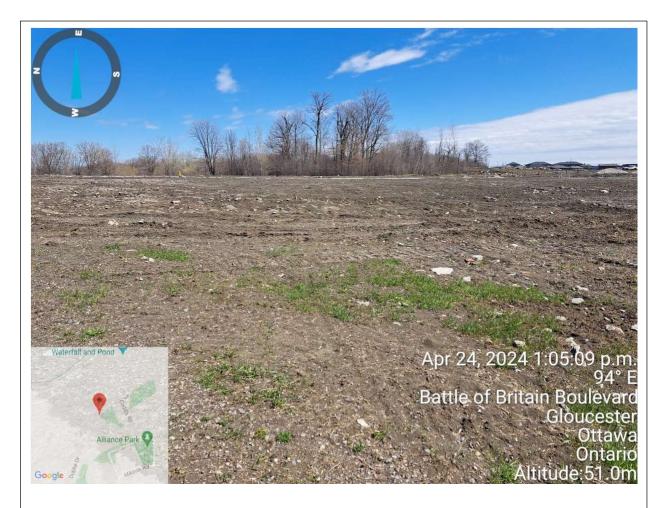
Standing at west side of Block 6 and looking towards East: No indications of existing slope greater or equal to 2 m in height or any settlement.

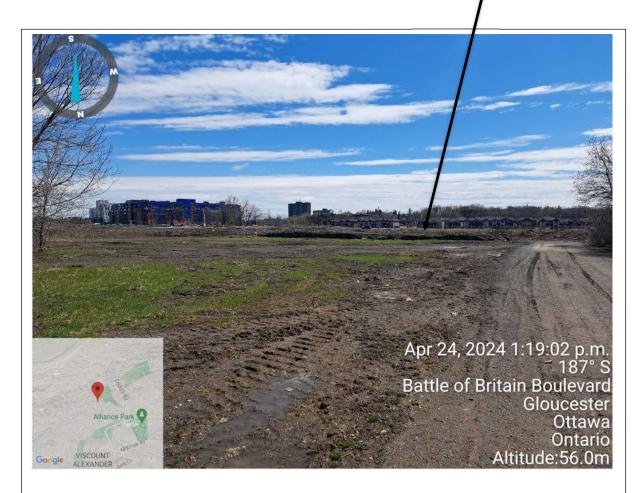
Standing at Northwest side of Block 6 and Looking towards south: No indications of existing slope greater or equal to 2 m in height or any settlement.

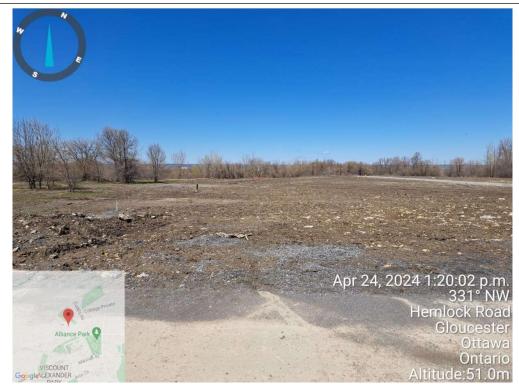
Standing at southeast side of Street No.1 and Looking towards northwest of Block 6: No indications of existing slope greater or equal to 2 m in height or any settlement.

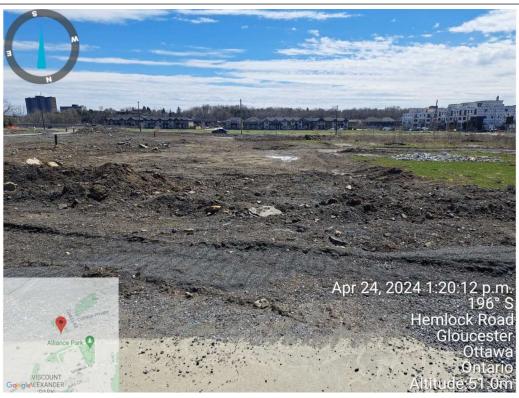
Standing at northside of Street No.1 and looking towards south of Block 5: No indications of existing slope greater or equal to 2 m in height or any settlement.

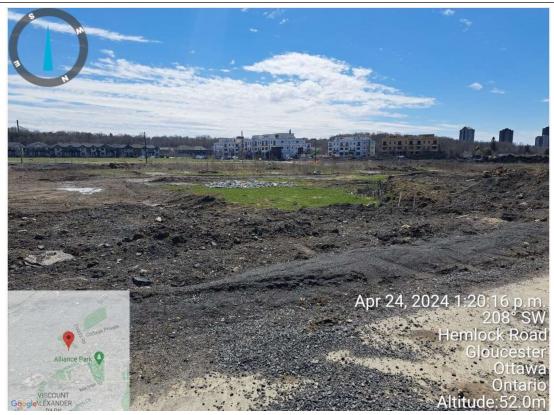
Standing at northeast side of Street No.1 and looking towards southwest of Block 5: No indications of existing slope greater or equal to 2 m in height or any settlement. Presence of vegetation such as grasses and small trees.

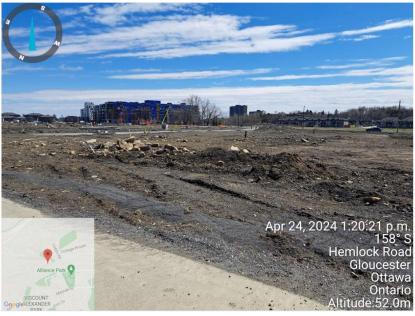
- Stockpiles of mixed vegetation, topsoil, rootlets, debris, and ponding water were observed at southwest area of Block 5.
- A pile of concrete block pieces was observed at southeast of Block 5.

Standing at northwest side of Street No.1 and looking towards southeast of Block 5: No indications of existing slope greater or equal to 2 m in height or any settlement. Presence of a pile of concrete block pieces.

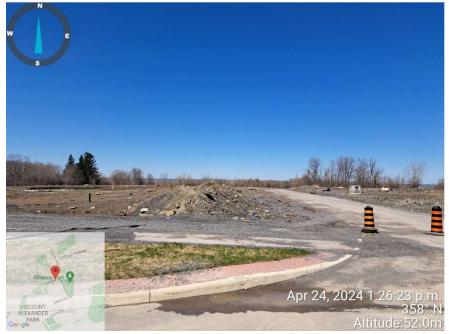
Standing at southside of Hemlock Rd. and looking towards North of Block 5: No indications of existing slope greater or equal to 2 m in height or any settlement. Presence of a pile of mixed topsoil, organics, debris, monitoring wells and service lines.

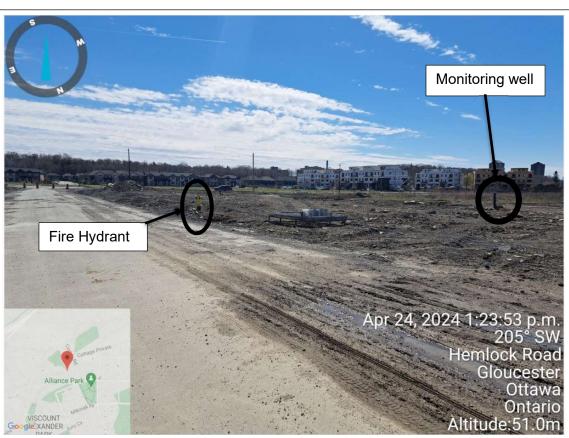
Standing at northeast side of Oshedinaa St. and looking towards southwest of Block 6 and **Block 5**: No indications of existing slope greater or equal to 2 m in height or any settlement. Presence of service lines, monitoring wells, etc.

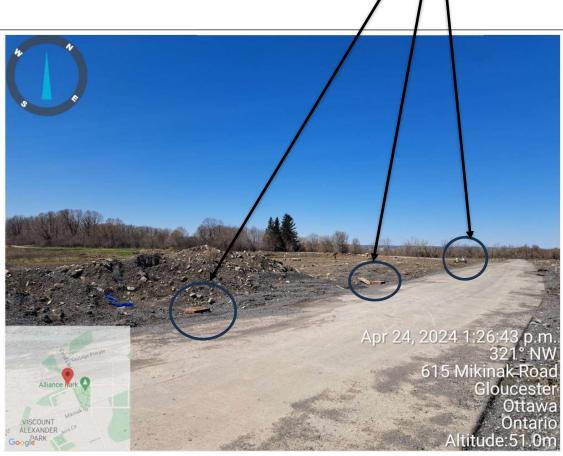
Service lines along **Oshedinaa Street**

Standing at southeast - close intersection of **Odshedinaa St.** and **Hemlock Rd.** and looking towards Northwest of Block 5: No indications of existing slope greater or equal to 2 m in height or any settlement. Presence of a pile of mixed topsoil, organics, debris, monitoring wells and service lines.
