HERITAGE IMPACT ASSESSMENT & CONSERVATION PLAN*

168 -174 MURRAY STREET, OTTAWA

Owner: David Yoo
Address: 168 – 174 Murray Street, Ottawa, Ontario

Revised March 2025

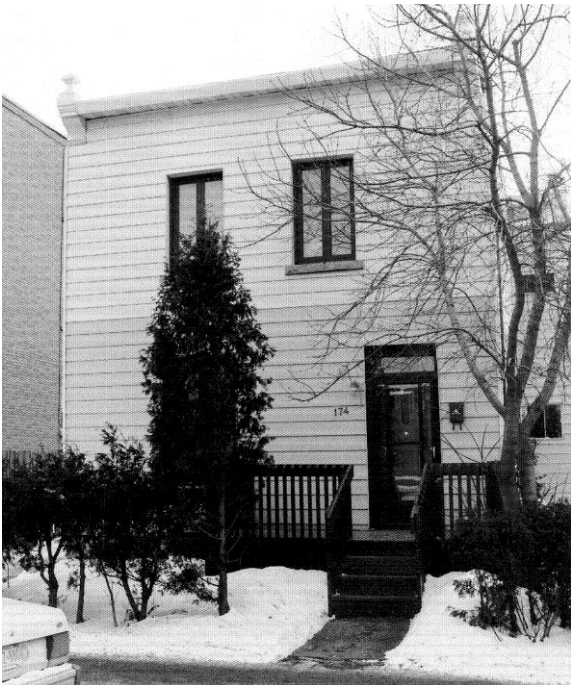
Figure 15 and 16: This collage of pictures documents the extensive alterations. Two views 1992 and 2022. 174 Murray (left) before the vinyl siding being removed and rehabilitated front. Note the different brick at the corner (both size and colour consistency) and the lack of corbelled banding and the transom treatment.

The house appears in a c.1949 photo, which highlights its attributes (Figure 14). The 1992 view of the building retains its form, with the exterior re-clad with a vinyl siding. The finials and a portion of the cornice detail are retained. The offset door is evident in the 1949 picture, but the distinctive hood has been covered or altered. In the 2022 view, the front door’s arched brickwork (voussoir), masonry hood and band of corbelled brickwork at the transom, were not incorporated into the replaced brick at the corner.
