ADDENDUM #1: CONSERVATION PLAN

John Stewart Commonwealth
June 20, 2024

1.0 CONSERVATION PLAN FOR 168 & 174 MURRAY STREET

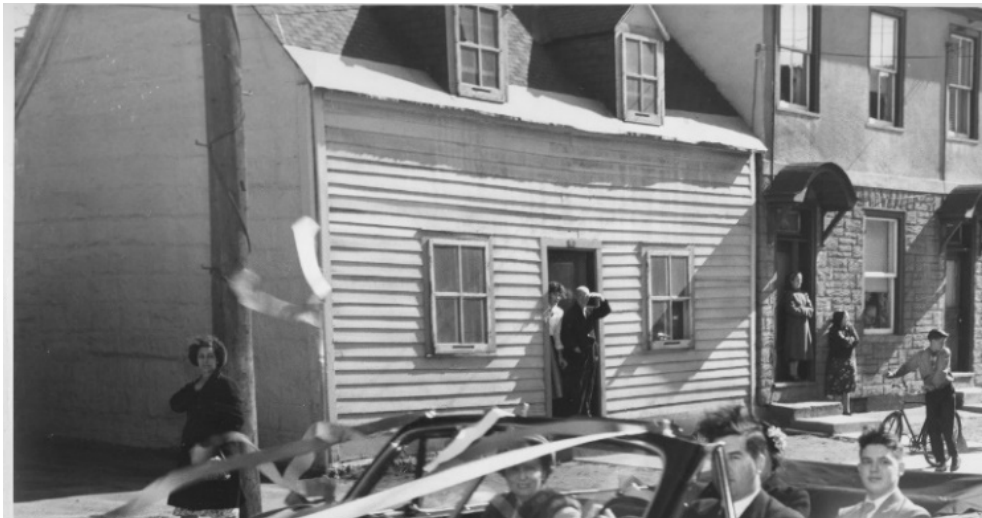
Figure 3: The house at 168 Murray appears in the background of the c.1949 parade. The house is a 1.5 storey side gable with two dormers facing the street, a centre front door with no canopy, horizontal siding on the front and squared timber chinked and whitewashed on the gabled side elevation. Source: Marc Aubin Collection.

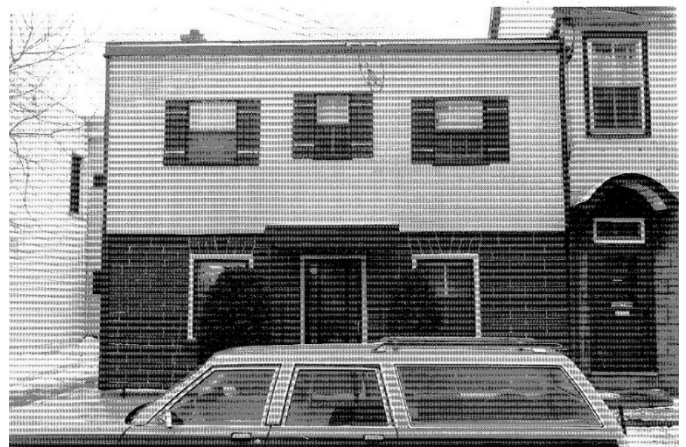
Figure 4: A 1991 view of the house documents the substantive alteration from its original one-and-one half storey side gable roof with gabled dormers facing the street. The house has been remodelled with a flat roof, a second floor added, and three windows replacing the dormers. The exterior was reclad in an angel stone on the ground floor and aluminum siding on the upper floor. A canopy over the front door has been added. Source: City of Ottawa Heritage Survey Forms 1991.

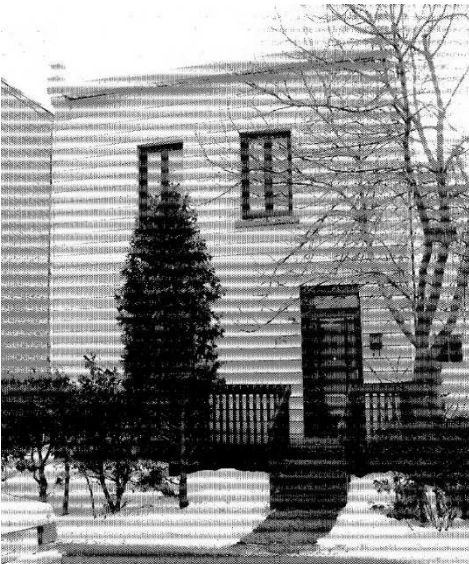
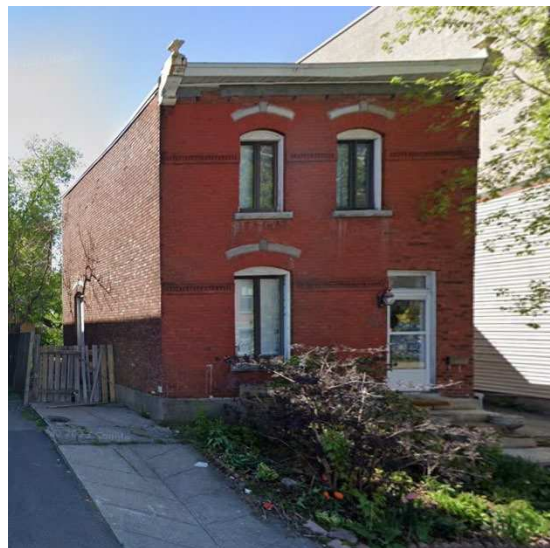
Figure 9 and 10: Two views 1992 and 2021 174 Murray (left) prior to the vinyl siding being removed and rehabilitated front. Note: A section of the cornice will need to be replicated. There is bulging of the brick along the 2nd floor between the windows. Also noted is the different brick at the corner (both size and colour)

consistency) and the lack of corbelled banding and the transom treatment. Earlier photos document a decorative hood over the door has been removed.
