# TREE CONSERVATION REPORT

5580 Manotick Main Street

February 3, 2025

## Tree Conservation Report v2.0

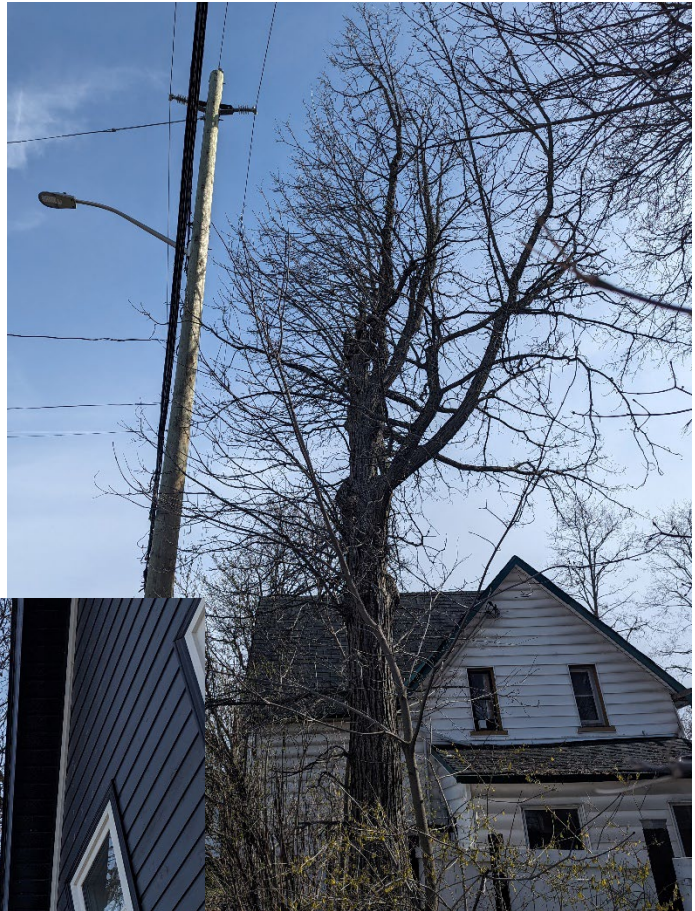
| Tree <sup>1</sup> | Species | DBH (cm) | Ownership <sup>2</sup> | Tree Condition | Action | Forester recommendation |
|---|---|---|---|---|---|---|
| 1 | Bur oak ( <i>Quercus macrocarpa</i> ) | 51 | City | Fair: pruned around wires – asymmetrical crown – pruning wounds with decay – epicormic shoots | Remove | Remove – in line with proposed entryway. |

Above: Tree 1 - City oak to be removed.

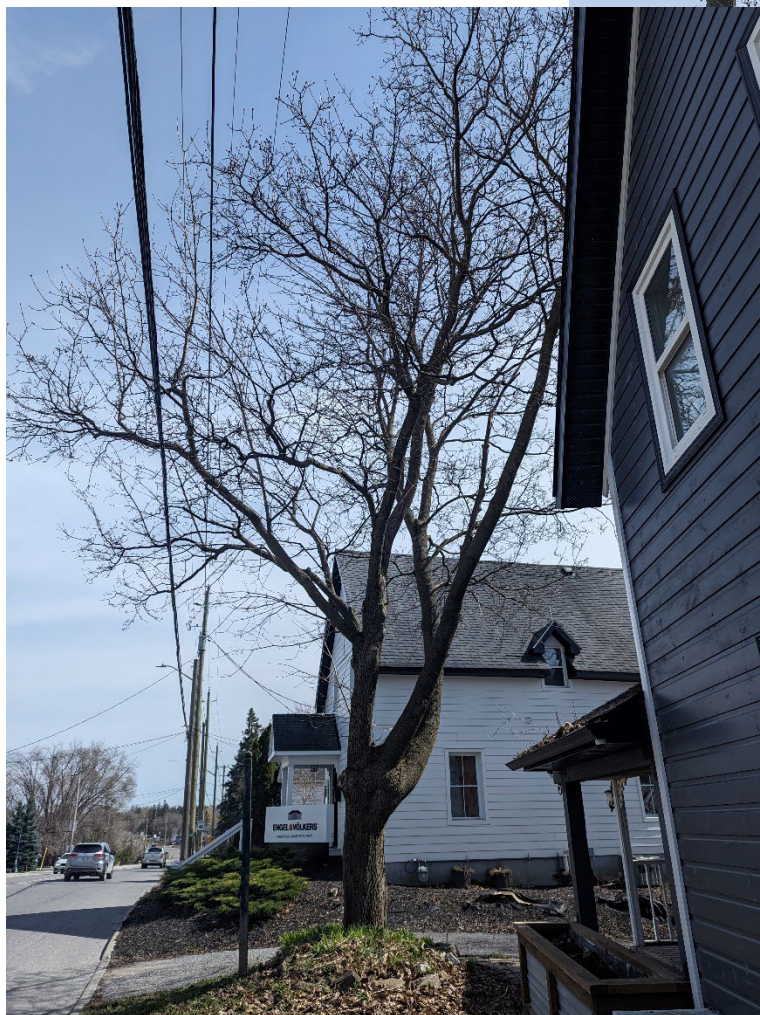
| Tree <sup>1</sup> | Species | DBH (cm) | Ownership <sup>2</sup> | Tree Condition | Action | Forester recommendation |
|---|---|---|---|---|---|---|
| 10 <sup>4</sup> | Norway maple ( <i>Acer platanoides</i> ) | 55 | Subject property | Poor/Fair: canker in canopy; slight lean to west; poor form at base; large dead branch | Remove | Remove due to health status and grading requirements. |

Left: Tree 10 - private Norway maple to be removed.

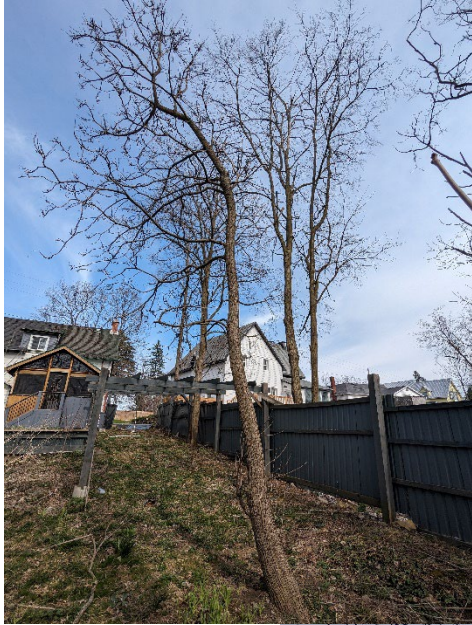
| Tree <sup>1</sup> | Species | DBH (cm) | Ownership <sup>2</sup> | Tree Condition | Action | Forester recommendation |
|---|---|---|---|---|---|---|
| 14 | Catalpa ( <i>Catalpa speciosa</i> ) | 16 | Subject property | Fair: lean and asymmetrical crown to south; broken branches | Remove | Remove – within excavation area |

**Right: Tree 14 - private catalpa to be removed. Trees 11-13 visible in background.**

**Trees 11-13** are not in good condition but should be far enough from excavation to be effectively protected. All roots along the line of excavation on the south property line are to be cleanly severed by hand.

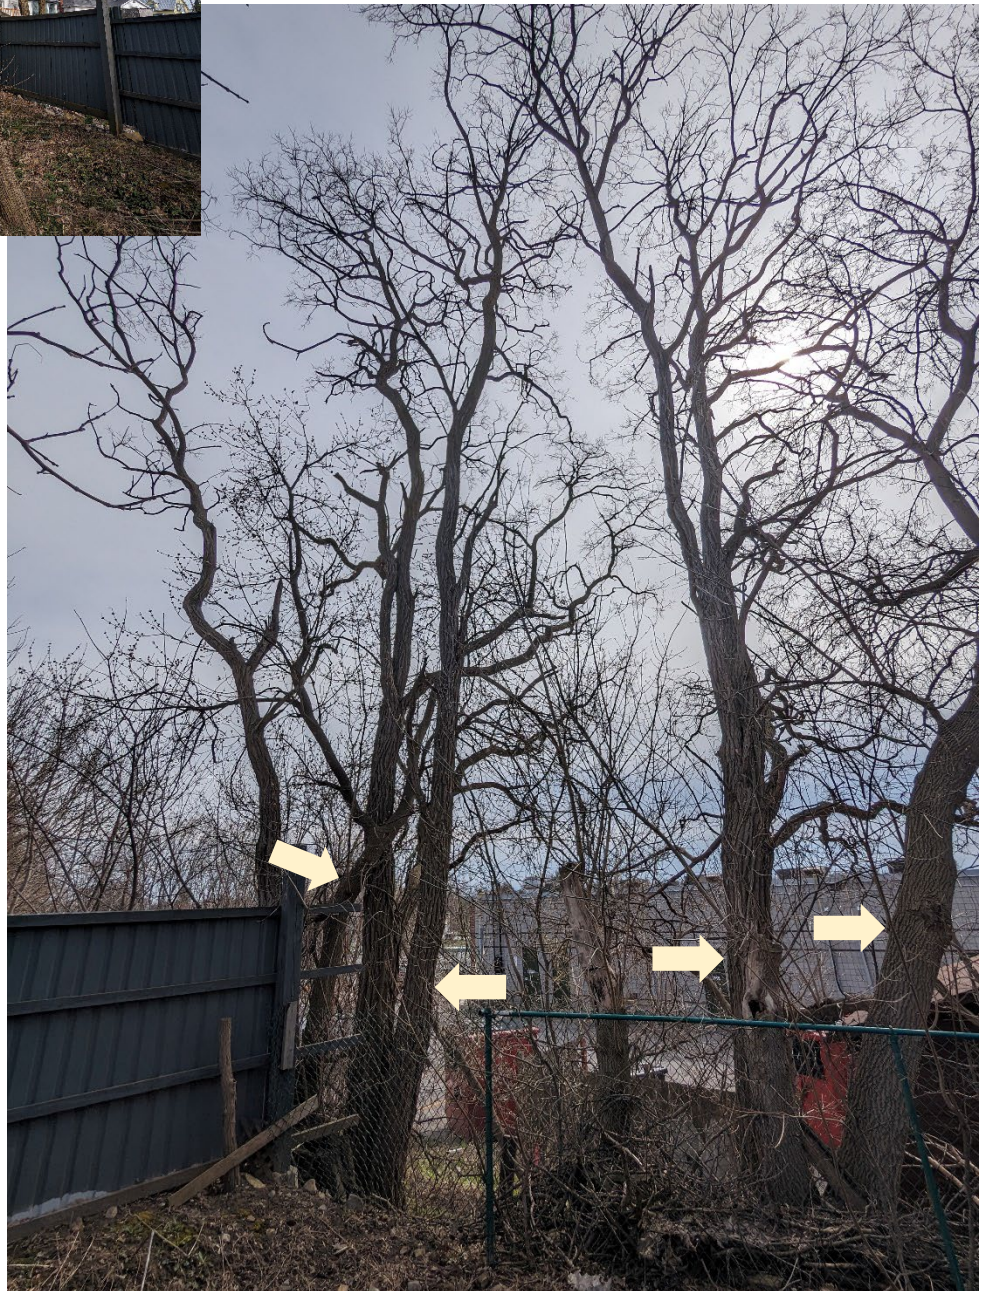
| 15 | Manitoba maple ( <i>Acer negundo</i> ) | 20 (estimate) | Adjacent – 1160 Beaverwood | Fair/Poor: heavy lean south; growing into Tree 16; sprouts at base; growing on slope | Retain | Retain. No action required. |
| 16 | Black locust ( <i>Robinia pseudoacacia</i> ) | 40, 30 (estimate) | Adjacent – 1160 Beaverwood | Poor: very little live canopy remaining; lean to south | Retain | Retain. No action required. |
| 17 | Black locust ( <i>Robinia pseudoacacia</i> ) | 45 (estimate) | Adjacent – 1160 Beaverwood | Fair/Poor: very little live canopy remaining | Remove | Remove due to health status and proximity of excavation. Permission required from neighbor for removal. |
| 18 | Manitoba maple ( <i>Acer negundo</i> ) | 40 (estimate) | Adjacent – 1160 Beaverwood | Fair: heavy lean northwest; vigorous growth | Remove | Remove due to proximity of excavation. Permission required from neighbor for removal. |

**Below: (left to right) Tree 15 & 16 – adjacent trees to be retained and 17 & 18 – adjacent trees to be removed.**

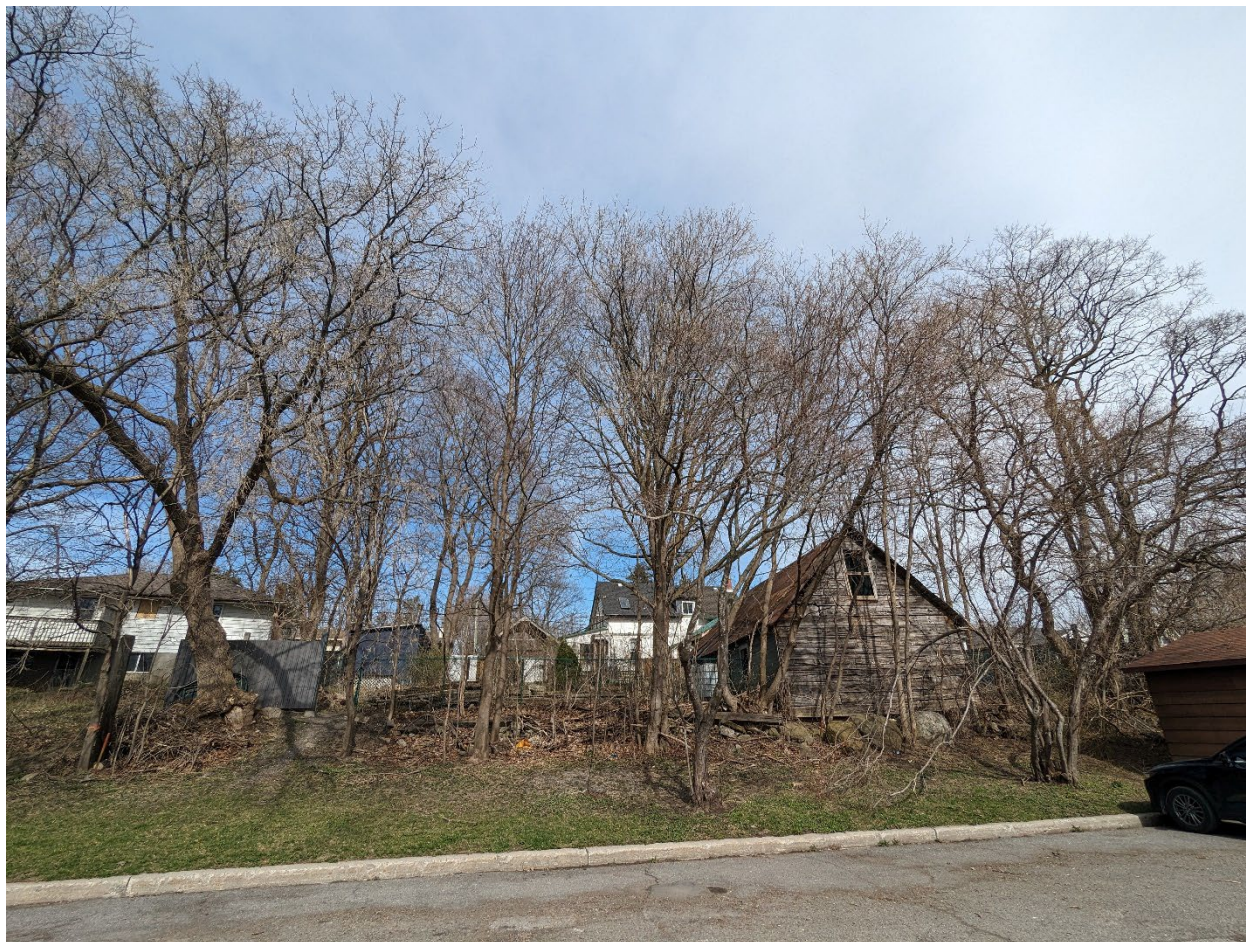
| G1 | Norway and Manitoba maples ( <i>A. negundo</i> & <i>A. platanoides</i> ) | 12 stems 8-29cm | Adjacent – 1160 Beaverwood | Fair: young trees, mostly vigorous; growing on slope, shaded | Retain | Retain to provide canopy coverage after construction. Grade changes not to occur past property line. |

Above: view from adjacent commercial area - Group 1 and Tree 20 (far left) along the rear of the property.

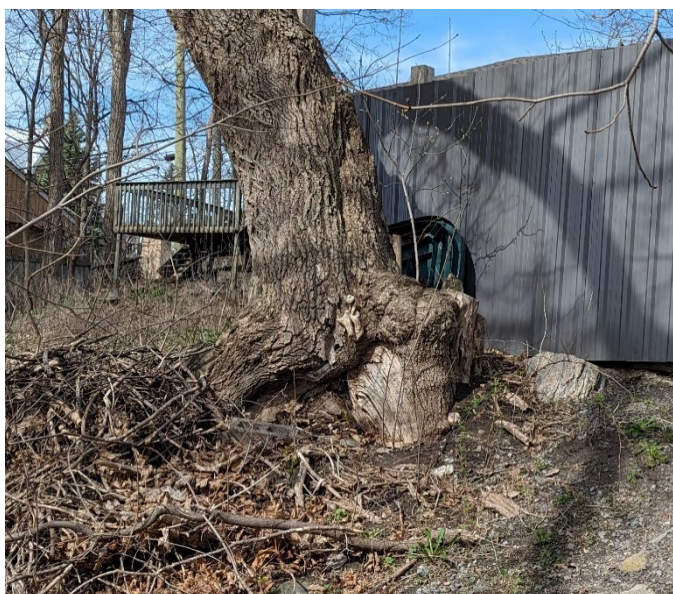
| 20 | Manitoba maple ( <i>Acer negundo</i> ) | 85 | Boundary – 5576 Manotick Main | Poor: decay and fungal bodies at base; lean to northwest; woodpecker activity in canopy | Retain | Remove – in line with proposed parking. |

Below: base of Tree 20

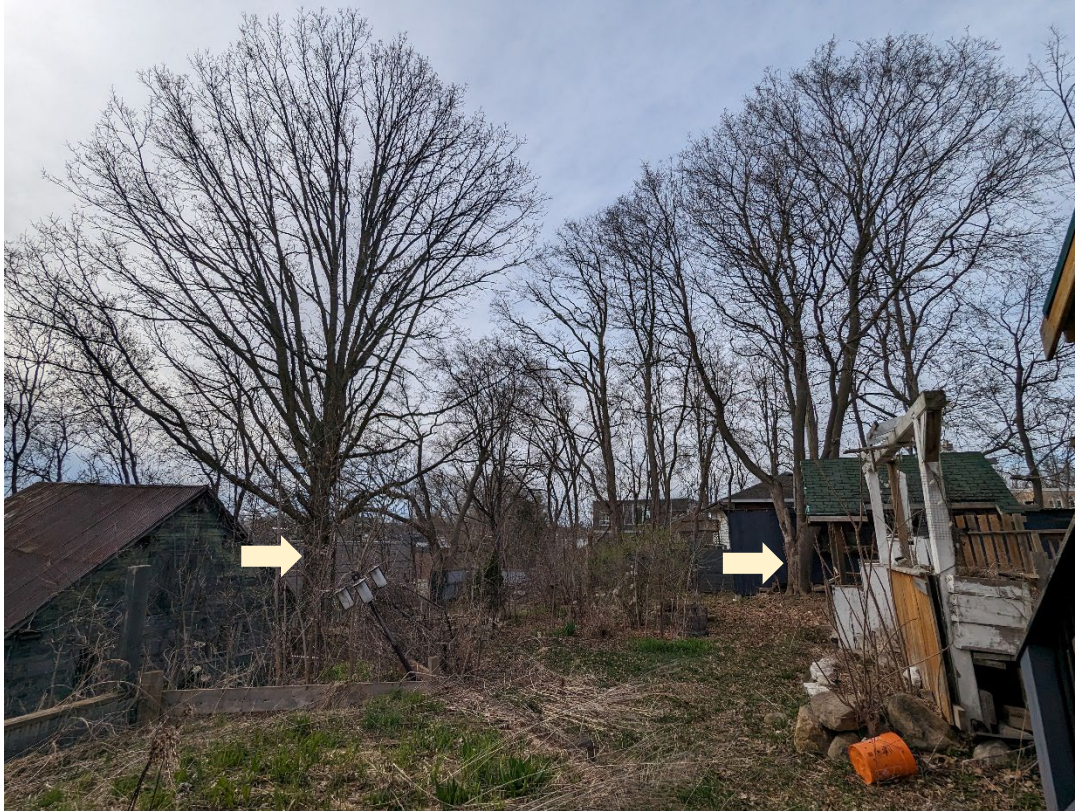
Above: western corner and northern property line. Tree 19 at left of image and Tree 25 in front of far structure at right.

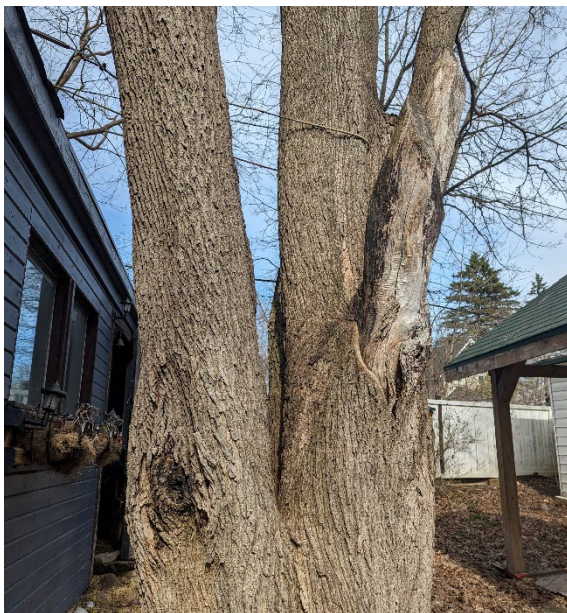
| 25 | Norway maple ( <i>Acer platanoides</i> ) | 66, 43 | Subject property | Poor: canker on smaller stem; decay at main union – 10cm deep hole – small crack from this hole to base; large branch stub | Remove | Remove due to health status and impacts from construction – in line with proposed parking. |

Below left: main union of Tree 25 with canker beginning and large branch stub.

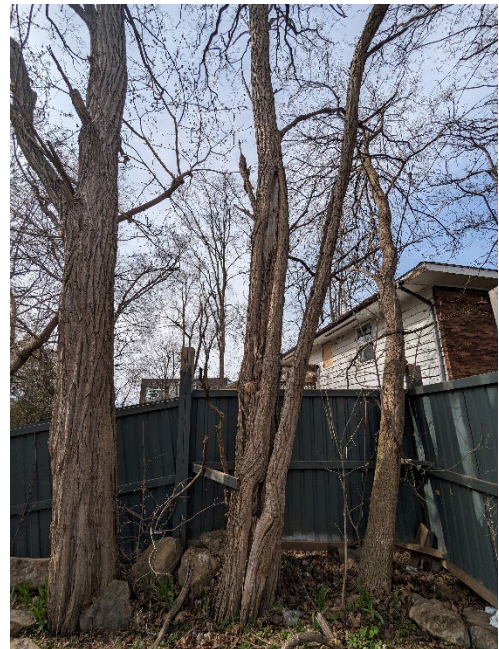
| 21 | Manitoba maple ( <i>Acer negundo</i> ) | 27 | Boundary – 5576 Manotick Main | Poor: top has been removed – only sprouts remain as canopy | Remove | Remove due to grade changes to install parking. |
| 22 | Black locust ( <i>Robinia pseudoacacia</i> ) | 53 | Boundary – 5576 Manotick Main | Poor: Very little live canopy | Remove | Remove due to grade changes to install parking. |
| 23 | Black locust ( <i>Robinia pseudoacacia</i> ) | 43 | Boundary – 5576 Manotick Main | Poor: large wound on trunk – decay present | Remove | Remove due to grade changes to install parking. |

Below right: Trees 21-23 – boundary trees to be removed.

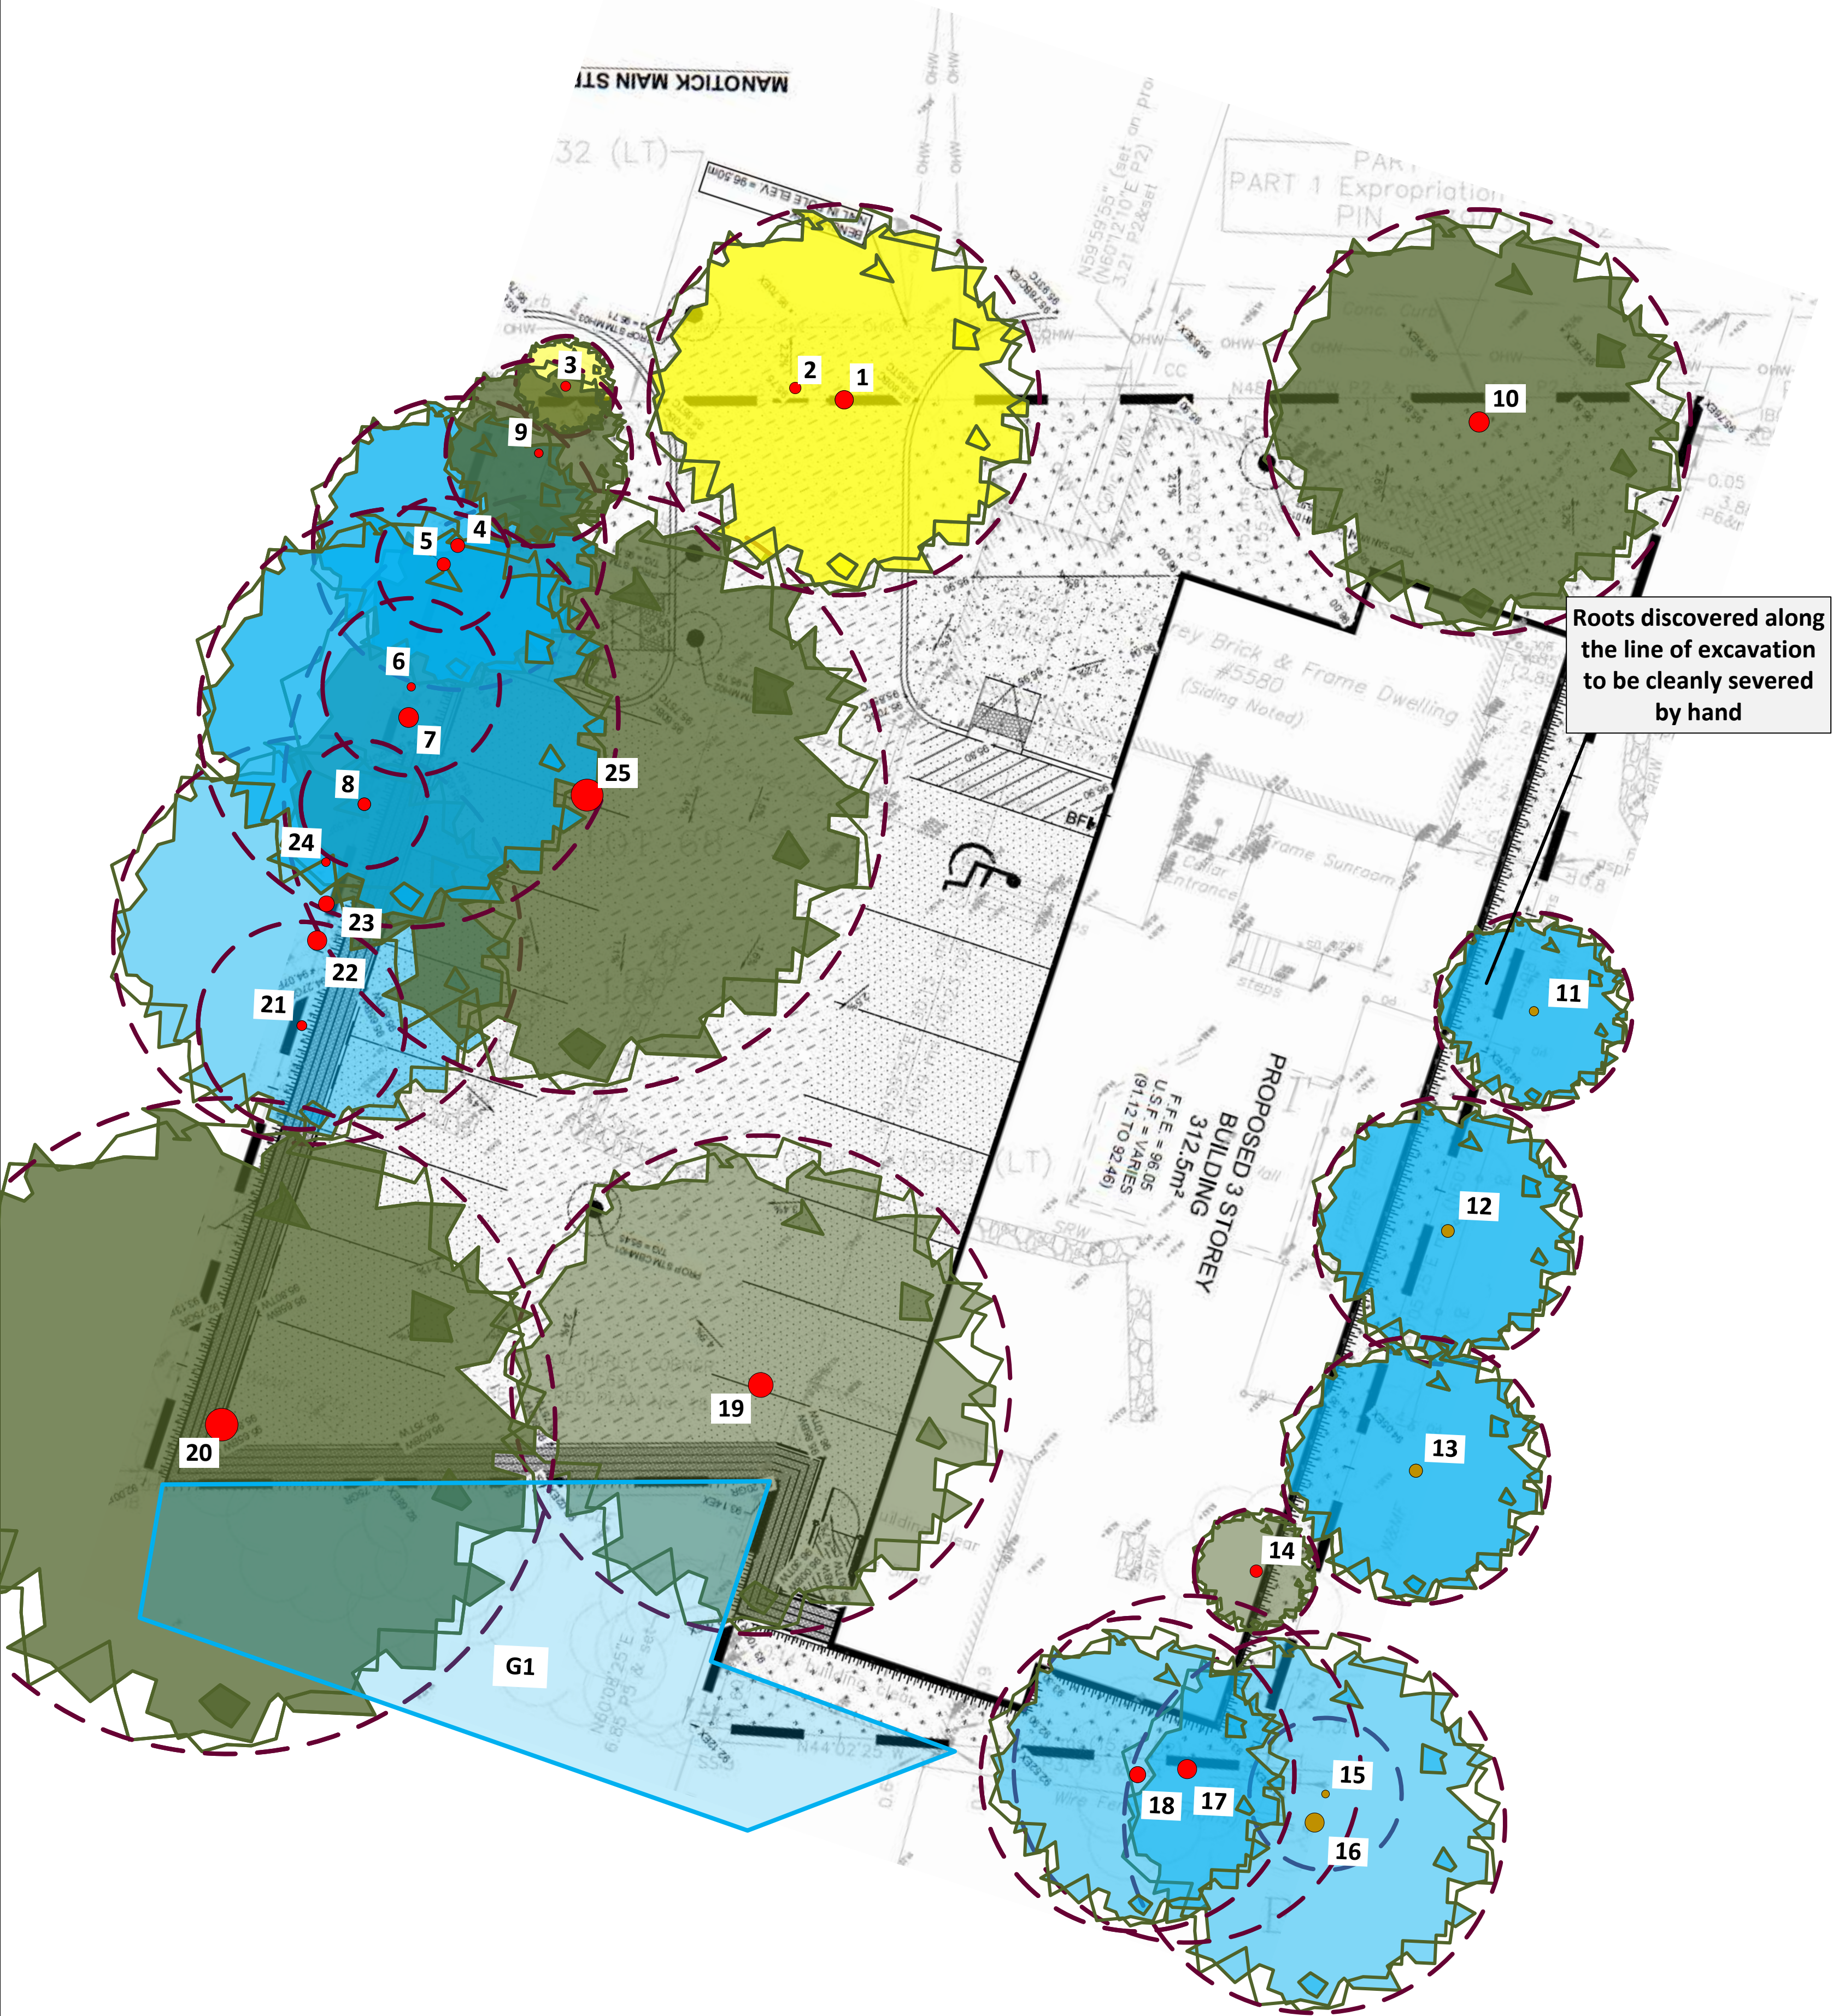
Due to the proposed grade changes, tree retention within the bounds of the subject property will be impossible. **Tree 9** is growing within and around an existing shed and is not a valid candidate for retention. In the previous version, **Tree 10** was recommended for removal. While the current plans indicate a potential for retention, the tree is not in good condition, and the amount of site works around its base to demolish the existing walkway and house will likely severely stress the tree, causing further and more rapid decline. What is more, the tree is currently growing on a raised piece of ground – this may interfere with the proposed drainage and grading.
