TREE CONSERVATION REPORT

5580 Manotick Main Street

Tree Conservation Report v3.0

Date of Report: August 14, 2025

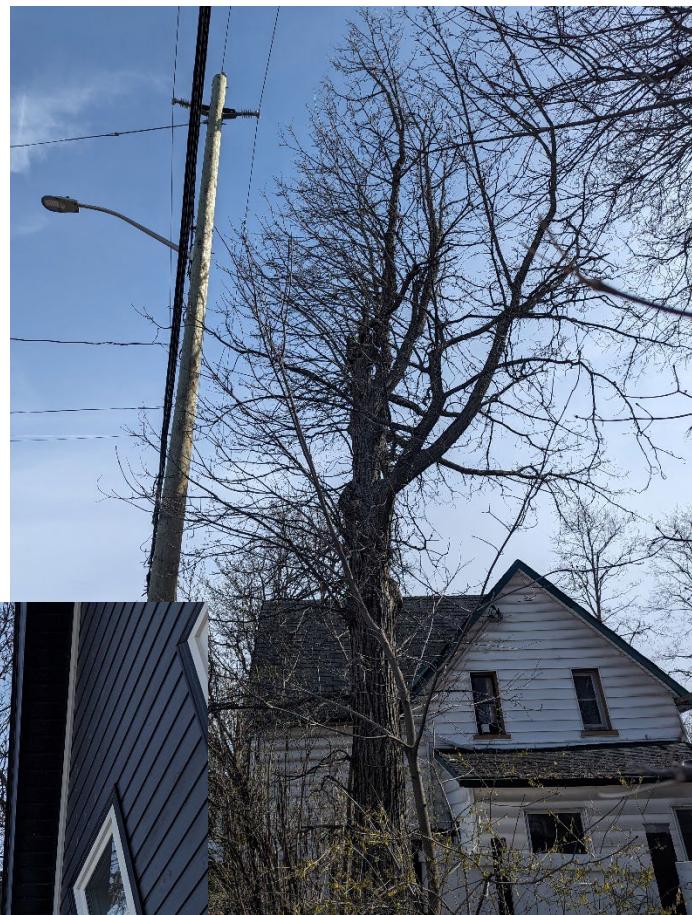
Tree ¹	Species	DBH (cm)	Ownership ²	Tree Condition	Action	Forester recommendation
1	Bur oak (<i>Quercus macrocarpa</i>)	51	City	Fair: pruned around wires – asymmetrical crown – pruning wounds with decay – epicormic shoots	Remove	Remove – in line with proposed entryway.
2 ⁴	Norway maple (<i>Acer platanoides</i>)	8	City	Good/Fair: leaning to road for sunlight	Remove	Remove – in line with proposed entryway.
3 ⁴	Norway maple (<i>Acer platanoides</i>)	7, 5, 6, 8	City	Fair/Poor: stems are sprouts from old stump; leaning heavily; growing under wires	Remove	Remove due to health status.
4	Black locust (<i>Robinia pseudoacacia</i>)	38	Boundary – 5576 Manotick Main	Fair: poor growing location; crowded	Remove	Remove – opportunities to retain may be explored during site works.
5	Norway maple (<i>Acer platanoides</i>)	17	Boundary – 5576 Manotick Main	Fair: young and vigorous; poor growing location; suppressed by larger trees	Remove	Remove – opportunities to retain may be explored during site works.

Above: Tree 1 - City oak to be removed.

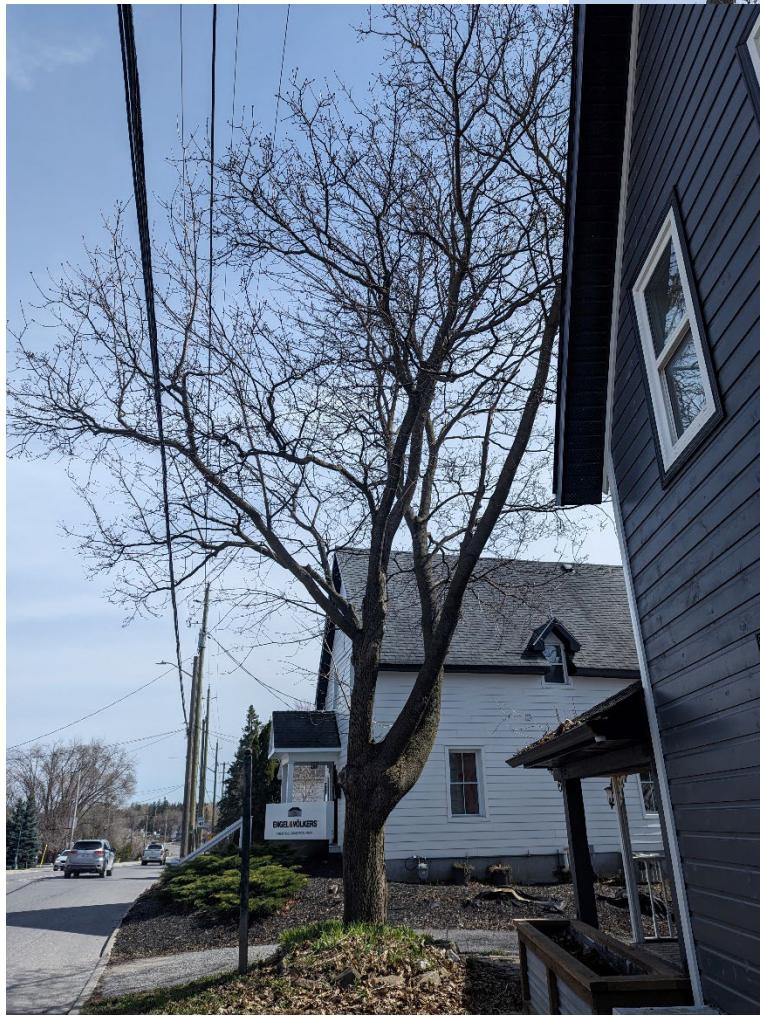
Left: Tree 10 - private Norway maple to be removed.

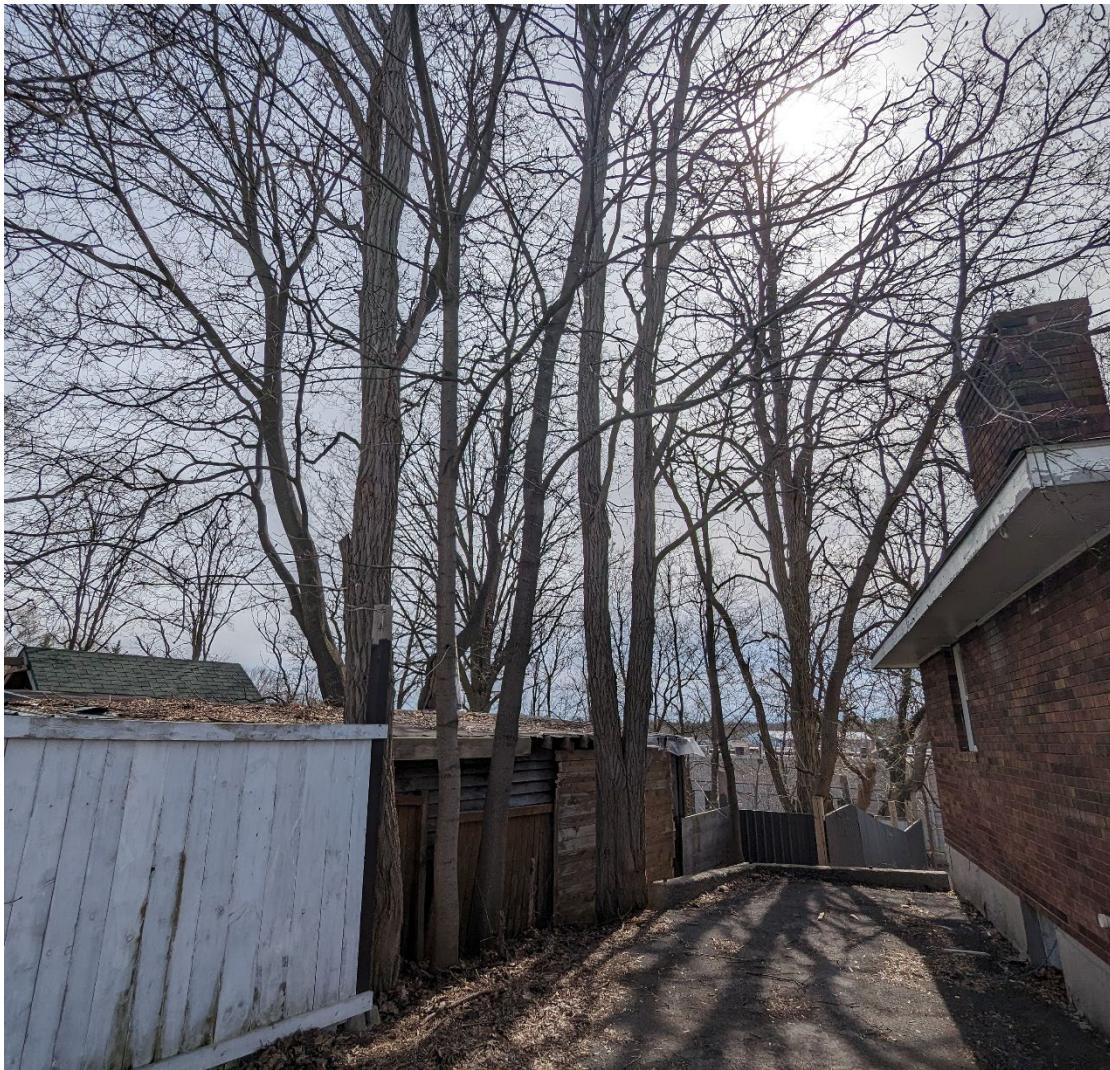
There are many trees located on the boundary, or just within the adjacent property at 5576 Manotick Main Street that are listed in the tree inventory, including **trees 4-8 and 21-24**. Most of these are in fair/poor health and have seeded in naturally and are being suppressed by larger trees. The rooting zones of these trees are in conflict with the proposed development, and removal and replacement is recommended at this time. Opportunities may exist to protect **Trees 4 and 5**, but this would require further details about on-site construction methods and in-situ mitigations, including root cutting and sensitive removal of other trees. Because these trees are located on the adjacent boundary, permission from the adjacent property owner will be sought prior to removal and issuance of a tree permit.

Trees 4-8 – boundary black locust and Norway maples to be removed.

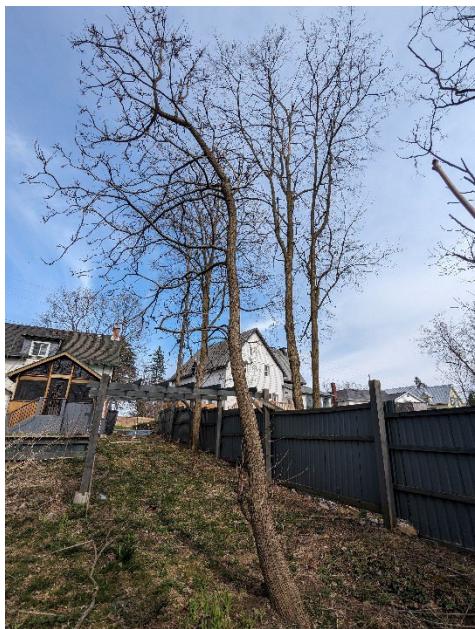
Right: Tree 14 - private catalpa to be removed. Trees 11-13 visible in background.

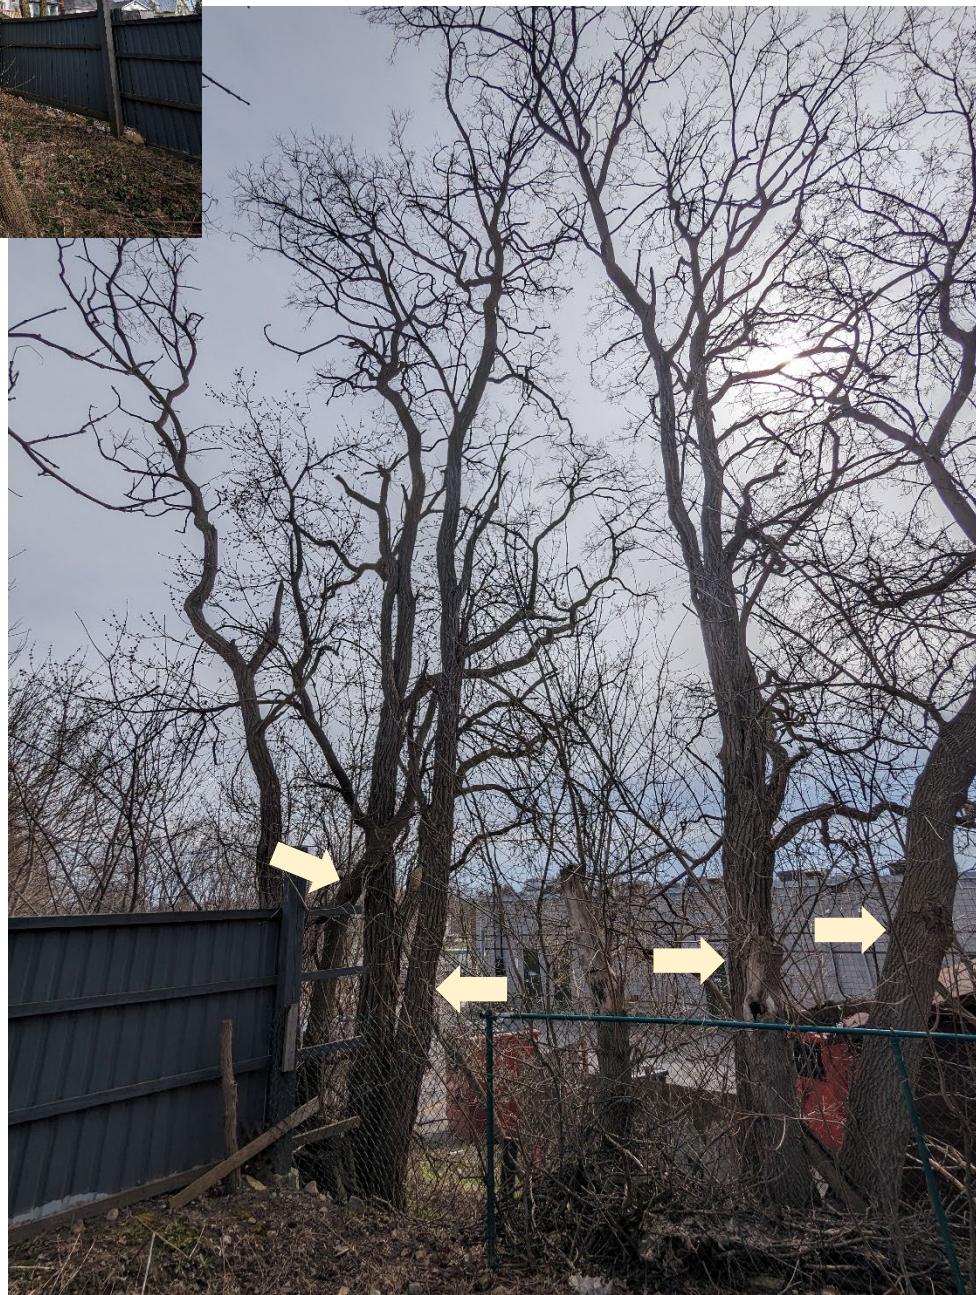
Below: (left to right) Tree 15 & 16 – adjacent trees to be retained and 17 & 18 – adjacent trees to be removed.

17	Black locust (<i>Robinia pseudoacacia</i>)	45 (estimate)	Fair/Poor: very little live canopy remaining	Remove due to health status and proximity of excavation. Permission required from neighbor for removal.
18	Manitoba maple (<i>Acer negundo</i>)	40 (estimate)	Fair: heavy lean northwest; vigorous growth	Remove due to proximity of excavation. Permission required from neighbor for removal.
19	Bur oak (<i>Quercus macrocarpa</i>)	65	Good/Fair: some crossing branches; branch stubs from pruning with epicormic shoots	Remove – in line with proposed parking.
20	Manitoba maple (<i>Acer negundo</i>)	85	Poor: decay and fungal bodies at base; lean to northwest; woodpecker activity in canopy	Remove – in line with proposed parking.
21	Manitoba maple (<i>Acer negundo</i>)	27	Poor: top has been removed – only sprouts remain as canopy	Remove due to grade changes to install parking.
22	Black locust (<i>Robinia pseudoacacia</i>)	53	Poor: Very little live canopy	Remove due to grade changes to install parking.

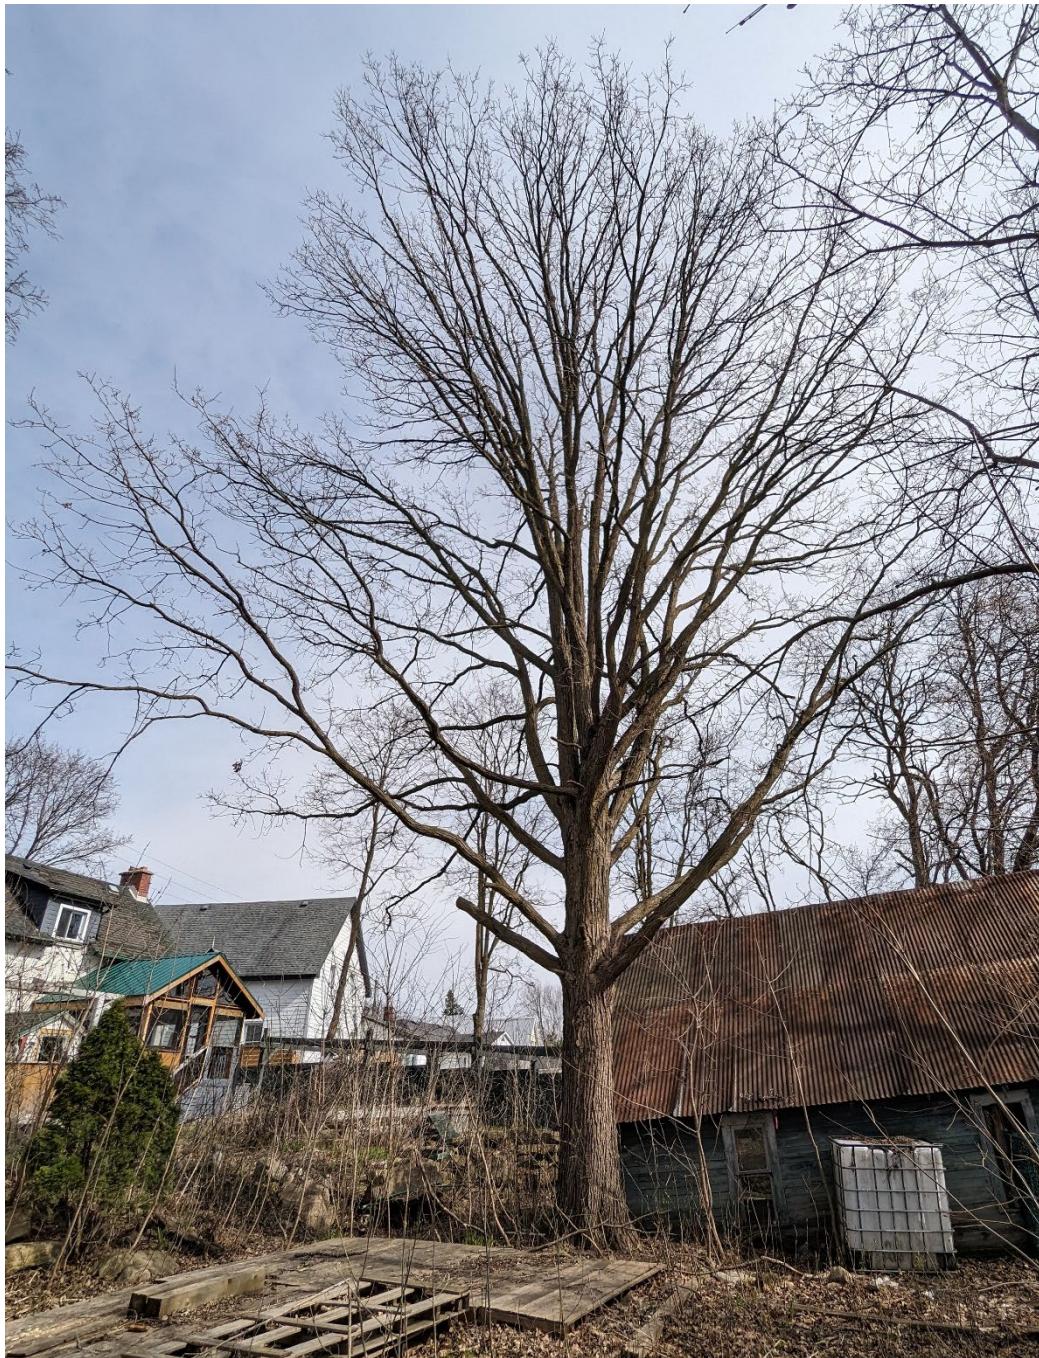
Tree 19 - private oak to be removed.

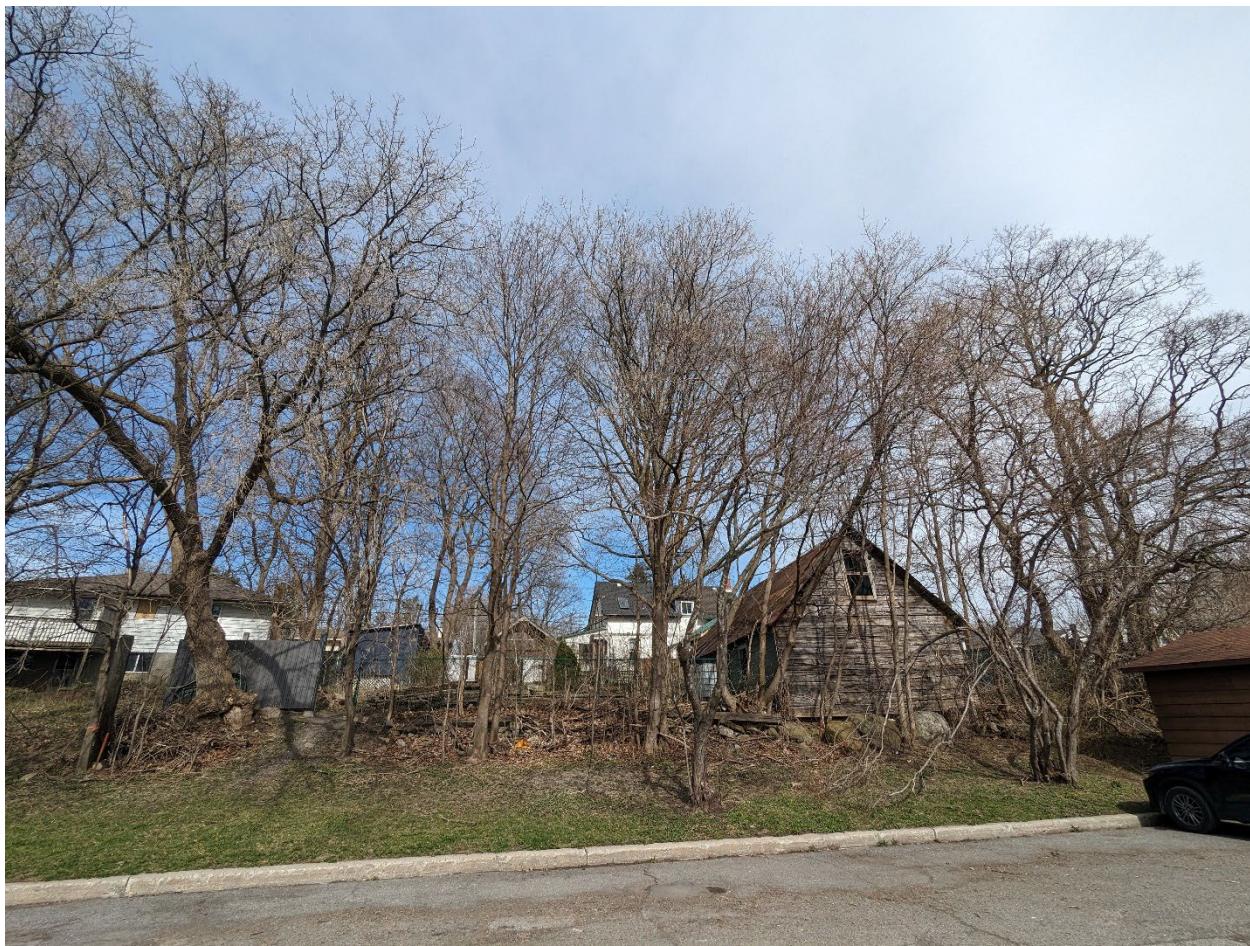
Above: view from adjacent commercial area - Group 1 and Tree 20 (far left) along the rear of the property.

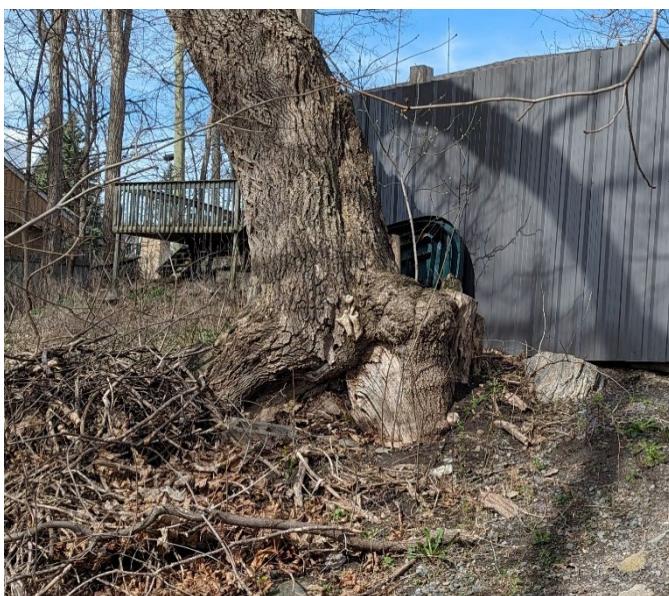
20	Manitoba maple (<i>Acer negundo</i>)	85	Boundary – 5576 Manotick Main	Poor: decay and fungal bodies at base; lean to northwest; woodpecker activity in canopy	Retain	Remove – in line with proposed parking.
21	Manitoba maple (<i>Acer negundo</i>)	27	Boundary – 5576 Manotick Main	Poor: top has been removed – only sprouts remain as canopy	Remove	Remove due to grade changes to install parking.
22	Black locust (<i>Robinia pseudoacacia</i>)	53	Boundary – 5576 Manotick Main	Poor: Very little live canopy	Remove	Remove due to grade changes to install parking.
23	Black locust (<i>Robinia pseudoacacia</i>)	43	Boundary – 5576 Manotick Main	Poor: large wound on trunk – decay present	Remove	Remove due to grade changes to install parking.
24	Manitoba maple (<i>Acer negundo</i>)	24	Boundary – 5576 Manotick Main	Poor: crack in trunk; lean to northeast	Remove	Remove due to grade changes to install parking.
25	Norway maple (<i>Acer platanoides</i>)	66, 43	Subject property	Poor: canker on smaller stem; decay at main union – 10cm deep hole – small crack from this hole to base; large branch stub	Remove	Remove due to health status and impacts from construction – in line with proposed parking.

Below: base of Tree 20

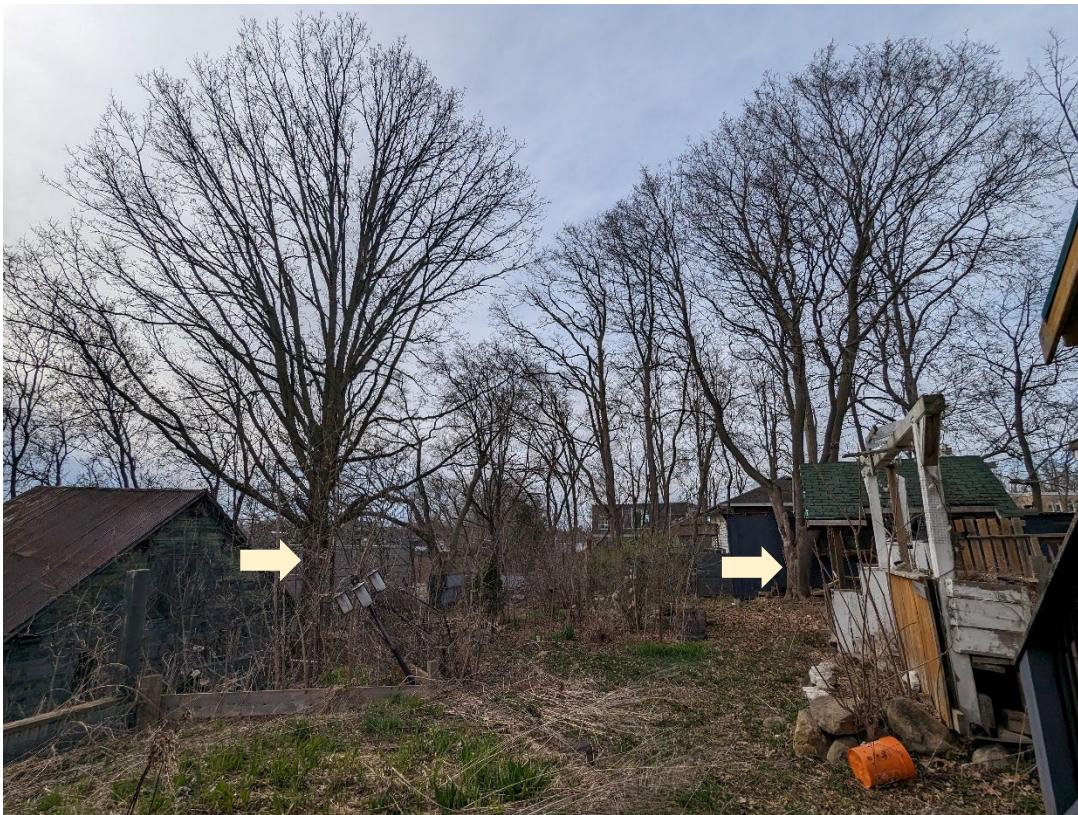
Above: western corner and northern property line. Tree 19 at left of image and Tree 25 in front of far structure at right.

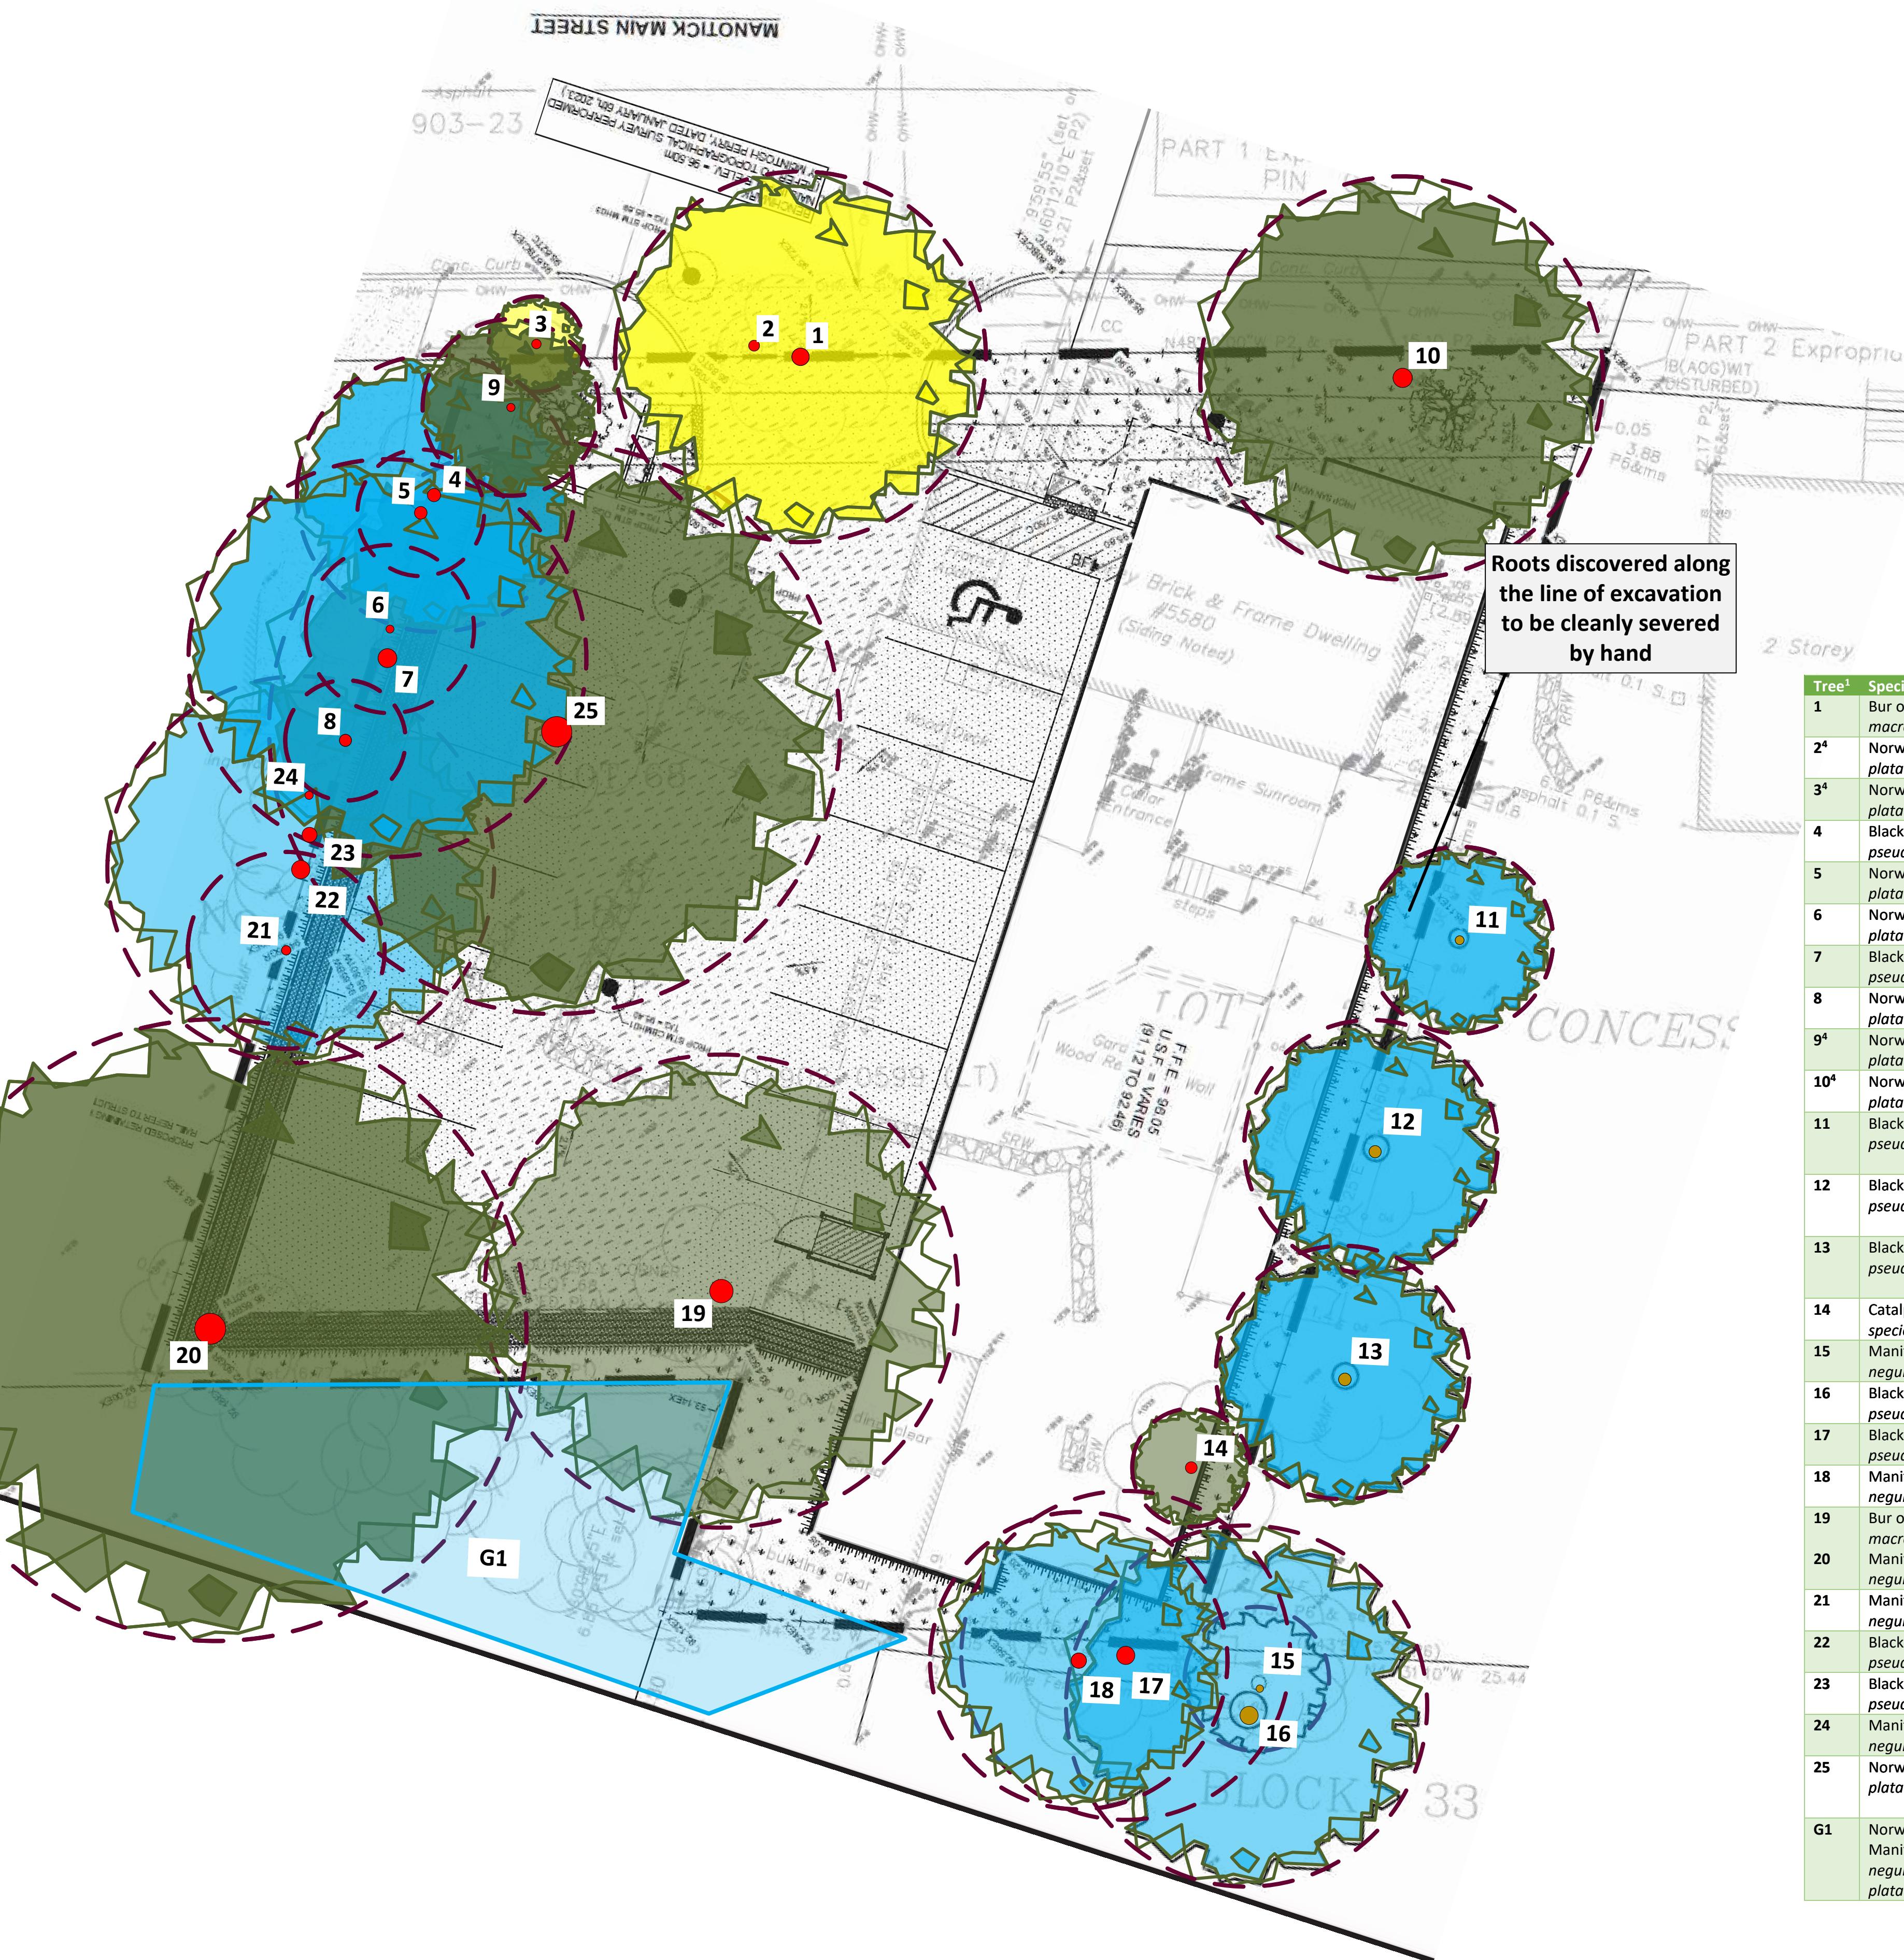
TCR Map #2 – 5580 Manotick Main

Roots discovered along
the line of excavation
to be cleanly severed
by hand
