# **TREE CONSERVATION REPORT V5.0**

**6600 Rue Carrière**

Tree Conservation Report prepared as Partial  
Requirements for a Site Plan Control  
Application, September 11, 2025

**Dendron Forestry Services**

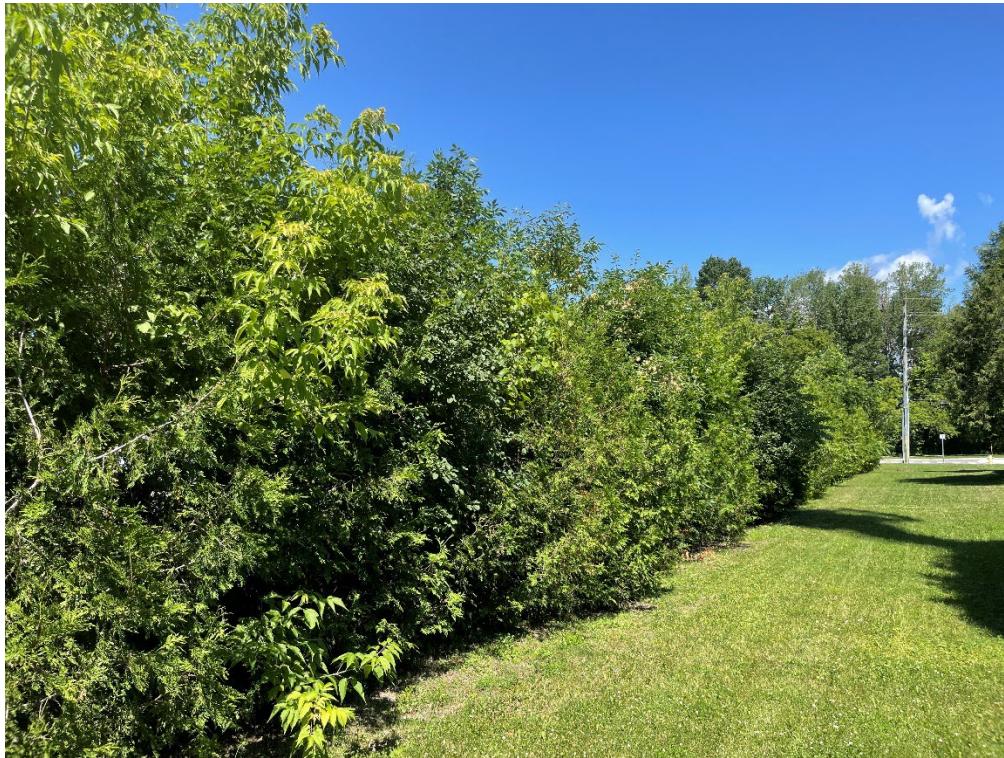
| 5 | Cedar hedge<br>( <i>Thuja occidentalis</i> ) | 5-15 cm | Private | Good/fair | Partial removal as shown on map, remaining section to be protected with fencing as per City of Ottawa Tree Protection Specifications (March 2021) |
| 7 | Cedar hedge<br>( <i>Thuja occidentalis</i> ) | 5-10 cm | Private | Good/fair | Partial removal as shown on map, remaining section to be protected with fencing as per City of Ottawa Tree Protection Specifications (March 2021) |

**Figure 1: Cedar hedge along the western property line**

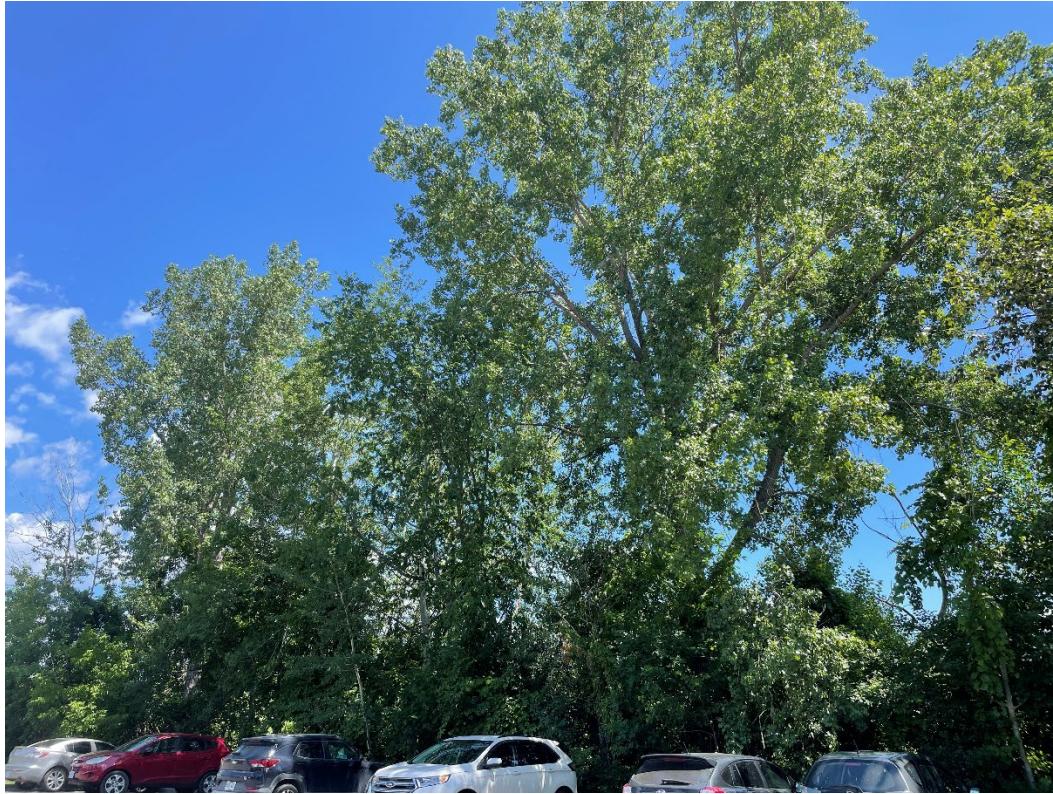
The school property to the east and south of the subject site is lined with trees, mostly poplar and red maple. The larger poplars are eastern cottonwood (*Populus deltoides*) whereas there is a healthy understory of trembling aspen (*Populus tremuloides*). Along the east side, it is mostly poplar, with one small red oak and a few dead ash trees. Along the rear (south) end of the property, there is a row of eastern cottonwood closest to the property line with red maple (*Acer rubrum*) dominating the row behind.

The Geotechnical Report prepared by Paterson Group on December 15, 2021, identified the presence of sensitive silty clay on the site. This soil is common in Ottawa and can cause foundational issues if trees are planted too close to structures. Trees, especially high-water demanding species, can deplete water from the soil which may cause shrinkage and shifting of foundations. The new building will be approximately 2 m from the eastern property line where there is an 8-10 m wide row of poplar trees. Poplar trees are fast growing and are high water demanding trees. The recommendation from the report is to provide a setback of 7.5 m from the foundation for smaller trees. For medium to larger trees, the setback should be equivalent to the tree height at maturity. Since these poplars can grow 25-30 m high at maturity, they are closer than the recommended setback distance.

As per the recommendations of the geotechnical report regarding maximum tree heights and distances to the building, the row of poplars should be removed to reduce the risk of future foundation issues. In addition to this, the excavation for the new building will be close to the property line which would likely cause some instability of some of the large trees close to the property line on the school side.

**Figure 2: Poplar trees along the eastern property line**

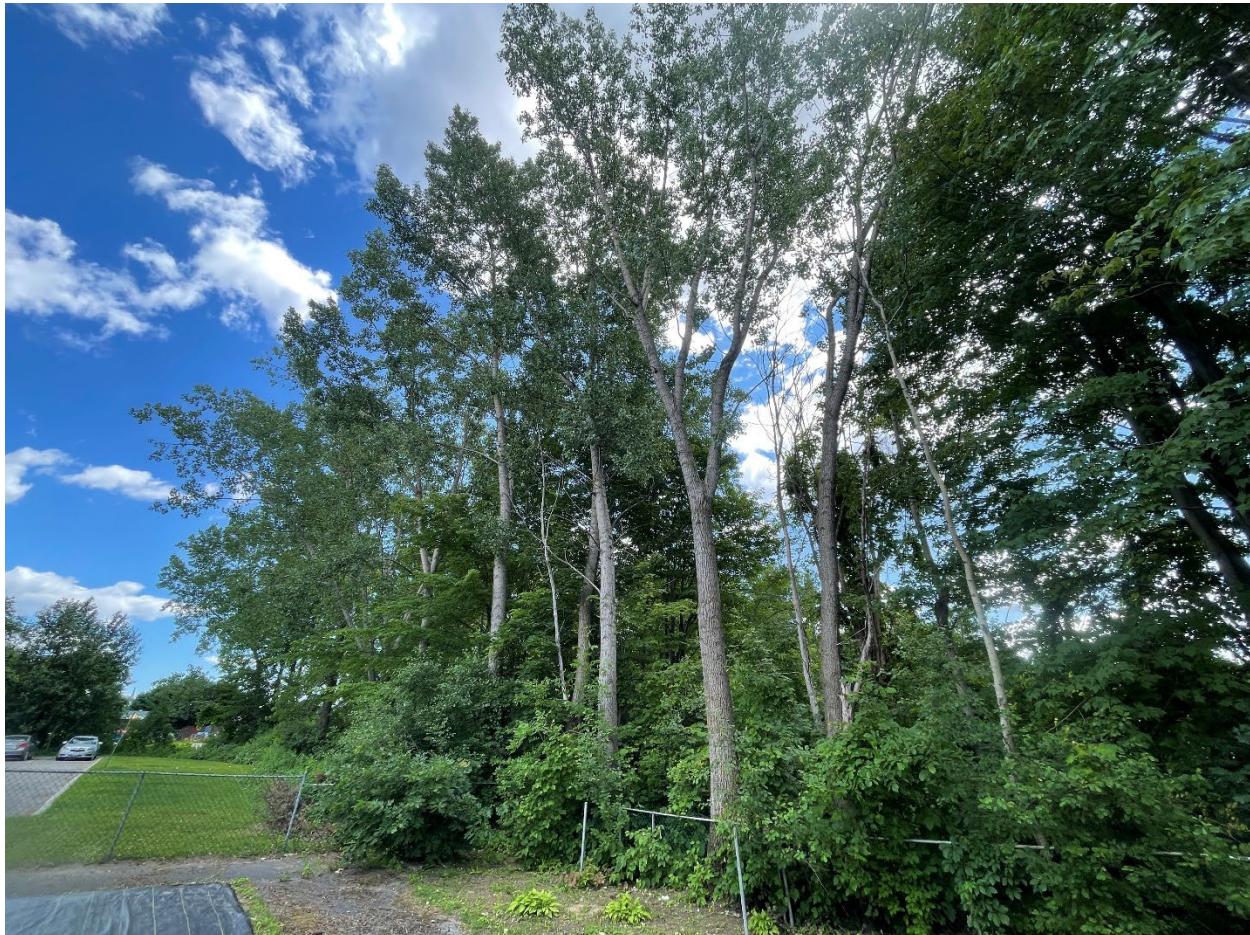
The trees along the south side (trees 18, 24-27) will also be within a tree height of the foundation and require removal. All these trees are within a distance that is less than their current height from the proposed building. Furthermore, there is a transformer to be installed within 2 m of trees 24 and 25. In

The row of poplars to the south (trees 20 – 23) will be less than 2 m from the new parking area. The excavation for the proposed parking lot will impact the roots of these trees and may contribute to instability, and removal and replacement is the preferred option in this area.

**Figure 3: Poplars and red maples along the southern property line**
