TREE CONSERVATION REPORT V4.0

6600 Rue Carrière

Tree Conservation Report prepared as Partial
Requirements for a Site Plan Control
Application, May 2, 2025

Dendron Forestry Services

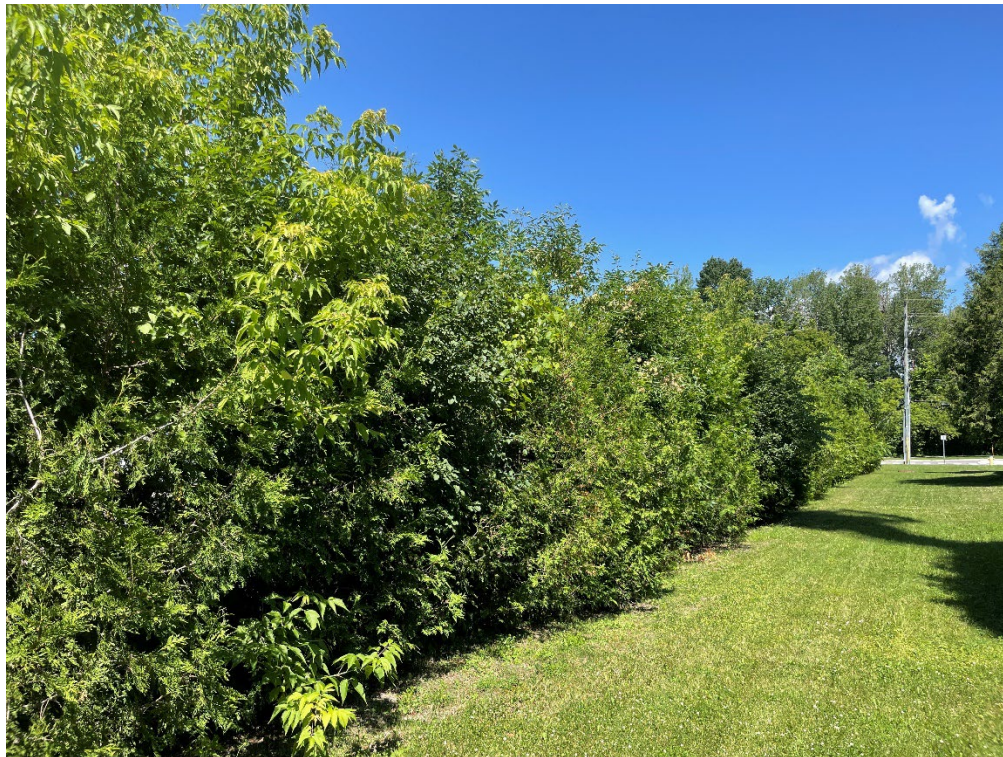
5	Cedar hedge (<i>Thuja occidentalis</i>)	5-15 cm	Private	Good/fair	Partial removal as shown on map, remaining section to be protected with fencing as per City of Ottawa Tree Protection Specifications (March 2021)
6	Austrian pine (<i>Pinus nigra</i>)	39 cm	Private	Fair; boring insect holes, heavy grapevine presence	Remove based on health and conflict with infrastructure
7	Cedar hedge (<i>Thuja occidentalis</i>)	5-10 cm	Private	Good/fair	Retain and protect with fencing as per City of Ottawa Tree Protection Specifications (March 2021)
8	Cedar (<i>Thuja occidentalis</i>)	51 cm (measured at 0.5 m)	Private	Fair: multiple stems, 5% lean	Remove; in footprint of proposed parking area; Tree permit required
9	Cedar (<i>Thuja occidentalis</i>)	21, 45, 22 cm	Private	Good/fair	Remove; in footprint of proposed parking area; Tree permit required
10	Cedar hedge (<i>Thuja occidentalis</i>)	5-15 cm	Private	Poor; unmaintained and shaded by adjacent tree	Remove; in footprint of proposed parking area; Tree permit required

Figure 1: Cedar hedge along the western property line

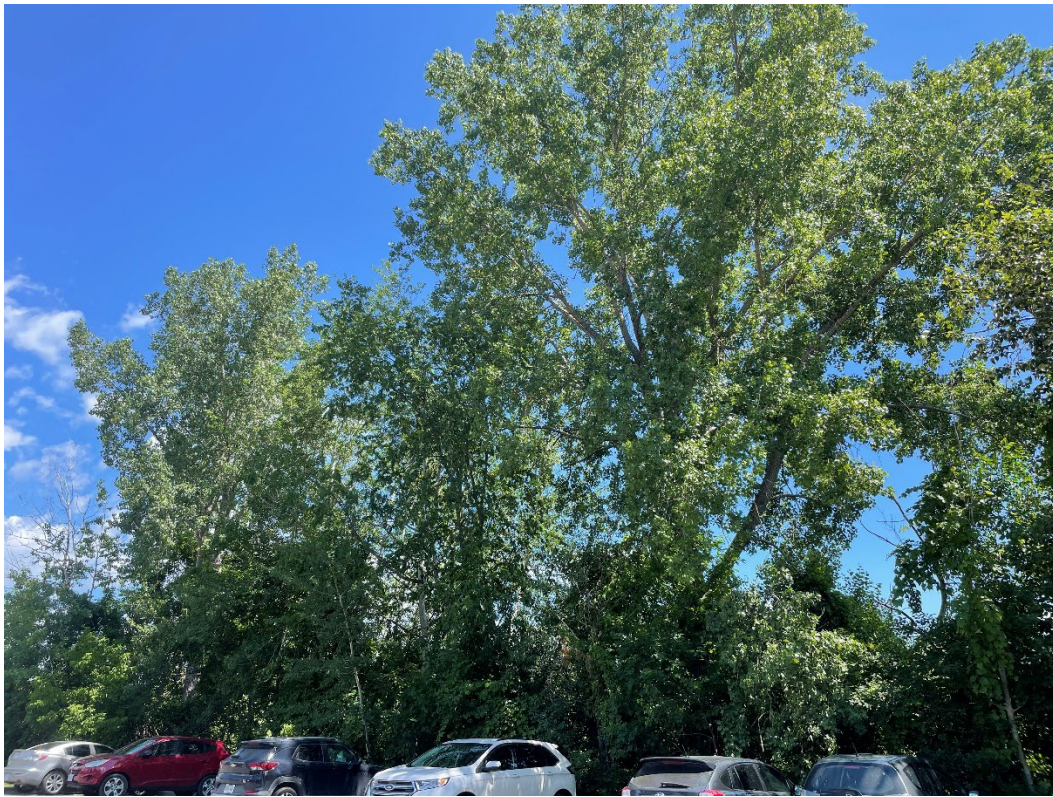
The Geotechnical Report prepared by Paterson Group on December 15, 2021, identified the presence of sensitive silty clay on the site. This soil is common in Ottawa and can cause foundational issues if trees are planted too close to structures. Trees, especially high-water demanding species, can deplete water from the soil which may cause shrinkage and shifting of foundations. The new building will be approximately 2 m from the eastern property line where there is an 8-10 m wide row of poplar trees. Poplar trees are fast growing and are high water demanding trees. The recommendation from the report is to provide a setback of 7.5 m from the foundation for smaller trees. For medium to larger trees, the setback should be equivalent to the tree height at maturity. Since these poplars can grow 25-30 m high at maturity, they are closer than the recommended setback distance.

As per the recommendations of the geotechnical report regarding maximum tree heights and distances to the building, the row of poplars should be removed to reduce the risk of future foundation issues. In addition to this, the excavation for the new building will be close to the property line which would likely cause some instability of some of the large trees close to the property line on the school side.

Figure 2: Poplar trees along the eastern property line

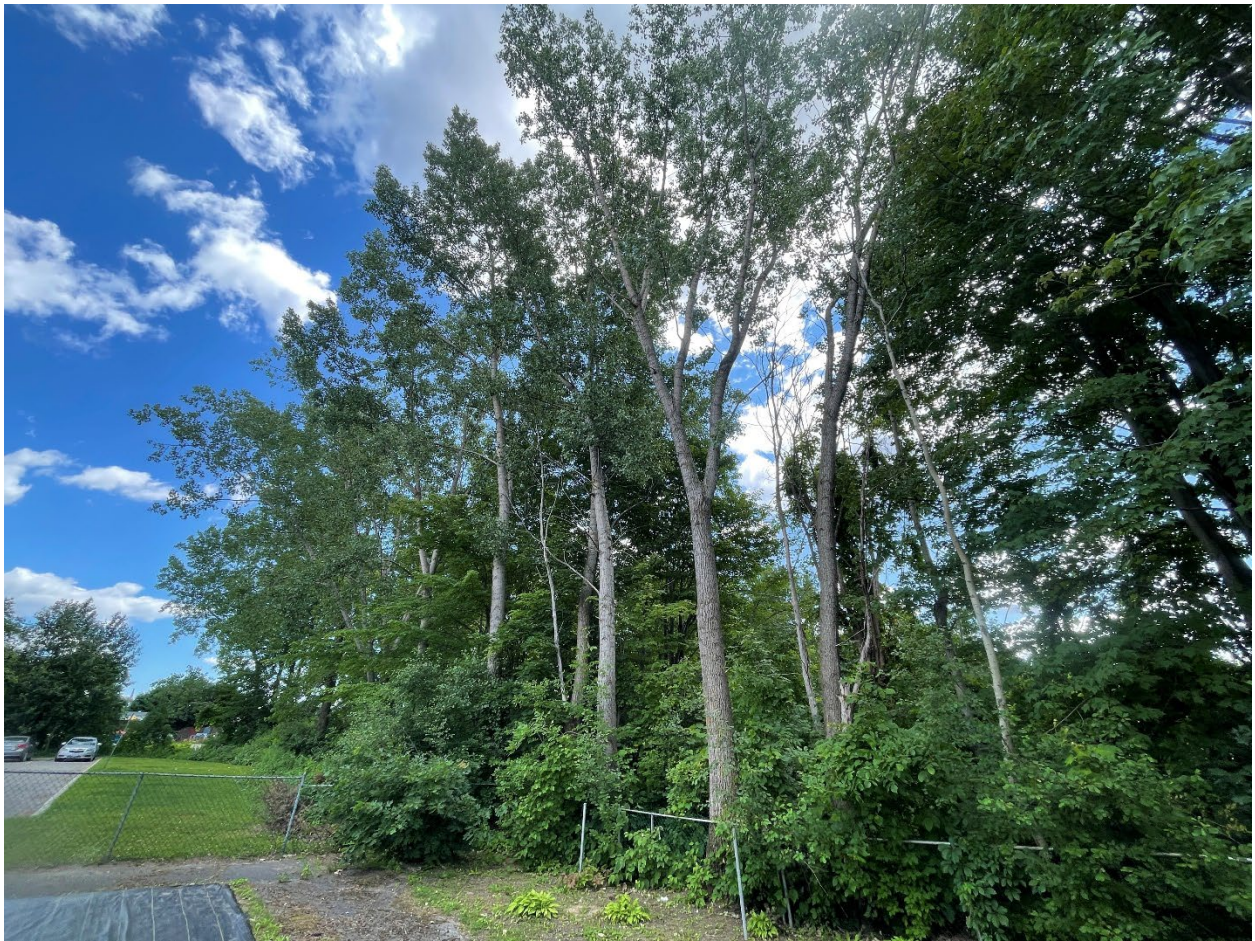
The trees along the south side (trees 18, 24-27) will also be within a tree height of the foundation and require removal. All these trees are within a distance that is less than their current height from the proposed building. Furthermore, there is a transformer to be installed within 2 m of trees 24 and 25. In earlier report iterations, the option of retaining trees 24-26 was explored. The theory was that perhaps the hard surface of the new loading ramp would provide a sufficient barrier to alleviate any concerns around the potential for soil shrinkage by these trees. However, the responses to this question received by the Paterson group memorandum dated April 29, 2025, do not support this concept and, therefore, removal of these trees is now recommended. The option to relocate the transformer was also explored but no longer being considered given the concern around the potential for soil shrinkage.

The row of poplars to the south (trees 20 – 23) will be less than 2 m from the new parking area. The excavation for the proposed parking lot will impact the roots of these trees and may contribute to instability, and removal and replacement is the preferred option in this area.

Figure 3: Poplars and red maples along the southern property line
